**ARCHAEOLOGICAL RECORDING OF A REDUNDANT  
AGRICULTURAL BUILDING AND SITE AT  
STURRIDGE, KENNERLEIGH ROAD,  
SANDFORD, DEVON**

**March 2008**

**MW.164/07**

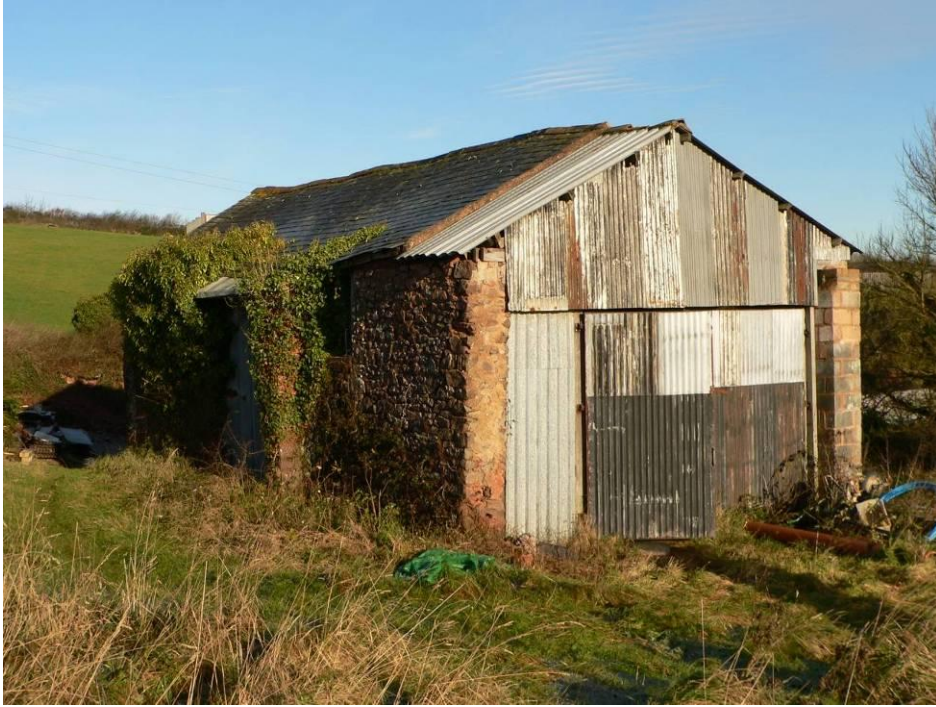
The south end of the barn has been truncated and the south east corner rebuilt to eaves level in concrete blockwork. The south gable is infilled with corrugated metal sheeting on timber studs, with double doors of corrugated sheet metal on angle iron frames, hung on vertical softwood posts, with a fixed panel of sheeting on timber studs at the west side.

The west wall is of random rubble stone, a grey/brown local sandstone bedded in a clayey mortar. There is a single window opening at high level with a modern domestic-style timber window inserted in it, which has two 3 x 2 light fixed casements. To the south side of the large central opening is a projecting brick buttress, and the north side of the opening has brick quoins. The opening, which would formerly have contained large double doors, is infilled with corrugated metal sheeting fixed to timber studs. The roof extends downwards over the head of the door to form a small porch, now clad with corrugated metal sheet. At its north-west corner, the west wall is tied into the cob of the north gable with stone and some brickwork.

Sturridge: barn from the south-west

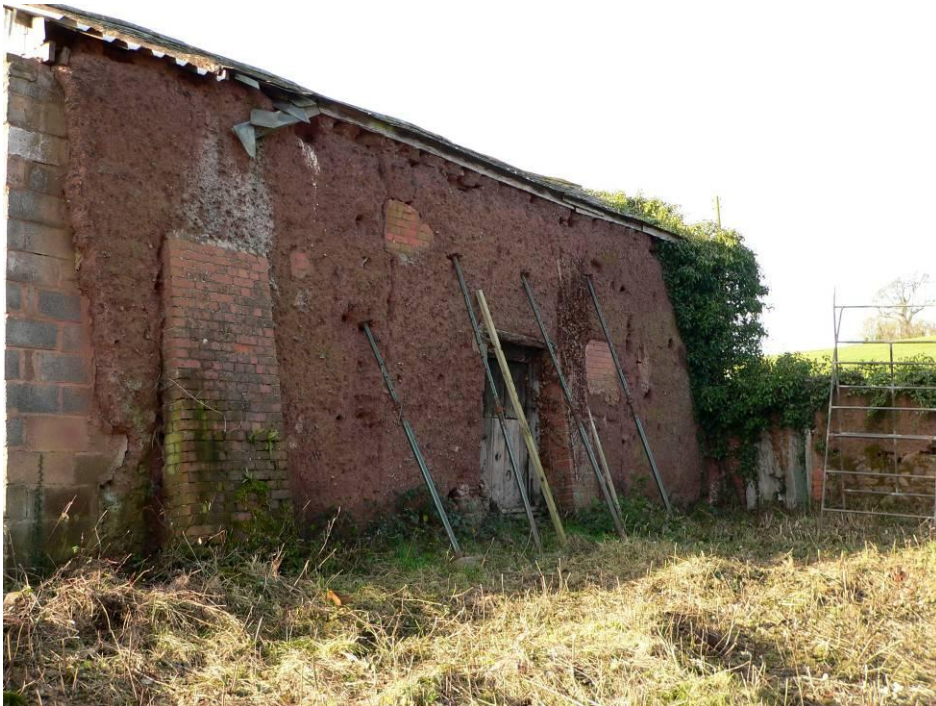
The east wall is of cob on a low rubble stone plinth, which is just visible above present ground level. The top part of the wall is leaning outwards and is supported by two brick buttresses (see plan) and some recently added Acrow props. The cob is quite red in colour, with many small/medium stone inclusions. There are two areas of brick infill between the north end and the central doorway: the smaller surrounds the end of the timber beam that supports the mezzanine floor across the north end of the barn and the larger is where the drive was taken from the horse gear into the barn. The central doorway has a weathered timber lintel over and an inward-opening door hung in a heavy, chamfered oak tenoned and pegged frame, with a built-up timber threshold. The door is split, or stable type, with two opening leaves formed of vertical timber boards nailed to plain horizontal ledges. It is hung on blacksmith-made strap hinges, the bottom hinge being of a different (?newer) pattern than the other three. The lower leaf of the door has a cat hole cut in one of the boards.

Sturridge: barn from the south-east

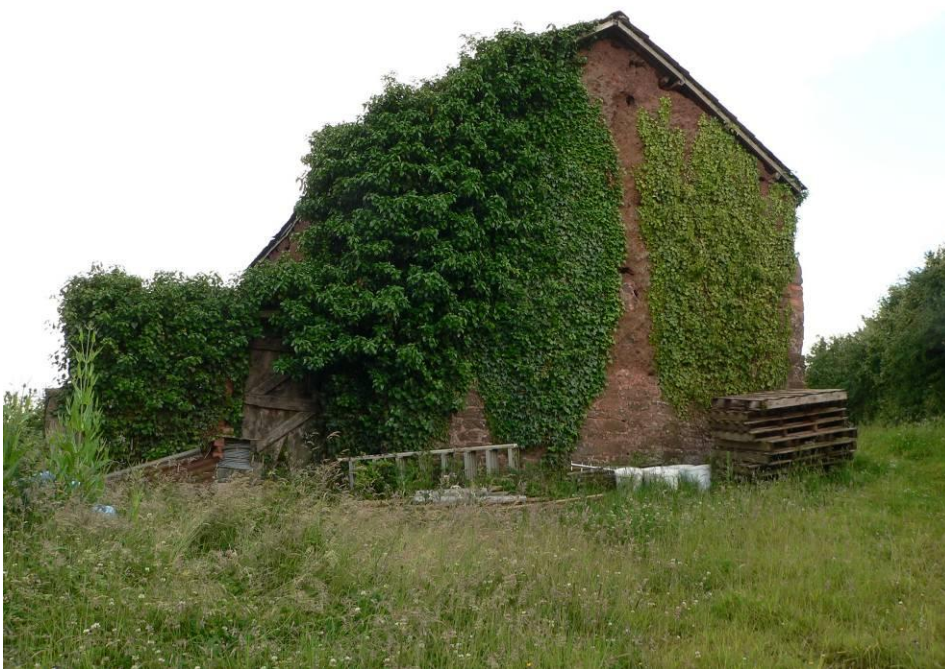
The north gable end is built of weathered cob on a coursed rubble stone plinth about 1m high, the cob standing to the full height of the ridge. It is partially overgrown with ivy. There is a small area of stone infill in the cob just west of centre, and the roof purlins and rafters overhang the wall at the eaves. Extending about 2.1m eastwards from the north gable end, but set back about 0.3m from it, are the remains of the north side of the roundhouse shown on the OS 1:2500 maps. This comprises a cob wall on a rubble stone plinth, with a doorway with brick jambs and a timber lintel over. There is no building break between the north gable of the barn and this wall. The door is a plain timber-

Sturridge: barn from the north-east

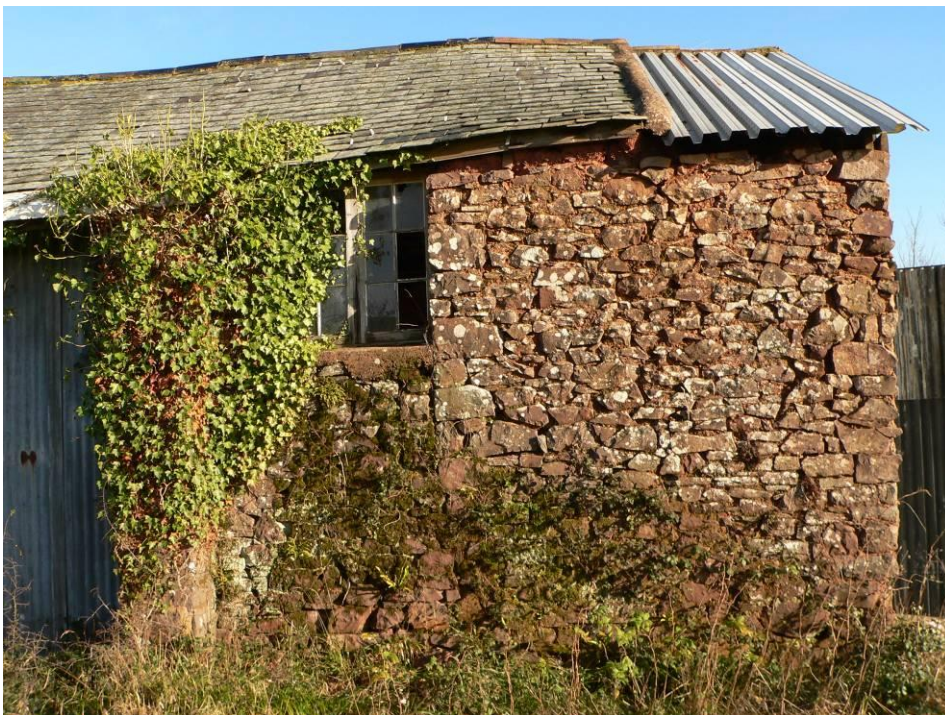
Sturridge: south end of west elevation of barn

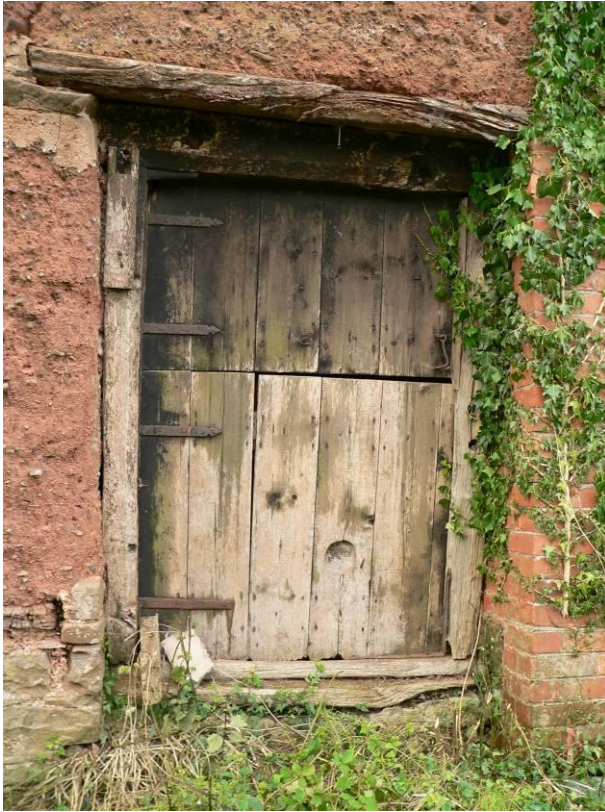
boarded ledged and braced leaf with a wooden lifting latch. The doorway has a concrete cill, with concrete steps down on the north side.

East doorway: exterior

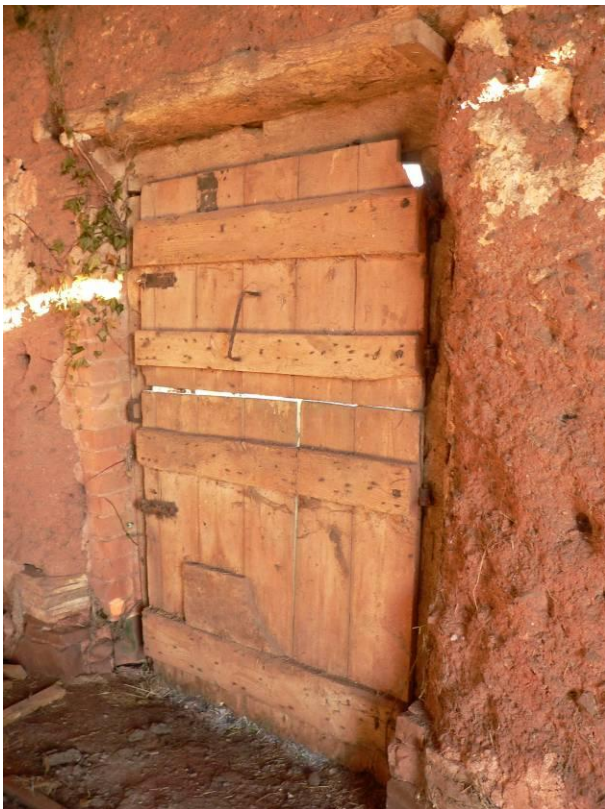
central doorway. The blocked opening, through which the drive was taken from the horse gear, is filled with hard, machine-made bricks. The central doorway has already been described, with its sturdy frame and plank and batten door. This door and frame are good early features of the building. There is a circular recess in the cob wall in the middle of bay 4 (from north), about 0.3m in diameter and 2.7m above the floor. The southeast corner of the east wall has been rebuilt in concrete blockwork. The south end of the building comprises the corrugated metal double doors and fixed panel, already described. The west wall is of unfinished rubble stonework, the window opening having splayed reveals. There is a straight joint in the stonework extending about 0.8m vertically downwards from the south side of this window opening.

East doorway: interior

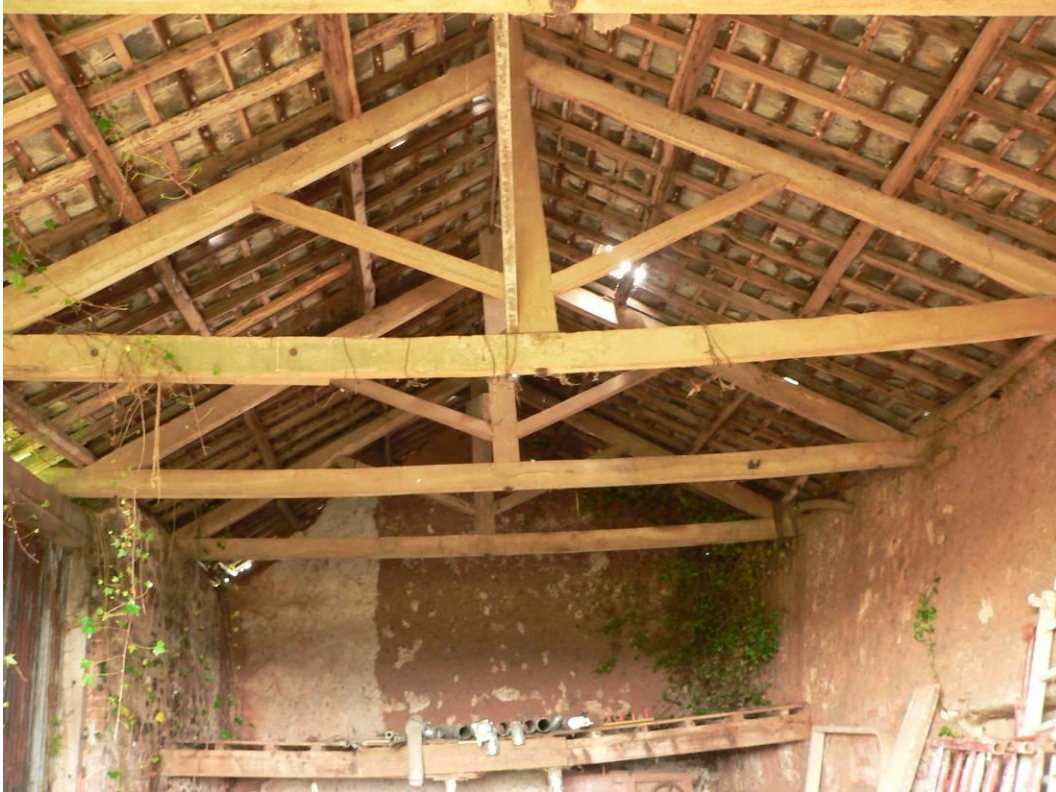
The roof is of 5 bays, defined by 4 timber trusses of similar construction. The south gable has an improvised truss formed from lengths of softwood held together with nails, bolts and modern joist hangers, to form a structure that supports the purlins, rafters and corrugated sheet metal vertical cladding. Three of the original trusses are numbered with carpenter's marks from south to north, I, II and III, while the fourth (north) truss is unmarked. They are king post trusses, the foot of the king post being bolted up through the centre of the tie beam. There are raking struts on each side between the king post and the principals, and the feet of the principals are birdsmouth-jointed to the top of the tie beam. The tie beams, king posts and principals are all of oak, about 180 x 75mm in section. There are two rows of purlins on each slope, the purlins being carried on the outer faces of the principals, and softwood common rafters, approx. 64mm square, at about 405mm centres. The slates are nailed to 50 x 25mm softwood battens. The west ends of the tie beams are set on timber blocks on the top of the cob wall, except for truss III, where it is carried on the timber lintel over the double doorway. The east ends of the tie beams are set into the cob wall.

The mezzanine floor extends across one and a half bay from the north gable end. Its south end is carried on a beam of c.200 x 100mm section, which is built into the walls at both ends. This beam has broken at about mid span and is now propped. The floor is of butt-jointed softwood boards of 230 x 22mm section, nailed to 100 x 70-75mm section circular-sawn softwood joists, at about 355mm centres. The floor, which is partly covered with feed or bedding, has several spout holes cut into it.

Interior of barn, looking north, showing roof structure and mezzanine floor

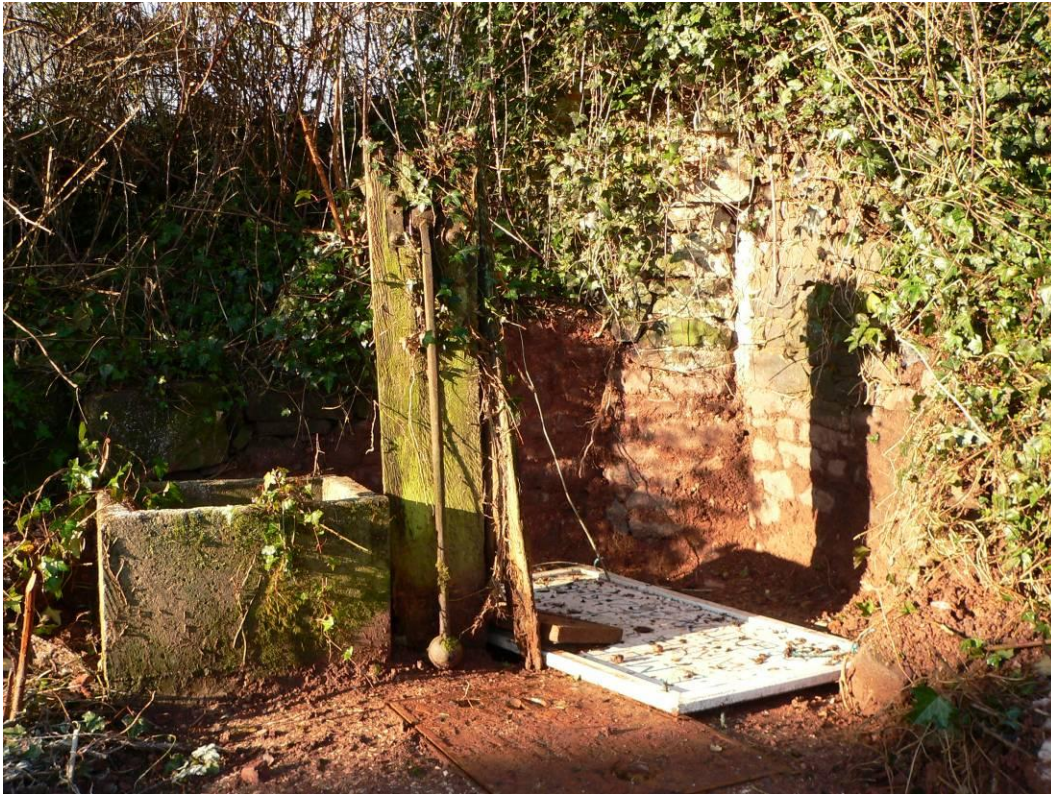
Well head and pump, with curved stone feature (?oven) behind

The ruins of cottage D include a rounded feature projecting from its south wall next to the surviving well. The feature has an internal brick lining which is just visible from the south and which might be an oven associated with a fireplace, although little if anything of the fireplace itself is visible at present. The well water level is some 4-5m below ground, suggesting that it taps into an aquifer in the rock rather than collecting surface rainwater as some shallower wells do.

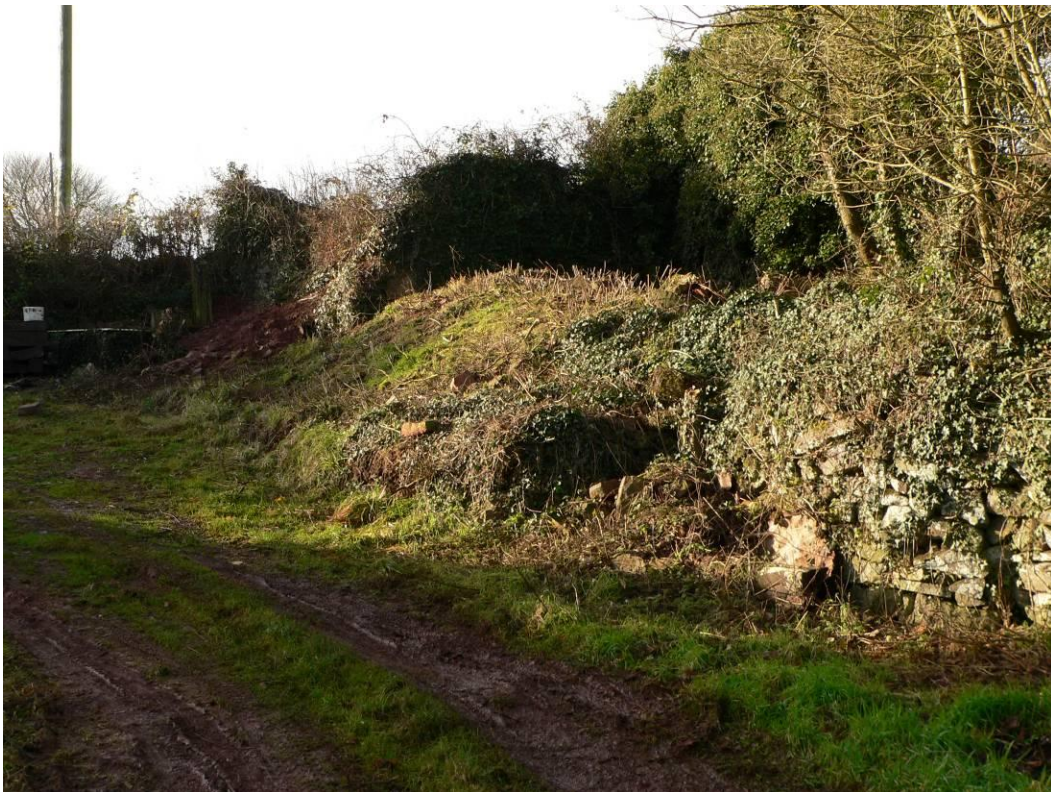
**Cottages:** A row of cottages stood at the northwest corner of the site and their position is shown on the Tithe Map and large scale OS maps (Figs.3, 4 and 5). There are some remains of standing walls and a well in the corner of the present site, but only a small area of these former buildings is included within the present site (see Fig.1). This corner of the site rises quite steeply to the north and west and is overgrown. Some sections of walling of rubble stone and brick are visible. The well is covered by an inspection cover and was not examined. It is understood that it is well built and quite deep. There are the remains of a hand pump and a concrete trough at the well head. It appears that the remains of the cottages, which do not appear to have been occupied after about 1871, were adapted and subsequently used for agricultural purposes. An undated aerial photograph shows the cottages in an advanced state of dereliction, although they appear to have been occupied into the second half of the 20th century.<sup>12</sup>

North side of site, from east, looking towards well and position of former cottages

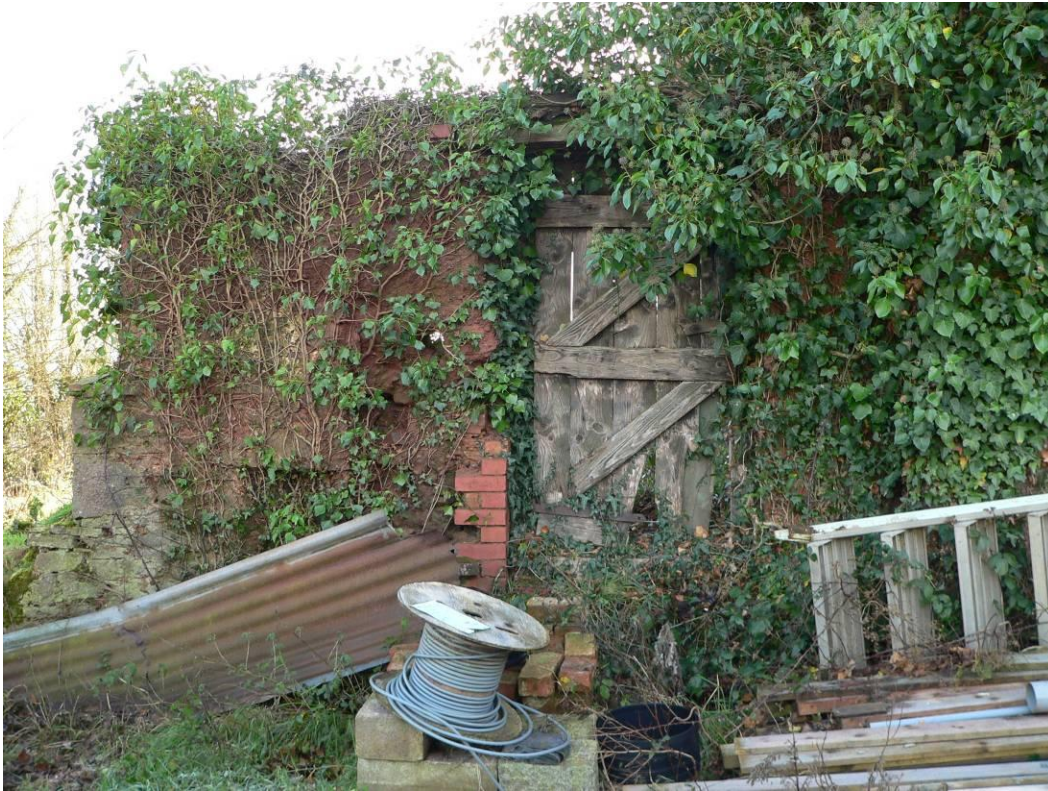
North side of wall projecting to east of north gable end of barn

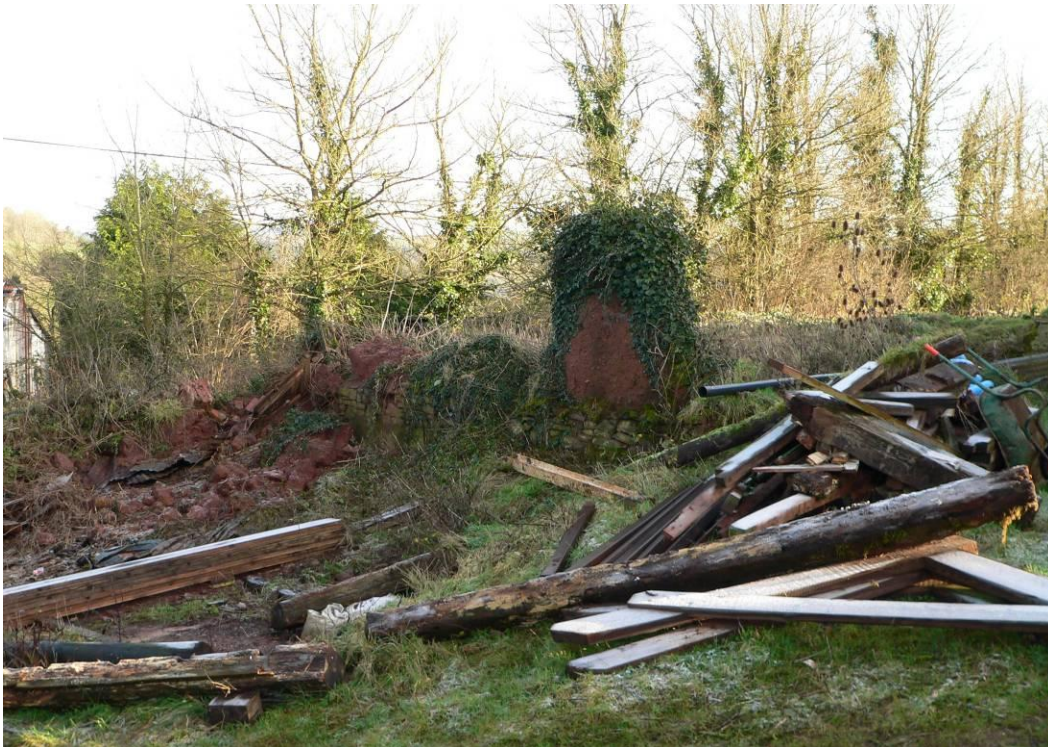
Barns to northeast: Two adjoining buildings are shown to the north of the roundhouse on the first and second editions of the OS 1:2500 maps. These were set at two levels: the southern building, which was about 5m wide, stood immediately north of the roundhouse and this area is now infilled with rubble and overgrown. Its north wall formed the back

wall of the barn close to the site entrance, which was set at a lower level, being cut back into the natural slope. Its maximum internal dimensions were approximately 6.4m (n-s) by 8.2m (e-w). This barn, which was cob-walled, has collapsed within the last five years and its remains, including some fragments of timber roof structure, a pine boarded door with a blacksmith-made hinge and a window frame with vertical staves, have been dumped on and just within the property boundary to the road. The south (back) wall has a random rubble stone plinth with cob above. The stonework was partially rendered.

Remains of former barn to south of site entrance
