**ON BEHALF OF  
CAMPBELL OF DOUNE LTD  
AND  
DRUMMOND ESTATES**

**KELTIE WATER, CALLANDER  
HYDRO-ELECTRIC SCHEME**

**Archaeological  
Watching Brief and Site Protection  
March 2015**

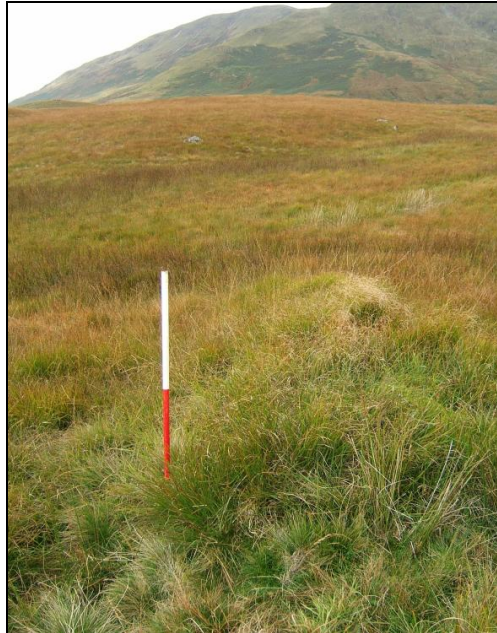
What was believed to be turf-covered boundary bank runs from NN 64120 13422 westwards to NN 64051 13406 where it peters out. It measures 1.5m wide and 0.5m high.

*West end of Site 2 viewed from the east*

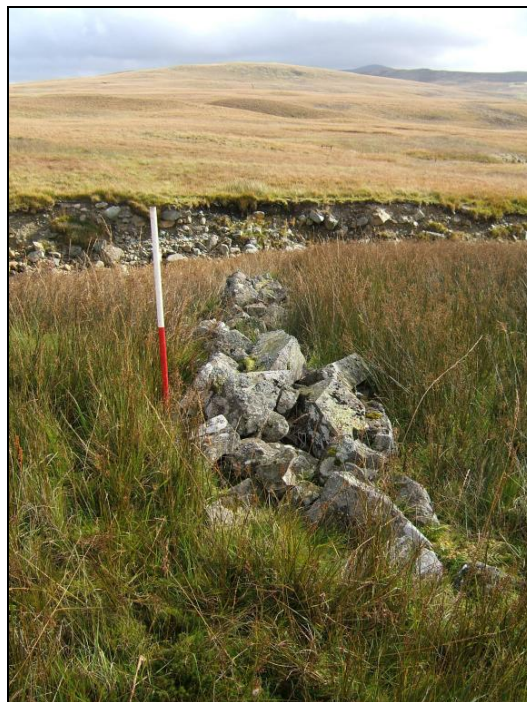
Site 3 consists of a stretch of drystone wall running from NN 64145 13112 eastwards to NN 64155 13110, a distance of some 11m. It is 0.7m wide and survives to a height of 0.6m.

*Site 3 viewed from the west*

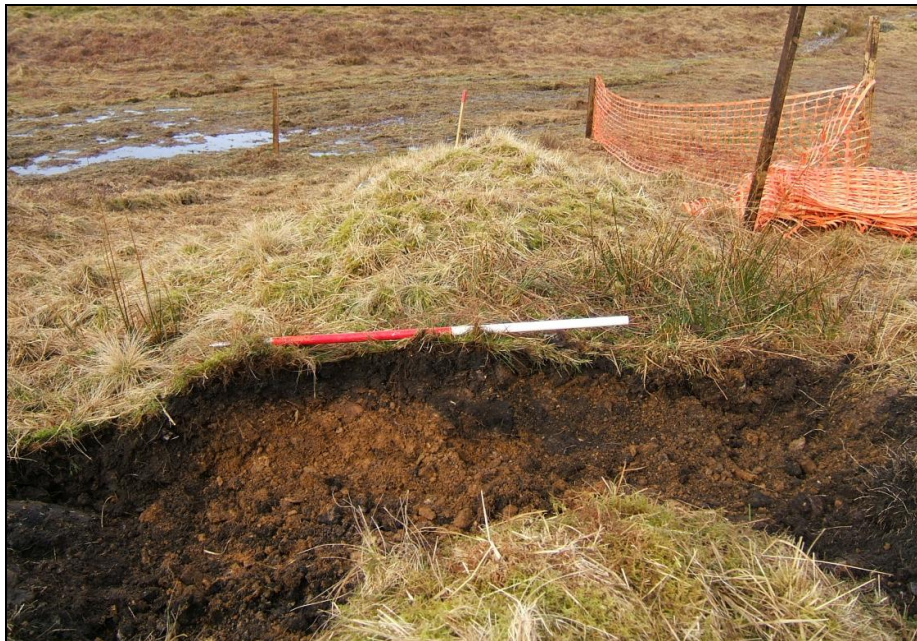
**Section across Site 2, viewed from the east**

Trenching demonstrated that this feature was made up of 0.2-0.3m of peaty soil lying directly over glacial till of orange clay and pebbles. From the evidence of excavation, its interpretation as a boundary bank now seems unlikely. A more likely explanation is that this feature comprises a small amount of upcast resulting from the excavation of an adjacent drainage ditch, now mostly blocked, to its immediate south.

Almost the entire length of this feature was threatened by the construction of the penstock and its access road. Rather than merely watching its removal, the decision was taken to cut two trenches across this feature in order to assess its nature and construction.

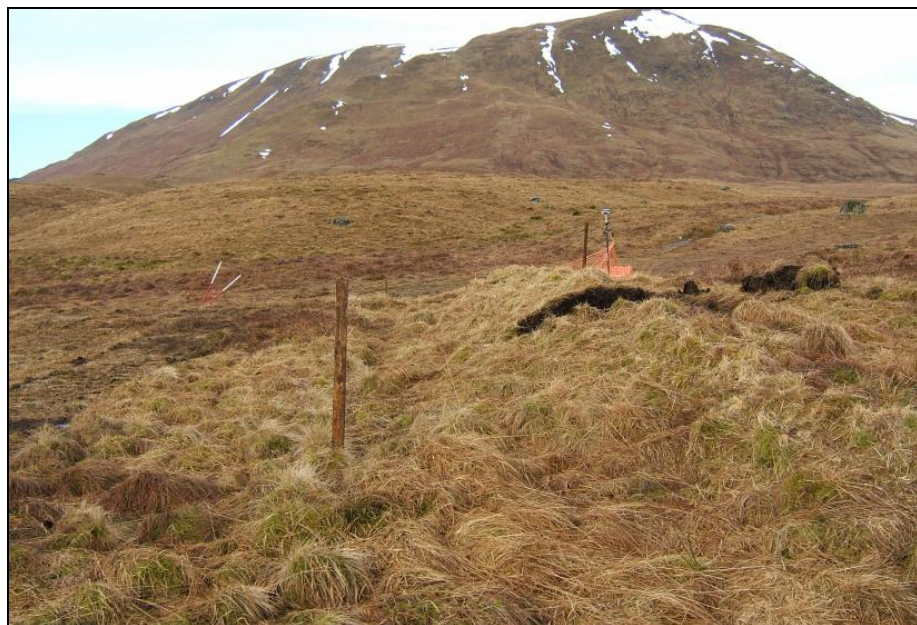
**View of Site 2 with remains of adjacent ditch**

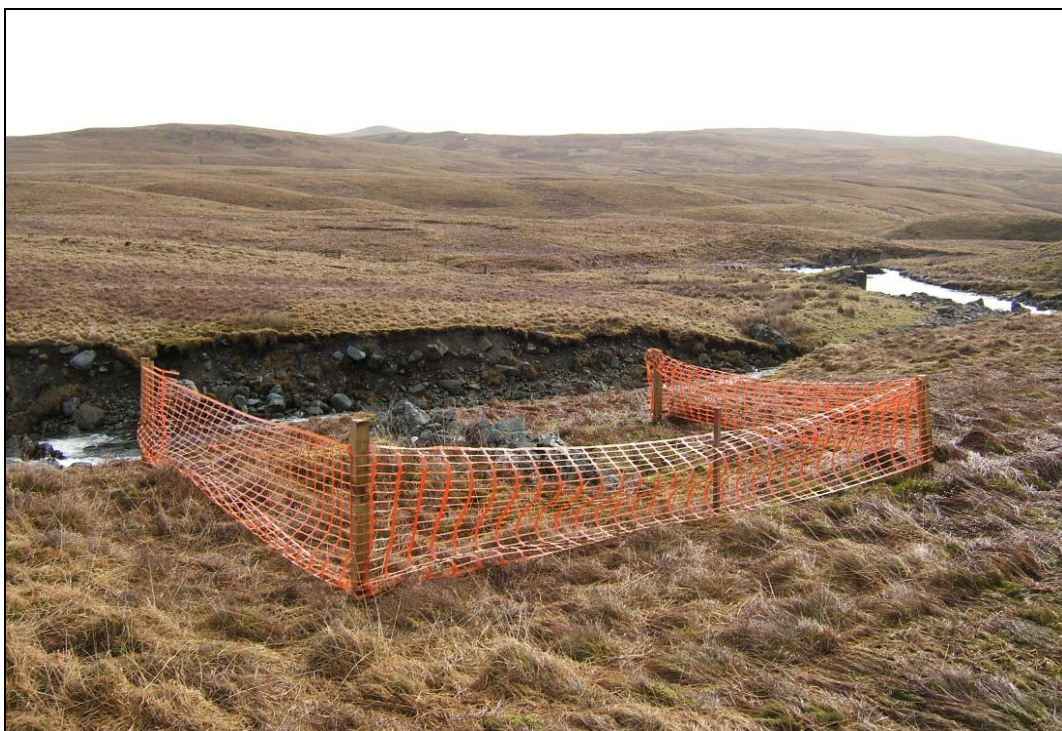
Site 3, a short stretch of partly demolished drystone field wall, was located well to the east of both the penstock and the new access road and will not be affected directly by the development. However, to ensure the structure's preservation, TSL Ltd erected a protective fence around it (see photograph below).

**Site 3, viewed from the north-west, with protective fence around it**

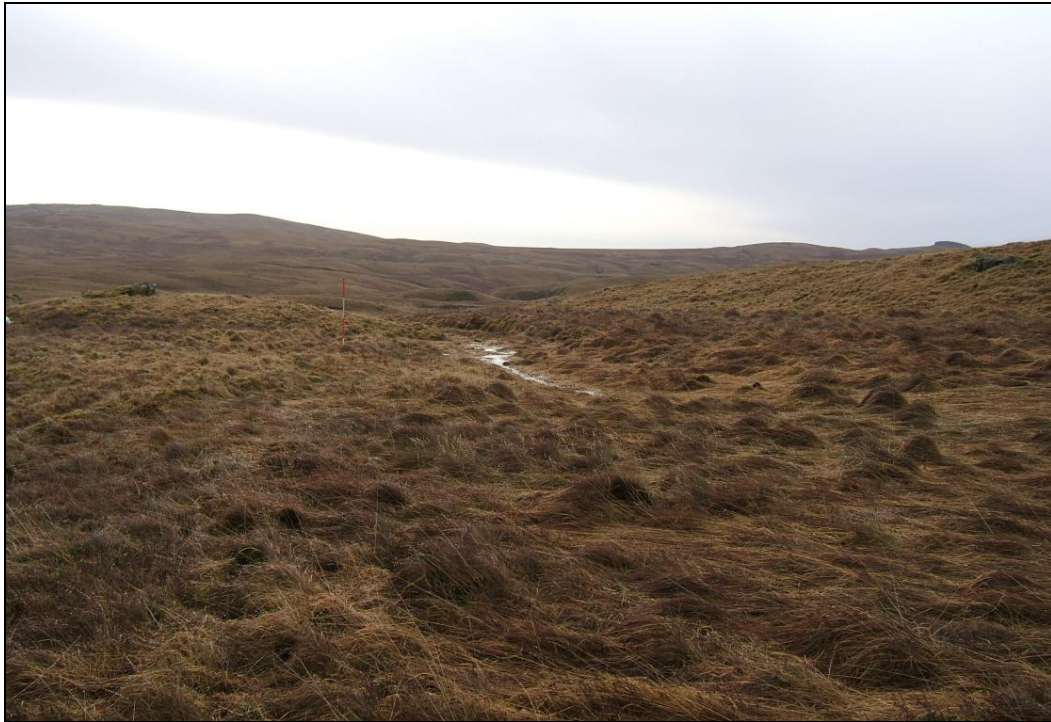
Conversation with the local farmer confirmed that Site 23, initially interpreted as a possible boundary or ditch, was the original access track to the reservoir and hence of modern date. As a consequence, no mitigation measures were taken to protect this feature.

**Site 23 viewed from the north**
