**REPORT  
TO  
ALLT ENTERGY LIMITED**

**KENKNOCK  
HYDRO-ELECTRIC SCHEME  
GLEN LYON**

**Desk study  
and  
walk-over survey  
May 2015**

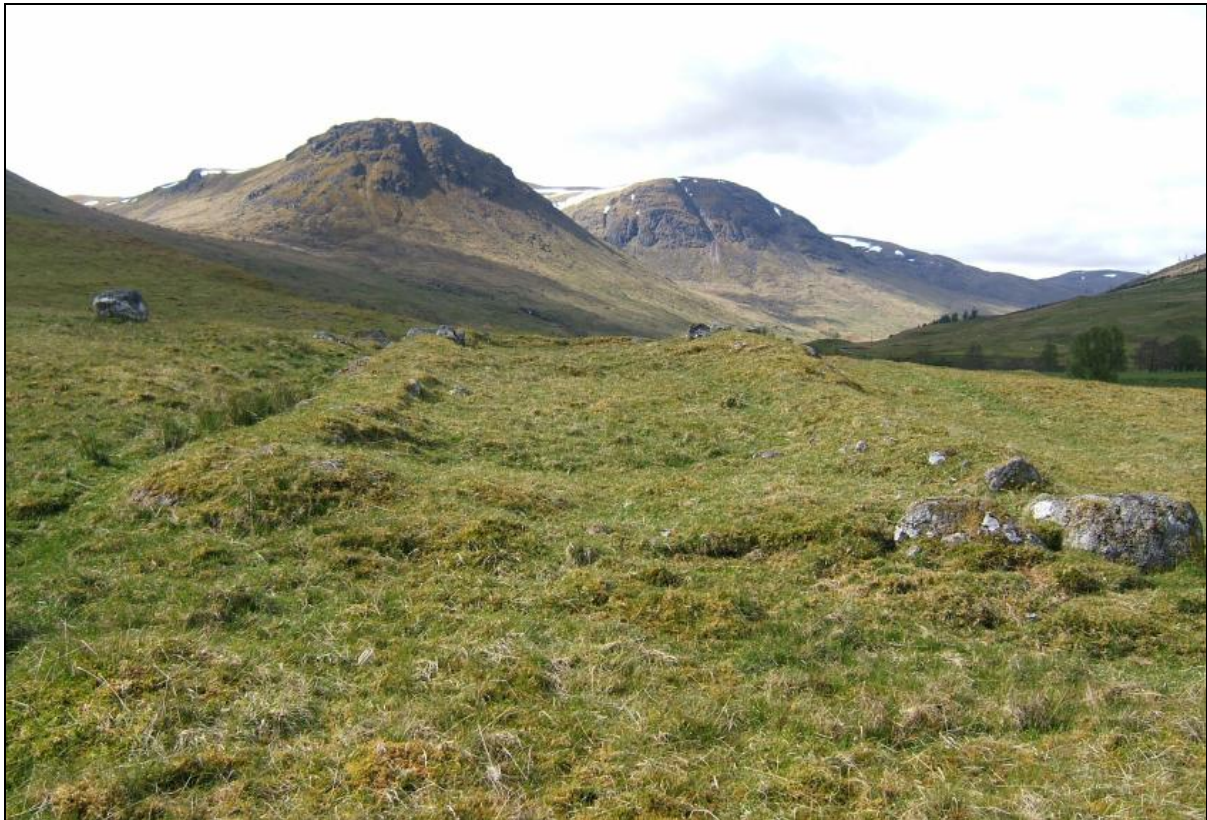
### *Structure 1 (Photos 3, 4)*

Structure 1 is located at NN 53236 44114 and comprises the remains of a building measuring some 21m north/south by 5m wide over drystone rubble walls, a maximum two courses of which survive. There is a cross wall 8m from the building's south end. No further features are discernible.

*Site 2, Structure 1, viewed from the north*

The various structures identified at these sites all lie relatively close to the proposed route of the new access road. It is recommended that each of them is protected by a fence prior to the commencement of trenching for the access road.

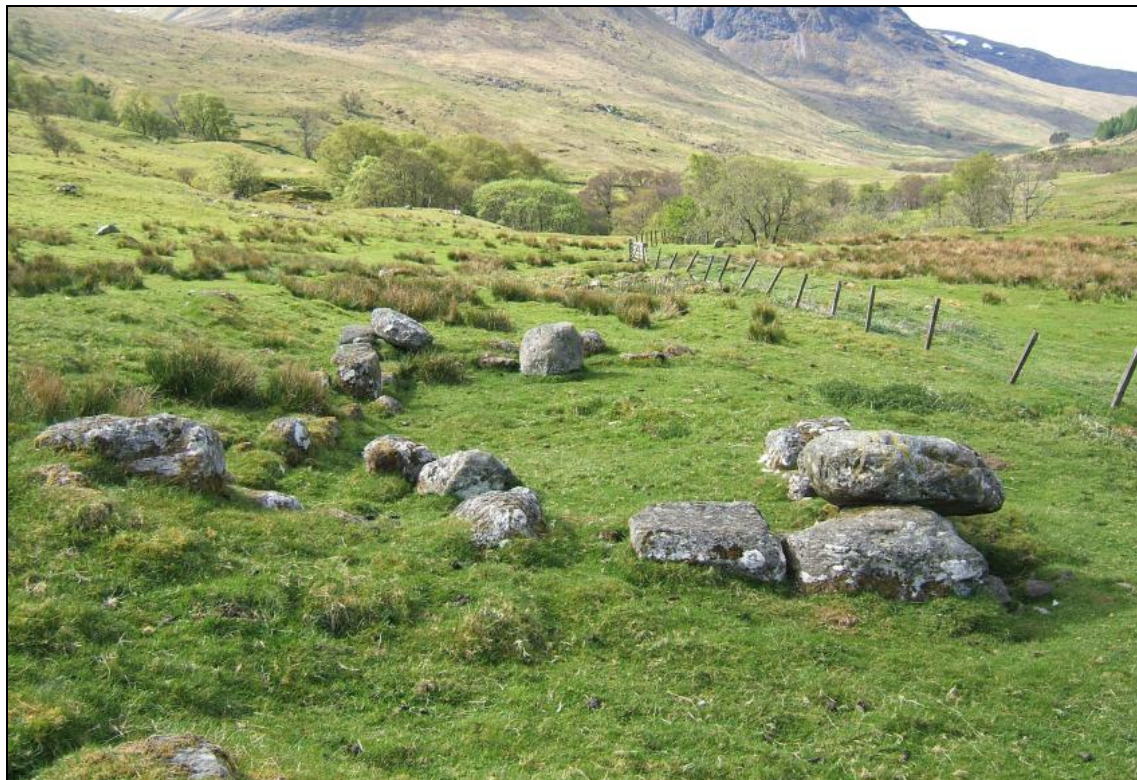
#### *Structure 1 (Photos 9, 10)*

Structure 1, located at NN 53095 43738, measures 9m north/south by 4m wide over drystone rubble walls of which a maximum of one course survives. There appears to have been an entrance midway along the east wall.

*Site 3, Structure 1, viewed from the north*

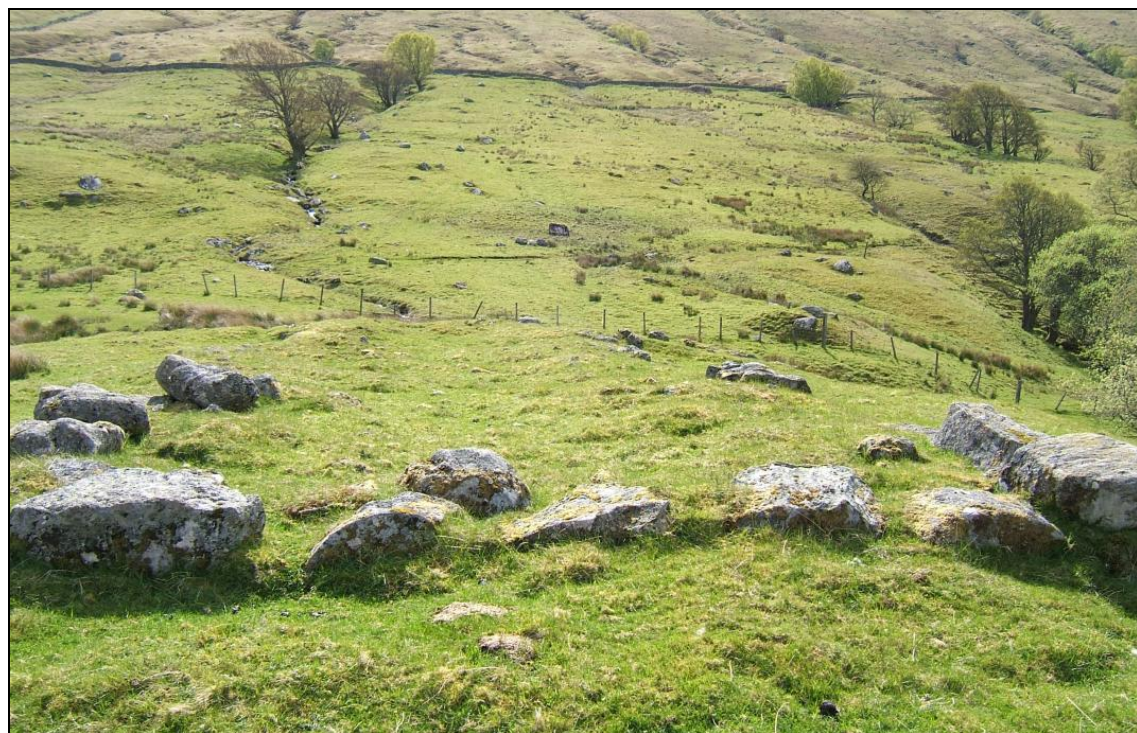
#### *Structure 2 (Photos 11, 12)*

The sparse remains of Structure 2 are located at NN 53038 43695, in a separate field from the one through which the new access road will run. This long building measures some 26m east/west by 5m wide overall, its walls almost completely covered by grass.

*Site 3, Structure 2, viewed from the west*

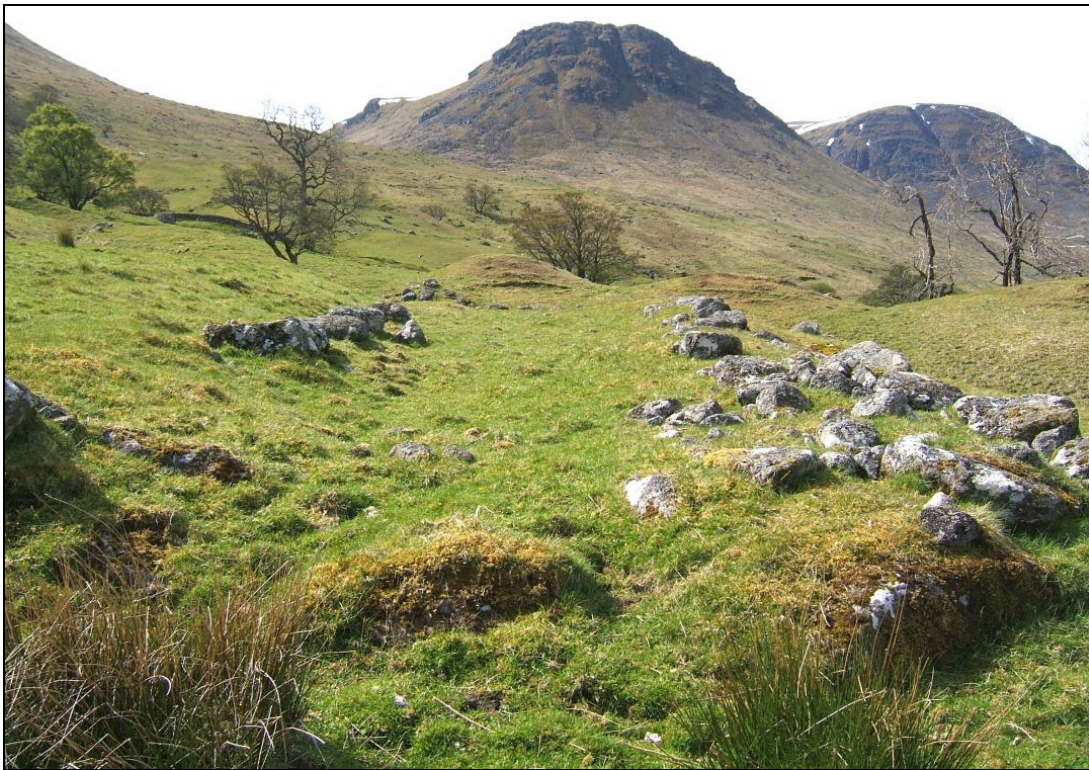
### *Structure 1* (Photos 15, 16)

Structure 1 is located at NN 53015 43498 and set on a platform supported on its west side by a low retaining wall. The building measures some 23m north/south by 4.5m wide, its walls standing to a maximum of two courses high and including some very large boulders.

*Site 4, Structure 1, viewed from the north*

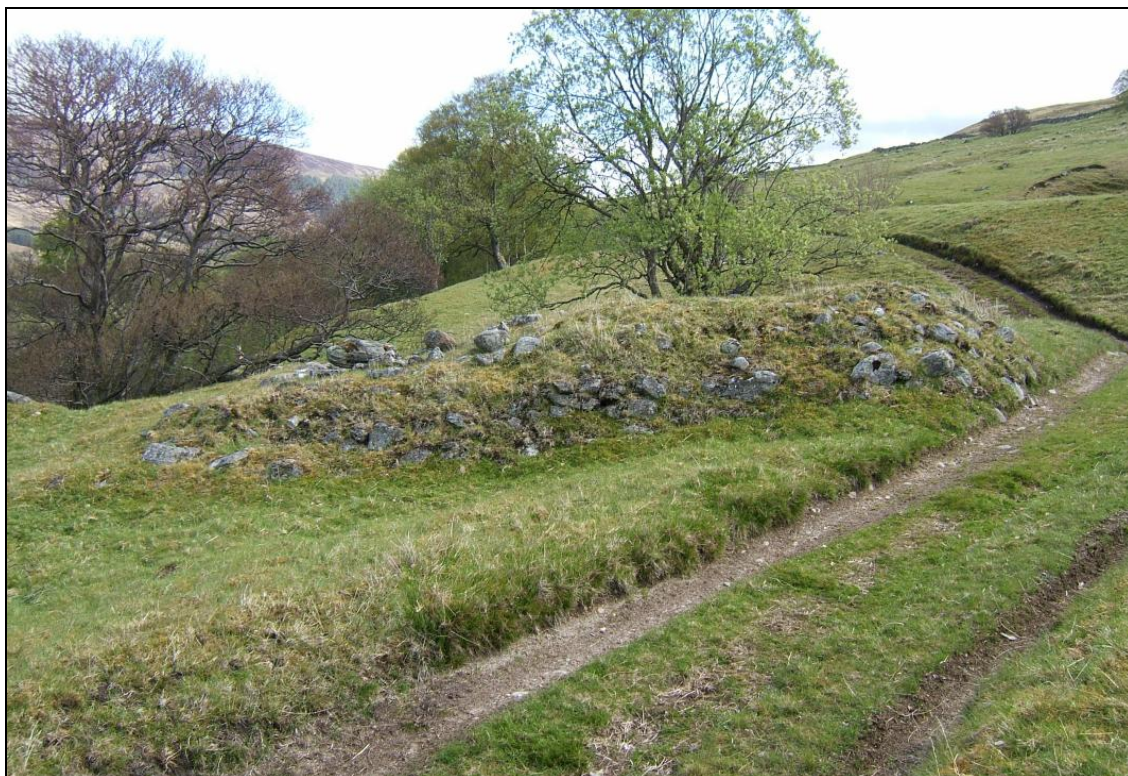
### *Structure 2* (Photos 17-19)

The remains of this small, bicameral building are located at NN 52996 43496, to the immediate west of the existing farm track. It measures 6m east/west by 4m wide, its turf-covered walls standing to a maximum height of 1m on the building's south side.

*Site 4, Structure 2, viewed from the south*

It should be noted that Structure 2 at Site 4 is located immediately adjacent to the existing farm track. As a consequence, the new road should deviate considerably from this structure which should still be fenced off for its protection.

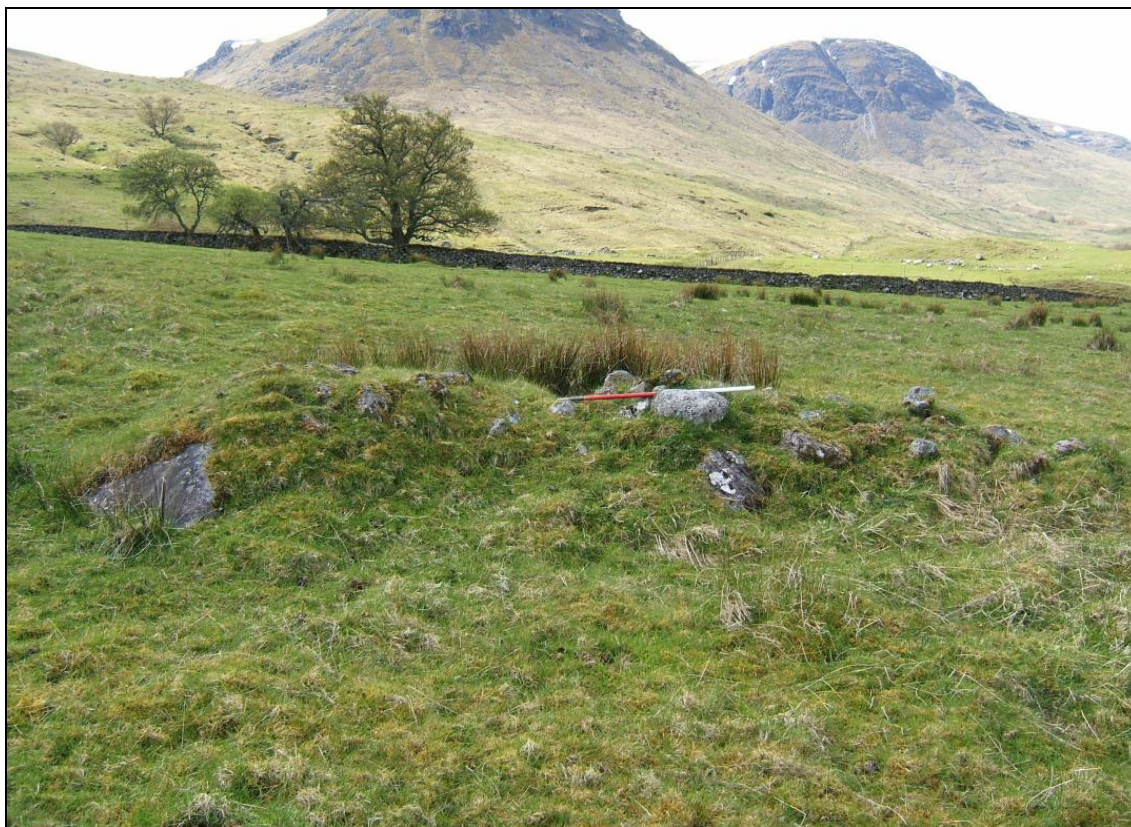
**Site 8 (Photos 29, 30)**

At NN 52979 43440, approximately 200m north of Site 4, is an oval mound measuring 4m east/west by 1.6m wide and 0.7m high. It is grass-covered but appears to comprise mostly boulders. It does not resemble any of the field clearance cairns in the area and it is tentatively interpreted as a prehistoric burial mound.

*Site 8: possible burial mound, viewed from the north*

Although its interpretation as a burial mound has yet to be confirmed, it is recommended that Site 8 is surrounded by a protective fence prior to the commencement of the development.

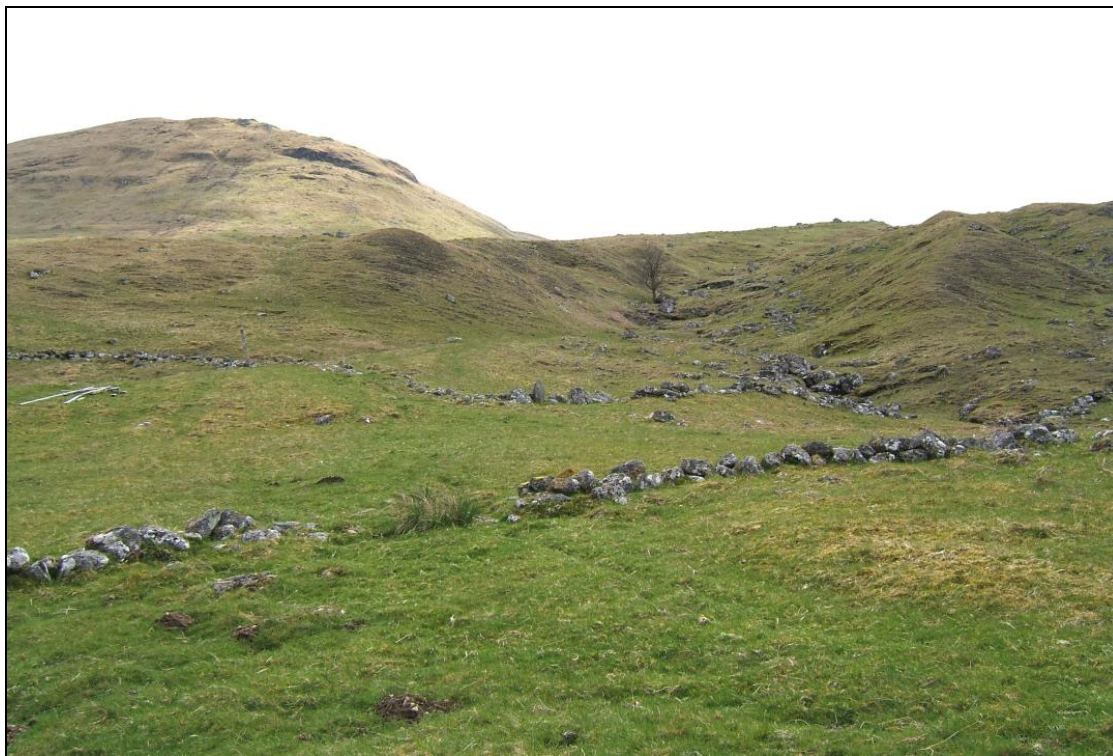
Both the new access track and the penstock will cross field walls. The new track is most likely to utilise existing gateways through walls that still define individual fields. The penstock, however, will cross the sparse remains of walls that no longer function as field boundaries, including what may have been the head-dyke for settlements arranged along the west bank of the river (see photo below).

*View to the south-east along the penstock route*

It is recommended that the penstock is taken through existing breaches in these walls and, if any walls are damaged during the development, they should be reinstated following the completion of the hydro scheme.
