**REPORT  
TO  
N & H McGUIRE JOINERS LIMITED**

**CONSTRUCTION OF NEW JOINER'S SHOP,  
ANCASTER SQUARE NORTH, CALLANDER**

**WATCHING BRIEF  
SEPTEMBER 2015**

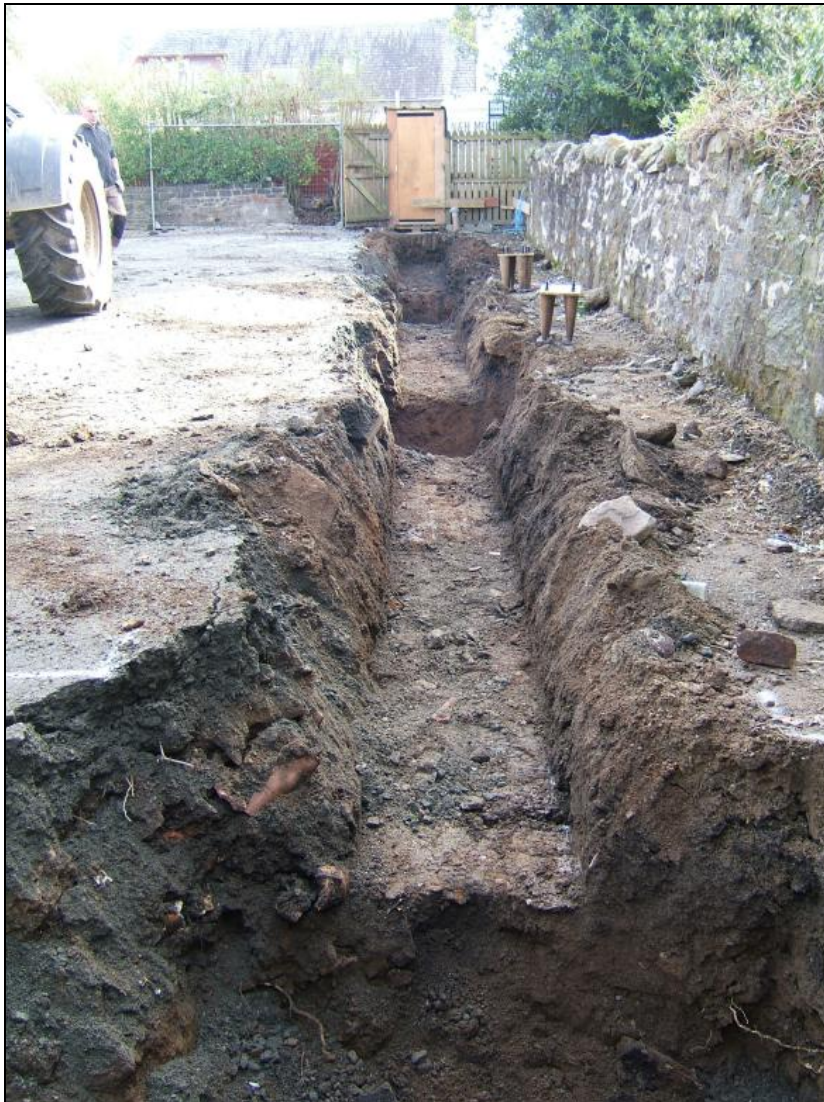
and perhaps other buildings of relatively recent age. This material, which included concrete, brick, rubble and ceramic tile fragments, was not bottomed in parts of the east and west trenches. Otherwise, the removal of the modern debris revealed glacial till of mid-brown silt, orange sand, gravel and occasional boulders. Only in parts of the east trench did topsoil of dark brown silty loam survive; elsewhere it had been removed, probably during construction and demolition work in the 20th century.

*South trench viewed from the west*

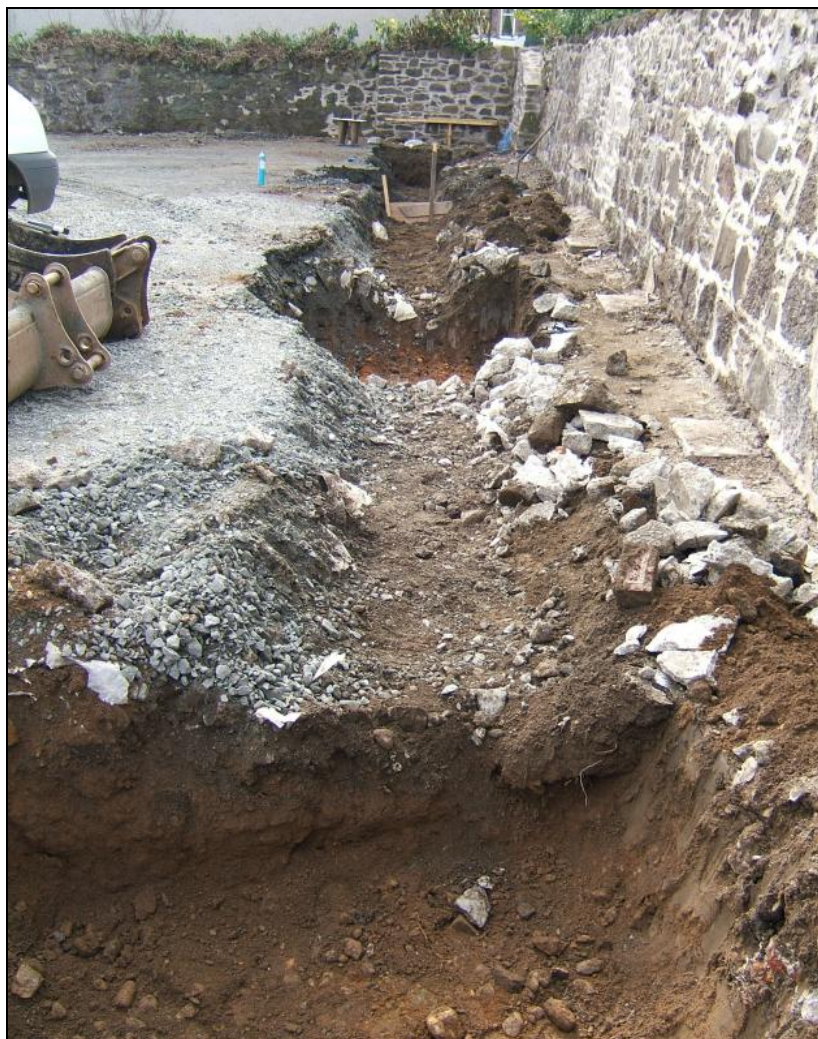
No structures, features or deposits of archaeological significance were uncovered in any of the trenches and no pre-20th-century artefacts retrieved from the site.

*West trench viewed from the north*
