REPORT TO SCOTTISH & SOUTHERN ELECTRICITY NETWORKS

UNDERGROUND POWER SUPPLY TO WOODSIDE, SHISKINE, ISLE OF ARRAN

ARCHAEOLOGICAL WATCHING BRIEF JUNE 2019

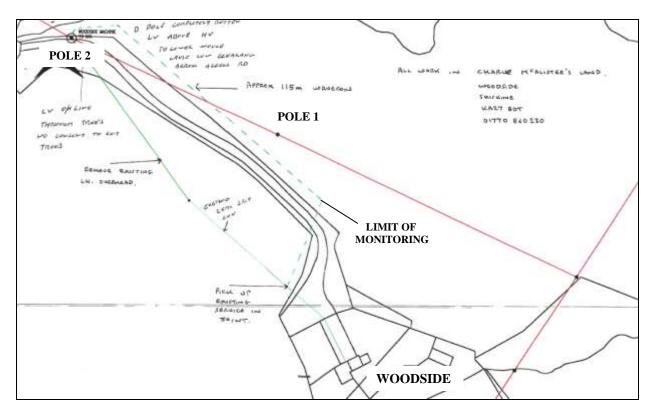
Map, showing location of trench

On the above map red lines indicate existing high voltage (HV) overhead lines, the unbroken green line the existing low voltage (LV) line to Woodside and the broken green line the intended route of the replacement underground cable. However, the underground cable route has been changed somewhat from that shown on this map. Instead of cutting across the field to the west of the road it will cross Woodside's access road and car park, through ground already disturbed on a previous occasion. As a consequence, trenching was monitored only between Pole 2, the transformer pole for the LV line at NR 92588 31376, as far as the point where the trench returned southwards, at NR 92646 31322.

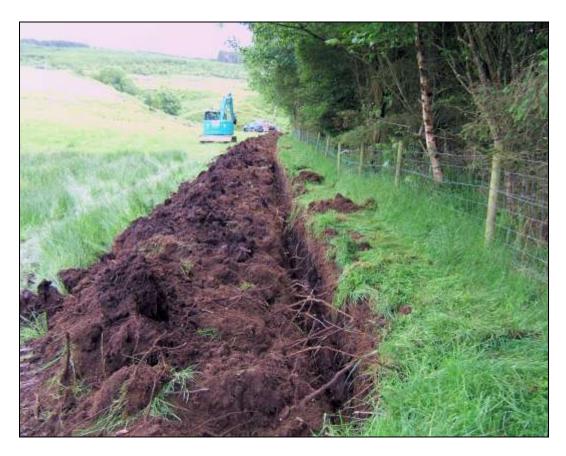
The monitored trench ran along the south-west edge of a pasture field which slopes down towards the access road to Woodside and which is bordered by young trees, mostly birch. It was some 80m long, 0.5m wide and 0.9m deep. The field also slopes down slightly towards Pole 2.

Topsoil of mid- to dark brown loam with lenses of boulders extended beyond the base of the trench, presumably because of hill-wash eroding down the slope. As the trench approached the transformer pole the ground became wetter and the topsoil darker and more peaty.

No features or deposits of archaeological significance were uncovered in the cable trench and the only artefacts retrieved from it were a single sherd of 19th-century china and a fragment of a ceramic field drain. Neither was retained.

Cable trench from the north-west

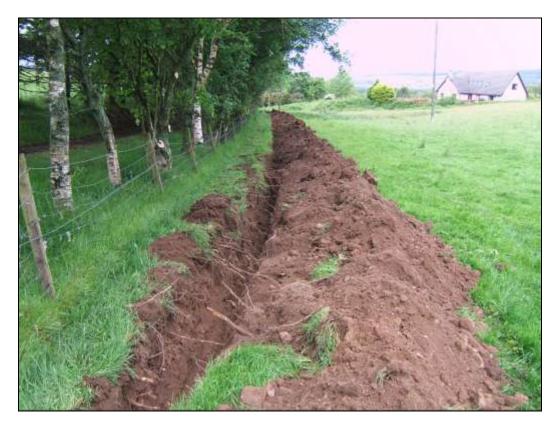
Cable trench from the south-east
