**AN ARCHAEOLOGICAL WATCHING BRIEF OF  
GROUNDWORKS FOR THE REDEVELOPMENT OF  
THE BRICK STABLES AT BARWELL COURT FARM,  
CHESSINGTON, SURREY**

## **Summary**

*Ground level reductions across the former stable yard and within the stable building were monitored for the presence of archaeological remains. Evidence of the former interior structural layout of the stable block was revealed as well as the foundations of a former cart shed. No features of archaeological interest were revealed and it is recommended that no further archaeological involvement is required in respect of the development.*

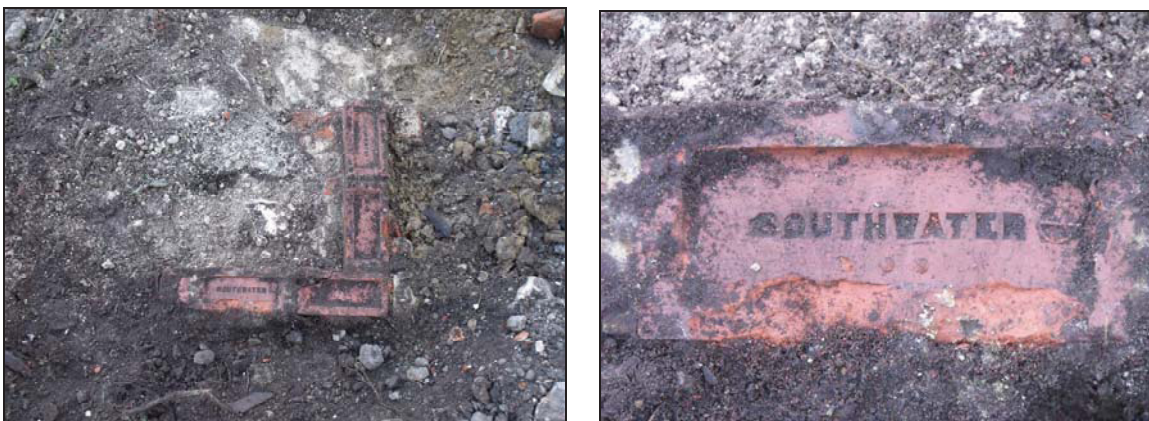
The excavation revealed two short sections of brick foundations that formed the northeast corner of a building (figs 2 and 3), most probably the L shaped building first shown on the second edition Ordnance Survey (OS) map of 1896, as the foundation's north wall was in line with the north end of the main stable building (note, previous reports erroneously cited this map's date as 1886). The foundations comprised of two courses of red bricks set on a shallow base of lime mortar. A single course of bricks set with lime mortar and stamped with the maker's name 'SOUTHWATER', formed the extant remains of the demolished wall. The remains of a compacted chalk floor was evident within the structure.

Fig 3 The foundations of the demolished building in the former stable yard, looking northwest, and detail of the bricks used in its construction

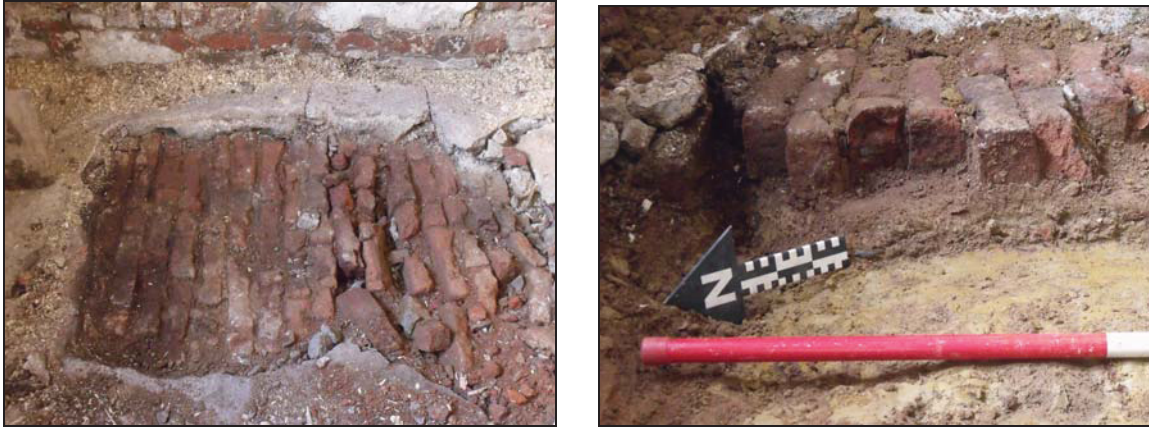
An area of approximately 7m<sup>2</sup> was observed (fig 4). It had a floor surface of concrete, 0.07m thick overlaying an earlier floor surface of shallow-frogged, red bricks laid stretcher side up on a layer of 0.08m deep orange/grey very sandy clay (fig 5). The bricks were heavily worn on their upper surface but completely unworn on their lower surface, suggesting they were unused when installed. The sandy clay on which they were set had occasional inclusions of struck flints and slate, and frequent brick and tile fragments. Two or three of the flints display flake removals on their distal surface indicating careful core preparation that is typical of a late Mesolithic or Neolithic date. Other flints may be the result of building activity. The inclusion of the prehistoric flints within this layer is curious but of little importance as they are clearly not in their original context and may even have been imported from outside of the site.

Fig 5 The brick floor and bedding substrate in Area 3

The four areas observed within the structure of the stables all showed that the area had been truncated, with no evidence of any top or subsoil present below the removed floor surfaces. All four areas were heavily disturbed by at least two phases of drains cutting the natural clay. What may have been an original brick laid floor was present in Area 3.
