**AN ARCHAEOLOGICAL WATCHING BRIEF ON THE STRIPPING OF
THE THAMES WATER SITE COMPOUND ADJACENT TO WATERLOO
FARM, OCKHAM, SURREY**

Project Manager	Rob Poulton
Author	Jane Robertson
Date	22 nd November 2007
NGR	TQ 0839 5529 (centred)
Client	Thames Water Utilities

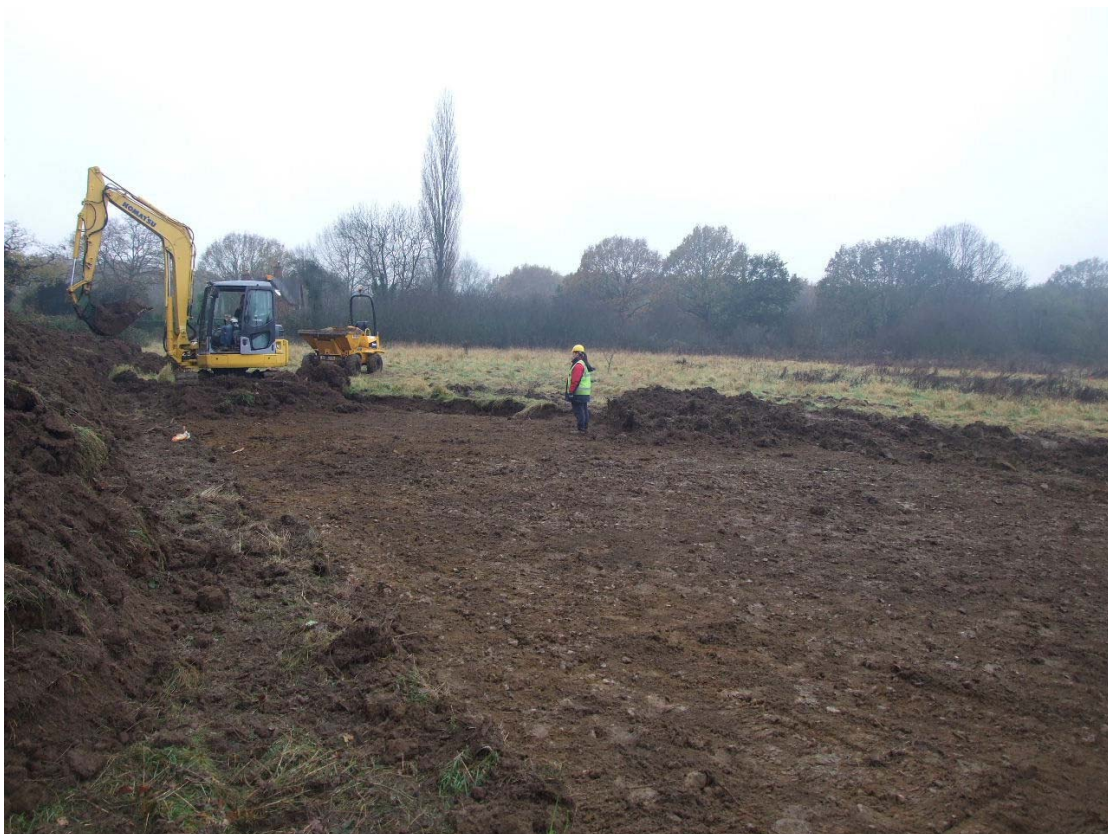
Fig 2 Thames Water compound, Ockham, looking west

The area of the compound is 50m by 35m, with an access strip of 10m by 12m (fig 1). The area was stripped of 0.25-0.30m of overburden using a 360° tracked excavator with a toothless ditching bucket (figs 2 and 3). The stripped surface was inspected for any features of archaeological significance, and the spoil checked in order to recover any artefacts of archaeological interest.

The stratigraphy observed across the stripped area was 0.25-0.30m topsoil over the natural mid/orange-brown sandy clay with patches of flint pebbles, and a few pockets of heavy clay in the western half of the area; this is representative of the Head deposits shown on the Geological Survey of Great Britain, map 285, covering this area, at scale 1:50,000. There was a 0.40m drop in the level of the land from east to west, and the stripped surface in the western corner of the compound area was just above the level of the water table, resulting in muddy conditions, exacerbated by the adverse weather conditions during the site strip.
