AN ARCHAEOLOGICAL WATCHING BRIEF FOR A NEW CLASSROOM UNIT AT REIGATE PRIORY JUNIOR SCHOOL BELL STREET REIGATE

An archaeological watching brief

Checked by	Rob Poulton
Author	John Payne
Date of fieldwork	31 May & 22 June 2016
Date of report	June 2016
NGR	TQ 25289 50064 (centred)
Post code	RH2 7RL
Site code	RPBS-16
Client	Surrey County Council Property Services

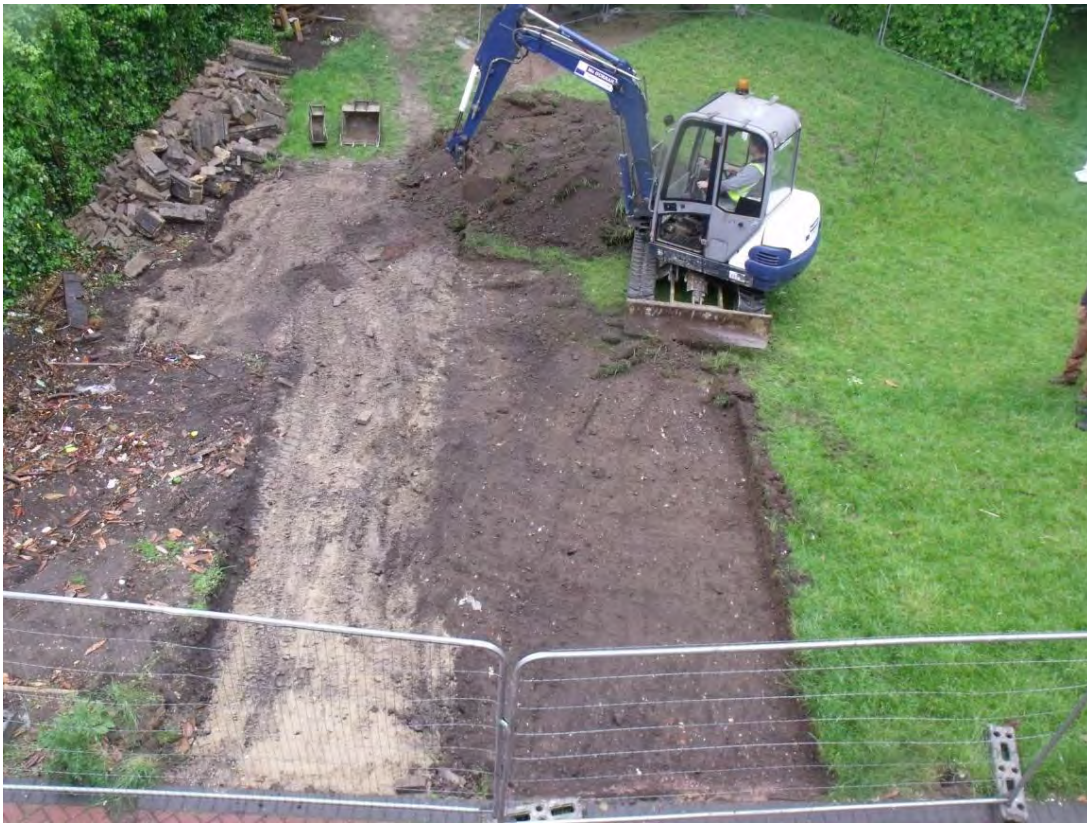
Fig 6 Reigate Priory Junior School, Reigate; removing topsoil, sand delineates line of modern pathway. View to west.

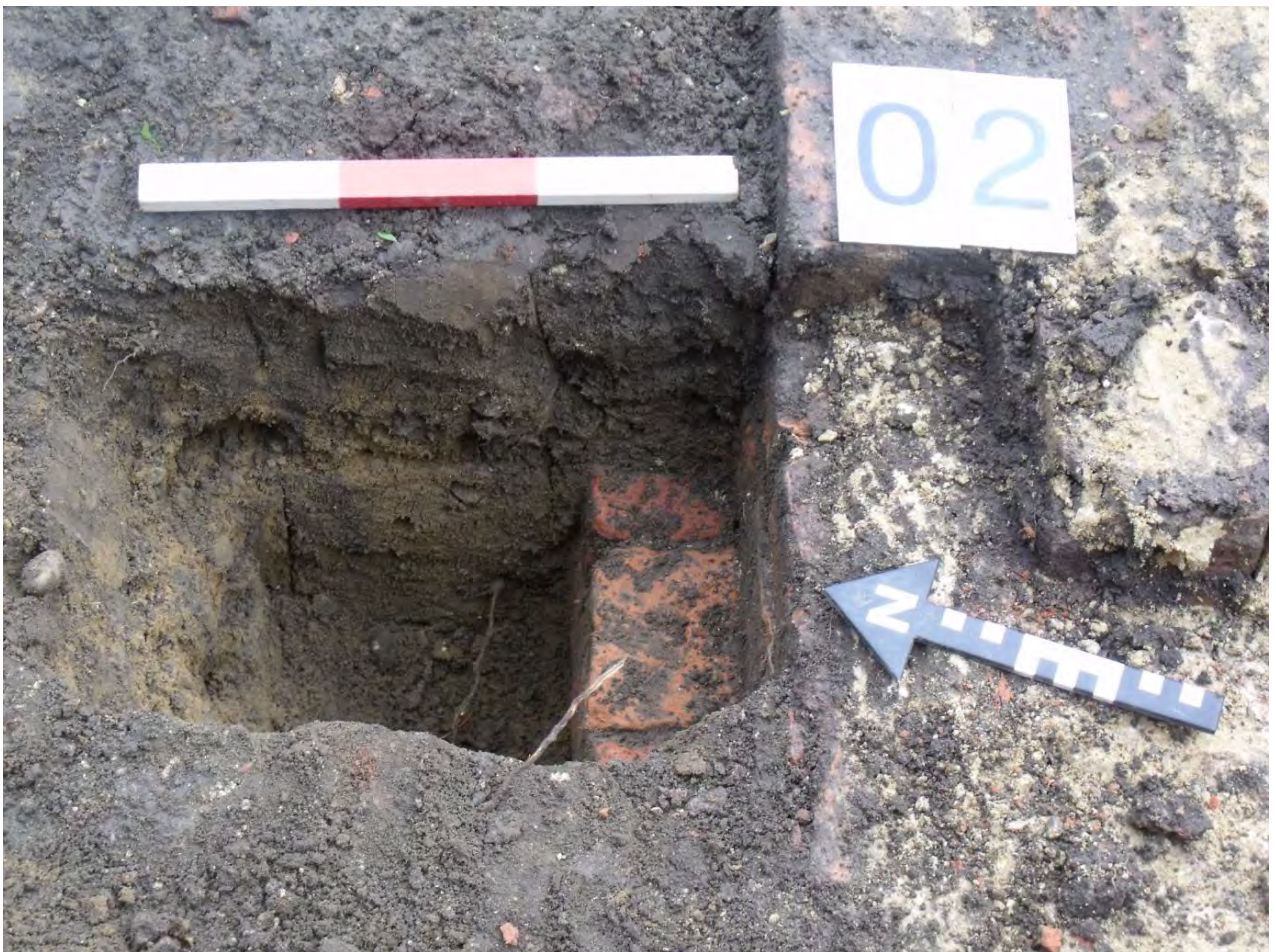
- 08 The earliest deposit revealed comprised a mid brown homogenous silty sand containing very occasional pebble inclusions. This context was only observed within the hand dug intervention. The extent of the deposit as seen measured 0.15m N-S x 0.22m E-W, whilst a thickness of 0.27m represents the excavated extent, rather than the thickness of the deposit in its entirety. The very limited amount of the deposit revealed makes any confident interpretation impossible, although the visually homogenous nature of the soil does suggest that it may represent an undisturbed, naturally derived subsoil horizon.

- 10 Directly overlying 08 was a layer of dark brown silty sand containing moderate amounts of pebble inclusions. This deposit was also only observed within the same small intervention as described previously, with the revealed extent here measuring 0.22m N-S x 0.22m E-W x 0.25m thick. Once again, the limited extent of the deposit revealed makes interpretation difficult and the deposit could represent a disturbed earlier topsoil or even a deliberate levelling deposit associated with unrecorded landscaping episodes

- 07 Linear cut [07] was orientated E-W and was partly revealed within the small intervention described previously. Only the northern edge of the cut was seen, which here revealed a steep, straight, side profile, which truncated the previously described deposits. The visible extent of the cut measured 0.50m N-S x 0.22m E-W x 0.50m deep, whilst its function was clearly to accommodate E-W orientated wall <02> (described below).

Fig 7 Reigate Priory Junior School, Reigate; intervention against north side of wall <02>, showing deposits (08) (10) and construction cut [07]. View to west.

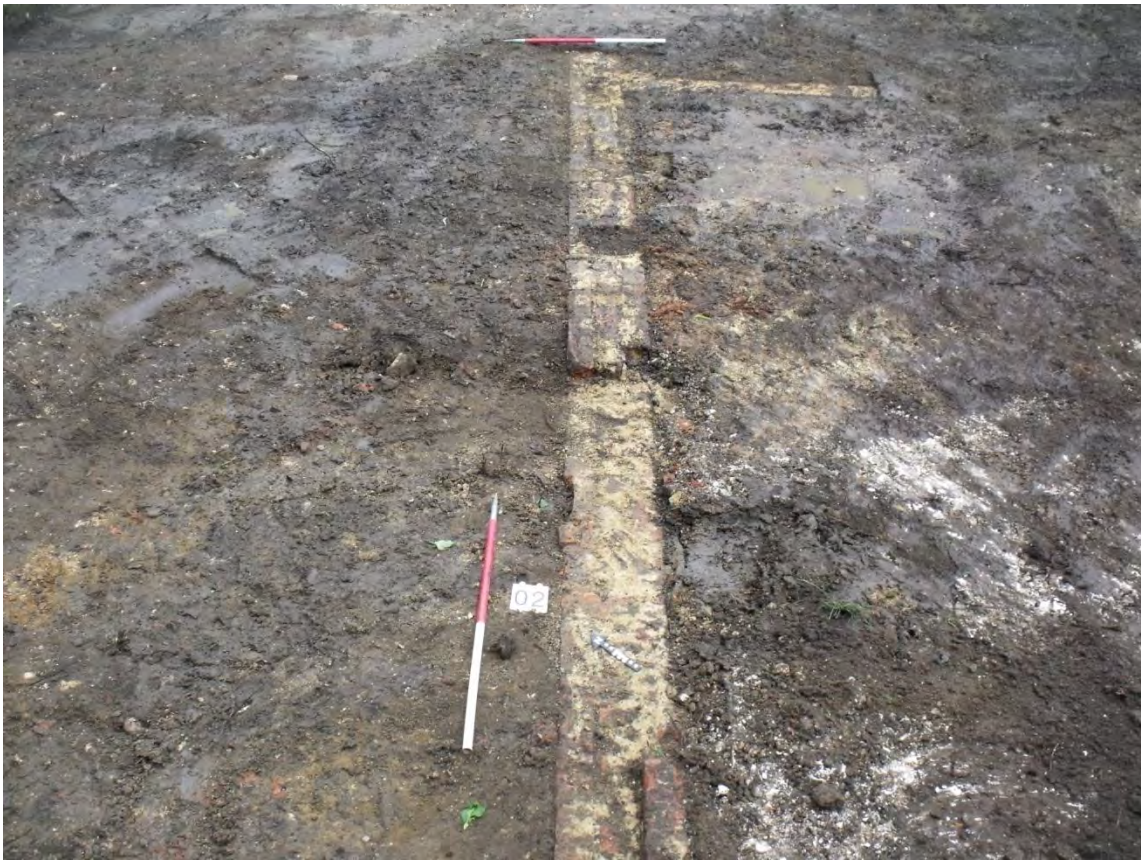
- 02 Wall <02> was housed within construction cut [07] and comprised at least seven courses of red brick lain so as to form a single stepped foundation arrangement. It was linear in plan, orientated E-W and bonded by a very sandy yellow mortar mix. The western limit of the wall was seen to continue beyond the excavation limits, whilst to the east it ended abruptly as an irregular edge that clearly represents the result of a subsequent truncation. Only a part of the wall's northern face was revealed within the small intervention mentioned earlier and here an excavated depth of 0.50m failed to reveal the wall's base. The final, upper course of the wall was the width of three bricks, which equates to around 0.35m, whilst the preserved stepped foundation on the northern face extended a further 0.08m beyond this, giving a combined width of 0.43m. This however is unlikely to represent the true overall width of the wall, as it seems probable that a similar stepped foundation

Fig 8 Reigate Priory Junior School, Reigate; E-W orientated wall <02>, with abutting wall <03> in the background. View to the east.

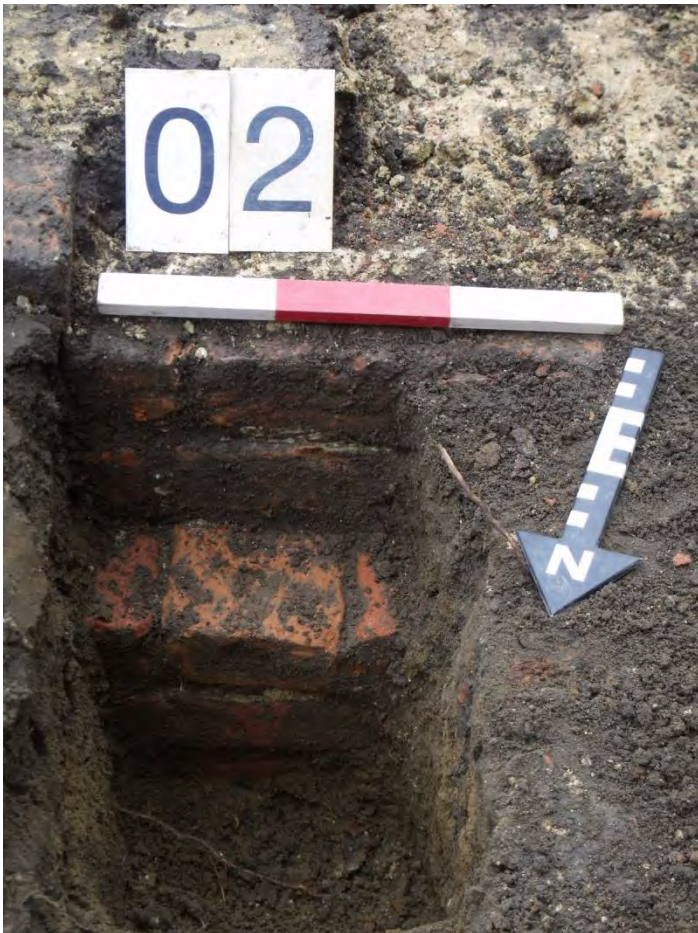
Fig 9 Reigate Priory Junior School, Reigate; Stepped foundation, wall <02>. View to the south.

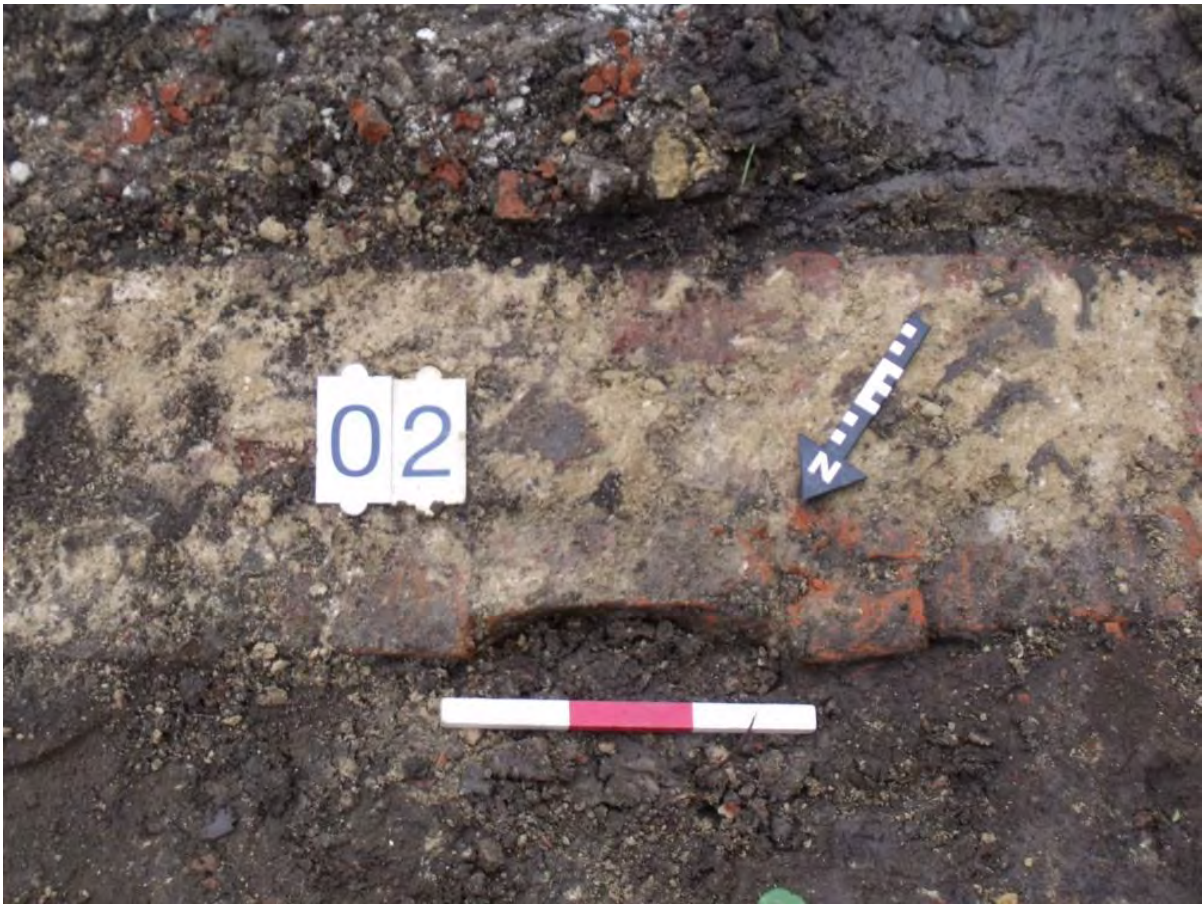
would be repeated on the wall's southern, unseen, face. Within the wall's northern face, towards its western limit, a shallow cut was preserved, which appeared to be the remains of an architectural element rather than a later truncation. Approximately 4.50m from the wall's eastern limit and abutting its southern face a second N-S orientated wall was observed (wall <03>).

Fig 10 Reigate Priory Junior School, Reigate; Possible architectural feature within the north face of wall <02>.

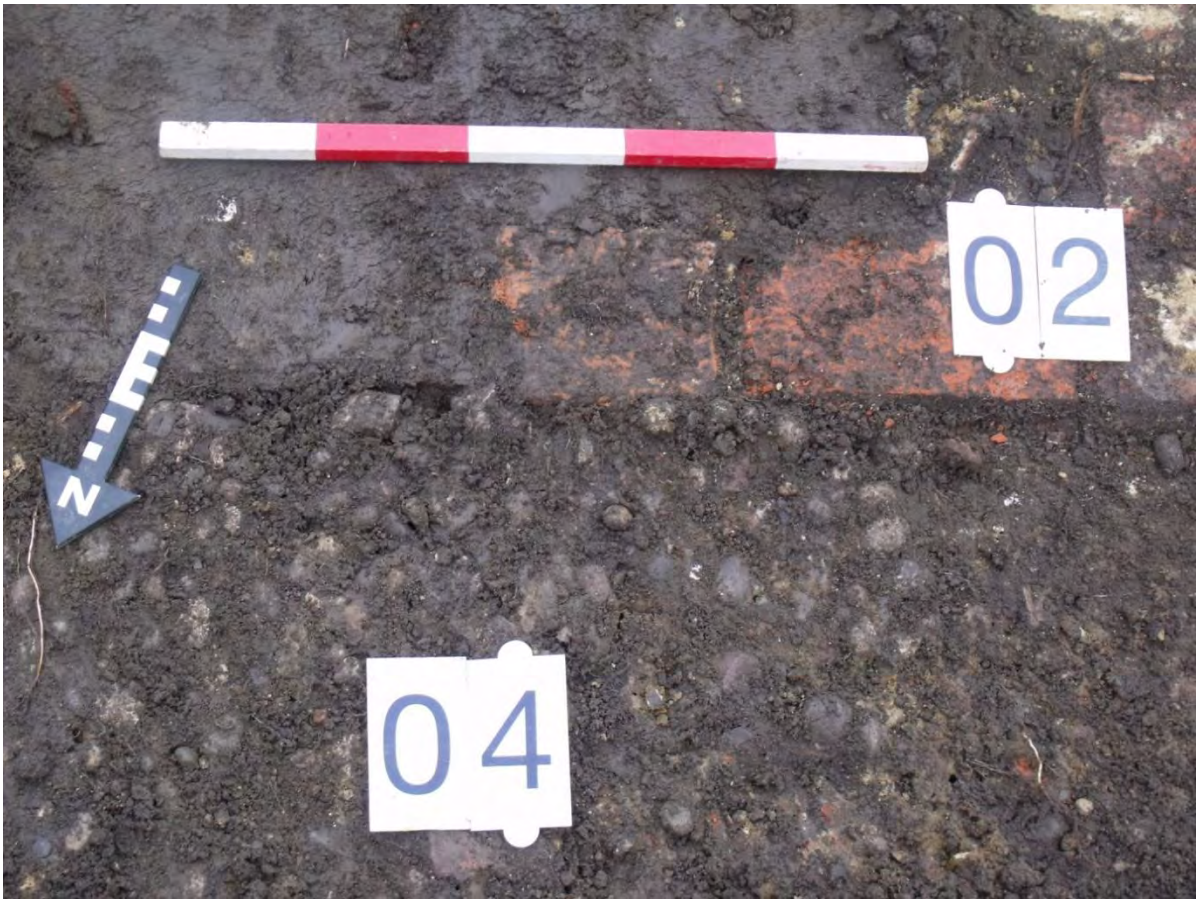
- 04 Deposit (04) was also located to the north of main E-W wall <02>.and comprised a compacted mass of small rounded and sub-rounded pebbles bonded within a dark soil matrix. The deposit generally appeared irregular in plan, although this was mainly due to the differential removal of the overlying topsoil which effectively defined the visible area of the deposit in many places. The extent, as revealed, measured 2.65m N-S x 3.85m E-W, whilst the overall thickness amounted to only around 0.04m. This deposit almost certainly represents a deliberately lain surface, which seems likely to be part of an external.area.

Fig 12 Reigate Priory Junior School, Reigate; Surface (04) abutting northern face of wall <02>. View to the south.

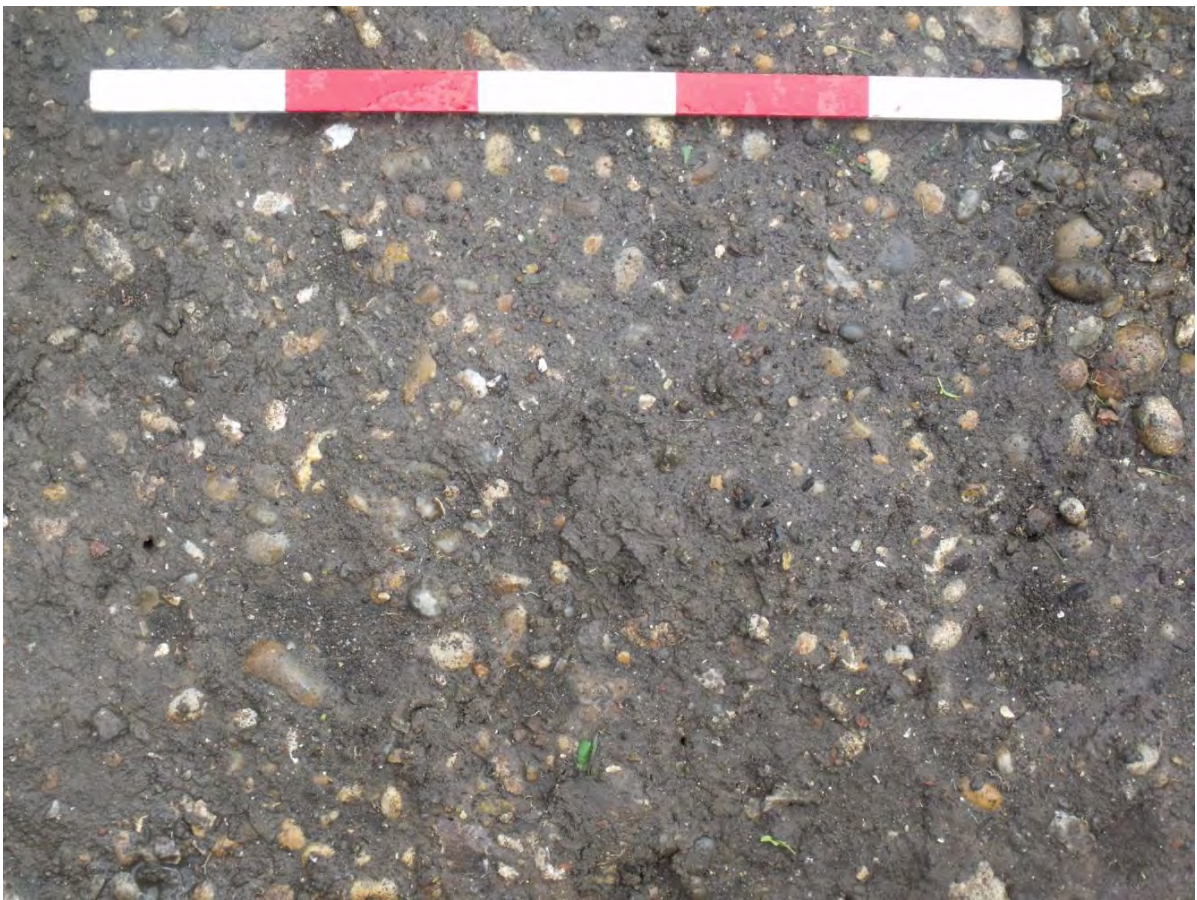
Fig 13 Reigate Priory Junior School, Reigate; surface (04), detail.

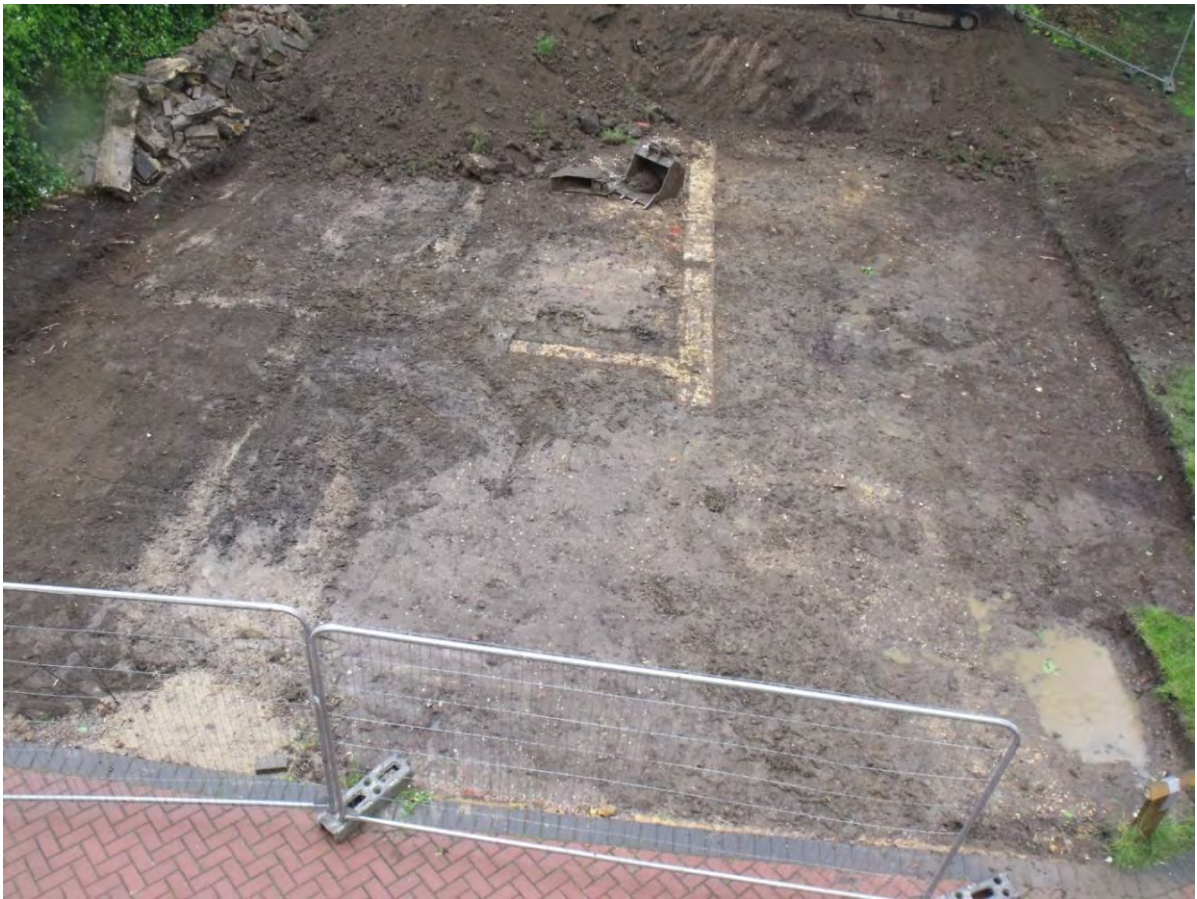
Fig 14 Reigate Priory Junior School, Reigate; progress shot of area strip, view to the west.

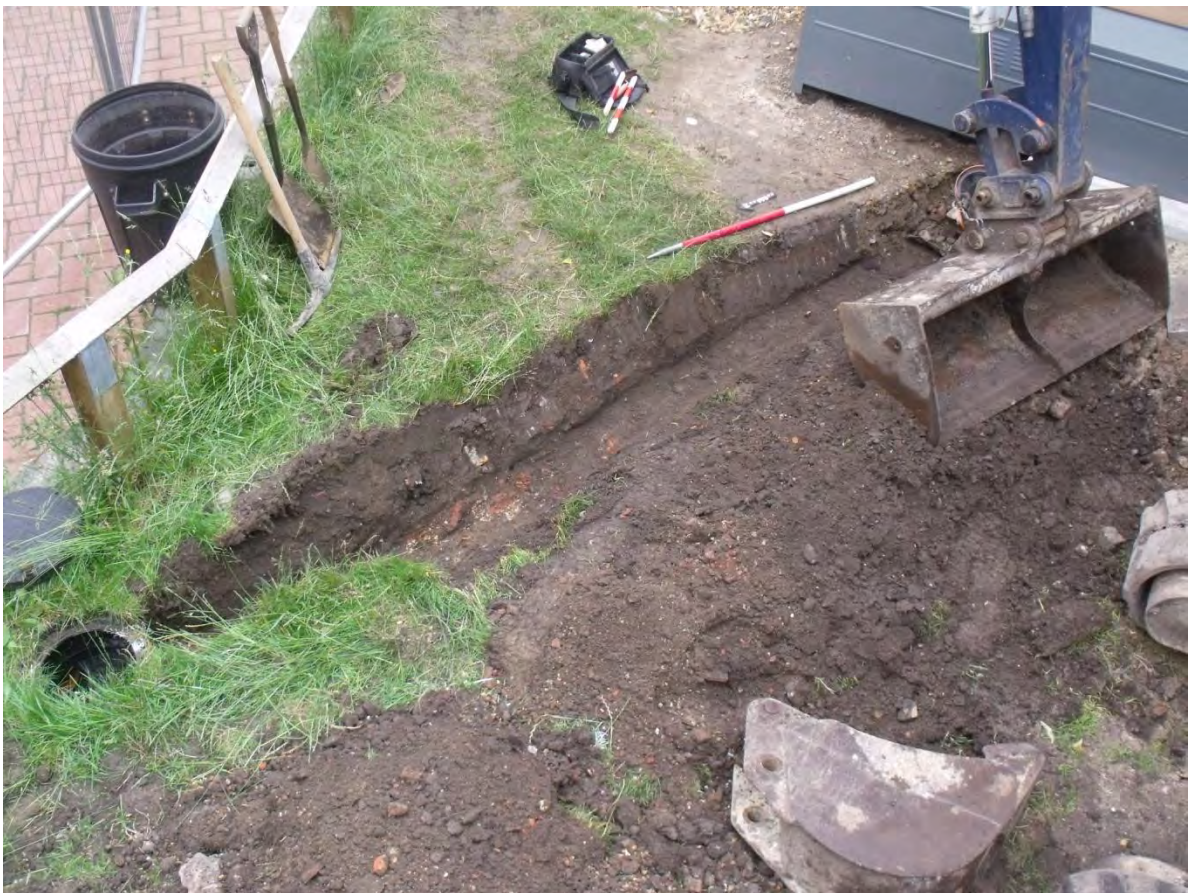
Fig 15 Reigate Priory Junior School, Reigate; drainage pipe spur trench, view to the southeast.
