REDEVELOPMENT OF THE SWIMMING POOL BUILDING AT SAXON PRIMARY SCHOOL, BRIAR ROAD, SHEPPERTON

AN ARCHAEOLOGICAL WATCHING BRIEF

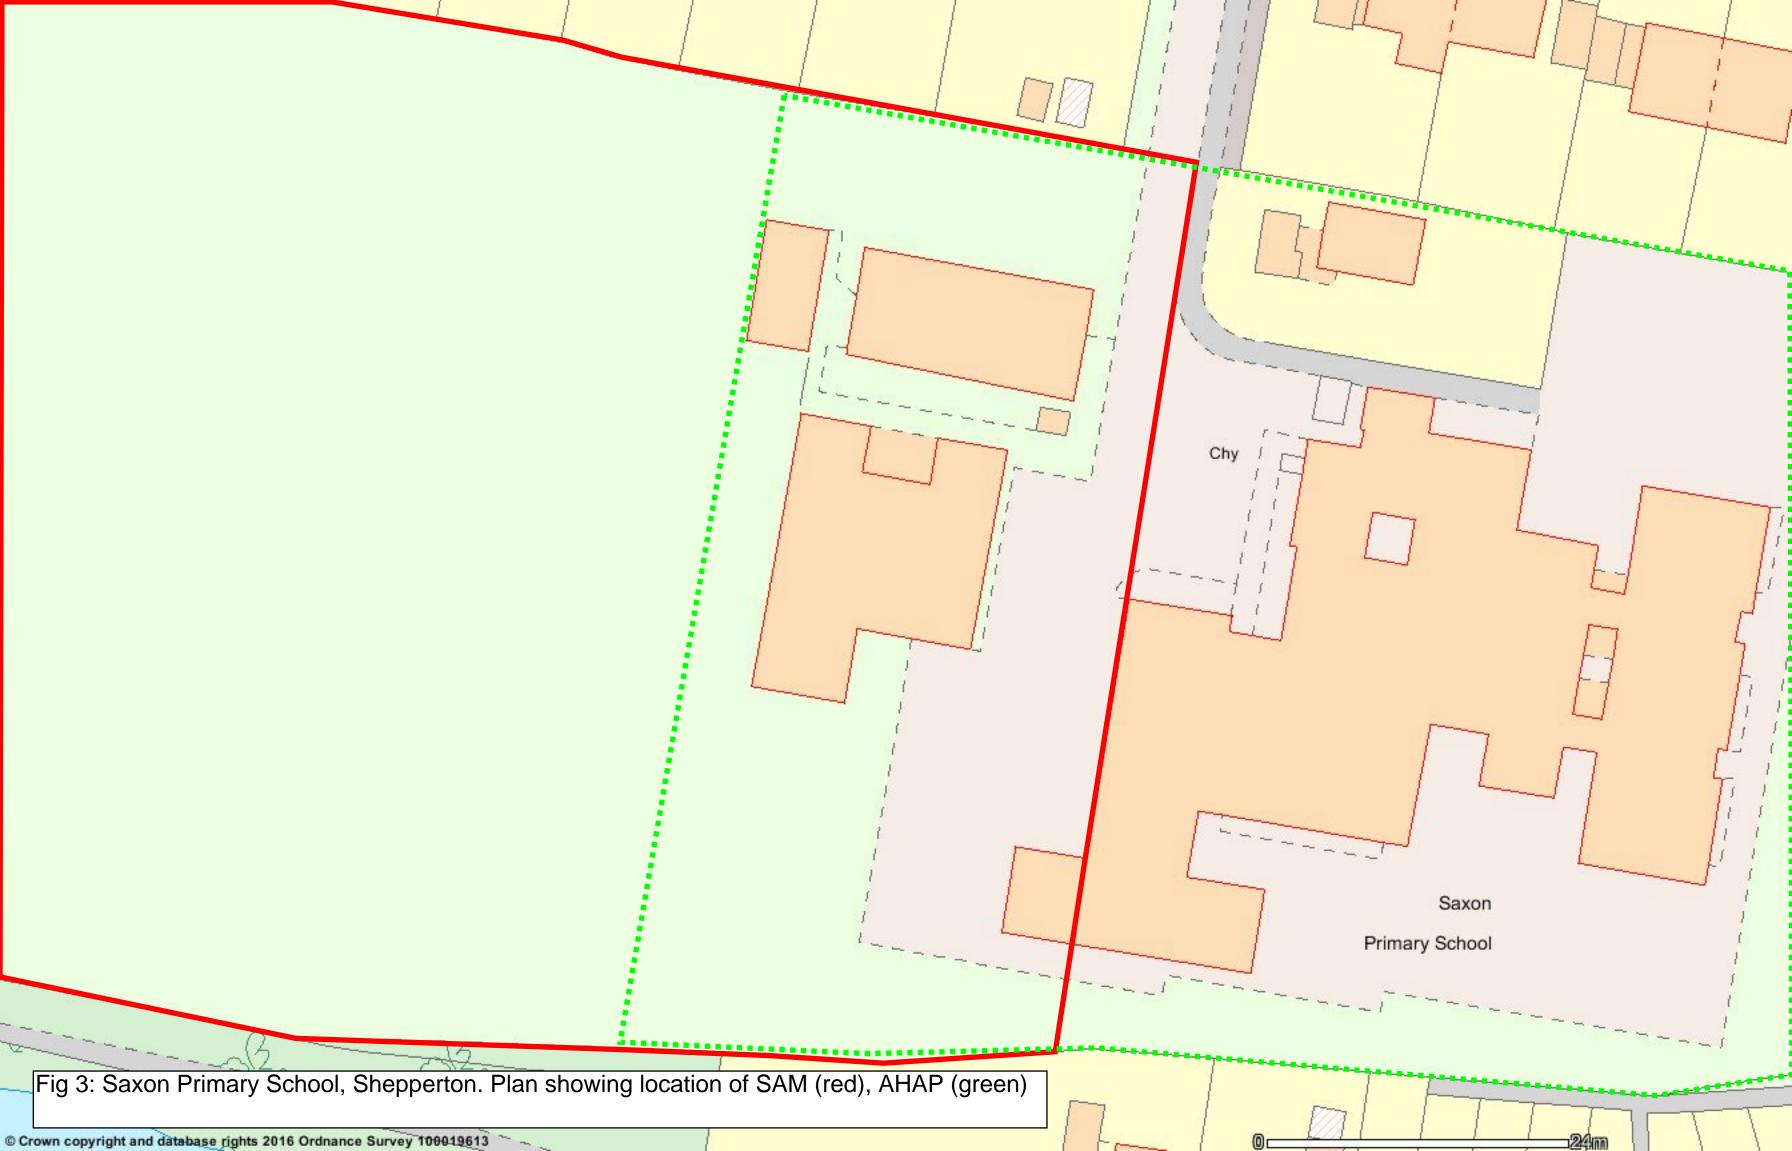
1.1 An archaeological watching brief was conducted between 31st August and 2nd September 2016 at Saxon Primary School, Briar Road, Shepperton in preparation for the redevelopment of the swimming pool building (see figures 1 and 2).

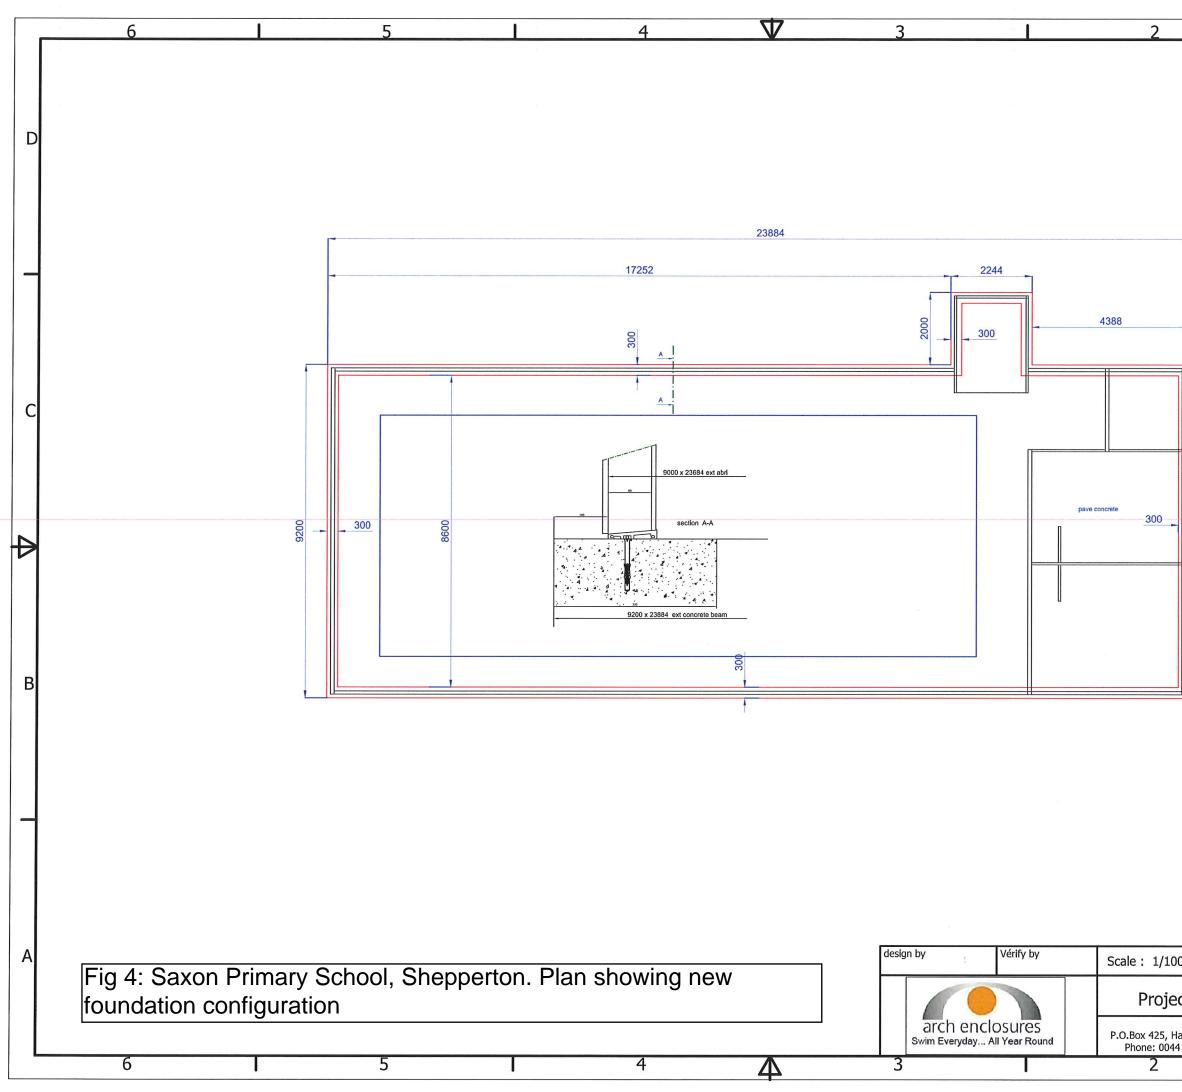
3.2 The prior structure (a metal framed, fibreglass construction), had been demolished prior to the commencement of the watching brief, exposing the swimming pool and the surrounding slab foundations. The aim of the works was to expand the foundations within the recesses (fig 4) and create a fully rectangular slab foundation, as well as raising the existing foundation at the west end. This basically consisted of exposing the existing foundation depth either side of the recesses and creating new strip foundations, connecting both. It had been previously agreed that these foundations were to be hand dug. The re-formatting of the existing foundation required no new deep excavations as the replacement structure is to be an aluminium framed, lightweight structure.

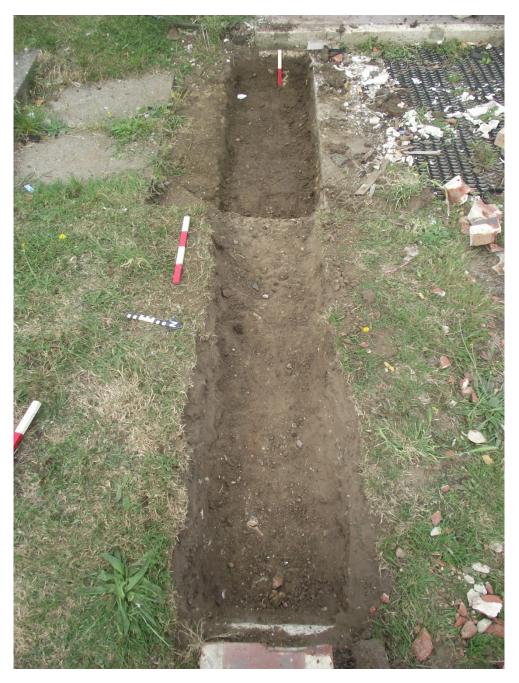
Fig 5. Shepperton Primary School, Shepperton. Strip foundation 1.

4.1 Strip foundation 1 (fig 5) was exactly 0.20m in depth at its deepest, before stepping up to approximately 0.12m in depth. The excavations barely exceed the topsoil and no features or finds of archaeological interest were observed.
