NEW CLASSROOM BLOCK AND CAR PARK EXTENSION AT SAXON PRIMARY SCHOOL, BRIAR ROAD, SHEPPERTON

AN ARCHAEOLOGICAL WATCHING BRIEF

An archaeological monitoring brief was conducted on land at Saxon Primary School, Briar Road, Shepperton between 2nd August and 9th September 2016. The site is a Scheduled Ancient Monument (monument no. SU142), as well as being located within an Area of High Archaeological Potential, associated to a Saxon/early medieval settlement and burial ground. A previous test pit evaluation revealed one deep lying archaeological feature, but no further archaeological deposits were encountered during this phase of work. 32 foundation pits were excavated within the south part of the site, with most excavated within made ground. Some produced finds, but of varying dates; both ancient and modern. The various services that were observed either did not impact deep enough or were excavated within disturbed soil. The car park extension was not excavated to depths that would impact on archaeological deposits. Many of the finds were of a post medieval date and only one sherd of Saxon pottery was found and was the only indicator of the potential of the underlying archaeology. No

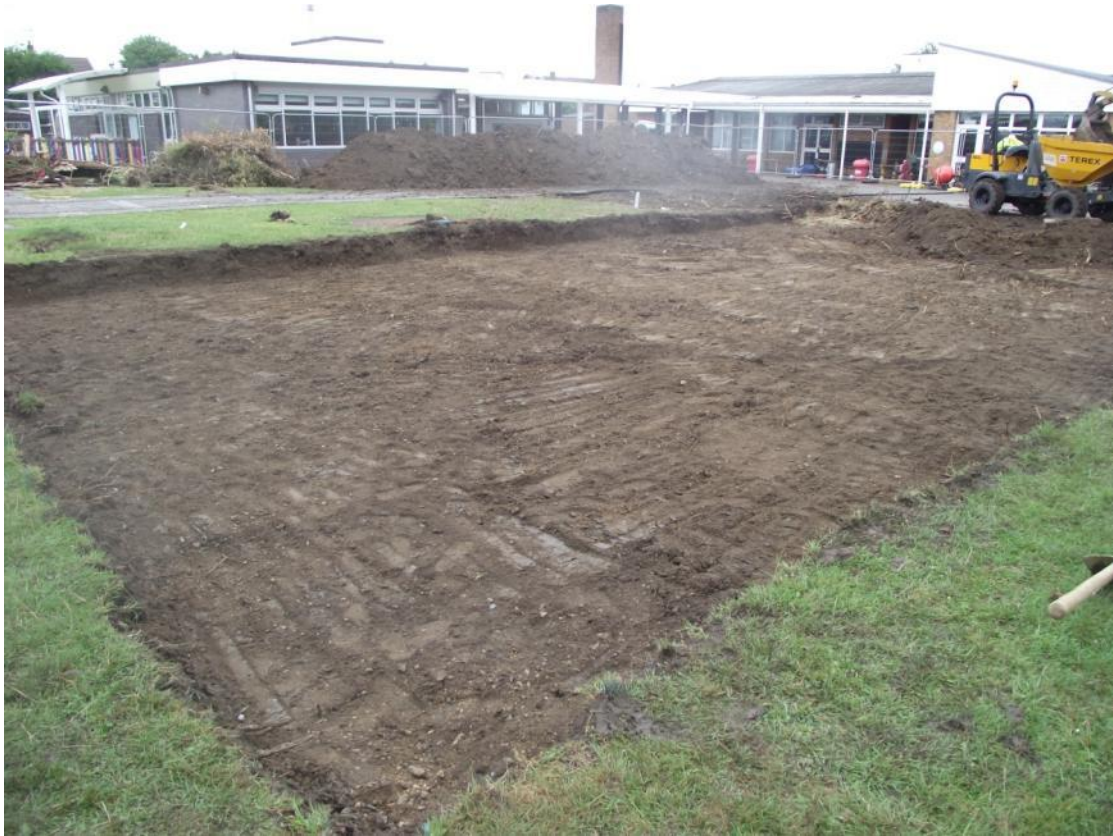
3.1 The general surface strip (fig 5) was conducted to remove turf and approximately 0.20m to 0.30m of subsoil. The subsoil here was fairly prolific for finds, with a number of fragments of calcined flint, occasional struck pieces of flint, a modern coin, a sherd of decorated green glaze white ware of medieval date and two sherds of modern pottery.

Fig 5: Saxon Primary School, Shepperton. Initial turf strip – new classroom building

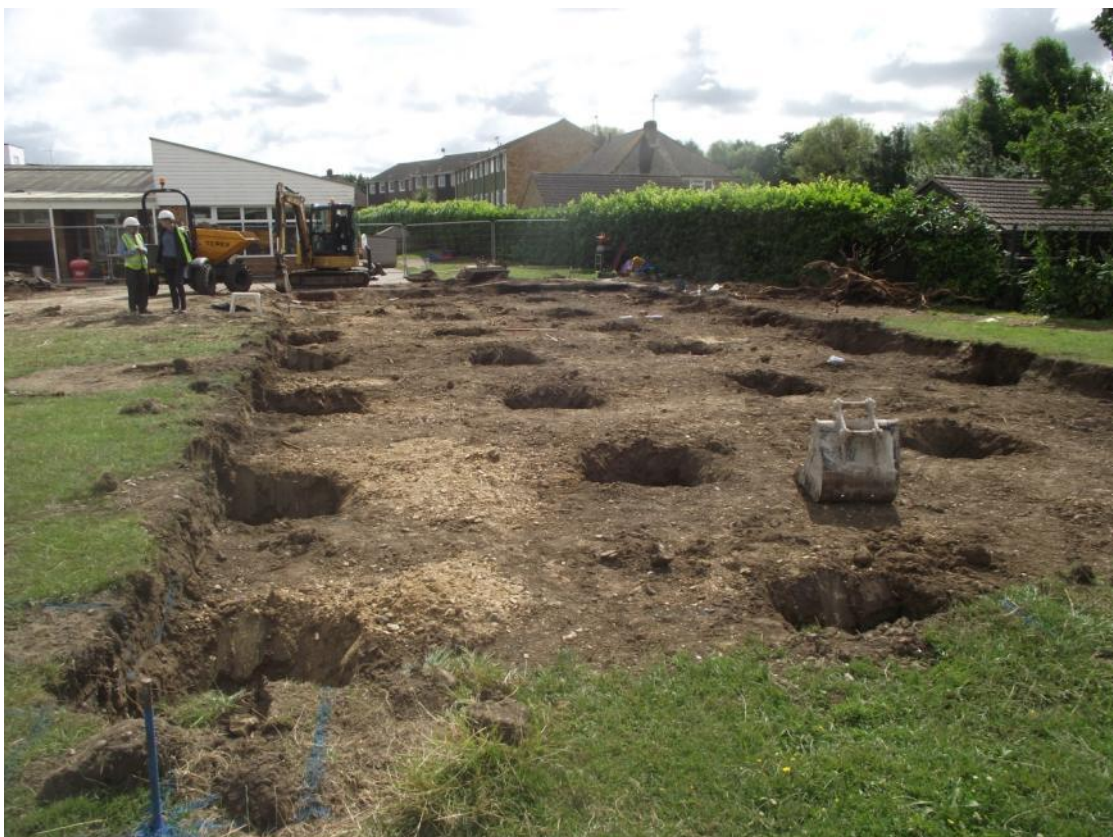
3.2 A total of 32 foundation pits were observed over a period of 3 days (fig 6). Only five of the pits overall displayed a probable 'natural' stratigraphy; numbers 4, 8, 20, 24 and 28 (figs 7 to 11) and are the most northern group of the pits. To a lesser extent, 12 and 16 potentially show deep disturbance, but with elements of the natural geology, in this instance sands and gravels, at lower levels than the previously mentioned foundation pits. All of the remaining pits show clear made ground, and produced finds of varying dates. No archaeological features were observed, but it should be noted that the size of the observable area within the pits would have made identification of such deposits extremely difficult.

Fig 6: Saxon Primary School, Shepperton. Excavated foundation pits

5.1 As was observed during the test pitting exercise, the land within the footprint of the new classroom block is made ground. Only five of the foundation pits displayed potential natural stratigraphy, although the ground was still possibly made up, or disturbed, in part. It had been postulated that the area in question had undergone localized quarrying at some point in the recent past and the results of the watching brief appear to clarify this, due to the lack of a recognizable stratigraphy and the general mix of finds of various dates. The potential for in situ archaeological deposits north of the new classroom building should still be considered high.

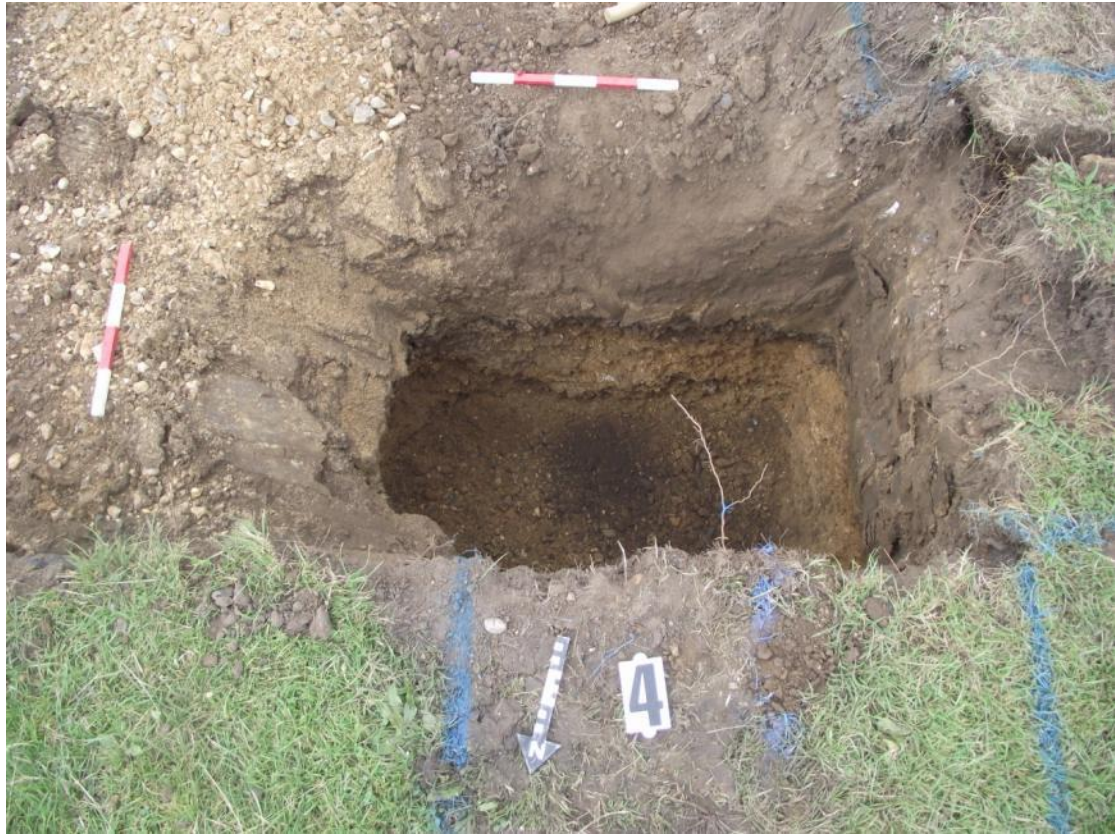
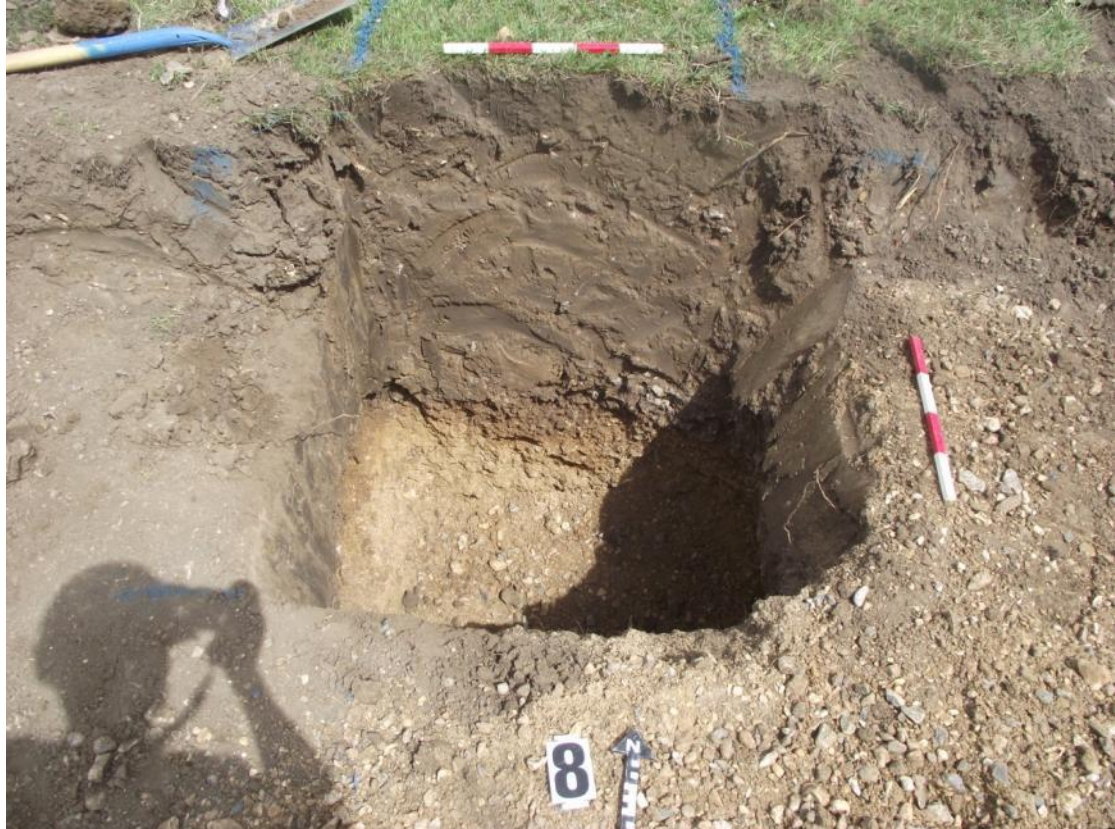
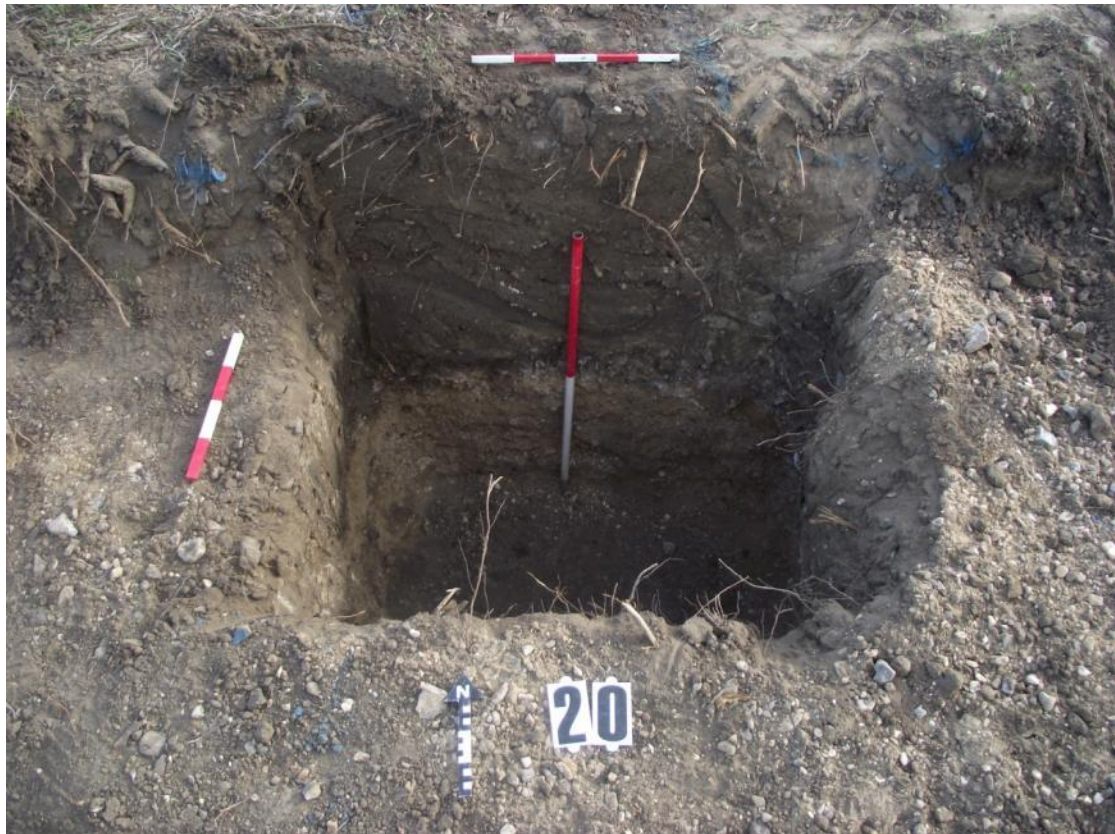
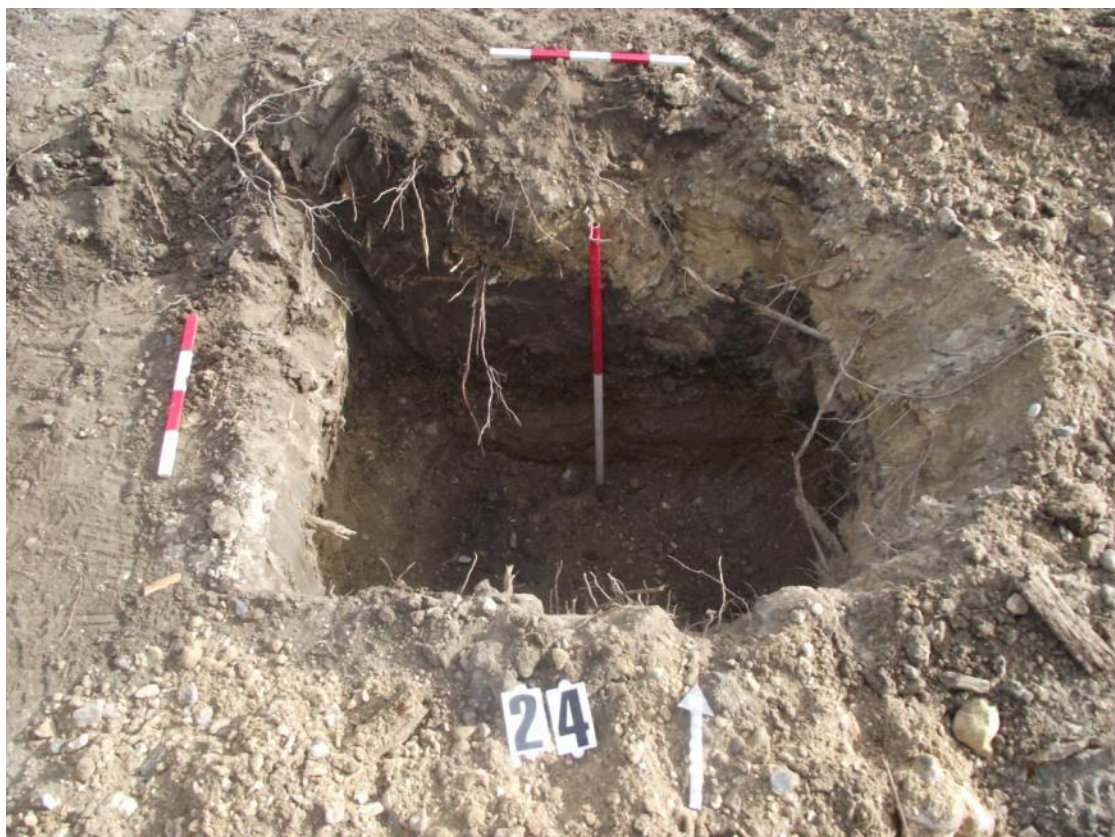
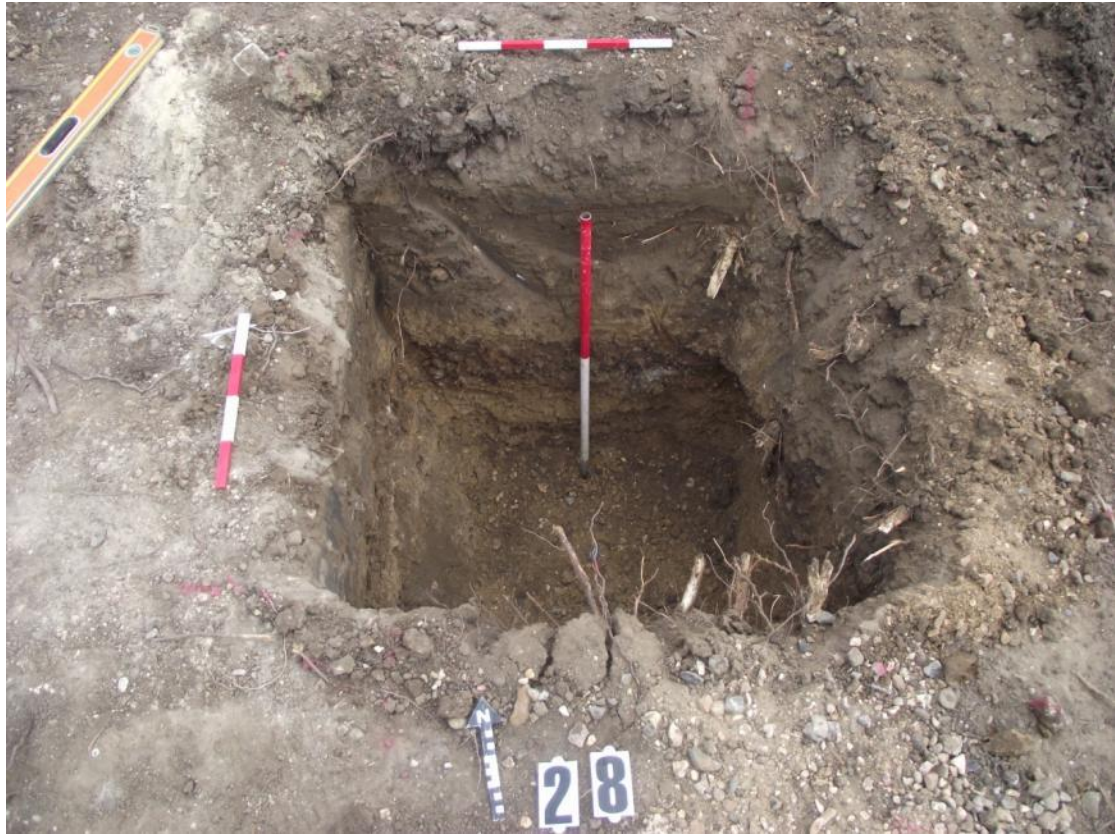
Fig 7: Saxon Primary School, Shepperton. Foundation pit 4

Fig 8: Saxon Primary School, Shepperton. Foundation pit 8

Fig 9: Saxon Primary School, Shepperton. Foundation pit 20

Fig 10: Saxon Primary School, Shepperton. Foundation pit 24

Fig 11: Saxon Primary School, Shepperton. Foundation pit 28

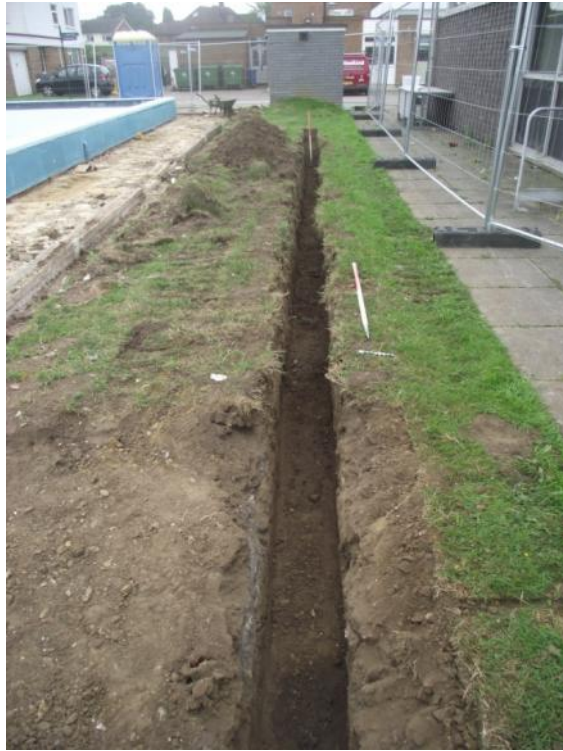
3.3 A narrow service trench (Trench 4) was excavated from east to west to the immediate north of the nursery building (fig 13), was approximately 0.60m deep and ran the full length, before traversing north along the western edge of the swimming pool building. This trench displayed made, or highly disturbed, ground throughout and revealed no features or finds of archaeological interest.

Fig 13: Saxon Primary School, Shepperton. Trench 4 (North of the nursery) looking east

5.2 The service trenches in both Area A and Area B were not deep enough to impact on any potential in situ archaeology and in general produced a distinct lack of finds. Whether deeper archaeological deposits exist at lower levels was not clarified within this phase of work and any future deep excavations would certainly require further observation, should future works exceed 0.60m.

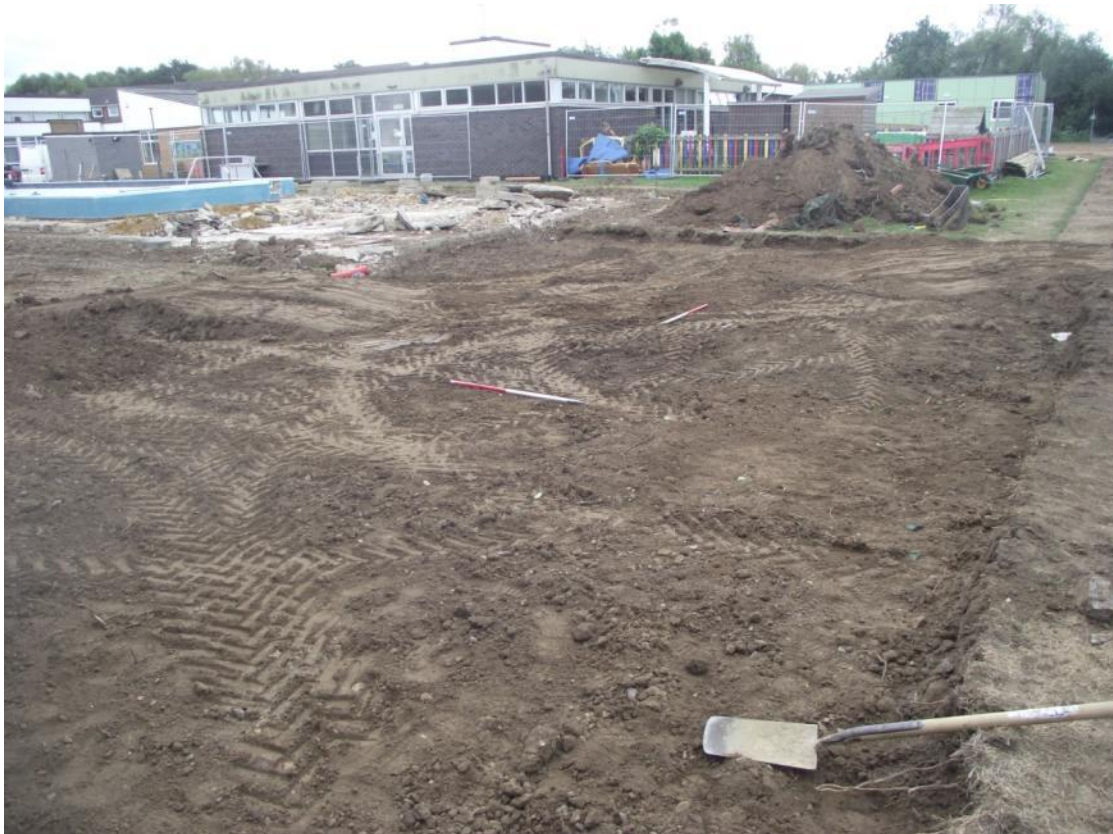
3.5 The car park extension consisted of a general strip (fig 14) west of the current car park to a general depth of 0.30m overall. The strip barely penetrated below topsoil and as a result no features or finds of archaeological interest were observed.

Fig 14: Saxon Primary School, Shepperton. Car park extension strip looking southeast

5.3 The car park extension was the shallowest of all the groundworks conducted on site, barely breaking the full depth of the topsoil, and as mentioned above, any future works exceeding (in this instance) 0.30m, would require further observation.
