PROPOSED DEVELOPMENT AT MARCHANTS HILL, HINDHEAD, SURREY

AN ARCHAEOLOGICAL TRIAL TRENCH EVALUATION

Project Manager	Nowal Shaikhley
Author	Matt Saywood
Date of fieldwork	29.10.15 – 02.11.15
Date of report	3 rd November 2015
NGR	SU 877 372
Site code	HMH15
Consultants	A&M Architectural Partnership LLP
Client	PGL Marchants Hill

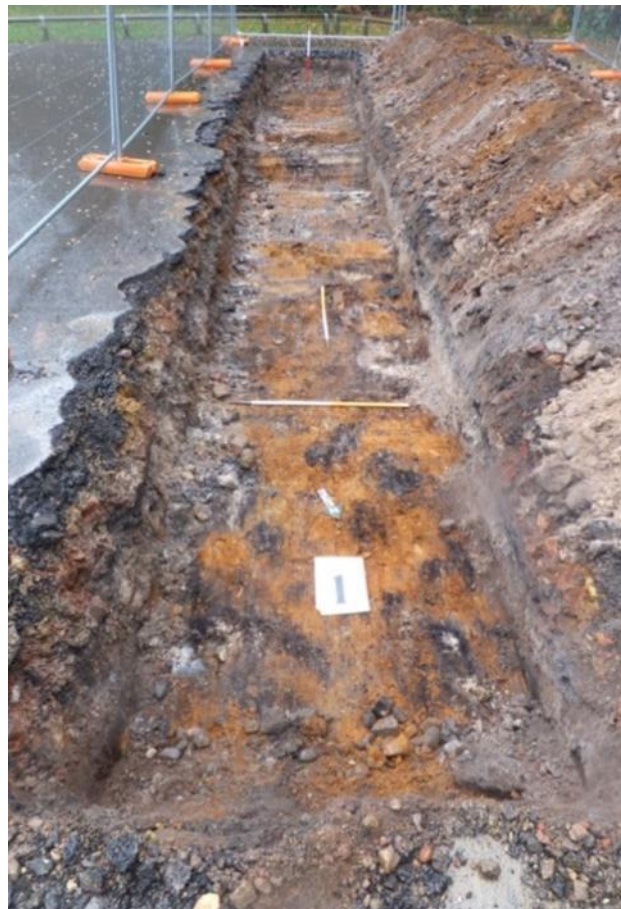
3.2 Trench 1 Cut through a tarmac playground which had clearly been levelled up at some point in the past, but the expected natural subsoils and natural were both present within the trench at the expected levels. A modern service ran through the trench 5.5m from the southern end. Because of this 1.5m was left unobserved. No archaeological features were identified and no finds recovered.

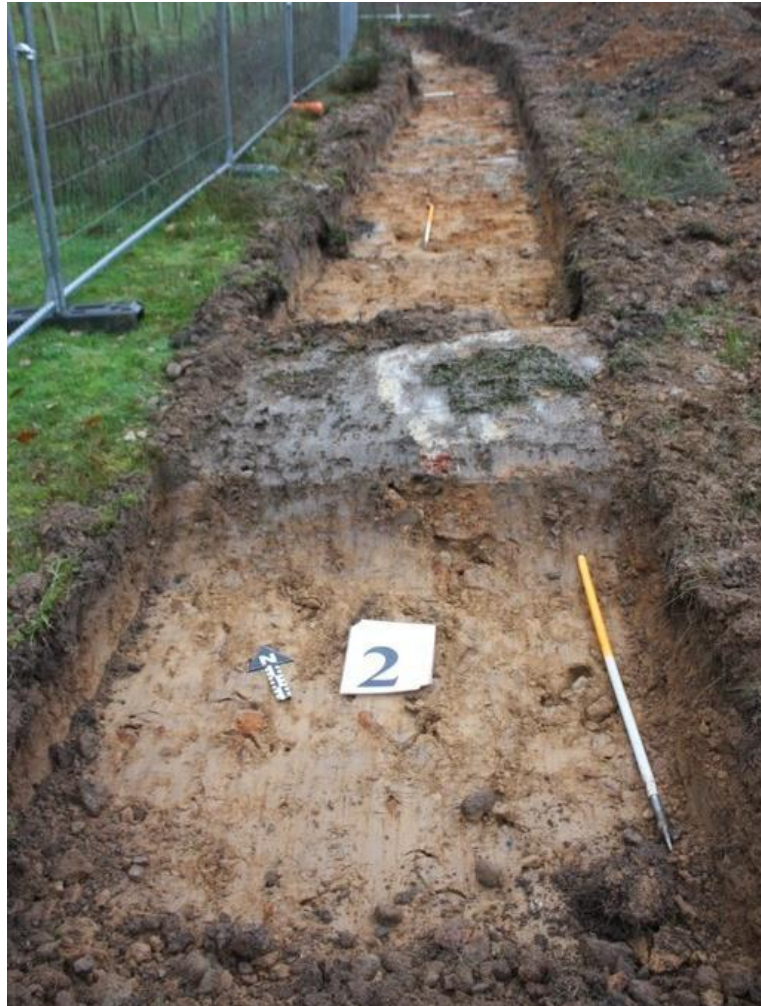
3.3 Trench 2 showed a thick topsoil layer of dark brown silty clay , underneath which was an incredibly clean layer of redeposited natural material almost identical to 107, but lacking the black dark rooting. Under 105 the expected subsoil and natural geology were observed. 1.5m from the southern end a concrete drain surround was discovered and 1m was left unobserved. No archaeological features were identified and no finds recovered.

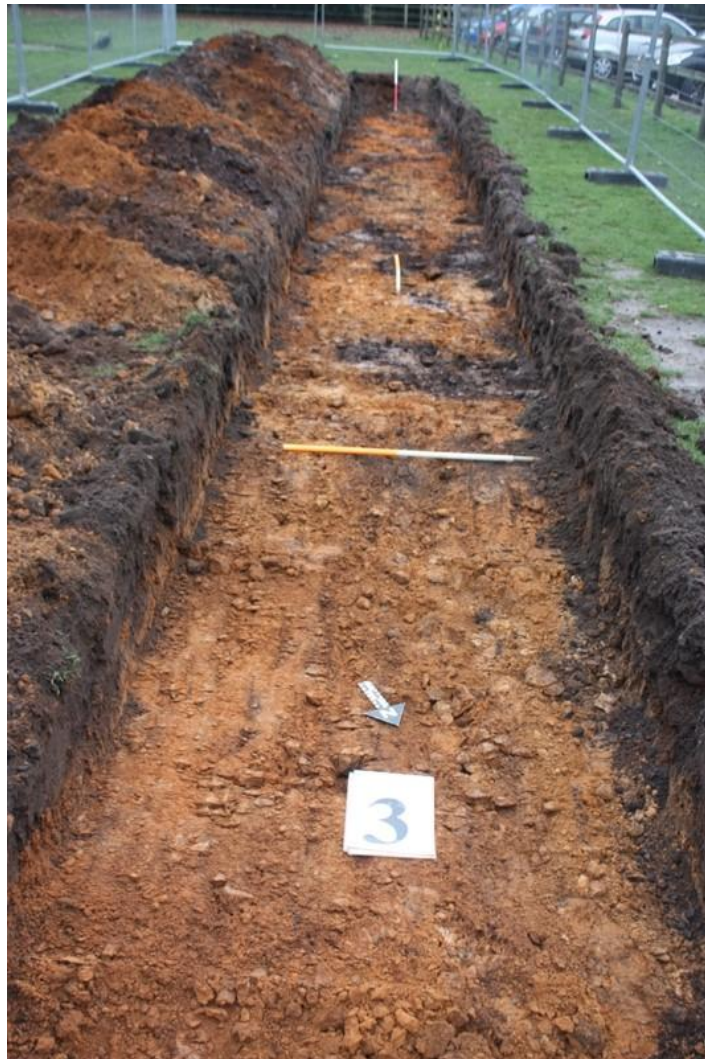
3.4 Trench 3 displayed nothing of note. The expected natural stratigraphy was revealed. no archaeological features were identified and no finds recovered.

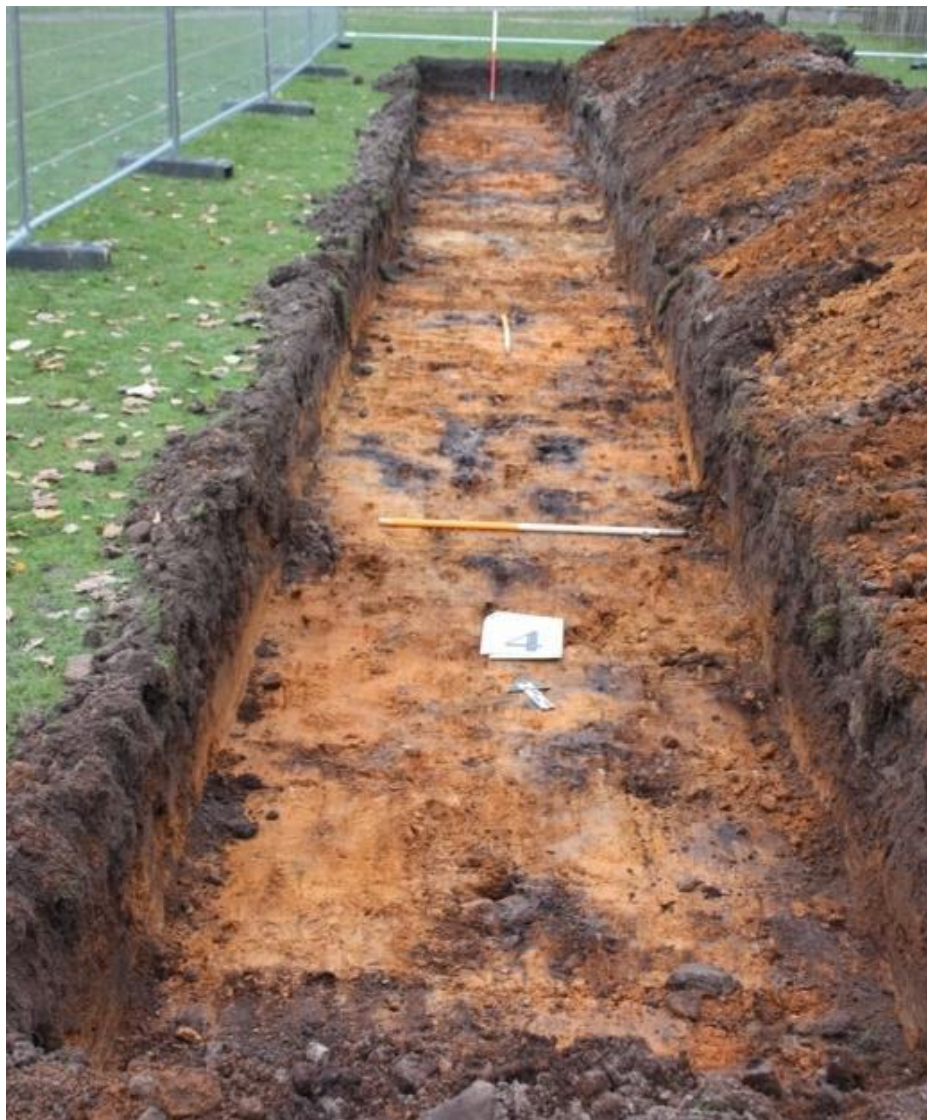
3.5 The planned location for trench 4 was on ground already occupied by other structures and guide lines, so in order to avoid these obstacles the trench was moved south east. Trench 4 displayed nothing of note except a slight variation in depth of subsoil from trench 3.. The expected natural stratigraphy was revealed. No archaeological features were identified and no finds recovered

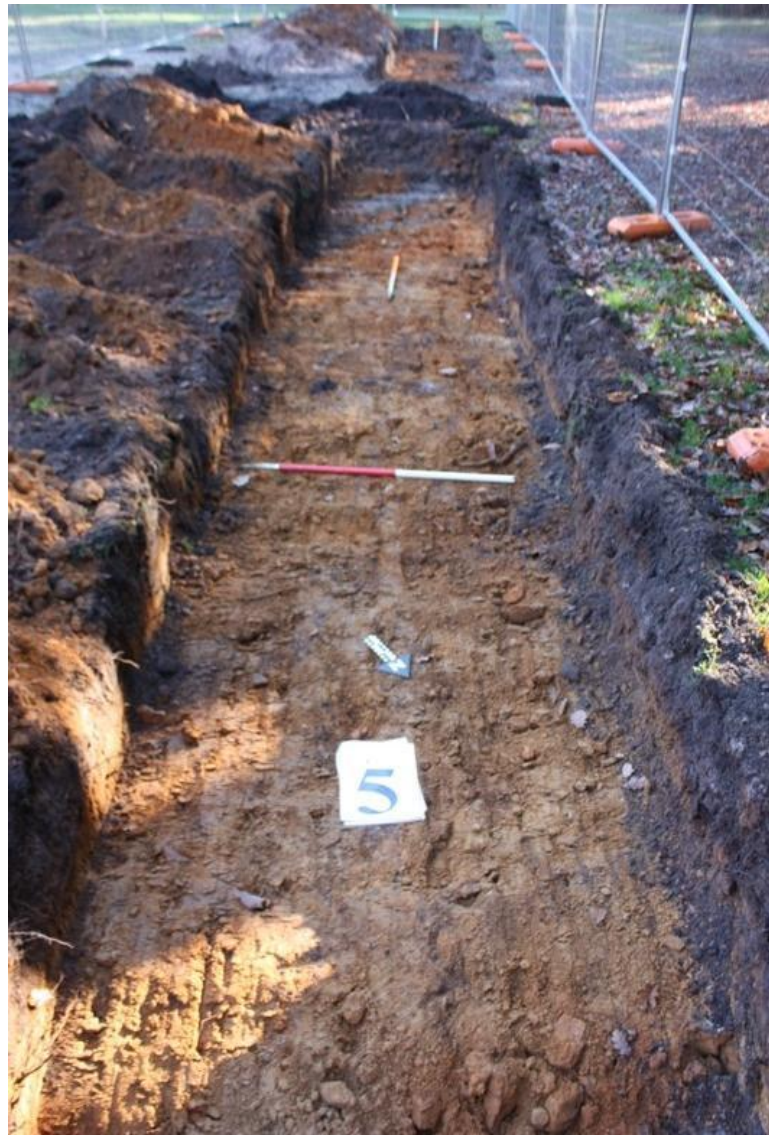
3.6 Trench 5 displayed little of note. A modern cable ran across the trench approximately 10m from it's northern end, leaving 4m in the middle unobserved. Because of this both trenches 5 and 6 had 2m extra added to their southern ends. The expected natural stratigraphy was revealed. no archaeological features were identified and no finds recovered.

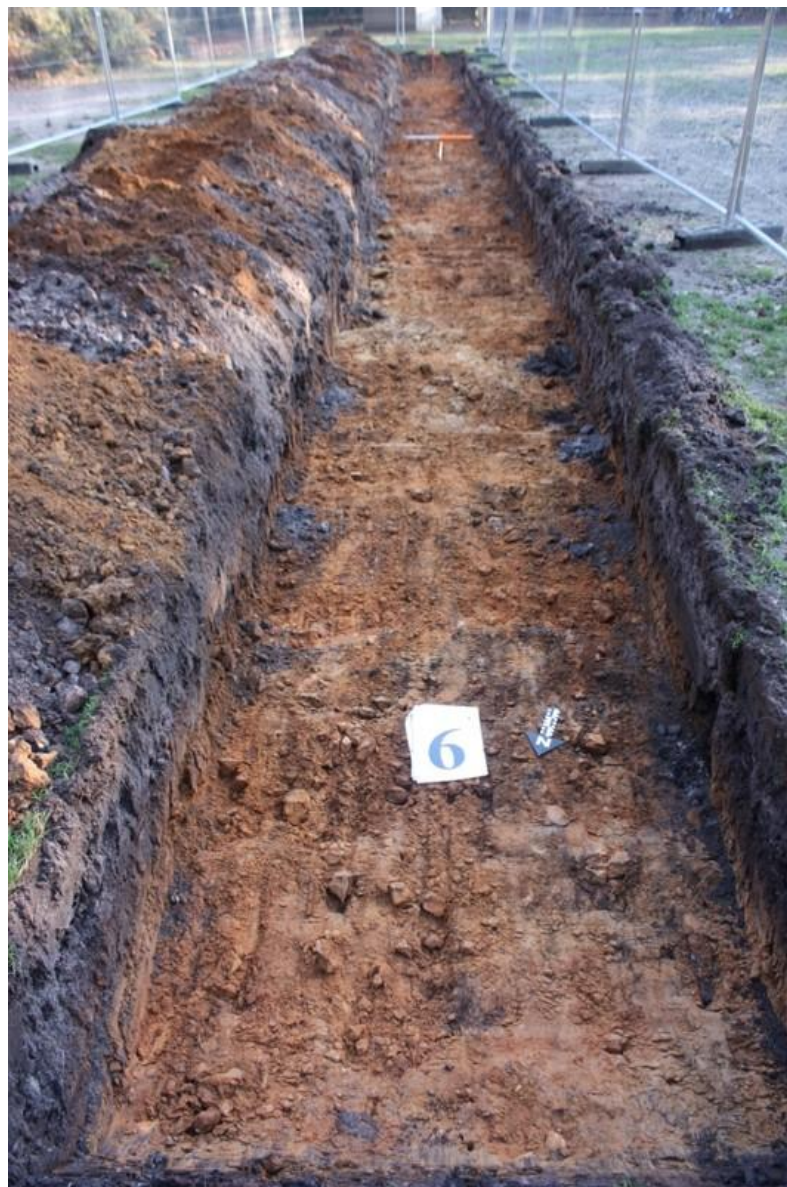
3.7 Trench 6 displayed nothing of note except a slight variation in depth of subsoil from trench 3. The expected natural stratigraphy was revealed. no archaeological features were identified and no finds recovered
