COMBERMERE BARRACKS, ST LEONARD'S ROAD, WINDSOR, BERKSHIRE

AN ARCHAEOLOGICAL WATCHING BRIEF

Project Manager	Rob Poulton
Author	Rebecca Lambert
Date of fieldwork	14 th -25 th January 2013
Date of report	25 th February 2013
NGR (centre of area)	SU 9619 7577 (Centred)
Client	InterServeCivils

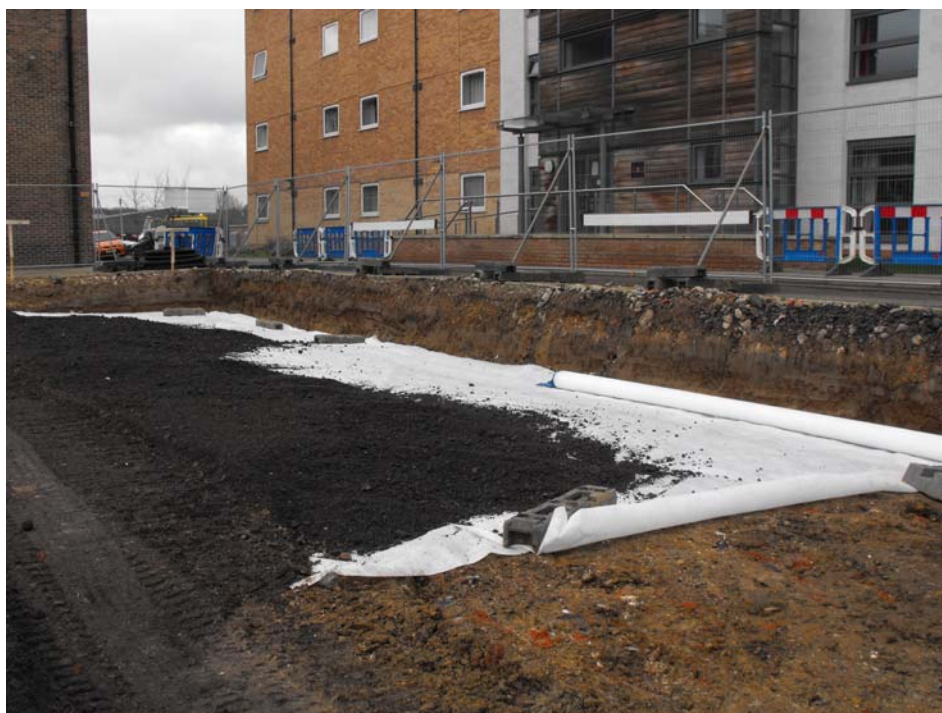
3.2 Upon arrival at the site it became clear that significant disturbance of the ground had already taken place during demolition and clearance, and a large area of ground across the southern and eastern parts of the site had already had its levels reduced unsupervised (see fig 2 and fig 7 below). This area had also been covered with membrane and crushed aggregate so it was not possible to observe whether any features, or the small ancillary building, were present. The focus of the watching brief therefore shifted to monitoring the north and western parts of area A.

Fig 7: Area A looking south west, showing site levelling and construction

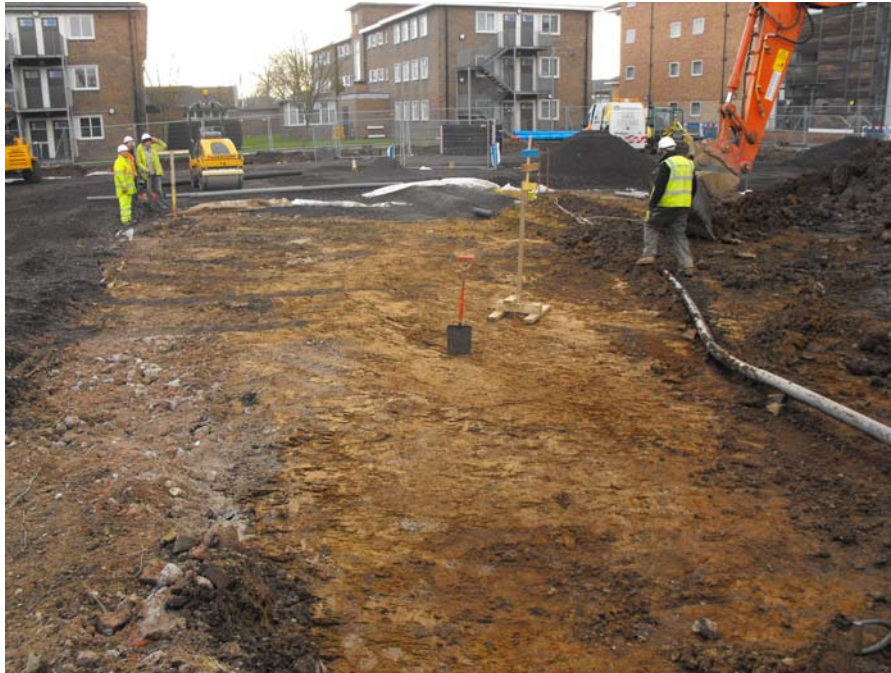
3.3 Observations in the north and west areas of site A were made periodically during the remainder of the stripping to check for features or finds of interest. In several places the natural clay geology was exposed but no archaeological features were identified cutting it (see fig 8 overleaf).

Fig 8: Area A Looking south towards the remaining barracks, showing natural clay geology exposed

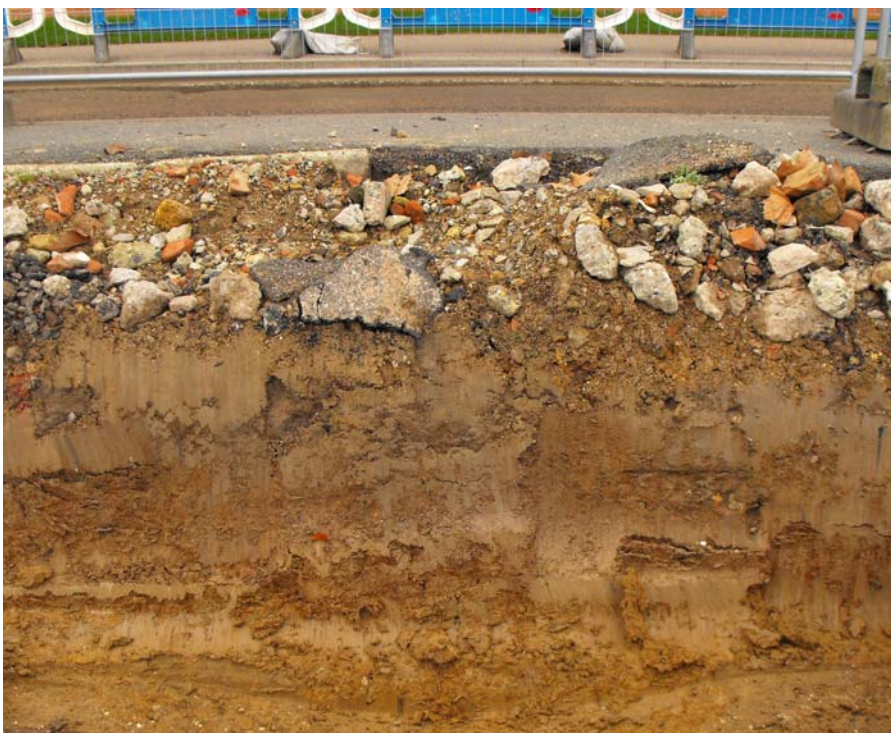
3.4 The stratigraphic sequence appeared to be truncated in most areas, having suffered heavy modern disturbance from the construction and demolition of the 1960s barracks. Where it was visible on the western edge of the site (fig 9), the stratigraphy consisted of modern rubble, over an orange-brown sandy-clay subsoil, over an orange slightly sandy clay natural deposit, clearly the London Clay geology identified on the British Geological Survey, sheet 269 which covers this area.

Fig 9: Stratigraphic sequence on the western edge of area A

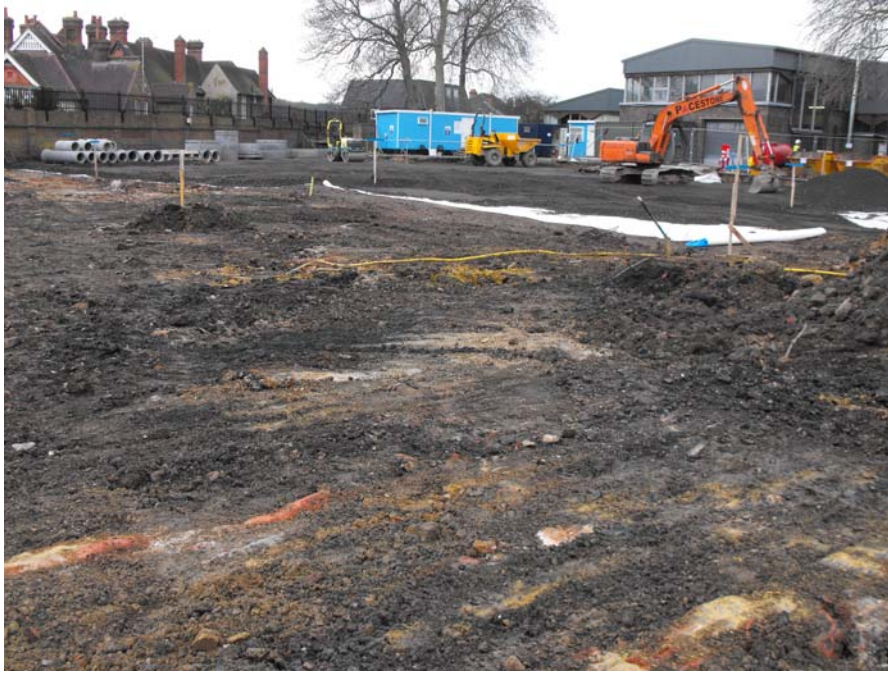
3.6 Prior to the start of the watching brief, clearance of the old car park surface had already begun in area B, exposing a number of different building foundations. The south western corner of the site had already had its levels reduced unsupervised and been re-covered (see figs 2, and 10 overleaf) so it was not possible to observe whether any features or buildings had been uncovered, however it is clear that both the married quarters and medical centre extended into this area.

Fig 10: Area B looking south west, showing exposed foundations of building and area re-covered with membrane and crush

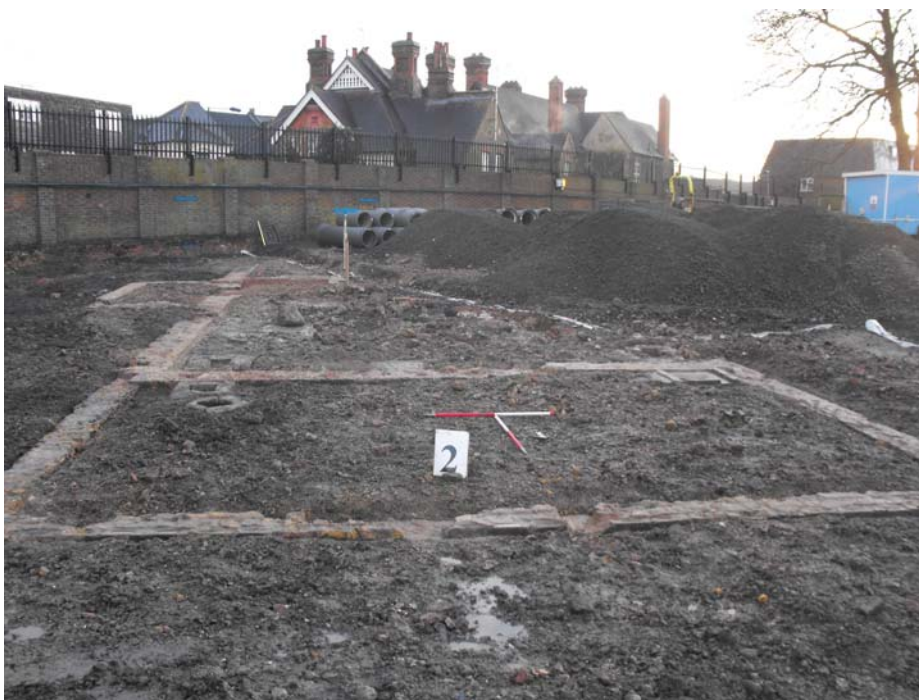
3.7 In the south east corner of the site, foundations of a building interpreted as the former medical centre, were identified. The main part of the building (3) was constructed from double stretcher width yellow-red bricks in a simple rectangular plan, with an annexe on its eastern edge (4). A large extension (2), with narrower coursing than 3, was subsequently added to the north end of the building (see fig 11), along with a series of smaller extensions (401 and 402) at its southern end (see figs 12-14 overleaf).

Fig 11: Looking south across building 3, showing extension (2)

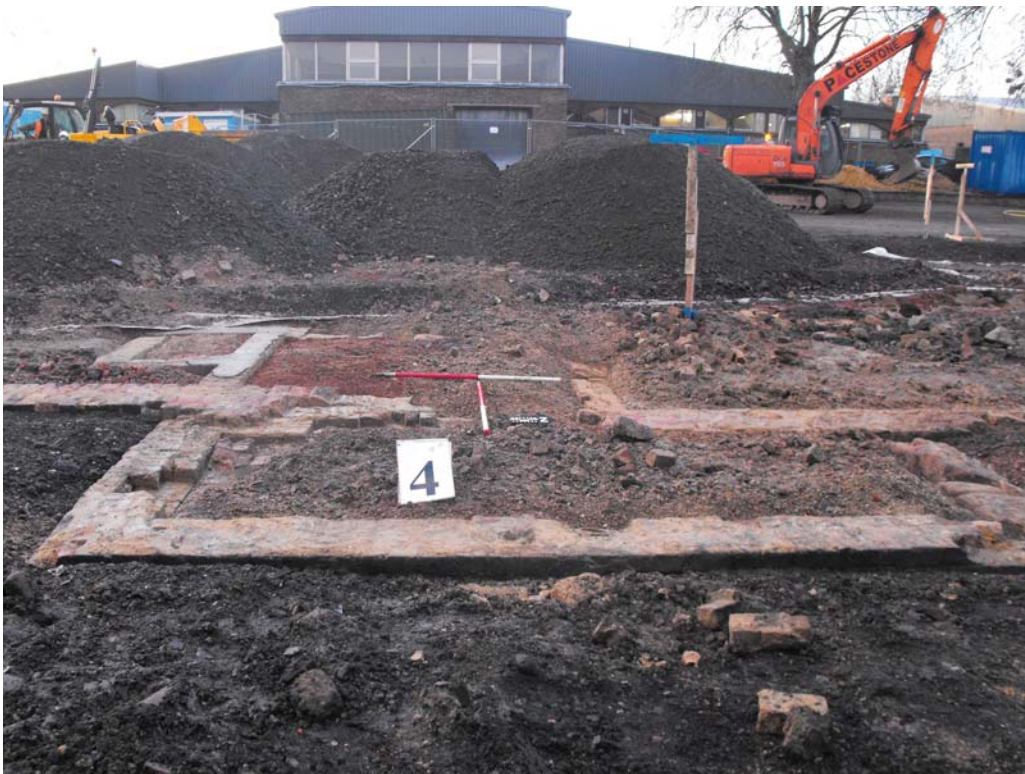
Fig 12: Looking west across building 3, showing annexe 4

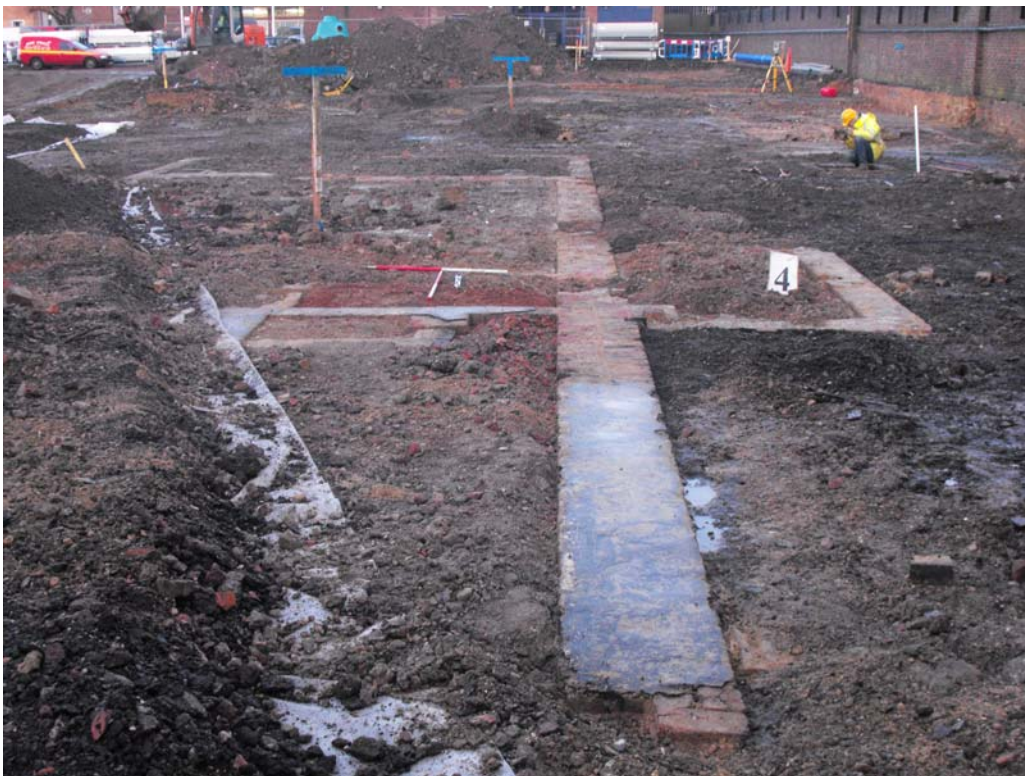
Fig 13 Looking north across building 3, showing south extensions

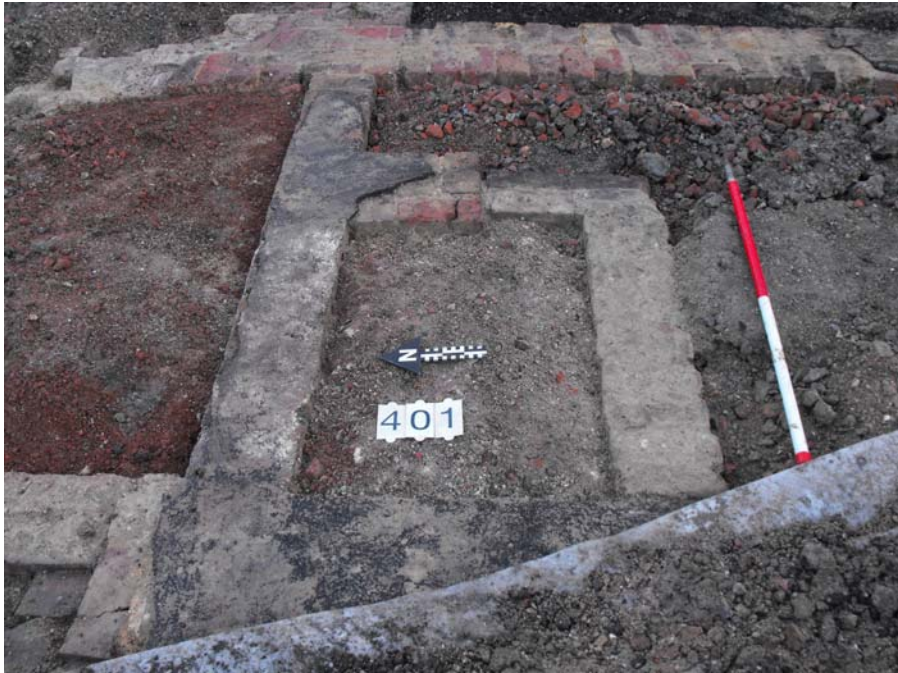
Fig 14: Detail of building 3, extension 401

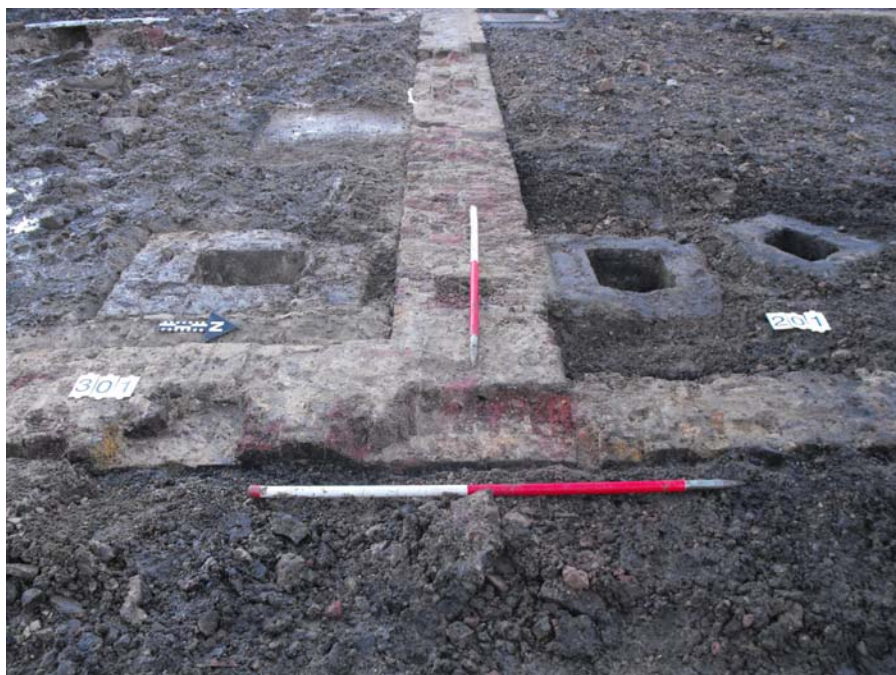
3.9 Internal drains 301 and 302 were constructed from red-black brick and sandstone, and appear to be contemporary with the construction of building 3, whereas drains 201 and 202 are made from brick and concrete, so are clearly later additions, relating to extension 2 (see figs 15 and 16). The drains may have supported the buildings function as a medical centre, allowing the rooms to be easily sluiced out.

Fig 15: Detail of building 3 looking west, showing drains 201 and 301

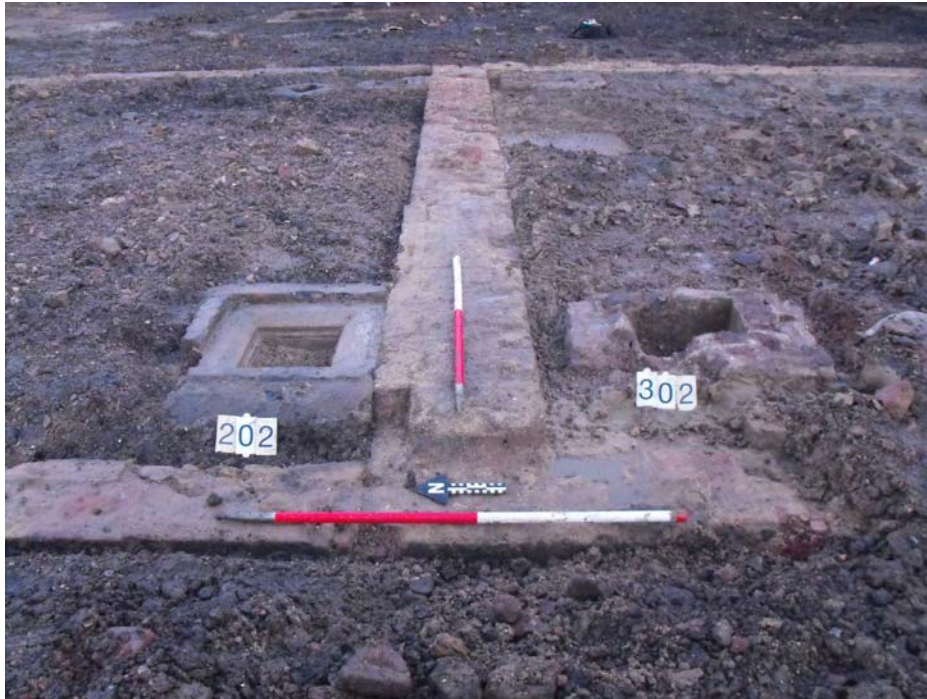
Fig 16: Detail of building 3 looking east, showing drains 202 and 302

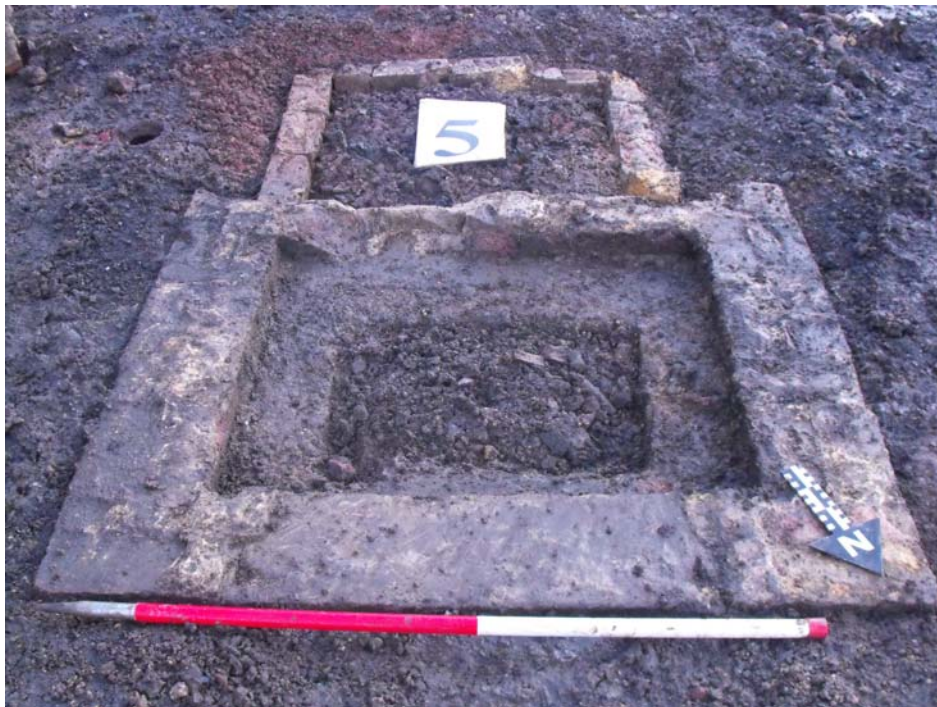
3.9 To the north east of building 3, an additional external drain or soakaway (5) was identified (see fig 17) which seems likely to be directly associated with building 3. The drain was made of red brick and concrete so is a later addition, but contained a range of finds of mid 19th century date (see sections 4.2 and 4.3), so these were probably stray finds dumped in the feature during demolition of the adjacent building.

Fig 17: Detail of drain/soakaway 5, looking south

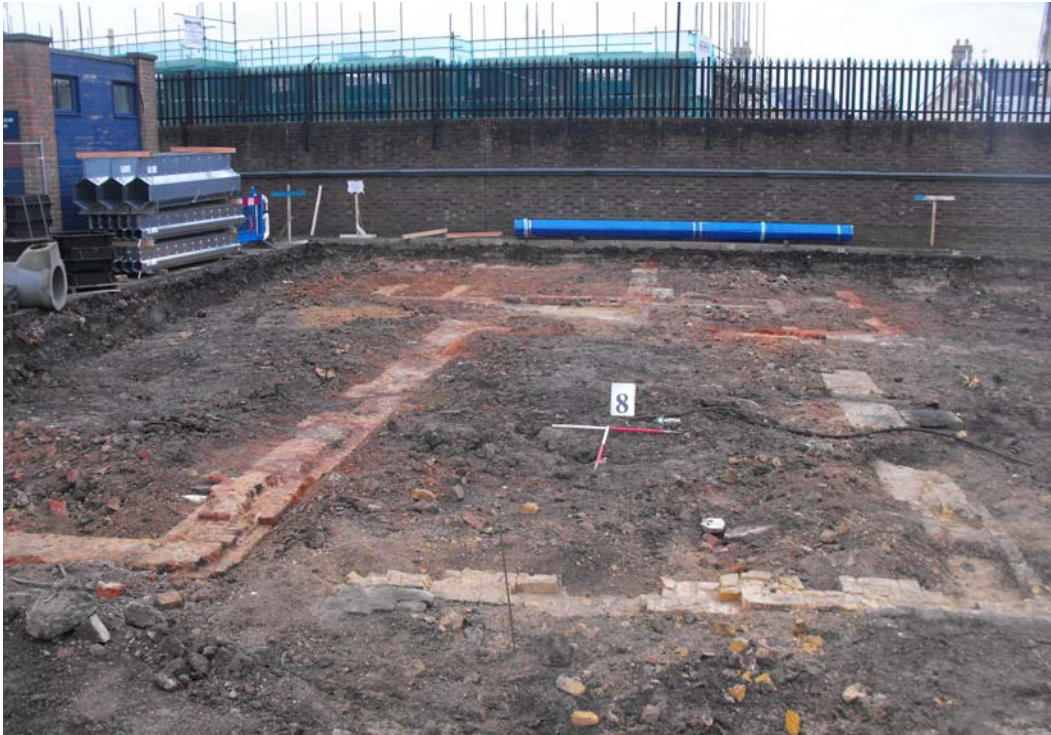
3.12 The red brick walls of building 8 represent the earliest phase of building (see figs 19 and 20). Wall 803 is two stretchers wide and appears to be the south wall of the main schoolroom, with 801 representing the threshold between the kitchen and backyard (see fig 21). A modern pipe trench cuts through the area of the original toilets and urinals. The northern half of the schoolroom, and the schoolmistress's sitting room, lay beyond the perimeter of the watching brief.

3.13 The yellow-red brick walls with external drainage channel that make up the south and south eastern parts of building 8, were also two stretchers wide, and appear to be a later extension to the schoolroom, shown to be completed by the 1912 edition OS map (see fig 5).

Fig 19: Looking east across building 8. The red brick walls on the left and in the background are part of the original schoolhouse, the yellow-red brick walls on the right and in the foreground are a late 19th/early 20th century addition

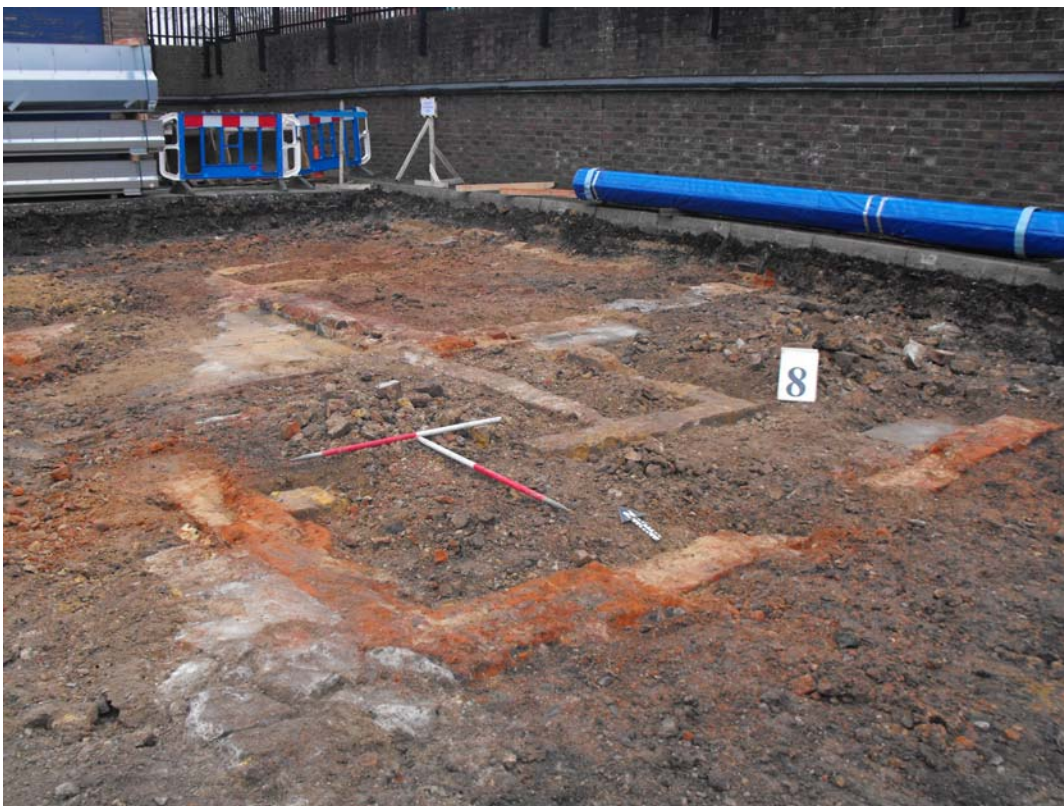
Fig 20: Looking north east across building 8, showing kitchen and backyard areas

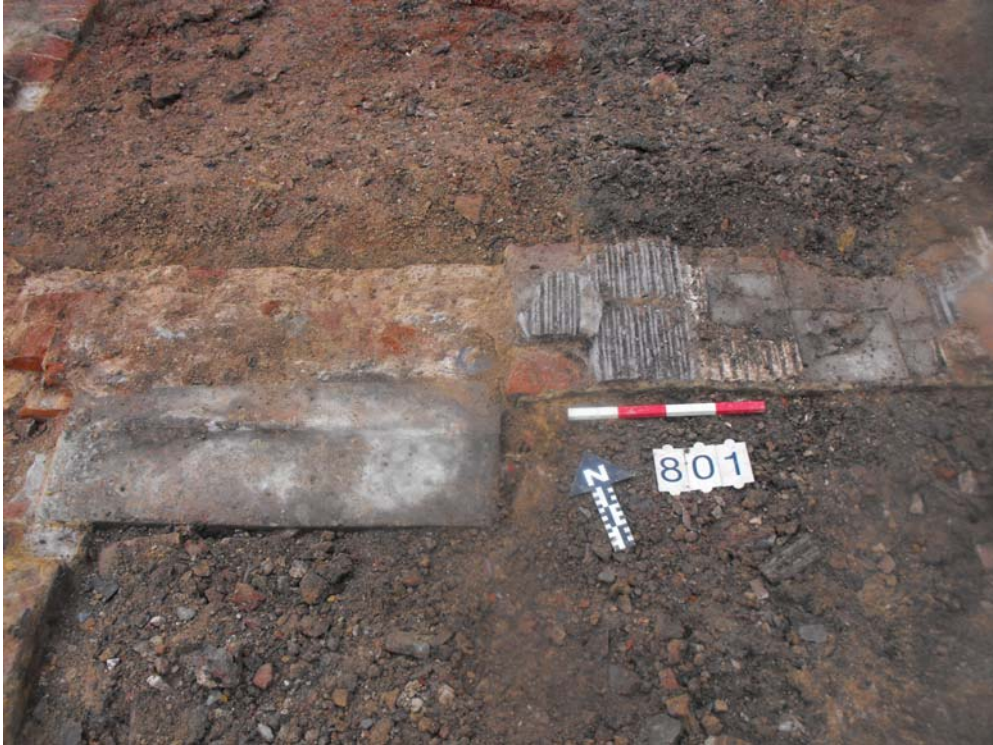
Fig 21: Detail of wall and threshold between kitchen and backyard - the corrugated airbricks would have provided ventilation behind the sink

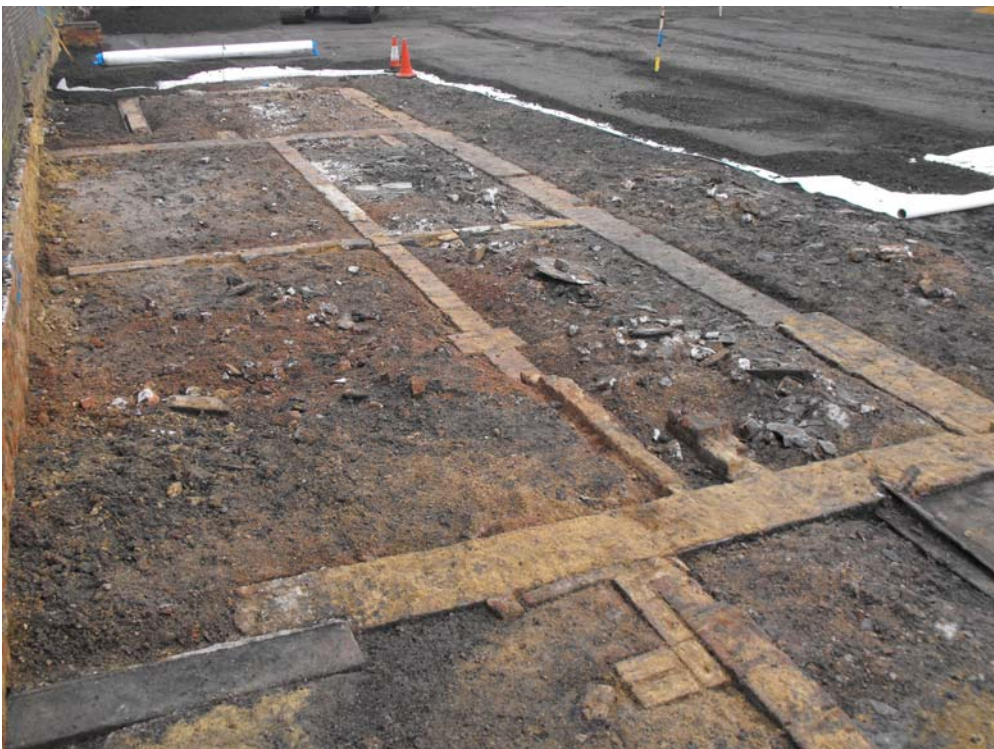
Fig 22: Looking south across building 7

3.15 The external walls of building 7 were made of yellow-red brick, two stretchers wide, with narrow internal walls of only one header or stretcher width. At the south end of building 7, a later extension (6) was added in the same brick but only 1.5 stretchers wide (see fig 22).

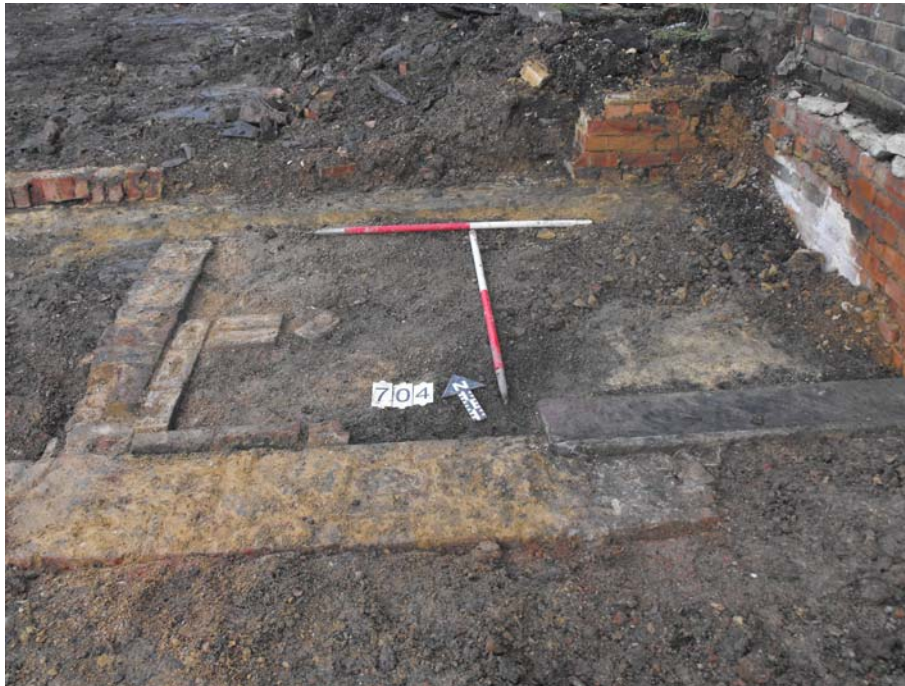
Within building 7 were a series of internal features. Room 704 had an internal cupboard and stone threshold (fig 23), and 703 and 706 are part of a new toilet block with sandstone flag floor, iron cubicle bases and ceramic pans (fig 24).

Fig 23: Detail of room 704, showing internal cupboard and stone threshold

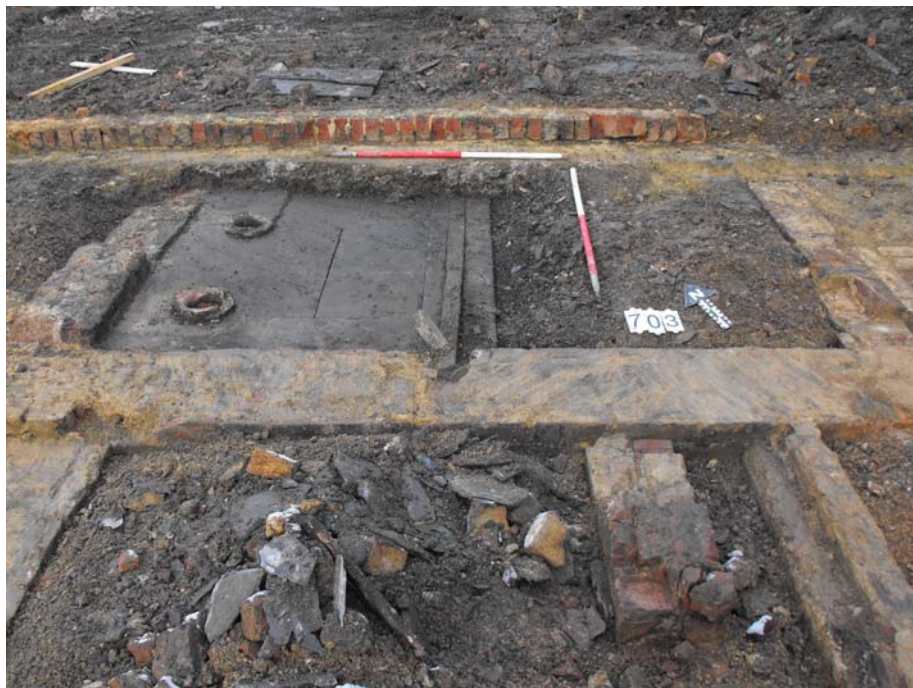
Fig 24: Part of toilet cubicle at north end of building 7

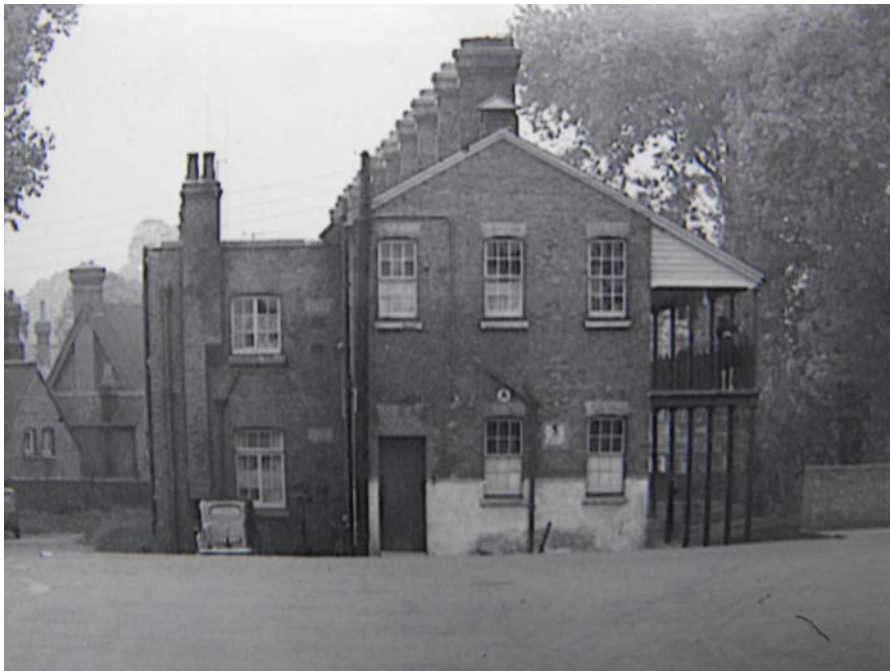
Fig 25: Photograph looking south towards the north end of 'A block', showing design details including chimneys and veranda (courtesy of the Cavalry museum archive)

3.17 The 1860's-1925 Ordnance Survey maps of the site clearly show the footprint of a very long narrow building running on a roughly north to south orientation across the western half of the site (King 2012, and see figs 4 and 5). The block is clearly 'A Block' barracks, which were constructed as married quarters accommodation for 35 families in the 1860's (King 2012). Photographs show the building was two stories in height, with a pitched roof and a large number of chimneys, and an ironwork veranda running along its western side (fig 25). The eastern side of the building had a castellated design, with extensions protruding out at regular intervals, shown clearly on the 1912 map (see fig 5).

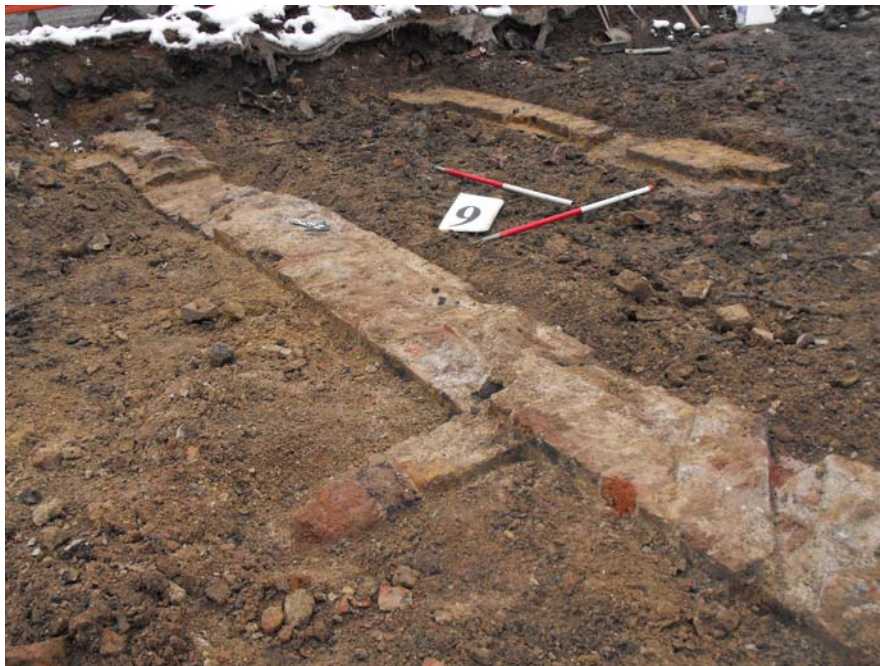
3.18 Significant evidence of A block was found during the watching brief, despite some modern disturbance from service trenches. The two main outer walls of the building were visible as continuous 55cm wide parallel red-yellow-black brick walls (figs 26 and 27 overleaf), recorded as 902, 1204 and 1502 (western wall, fig 28), and 1001, 1302 and 1402 (eastern wall, fig 29). The supporting wall of the veranda was also traced running parallel with the western wall (see figs 26 and 27), recorded as 901, 1303 and 1501, and extending c.2.25m wide. Much of the veranda wall was single stretcher width (22cm) red brick, with an alternating header/stretcher pattern (see fig 31),

Fig 26: Looking east at the northern end of A block, west and veranda wall

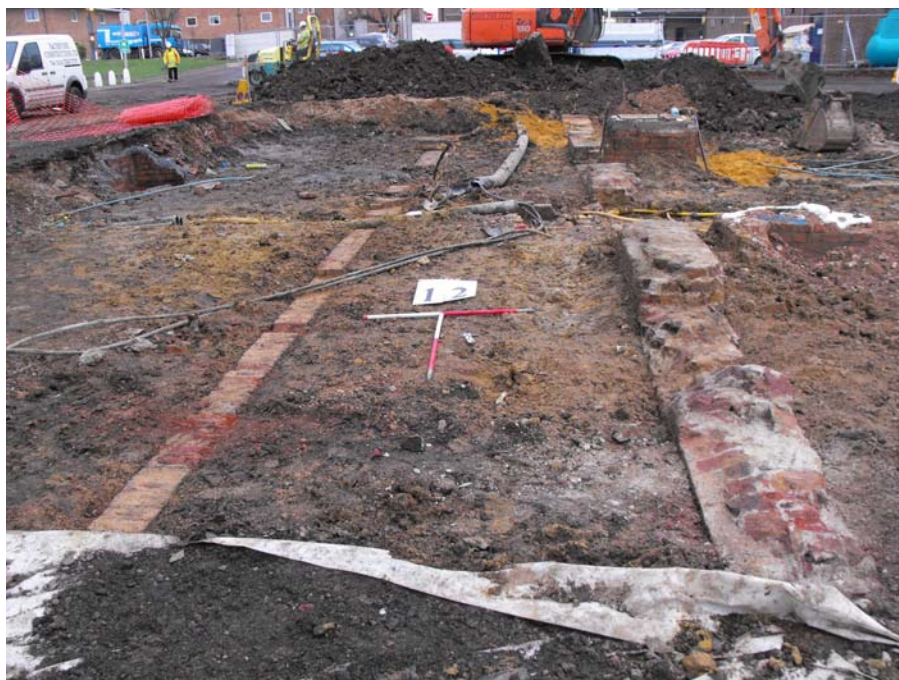
Fig 27: Looking north along A block, showing west and veranda walls, with modern disturbance

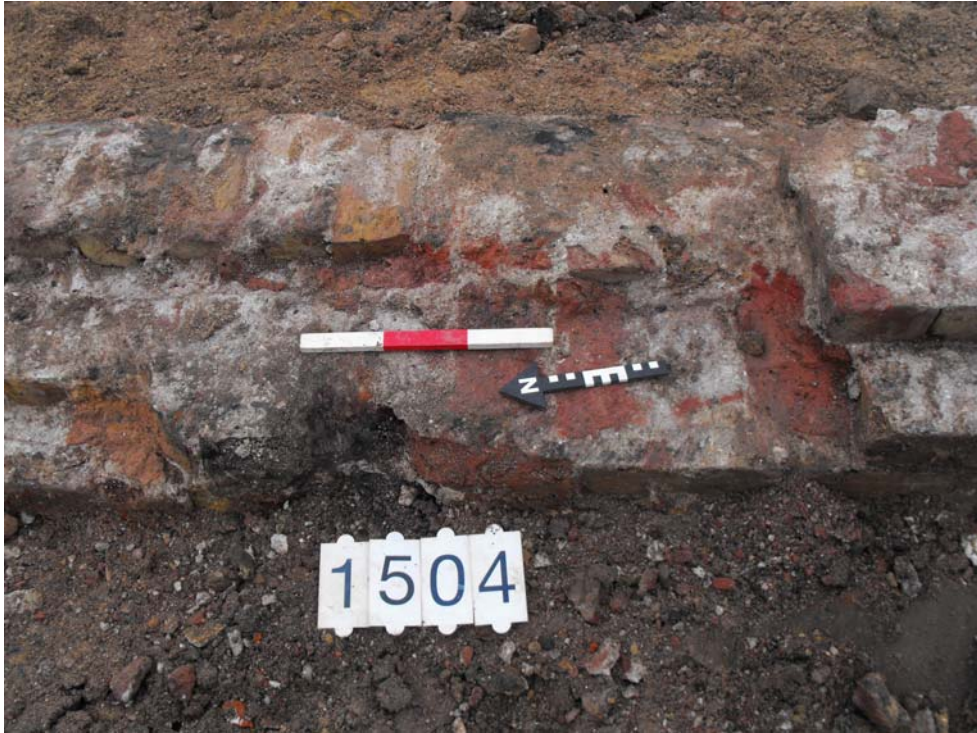
Fig 28: Detail of western wall at north end of building 16

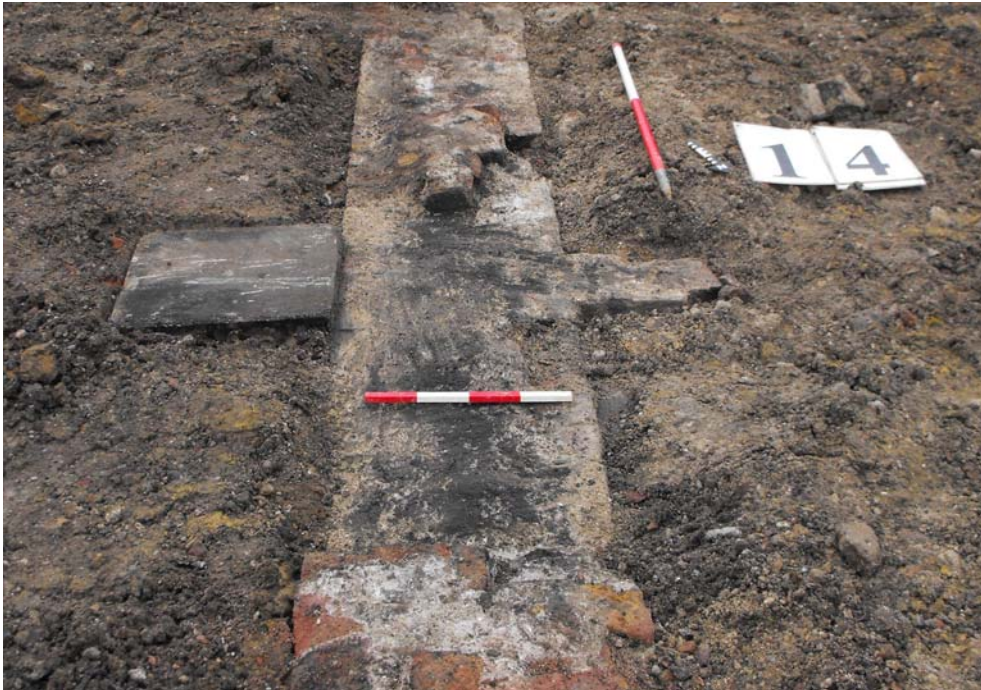
Fig 29: Detail of eastern wall at north end of building 16, with external greensand slab (unknown function), and part of an internal dividing wall

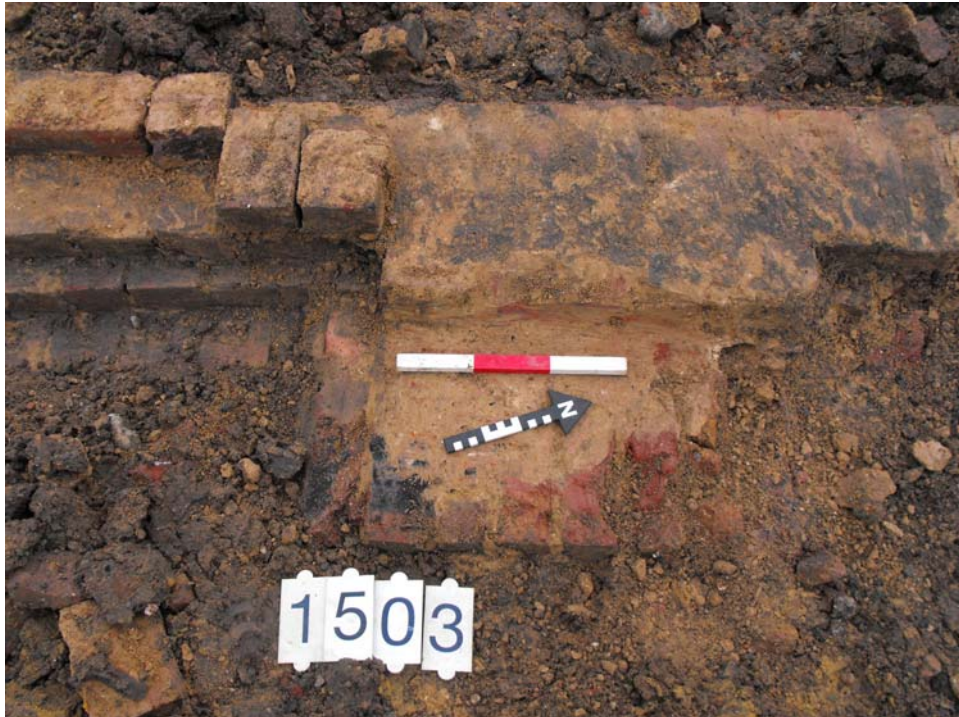
however at the northern end it was made of red-yellow brick and widened out to 50cm (see fig 30).

Fig 30: Detail of wall at north end of veranda, showing wider brickwork

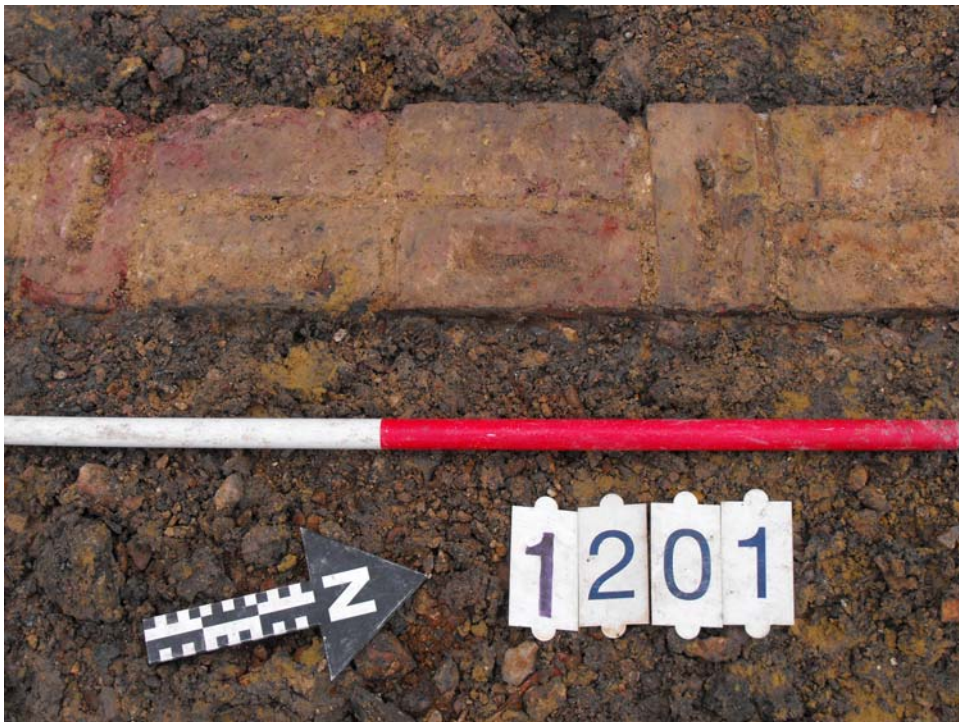
Fig 31: Detail of wall at south end of veranda, showing alternating header/stretcher pattern

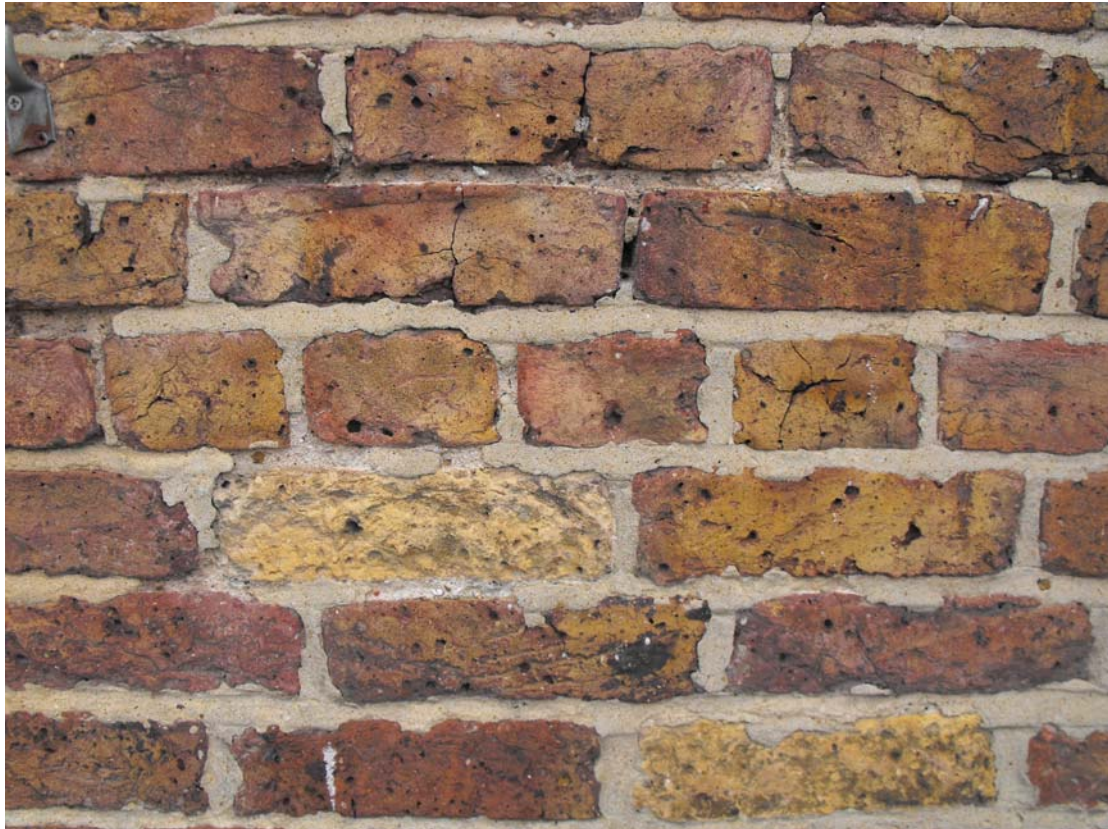
4.4 There was some variation in the size and frog measurements of bricks found on the site, and some were fairly poor quality with large voids, however the vast majority of bricks on the site were fired to a similar red-yellow, red-black, or red-yellow-black colour in a 'marbled effect'. This indicates that the bricks were made from clay originating from the Reading Beds geology. Seams of this clay occur immediately north of the site and it is highly likely that the bricks were manufactured locally, and potentially specifically for the construction of the barracks (Phil Jones SCAU pers comm.). The same type of bricks still survive within the intact structure of the covered riding arena, the only remaining Victorian building on the site (see fig 32 overleaf).

Fig 32: Detail of brickwork on the exterior of the covered riding arena, showing marbled colouring, uneven sizing and large voids.

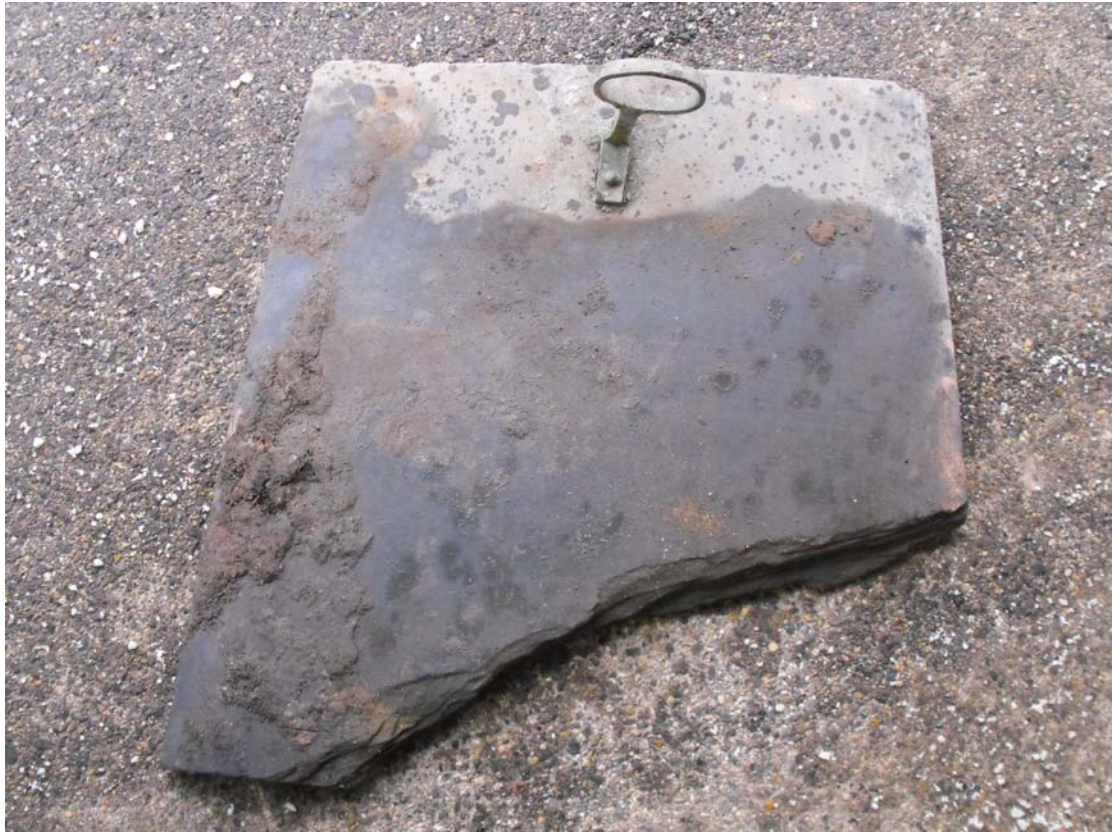
4.6 Surrounding the foundations of the recorded buildings was a large amount of demolition rubble, which contained brick, glass, greensand stone, and a large amount of slate, particularly in the vicinity of building 7. Because most of this material was damaged and not in-situ, no samples were taken, however one unusual slate with a copper alloy handle fitting was photographed (see figs 33 and 34 overleaf). A number of the slates within building 7 measured 20cm thick so some may have been used as flooring as well as roof slates.

Fig 33: Large slate with copper alloy handle fixing

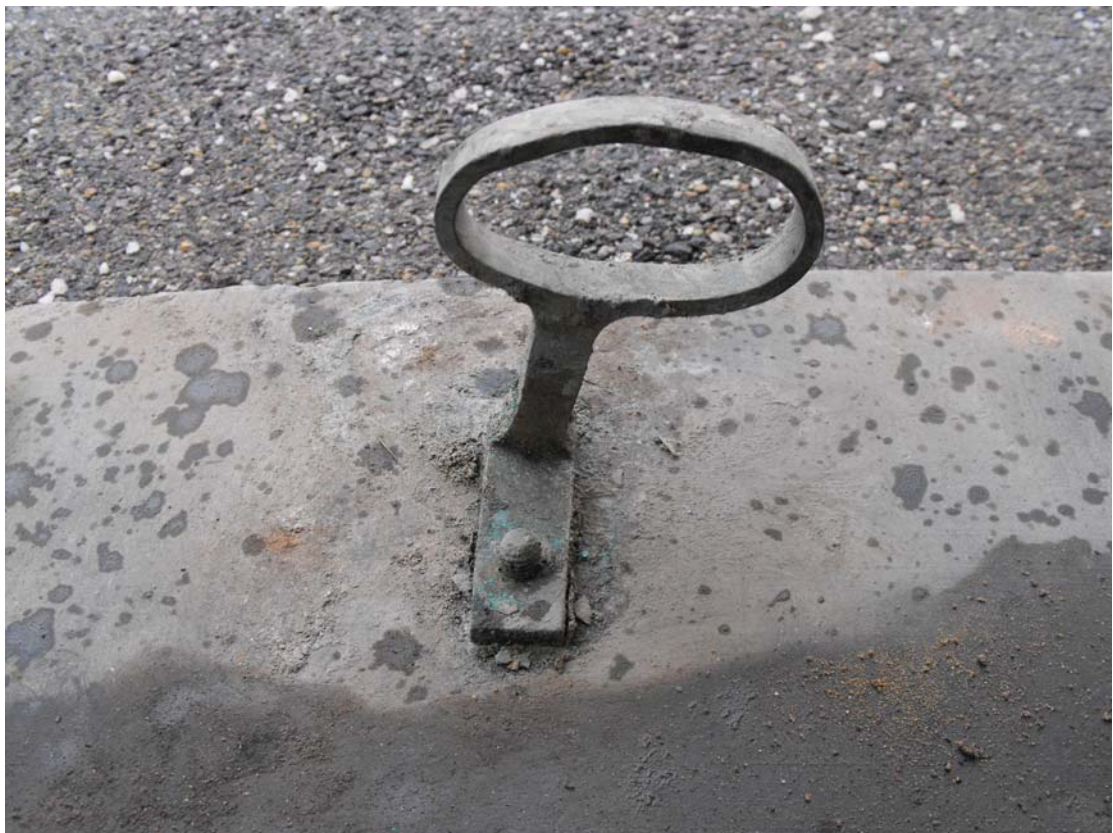
Fig 34: Detail of copper alloy fixing on slate

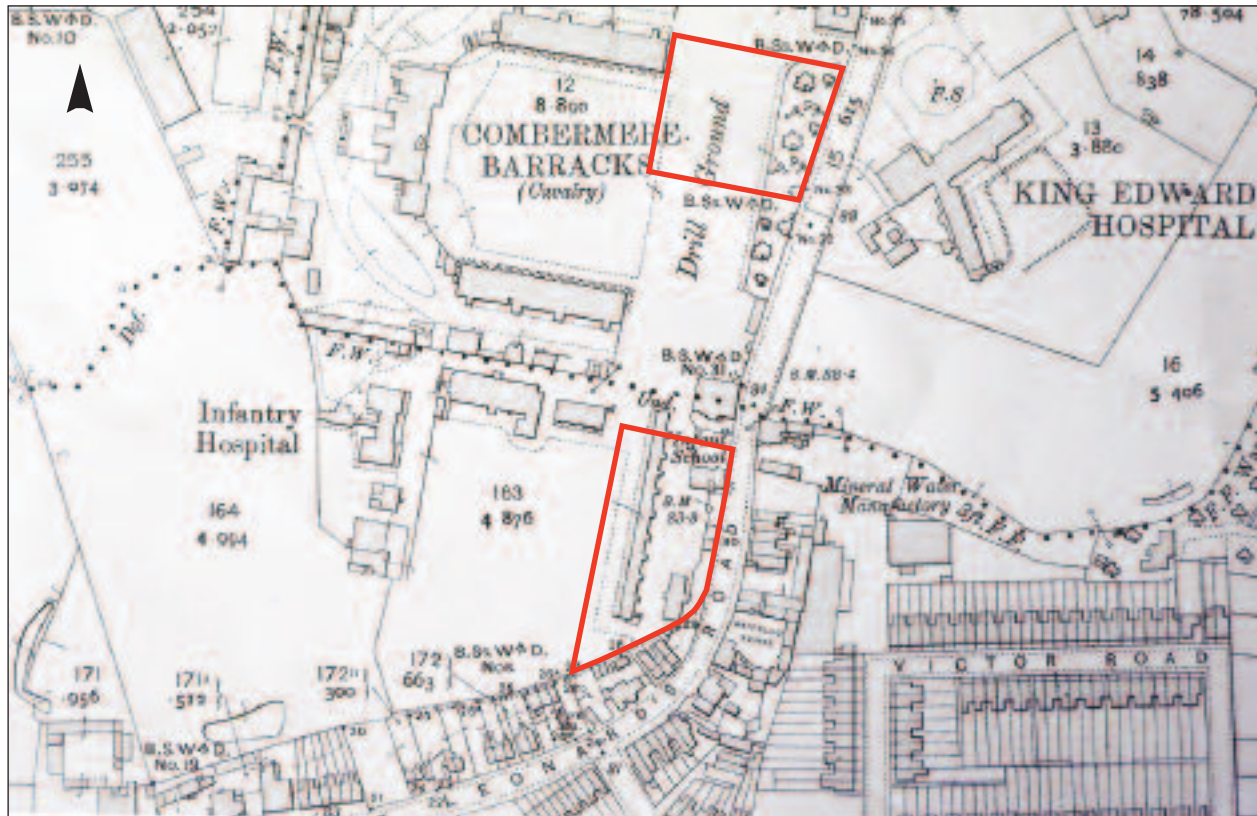
Figure 4: Combermere Barracks, Windsor; extract from 1912 edition OS (after King 2012), showing areas A (north) and B (south) outlined in red

3.14 Building 7 is first shown on the 1860's OS map (fig 4), but at this stage it is not joined with building 8, and its function is not clear. On the later OS maps (fig 5), the building is shown to have been altered and joined with the original school building (8), presumably representing an expansion of the school in the late 19th/early 20th century.
