AN ARCHAEOLOGICAL EVALUATION AT 'WEYHANGER' 50 COMPTON WAY, MOOR PARK, FARNHAM, SURREY

Summary

Project Manager Author Date of fieldwork Date of report NGR Client Rob Poulton Rebecca Lambert 23rd November 2006 27th November 2006 SU 8623 4680 MICA Projects Ltd

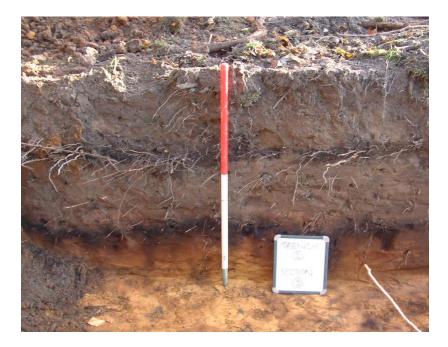
3.3 The north east end of the trench presented the most intact stratigraphic sequence (fig 3 below), as it had not suffered any obvious modern truncation and showed that the uppermost layer (100) survived to a depth of 30cm. A distinct line of rooting was also obvious at the interface of layers 100 and 101 and this supported the idea of there having been a tree in the immediate vicinity and suggesting the 'topsoil' (100) may be relatively recent in origin. Unlike the rest of the trench, the north east end also showed a very dark soil horizon (102) between 101 and the natural surface (103). Despite the dark colour of 102, the lack of charcoal, burnt flint or artefacts relating to it made it unlikely this was directly the result of anthropogenic activity. It is more likely the dark colour was created by an increased organic content within the soil, such as would occur from the decay of leaf mould or extant roots in-situ, or the leaching of such material through the soil profile, thus creating an accumulation at the top of the natural surface.

Fig 3: Photo showing the stratigraphic sequence at the northeast end of the trench 4. Conclusion & Recommendations

4.1 Good archaeological coverage of the area to be developed was achieved and the natural geology was exposed along the whole of the length of the trench. No archaeological finds or features were discovered, despite thorough examination of the machined surface and spoil. The stratigraphy was variable and the presence of a localised layer of colluvium should be noted for any future developments on similar terrain in the locality, as although in this case no archaeology was identified, such evidence may survive intact underneath similar deposits.

On the basis of the above information it is recommended that no further archaeological fieldwork is required in respect of this development scheme.
