BOLTON CHAPEL
BOLTON, Nr. GLANTON
NORTHUMBERLAND

ARCHAEOLOGICAL WATCHING BRIEF

MAY-JUNE 2013

<i>Project code:</i> AP 12/82	<i>Stage:</i> Final	<i>Compiled by:</i> MJ/RJC	<i>Control:</i> AR	<i>Completion date:</i> 28/08/13
----------------------------------	------------------------	-------------------------------	-----------------------	----------------------------------

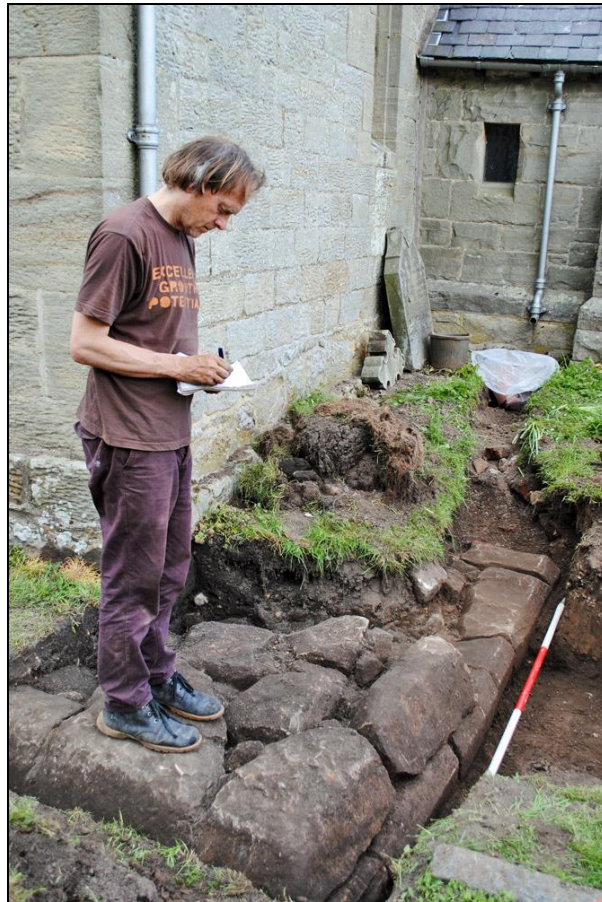
Frontispiece: *View of southwest Tower Foundations at Bolton Chapel.*

Whilst excavating these trenches, significant archaeological remains of a hitherto unknown 13th century church corner-tower or turret, were discovered at the southwest corner of the nave (see *Illus. 10-14, 33-46*). The large sandstone footings of this tower were observed at 0.20m below the turf and were in excellent physical condition.

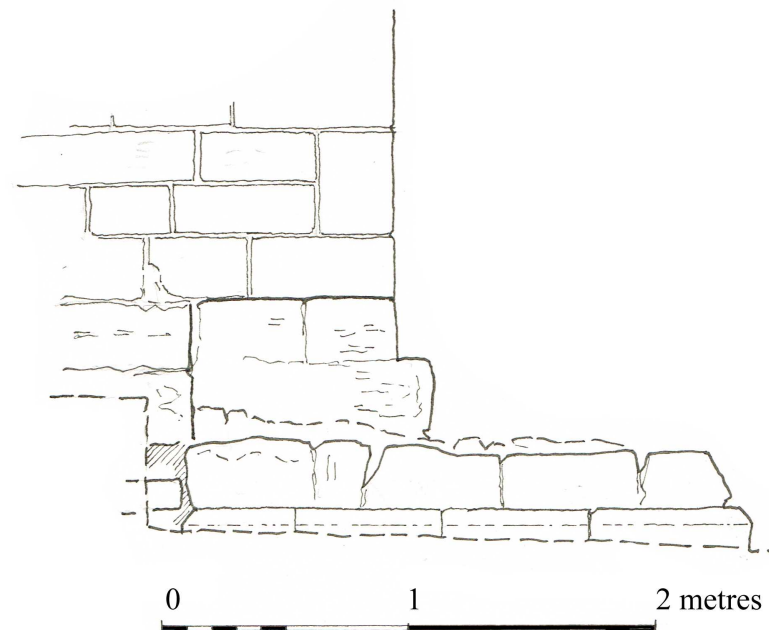
Illus. 13: West facing elevation of Turret footings, Bolton Chapel, Northumberland.

The structure had a two part plinth, a small chamfered step with a taller one above, which was interpreted as of general 13th century character; it measured 2.78m east-west x 2.23m north-south and projected 1.46m beyond the south and 1m beyond the west walls of the present nave. The plinth on its northern return in fact continues beneath the plinth of the west end of the later medieval nave, whilst that on its eastern return is cut short 0.50m from the 19th century south wall. The lower member of the plinth remained intact except where cut away on the east; the upper member only remained around the south-west corner. On the south on the large blocks of the upper member appeared to have been prised out of position, so that it overhung the lower. At the north-west corner, and in the centre of the east return, were blocks with faces that rose vertically above the lower chamber, interpreted as remains of later buttresses coeval with the rebuilding of the nave.

Bolton Chapel 4 6 13 SW turret, W elevation

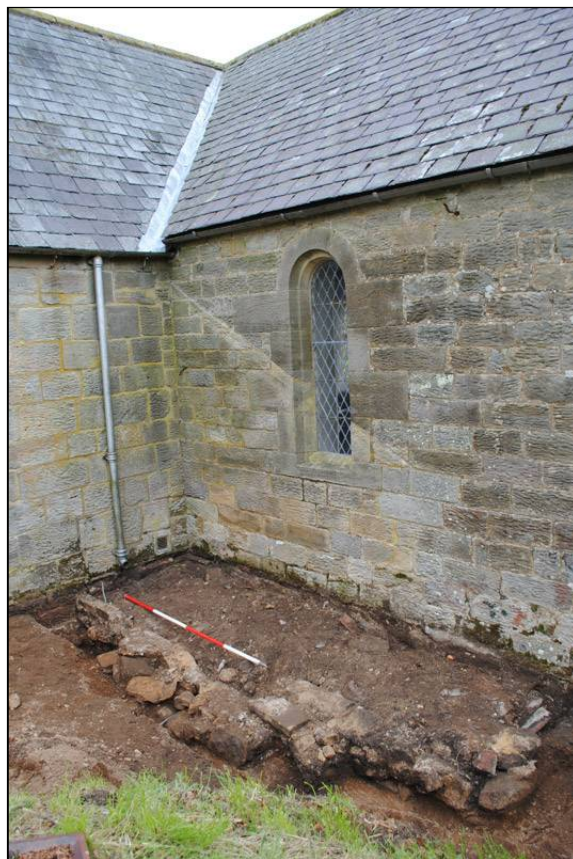
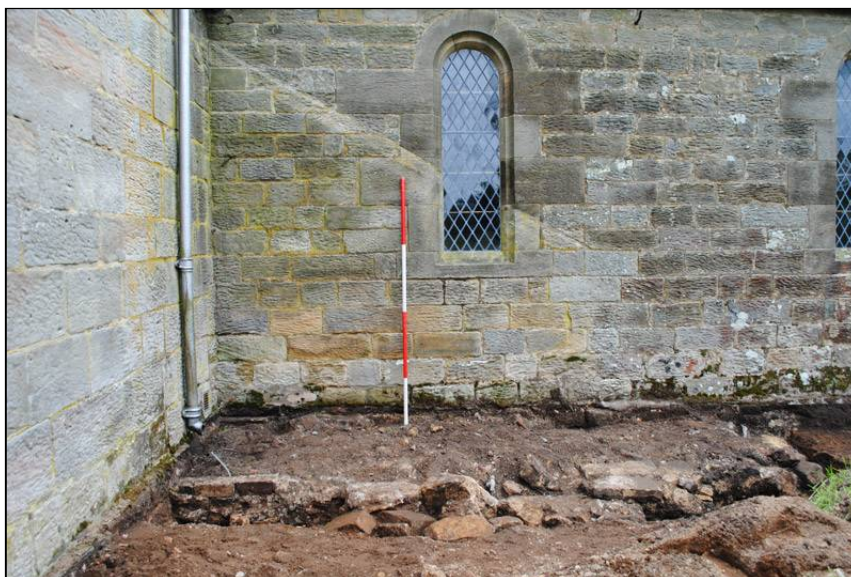
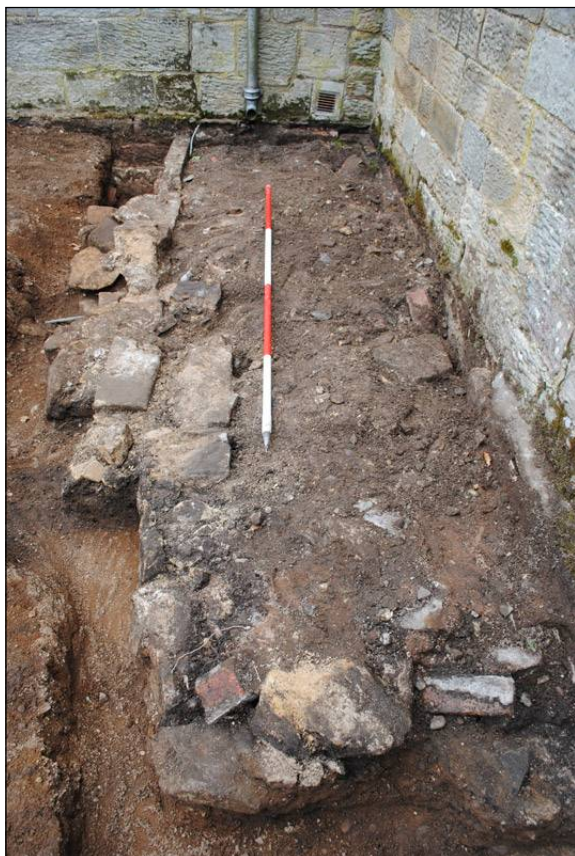
The only archaeological remains observed during the excavations on the north side of the chapel, were structural foundations belonging to a former (probably 19th century) boiler room (see *Illus. 9, 22-44*). This was located at the corner junction between the north wall of the nave and the west wall of the north transept and was aligned east-west. The former roof-line of the boiler room is still visible marked along the north wall of the nave. The interior of the boiler room was simply filled with demolition material, including brick and sandstone rubble. The foundations of the room were predominantly of roughly hewn and reused sandstones of differing sizes and with some modern brick patching on its east end. The dimensions of the boiler-room were as follows: 4.40m (length) x 1.73m (width).

Illus. 22: View looking southeast at structural remains at intersection of the north transept and north nave wall.

Illus. 23: View looking south at structural remains at intersection of the north transept and north nave wall.

Illus. 24: View looking east at structural remains at intersection of the north transept and north nave wall.

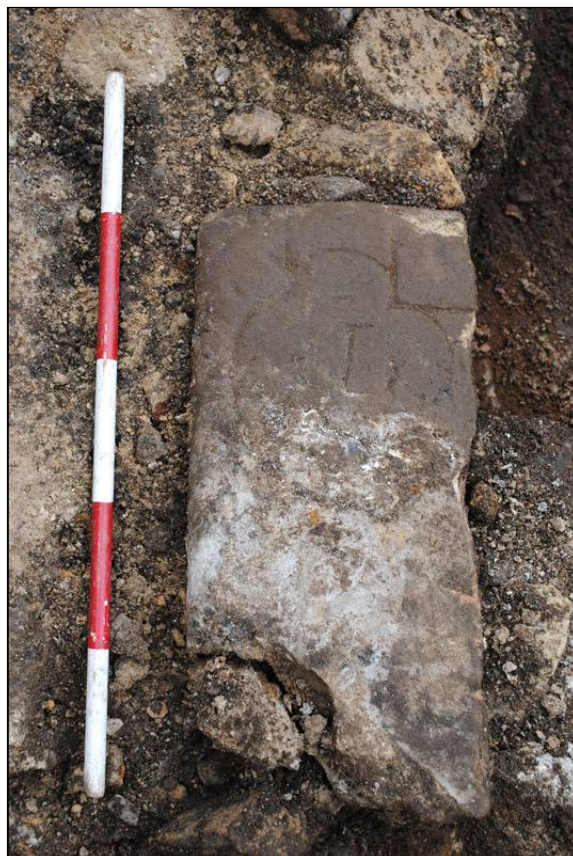
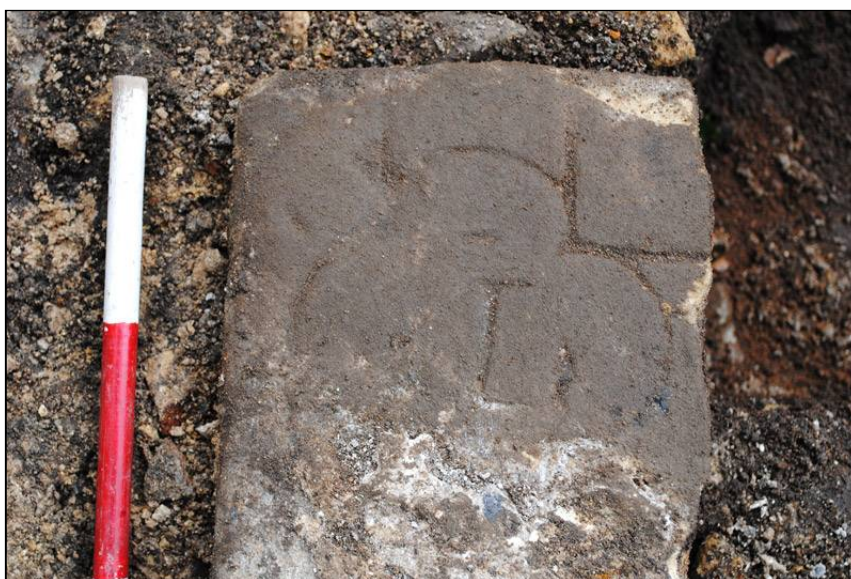
Although this crudely built structure offers little interest in itself, it contained within its foundation a reused grave slab of probable 13th or 14th century date (see *Illus. 25-26*). A short description of the grave slab has been produced by Peter Ryder in his separate desk-based assessment of Bolton Chapel.

This stone was found re-used in the walls of a small boiler room set in the angle between the nave and north transept of the chapel. It is a slab of buff sandstone, overall 420 by 220mm and c 90mm thick. Its two worked edges, here taken as the top and l. side, are set at approximately right angles, and are slightly rounded; the other two sides are fractures. The incised design consists of a quatrefoil, perhaps set at the centre of a straight-armed cross, although only the r. and upper arms are shown; in the centre of the quatrefoil is an incised motif rather like a capital 'L', with other sinkings below and to the l.

Illus. 25: Cross-slab grave cover, re-used in foundations of former structure at intersection of north transept and north nave wall.

Illus. 26: Detailed view of cross-slab grave cover, re-used in foundations of former structure at intersection of north transept and north nave wall.

This stone is a slab of fine-grained buff sandstone, overall 410 by 190 mm and 80mm thick, with two cut edges set at right angles and two broken. Towards one end it bears an incised cross with a quatrefoil at its centre enclosing a motif that looks a little like an anchor. The cross is incomplete – there is only a trace of the l. arm and no sign whatever of any shaft.

The stone may not have been a conventional cross slab; it does not appear to taper (as most cross slabs did) and whilst the cross is set central to the long axis of the stone in its present form, the r. edge is a fracture. So what was its original form? The most likely possibility is that it was a grave marker of some form, possibly cut square so as to fit into a pavement, or perhaps more likely set upright in the ground as a headstone or footstone, although the whole of its face is well tooled (rather than having the lower portion, which would have been underground only roughly finished). Another possibility is that it is part of a double stone, which would have borne two crosses side by side (usually commemorating man and wife), but these are relatively rare.

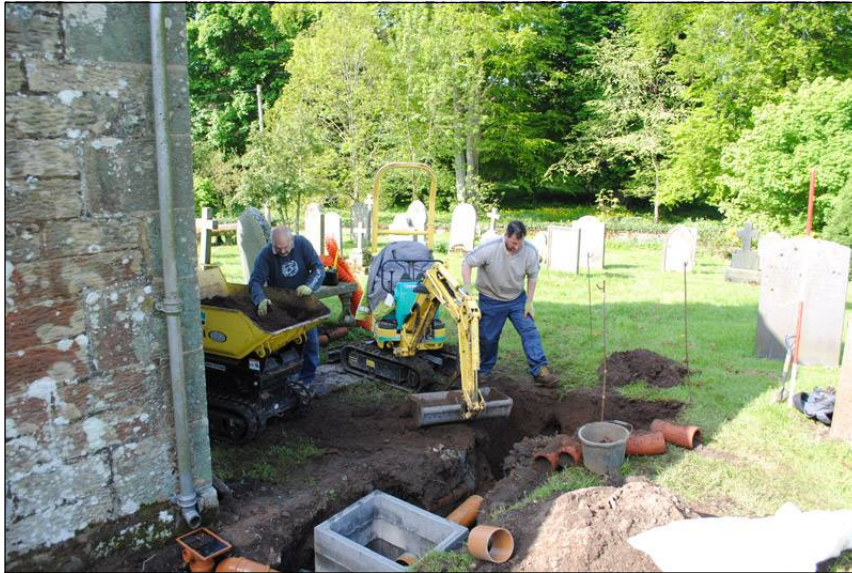
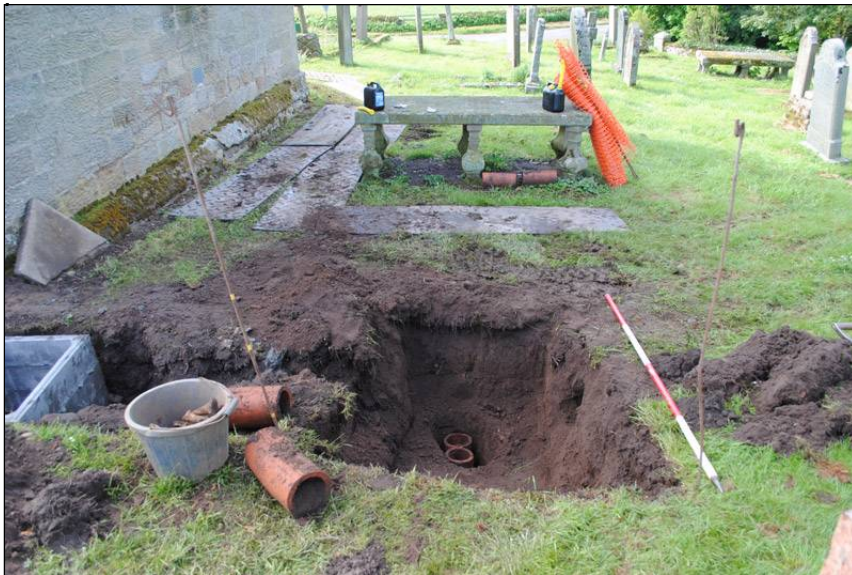
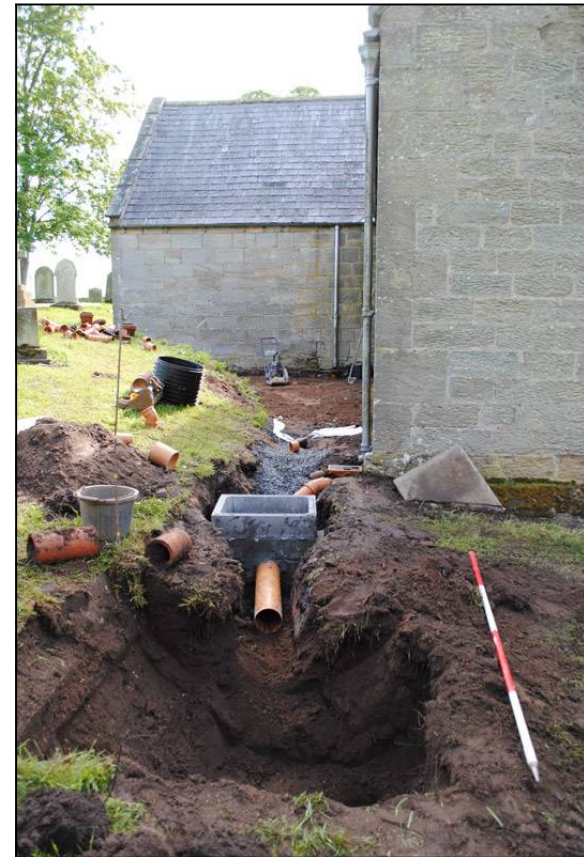
The excavation of a soak-away pit located 3.65m west of the northwest corner of the nave, revealed little archaeology except for several disarticulated human bones, evidently disturbed by the earlier pipe trench which had truncated this area. With the Vicar's permission, these bones were reburied at the base of the pit after it had been excavated. The soak-away pit measured 2m (length) x 1.70m (width) x 1.20m (depth).

Illus. 27: View looking southwest at excavation of services trench and soak-away pit, adjacent to the northwest corner of the nave.

Illus. 28: View looking south at excavated soak-away pit, adjacent to the northwest corner of the nave.

Illus. 29: View looking east at excavated soak-away pit, adjacent to the northwest corner of the nave.

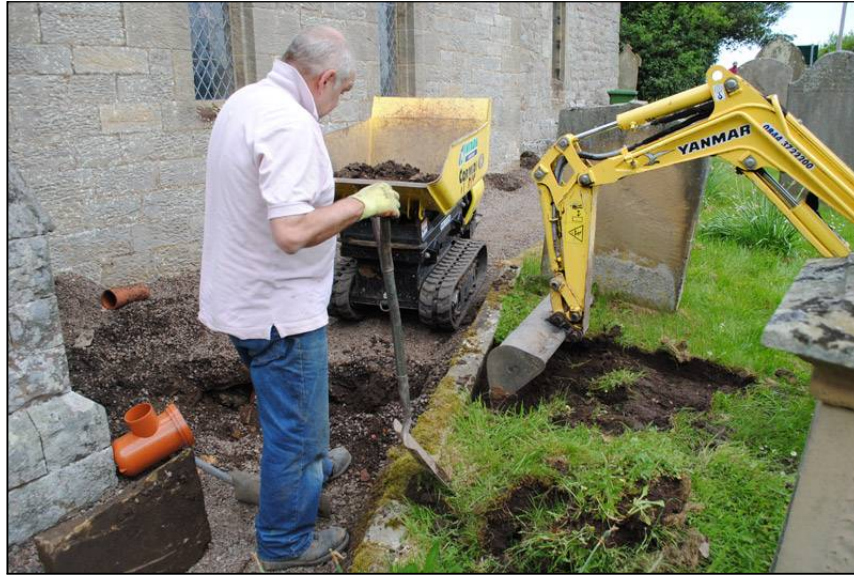
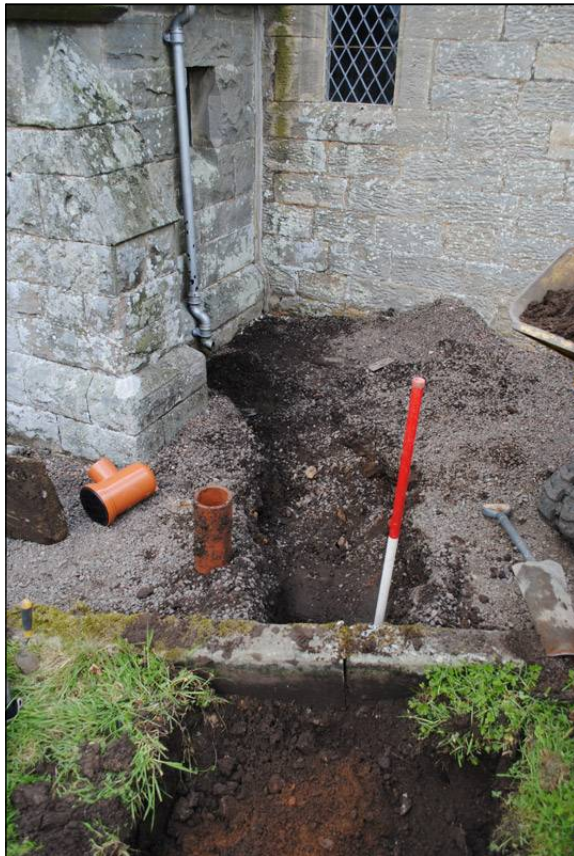
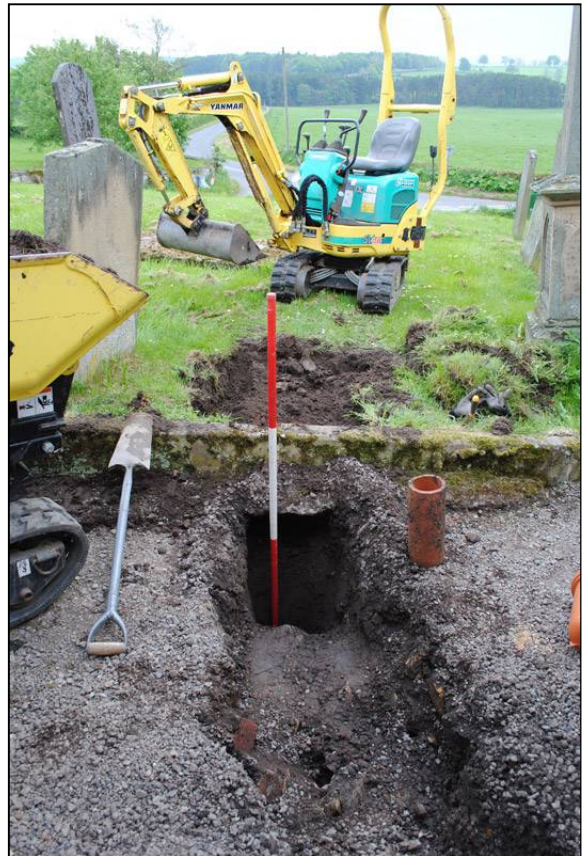
Trench 2 (see *Illus. 8, 30-32*) measured 3.30m in length and was located at the midpoint of the eastern porch wall, where it extended in a south-easterly direction for 1.50m before moving in a southwards direction for a further 1.80m. It soon became apparent that an earlier soak-away pit had been attempted in this area; a good deal of void-filled rubble was discovered in the middle of the trench, the new soak-away pit having to be excavated immediately behind it. No archaeological or skeletal remains were observed.

Illus. 30: View looking east during excavation of services trench and soak-away pit, running from the northeast corner of the porch turning southwards and bisecting the footpath.

Illus. 31: View looking northwest at services trench, running from the northeast corner of the porch across the footpath.

Illus. 32: View looking south at services trench, running from the northeast corner of the porch across the footpath.

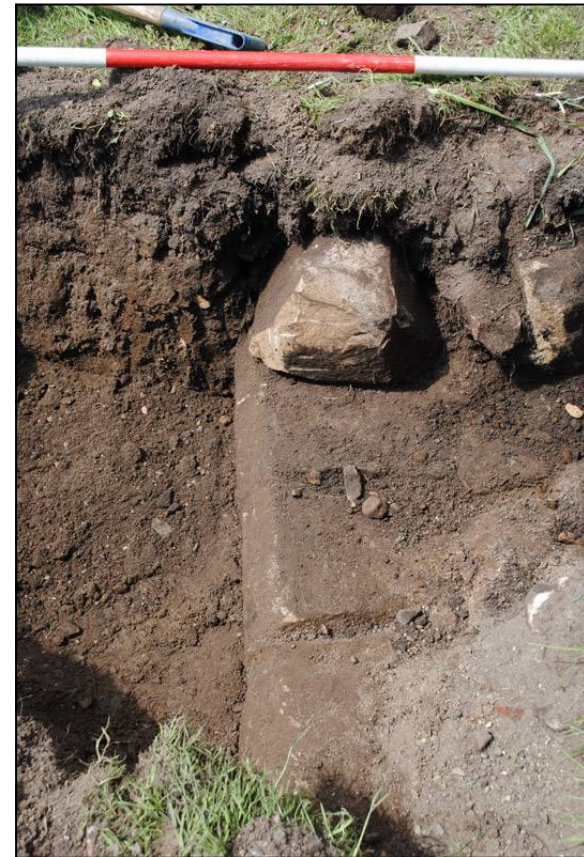
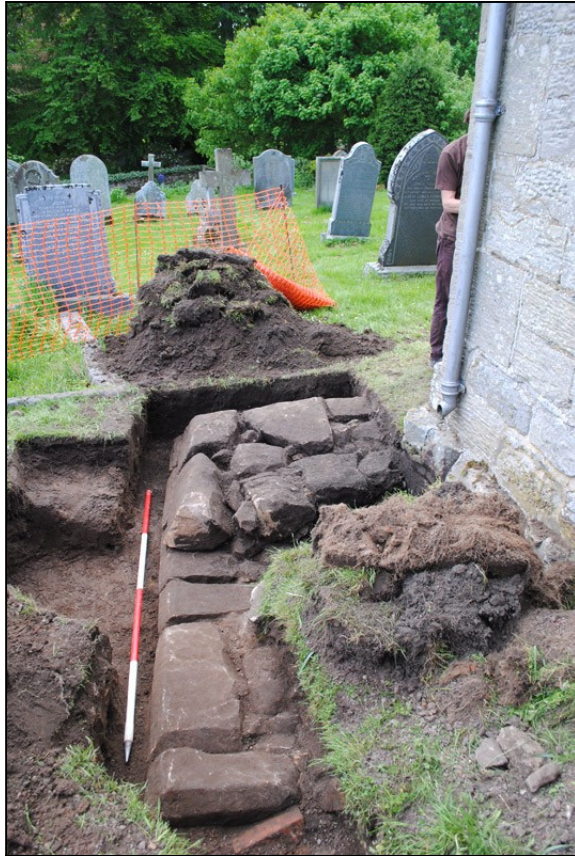
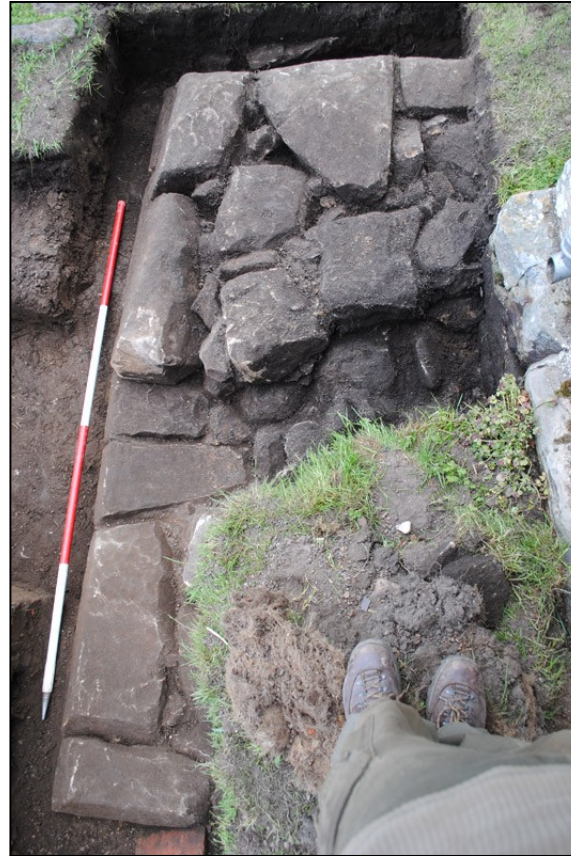
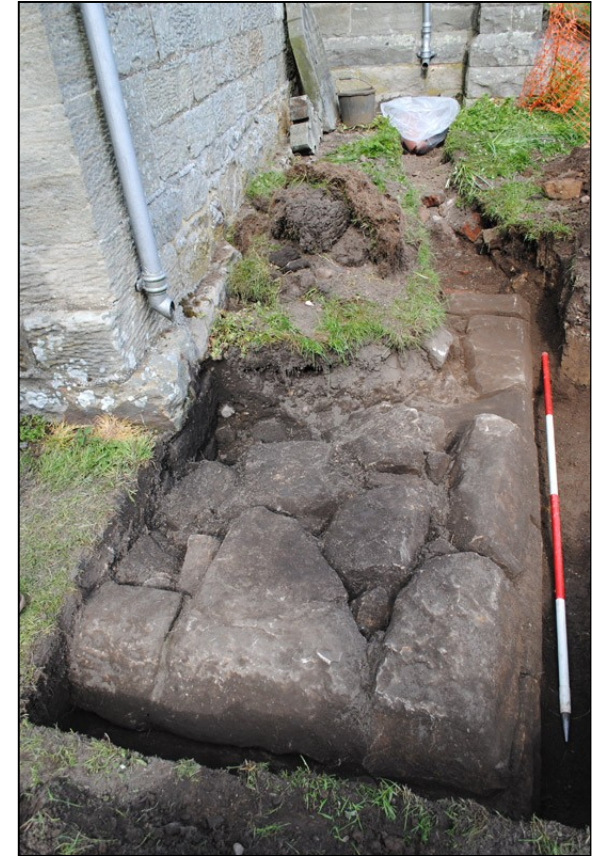
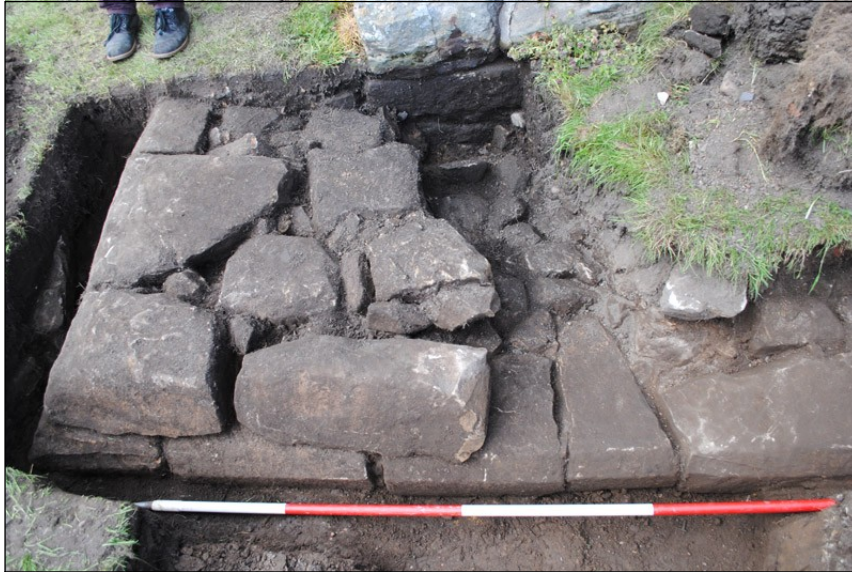
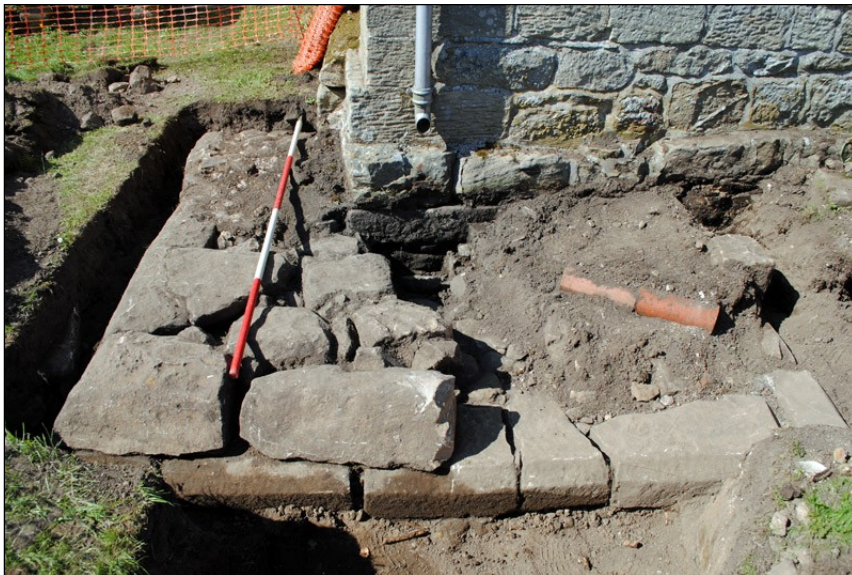
Illus. 35: View looking west of initial discovery of Tower foundations in services trench running from the west wall of the porch.

Illus. 36: View looking west along Tower foundations adjacent to the southwest corner of the Nave.

Illus. 37: Detailed view looking west along Tower foundations adjacent to the southwest corner of the Nave.

Illus. 38: View looking east along Tower foundations adjacent to the southwest corner of the Nave.

Illus. 39: View looking north across Tower foundations adjacent to the southwest corner of the Nave.

Illus. 40: View looking north across completed excavation of Tower foundations adjacent to the southwest corner of the Nave.

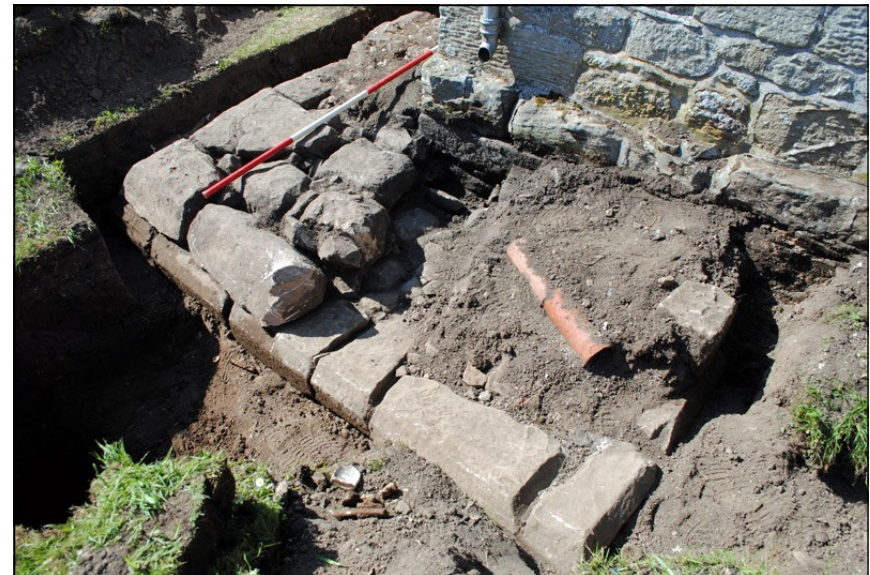
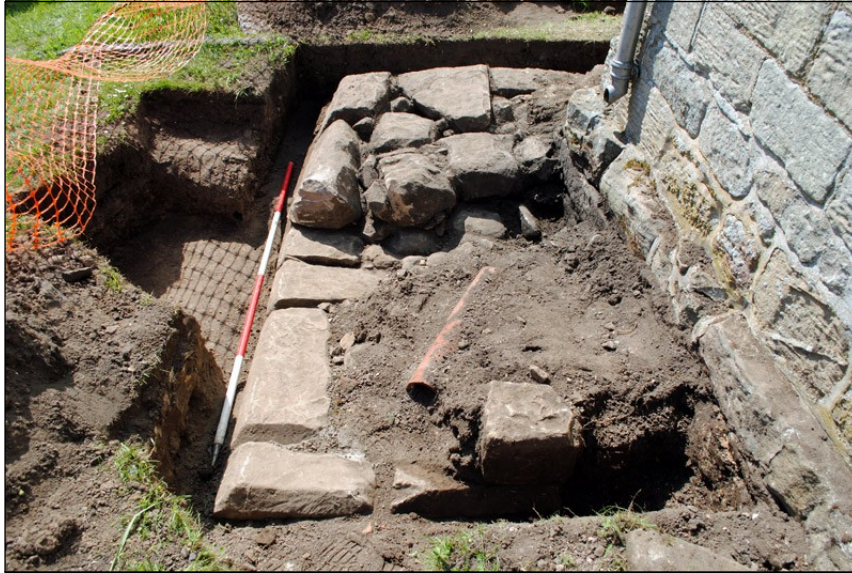
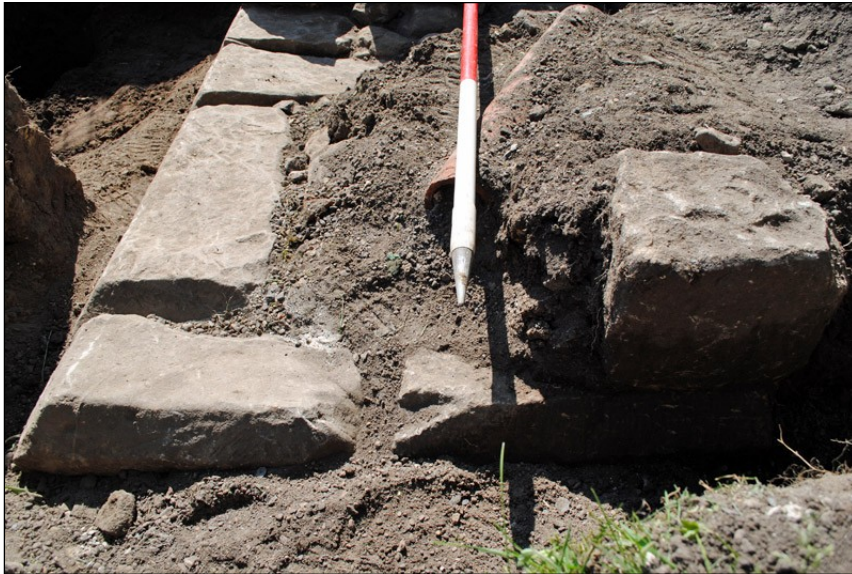
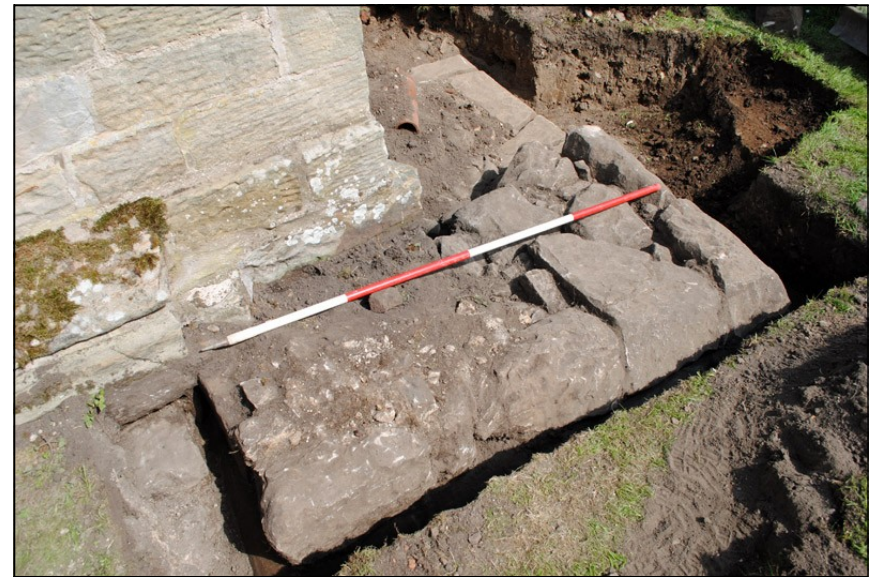
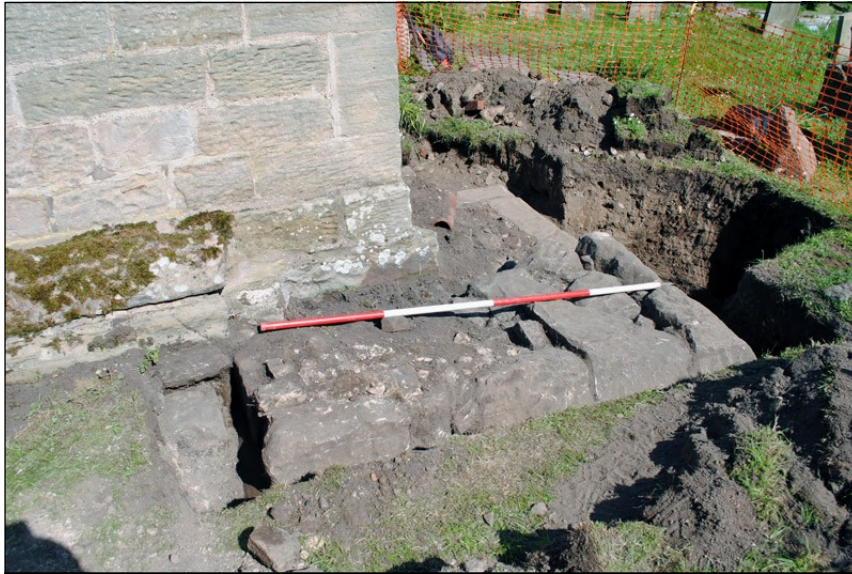
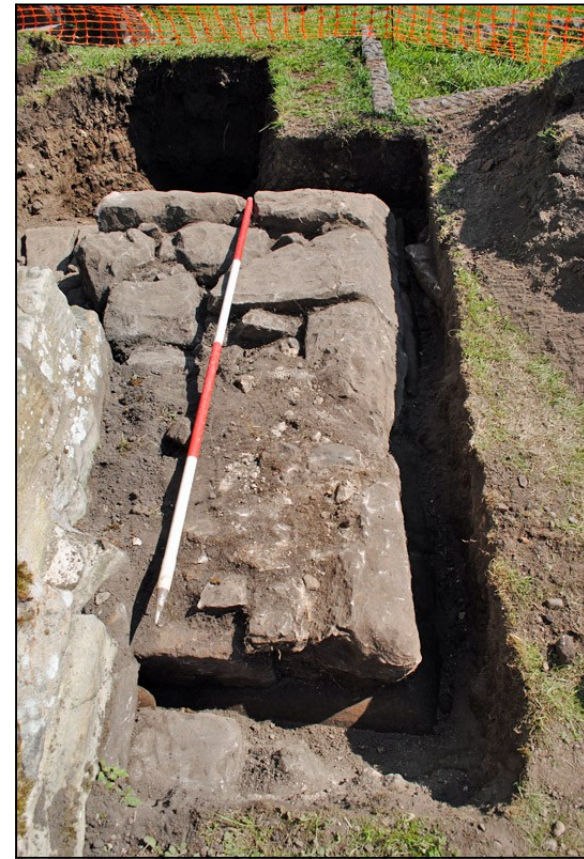
Illus. 41: View looking northwest across completed excavation of Tower foundations adjacent to the southwest corner of the Nave.

Illus. 42: View looking west across completed excavation of Tower foundations adjacent to the southwest corner of the Nave.

Illus. 43: View looking west at detail of Tower foundations adjacent to the southwest corner of the Nave.

Illus. 44: View looking southeast across completed excavation of Tower foundations adjacent to the southwest corner of the Nave.

Illus. 45: View looking east across completed excavation of Tower foundations adjacent to the southwest corner of the Nave.

Illus. 46: View looking south across completed excavation of Tower foundations adjacent to the southwest corner of the Nave.
