ST. ANDREW'S CHURCH WINSTON, Co. DURHAM

REPORT ON AN ARCHAEOLOGICAL WATCHING BRIEF

AUGUST 2013

PROJECT: *Archaeological watching brief at St. Andrew's Church, Winston*
CLIENT: *The PCC of St. Andrew's, Winston*
SITE GRID REF: *NZ 14353 16876*
FIELDWORK: *August 2013*
OASIS REF: *thearcha2-158154*

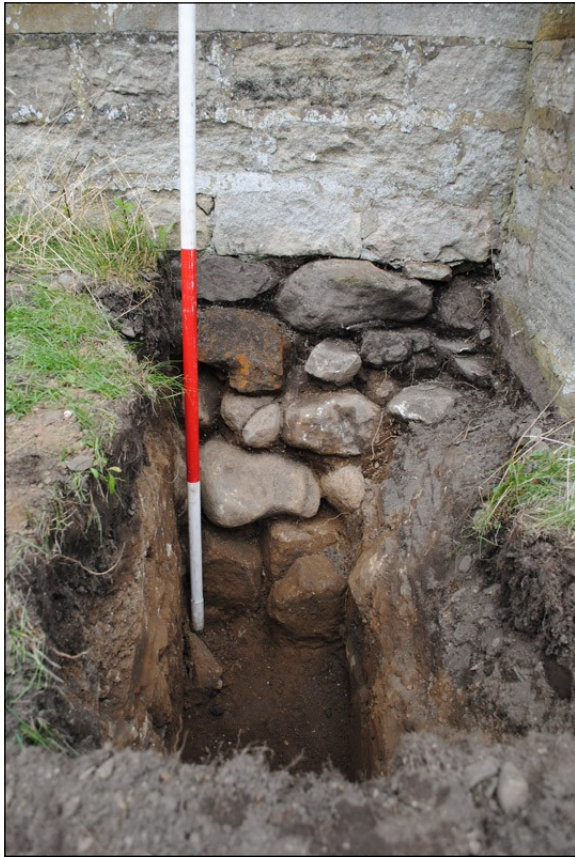
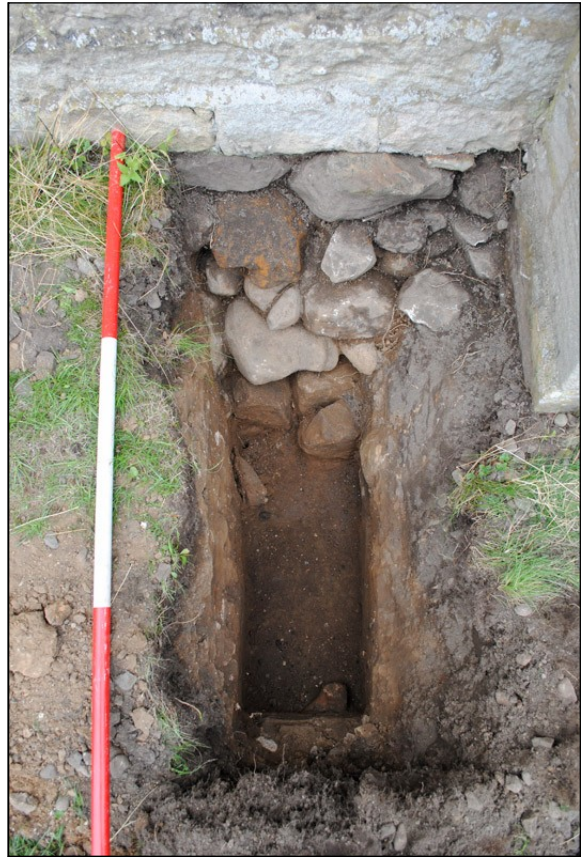
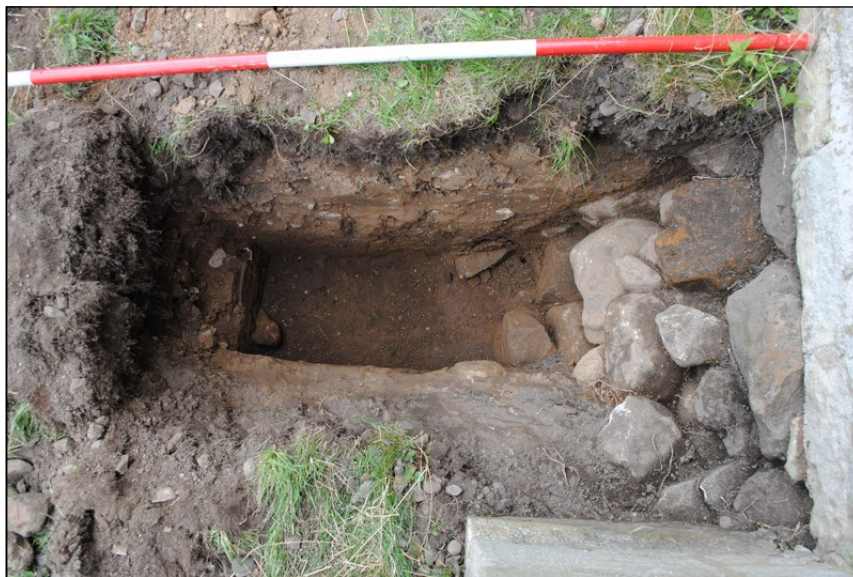
[03] Dry-stone rubble raft foundation for church, comprising of compact sub-rounded riverine cobbles and small boulders, predominantly of limestone with occasional sandstone. Observed in south-facing section of trench. Maximum depth of raft unreached, but extending to at least 0.87m below ground level and projecting 0.50m south of chancel south wall.

Illus. 14: South-facing section of dry-stone cobble foundation raft in Trench 1.

Illus. 15: View looking north at dry-stone cobble foundation raft in Trench 1.

Illus. 16: View looking west at dry-stone cobble foundation raft in Trench 1.

The horizon of compact dry-stone cobbles and small boulders [03] observed beneath the south wall of the church chancel, has been interpreted as a made-up foundation raft to help support the structural fabric of the chancel walls above. Despite the absence of datable material from within this layer and the impossibility of dating the raft stonework on stylistic grounds, one must still assume it to be contemporary with or earlier than the known chancel walls directly above, which are known to have an early 13th-century date. The maximum depth of the foundation raft was not reached as excavation ceased on discovery of articulated human remains, observed at 0.87m below ground level.

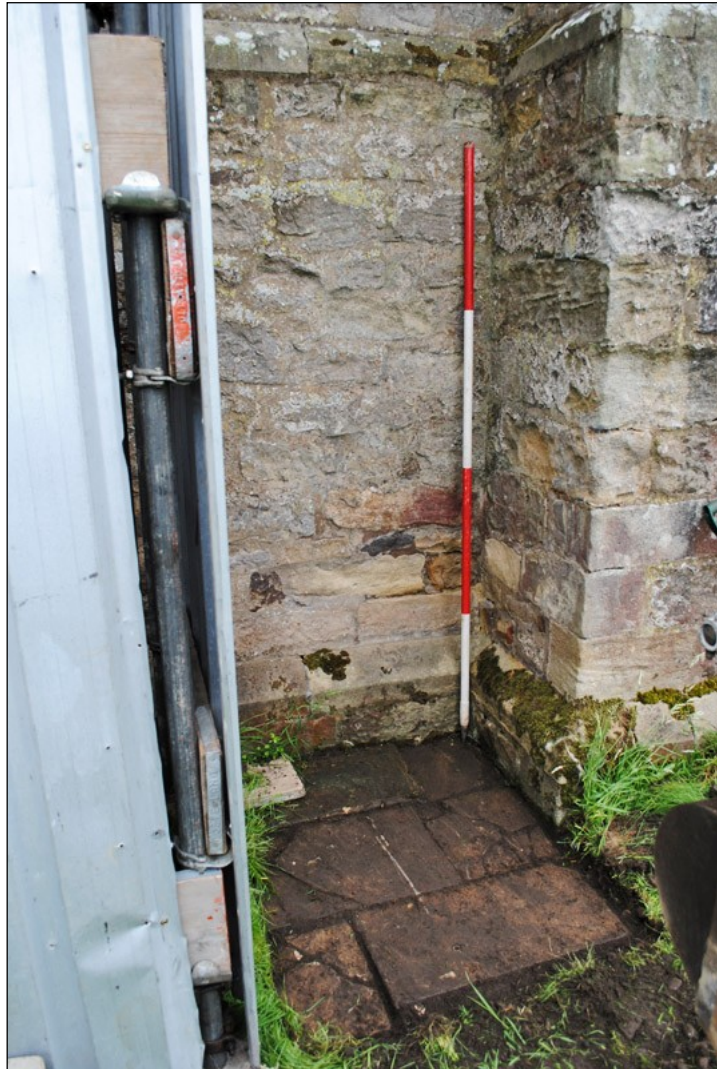
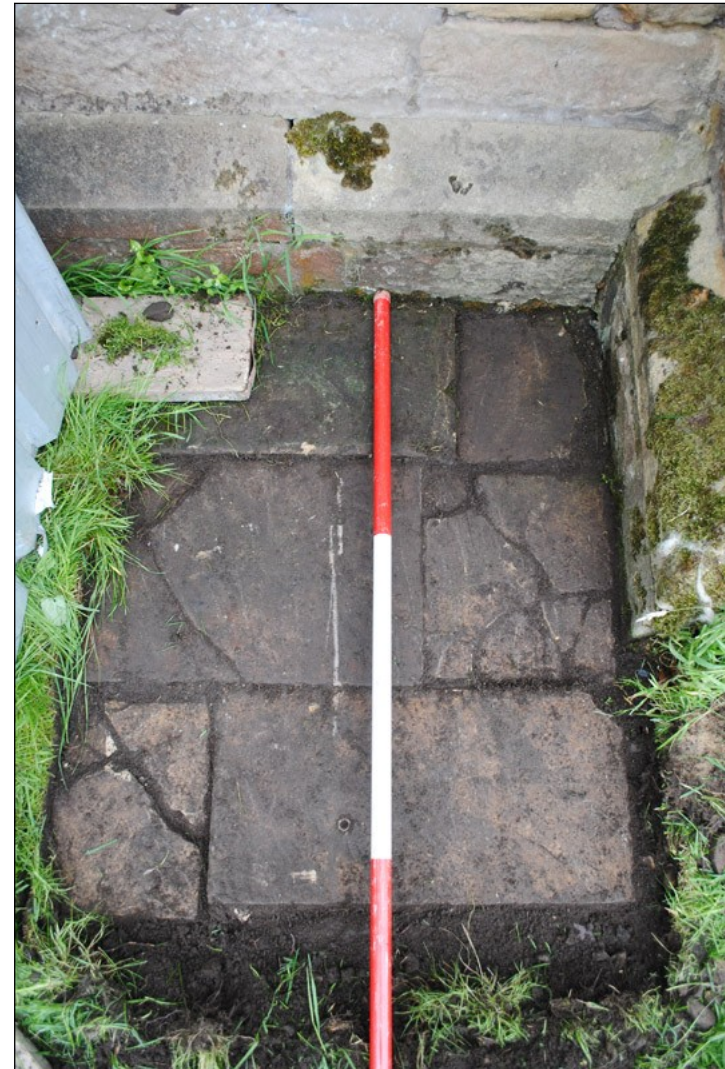
[02] A level sandstone flagged surface (*Yorkstone*), creating a churchyard walk/pavement parallel with the north wall of the chancel. The flags project 1.05m northwards from the chancel north wall, and were only exposed to a distance of 0.87m eastwards from the northwest buttress of the chancel. The flags were observed just under the turf at a depth of 0.01-0.02m below ground level, and had varying thicknesses from 0.04-0.08m. The larger of the two most northerly flags contained a metal-lined slot/socket for a gate or rail lock-bar.

Illus. 17: View looking south-west at a flagged surface just below the grass in Trench 2.

Illus. 18: View looking south at a flagged surface just below the grass in Trench 2.

The sandstone flagged surface [02] has been interpreted as a churchyard walk/pavement parallel with the north wall of the chancel. Unfortunately no stylistic or artifactual evidence from this context can be used to help date the pavement, although the varying thicknesses and fragmentary state of the flags may suggest a medieval or early post-medieval origin. The horizon of compact dry-stone cobbles and small boulders [04] observed beneath the north wall of the church chancel, (equivalent of [03] in Trench 1) has been interpreted as a made-up foundation raft to help support the structural fabric of the chancel walls above. Despite the absence of datable material from within this layer and the impossibility of dating the raft stonework on stylistic grounds, one must still assume it to be contemporary with or earlier than the known chancel walls directly above, which are known to have an early 13th-century date. The full depth of the foundation raft was not ascertained as the required depth of excavation was reached before the raft was fully exposed.

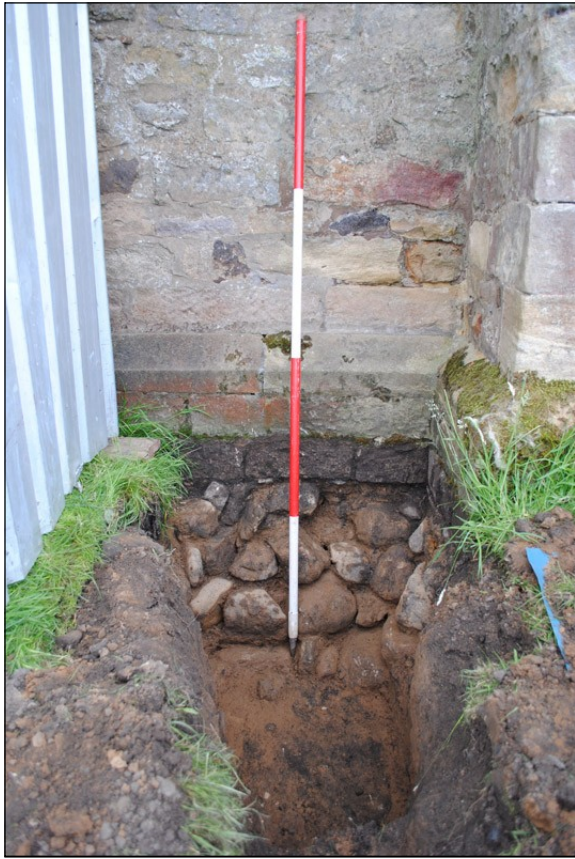
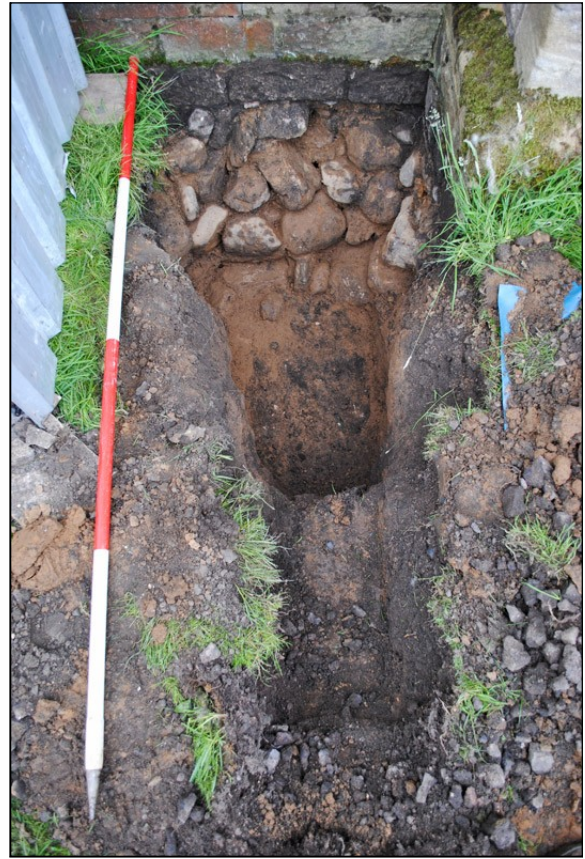
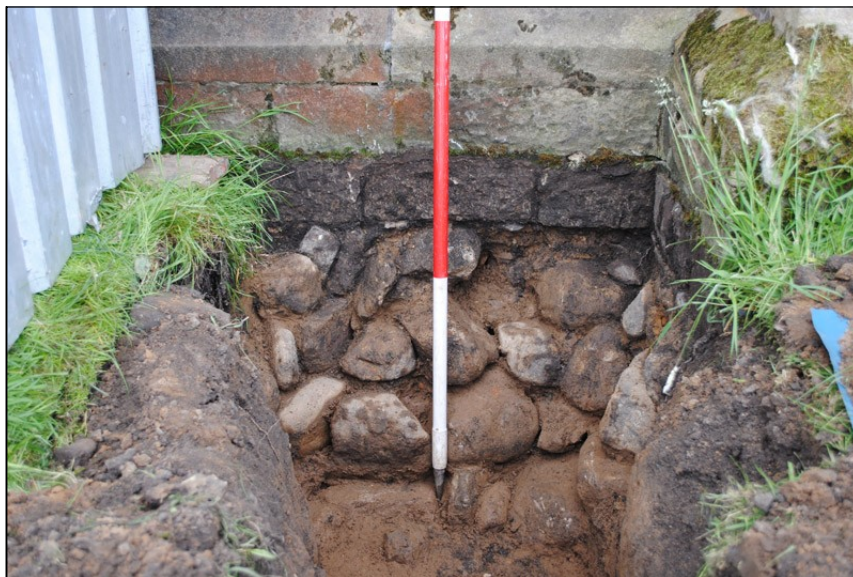
[04] Dry-stone rubble raft foundation for church, comprising of compact sub-rounded riverine cobbles and small boulders, predominantly of limestone with occasional sandstone. Observed in north facing section of trench. Maximum depth of raft unreached, but extending to at least 0.77m below ground level. Projecting to 0.50m north of chancel north wall.

Illus. 21: North-facing section of dry-stone cobble foundation raft in Trench 2.

Illus. 22: View looking south at dry-stone cobble foundation raft in Trench 2.

Illus. 23: Detailed view of north-facing section in Trench 2, showing dry-stone cobble foundation raft.
