ALNMOUTH BOYS' CLUB NORTHUMBERLAND

HISTORIC BUILDING RECORDING

NOVEMBER 2014

Historic Buildings Record

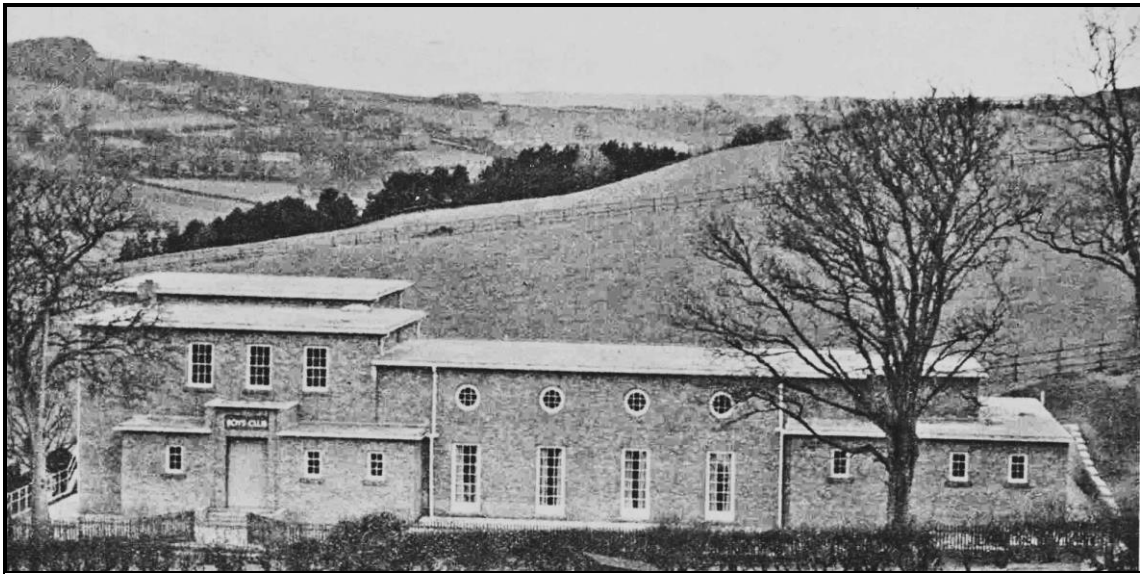
*Cover (upper): The east elevation of Alnmouth Boys' Club published in 'The Architect &
Building News', 1938.*

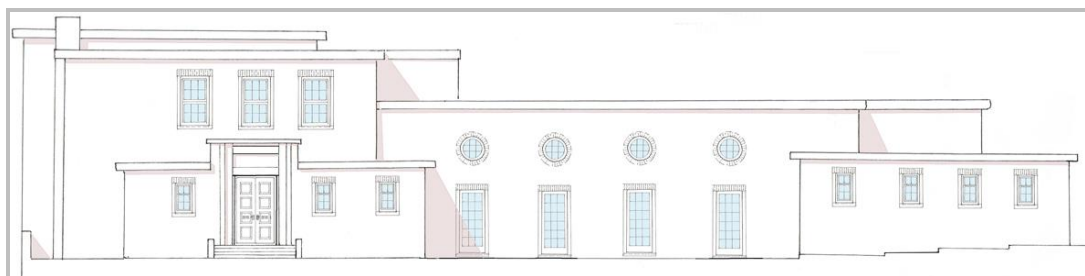
(lower): Drawing of the east elevation in 2014.

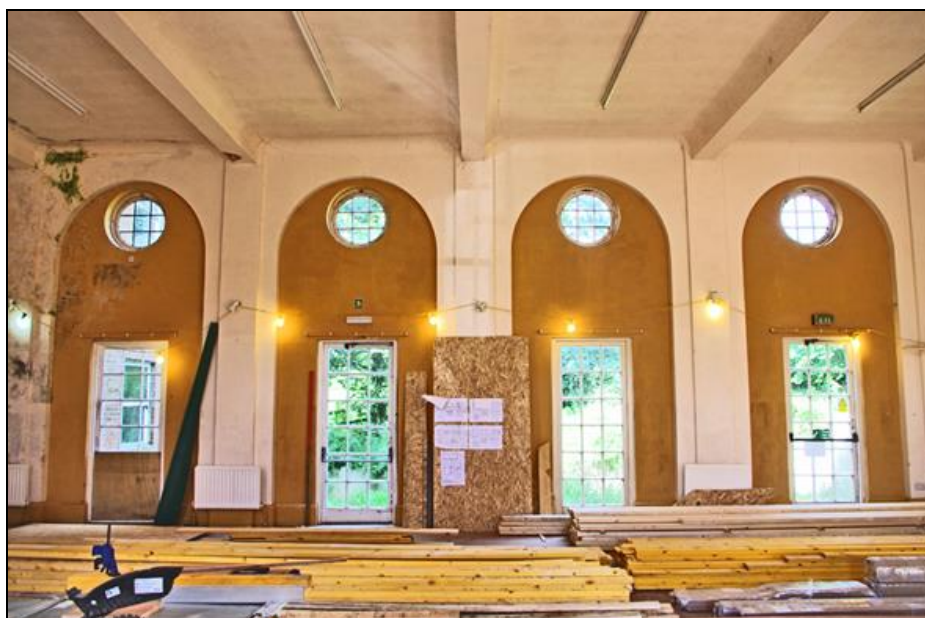
Frontispiece: East-facing elevation of the west wall of the Main Hall.

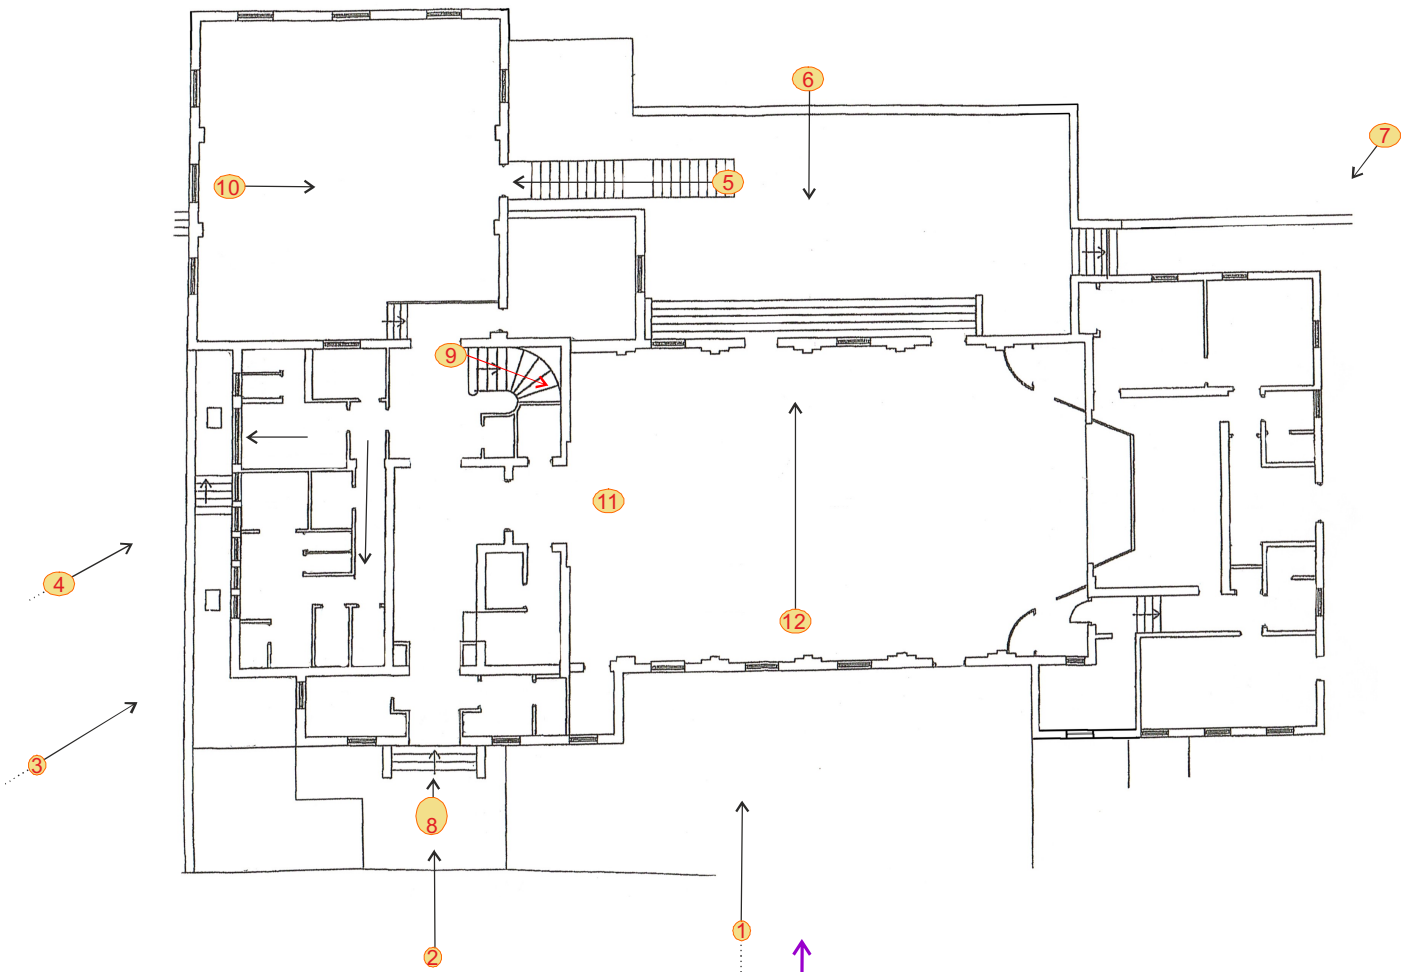
Illus. 07: Plan of Alnmouth Boy's Club, Ground Floor, showing the positions of photographs taken as part of the photographic record, keyed to Section 3.

Photo Record nos. 01-08 Exterior views from Ground Floor level (Illus. 07).

Photo Record nos. 09-12 Interior views at Ground Floor level (Illus. 07).

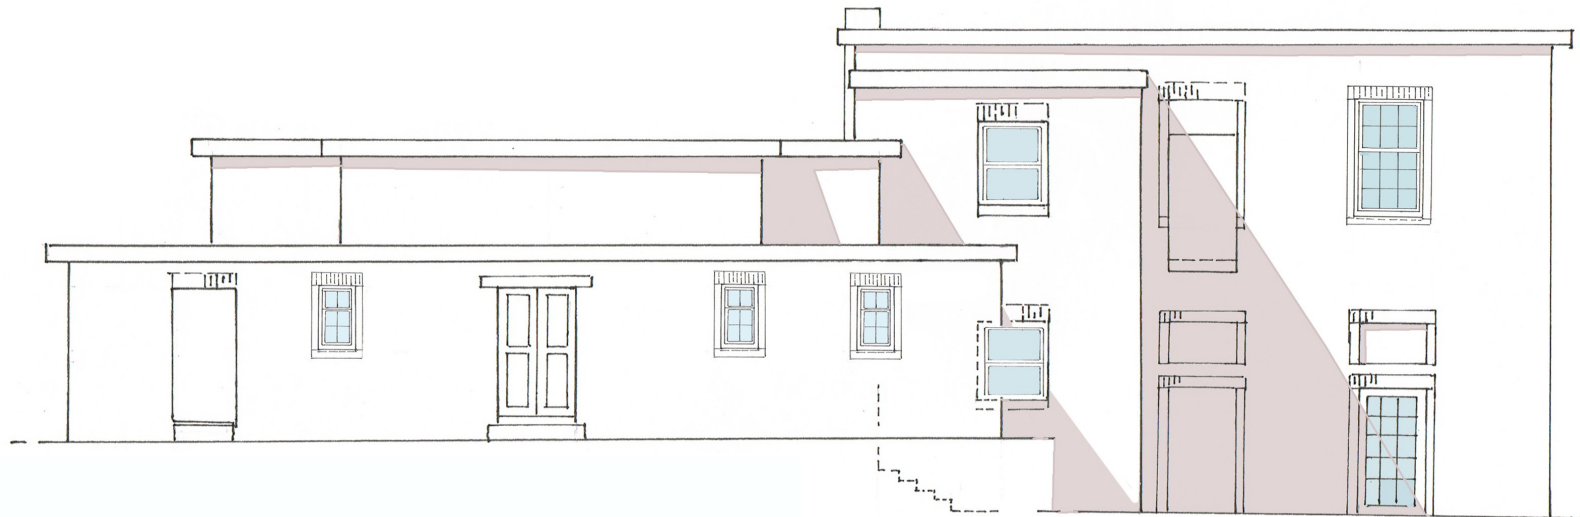
*Illus. 09: Alnmouth Boy's Club, North Elevation
by Peter Ryder.*

Fire escape
omitted

The north end of the building has a series of small windows and a central timber-lintelled doorway which looks like a later insertion, although a door in this position is shown on the original building plans.

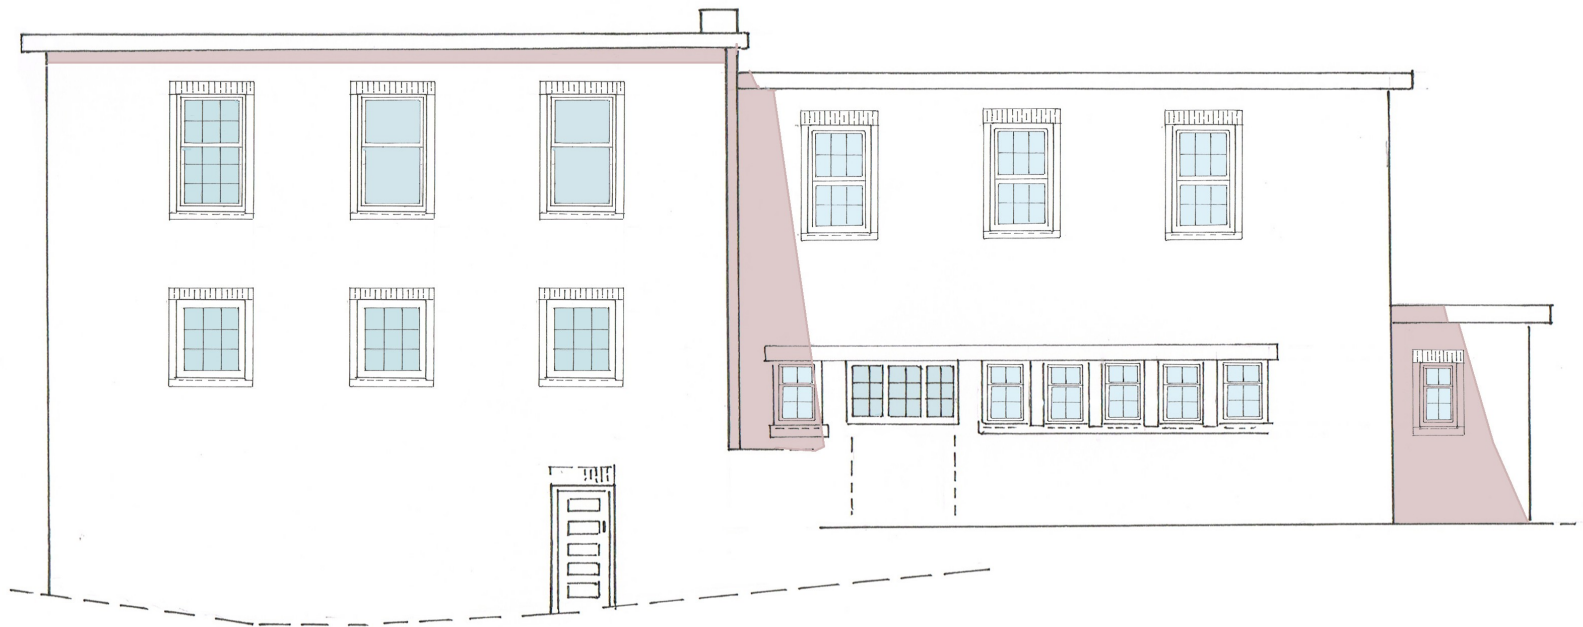
*Illus. 10: Alnmouth Boy's Club, South Elevation
by Peter Ryder..*

The south elevation, where the ground falls away steeply, is quite impressive. On the right is the south block with three 12-pane sashes on the upper floor and a range of close-set smaller windows, mostly 6-pane shortened sashes, below, with simple rounded brick jambs rather than the recessed quarter-round elsewhere. From the right end the first five have a continuous pitched sill and soldier lintel; then comes a triple casement set within a former doorway, shown as 'Boys' Entrance' on the architect's plans, followed by a final small sash. This entrance was approached by quite a narrow open passage between the block and the boundary wall to the south, which is in line with the south side of the projecting south-west block which has a 3-bay elevation as on the west, except here the first-floor windows are all late-20th century replacements of varying form; the natural slope means the ground-floor windows are high above the ground, and below the right hand is a door, of five horizontal panels, into the basement boiler room. In the re-entrant angle between south-west and south blocks is a truncated projecting stack.

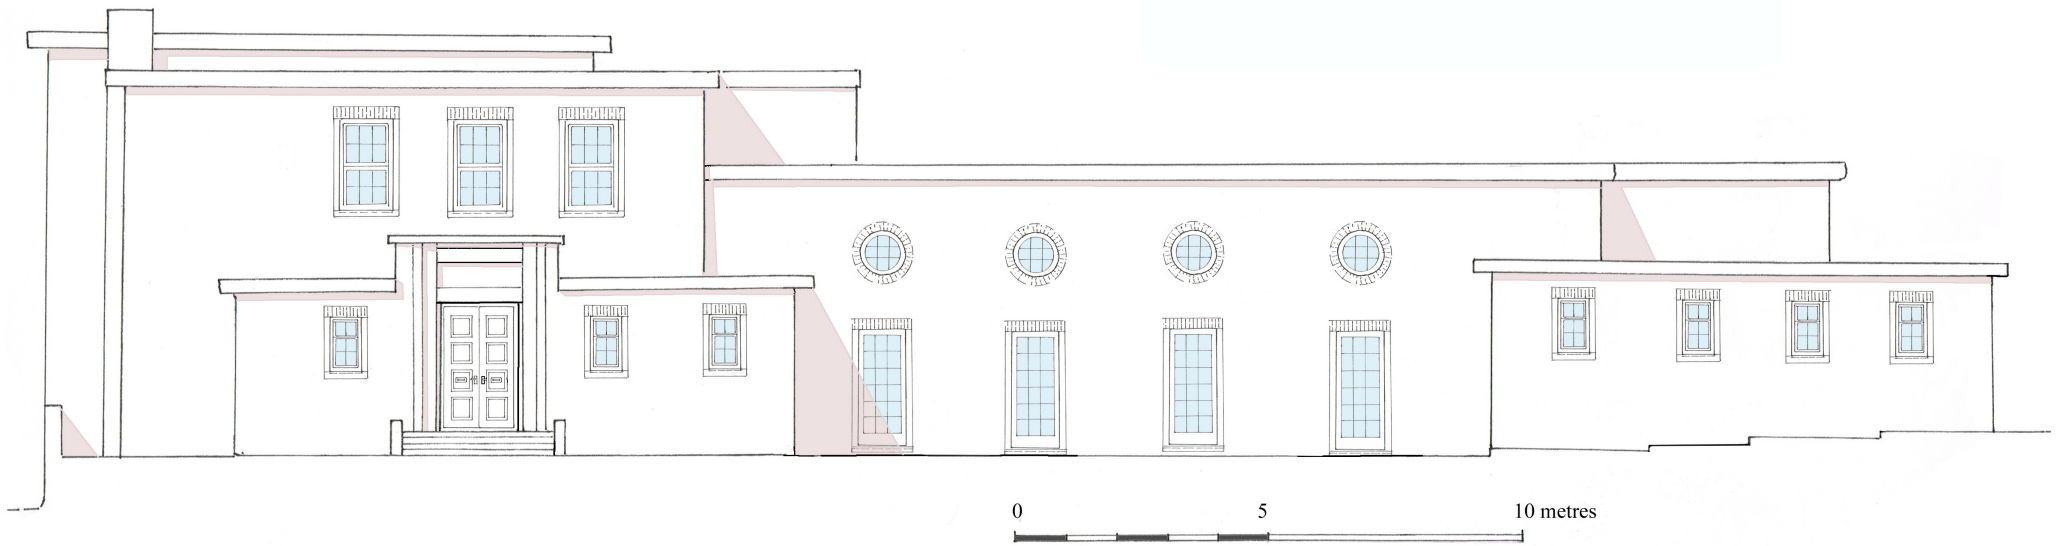
Illus. 11: Alnmouth Boy's Club, East Elevation (by Peter Ryder).

The front (east) elevation shows some pleasing asymmetry in its grouping of cubical elements. On the left is the entrance with four steps up to a pair of fielded-panel double doors with a sunk panel above, under a flat slab capping which breaks up above the eaves line of the porch, which has two small windows to the right and one to the left, all 6-pane shortened sashes. Behind rises the taller South Block with a triplet of 12-pane sashes to its upper floor, the doorway below aligning with the central sash although neither is central to their elevations, the porch extending to the right to overlap the main hall.

The hall is of four bays, each having a tall window with a small-paned casement, and a round window above; overlapping the hall to the right is the northern block with four more small sashes.

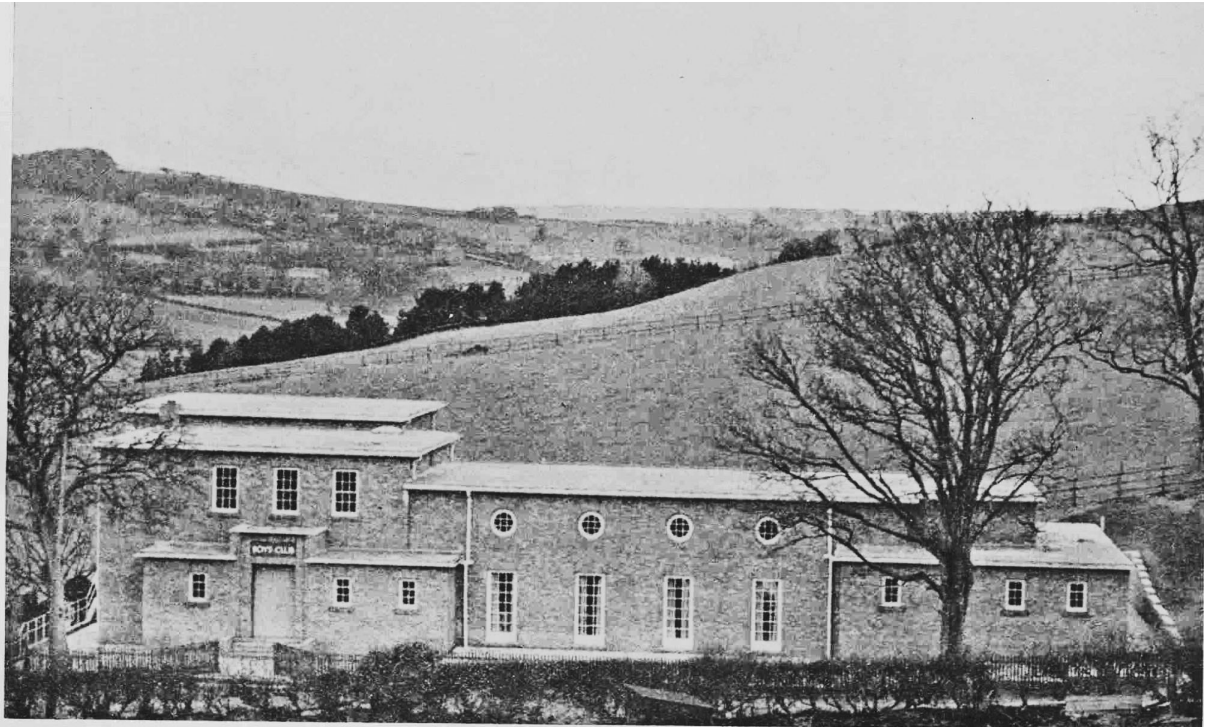
BOYS' CLUB ALNMOUTH

The club was built for Mrs. Scholefield and is to be used exclusively as a boys' club. The photograph above, reproduced by permission of the London and Northern Studios, shows the general massing and the steep slope of the ground which at one end was cut away to a depth of 10 feet. Externally the walls are faced with orange bricks and there is a plinth of russet-brown bricks. Below is a view from the back. The contract price was £6,029.

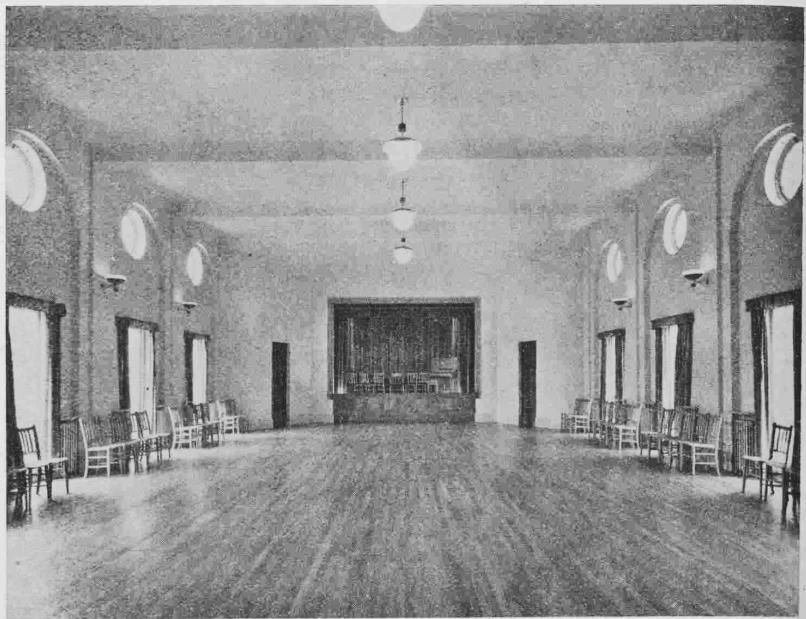
Above, right: The interior of the main hall which has an oak floor. The walls and ceiling are painted cream. The stage curtains of velvet are in two shades of red and fawn, while the lighting fittings are sprayed with bright red and silver cellulose. The ceiling consists of wooden joists supported on steel beams.

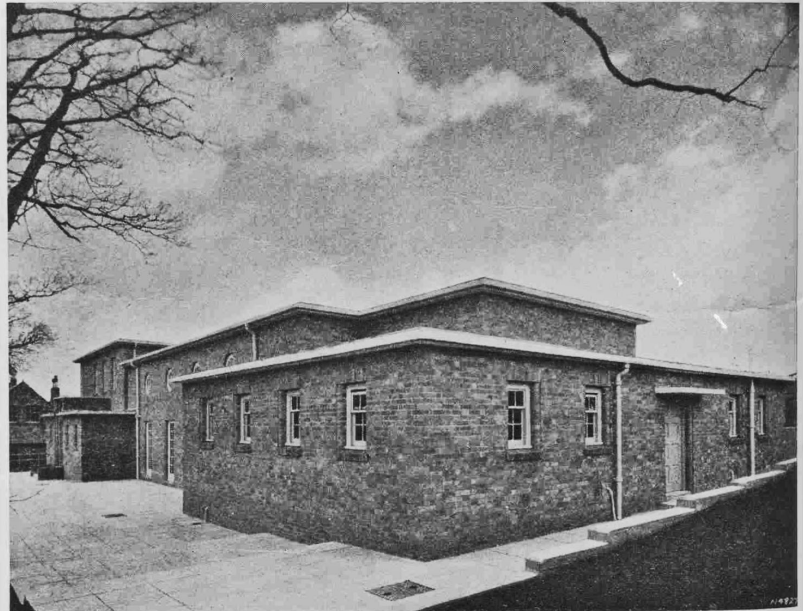
Right: A view of the terrace, which is paved with pinkish-coloured gravel pre-cast slabs. All external woodwork is painted cream except doors which are green.

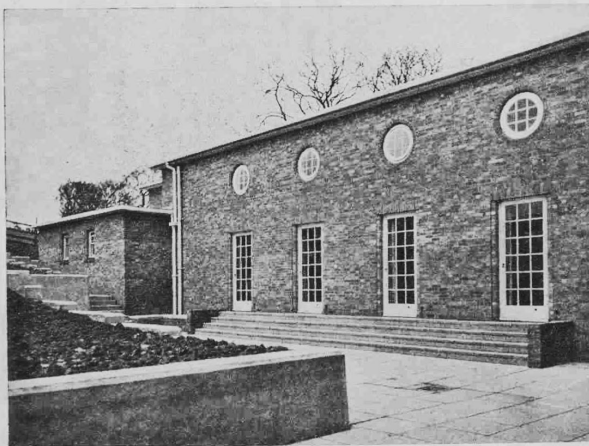
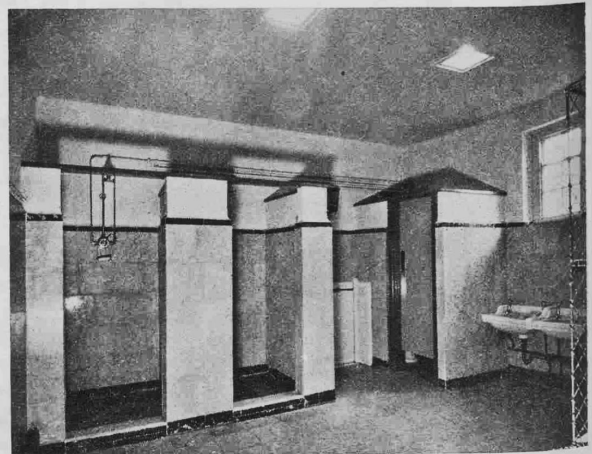
Boys' Club, Alnmouth. Architects: Dyson & Hebler

Below, left: A view from the terrace showing the doors and windows of the main hall, and, right, the changing-rooms which are panelled and floored in an exceptionally hard patent stone having a very highly polished finish, the colour in this case being light greyish.
