COLEPIKE HALL FARM
LANCHESTER
DURHAM

HISTORIC BUILDINGS RECORD

JUNE 2015

Historic Buildings Recording

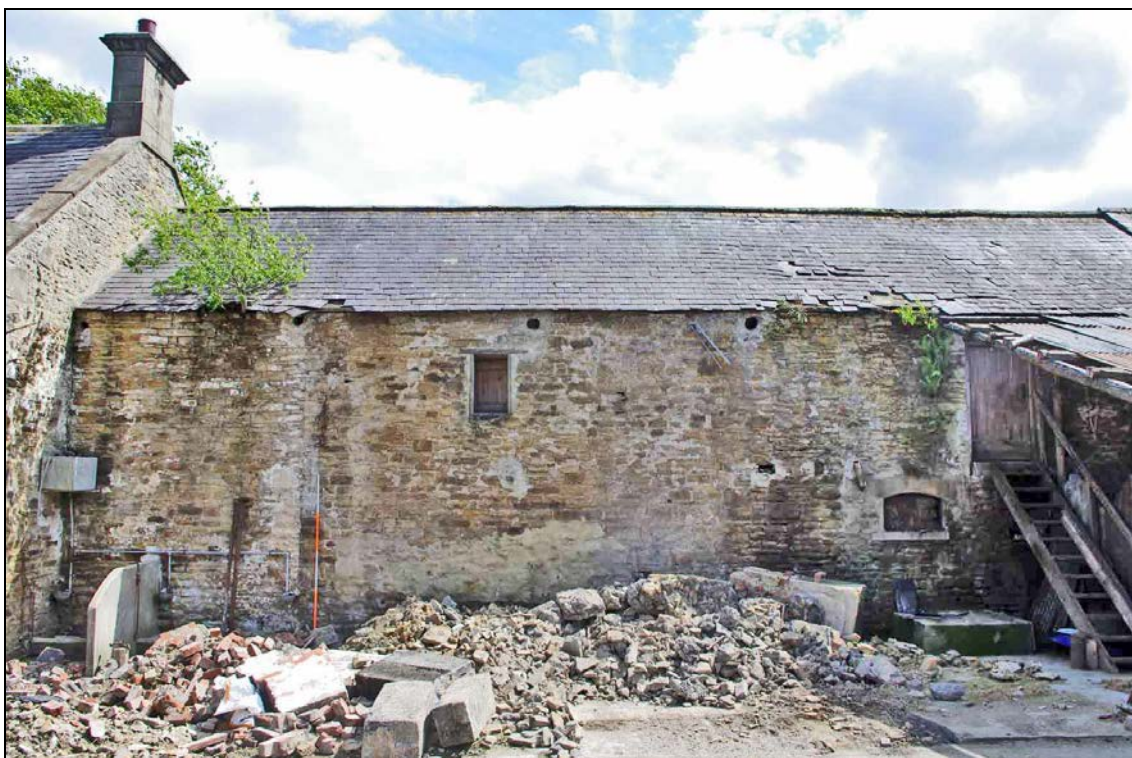
Frontispiece: North elevation of the east part of the Main Range.

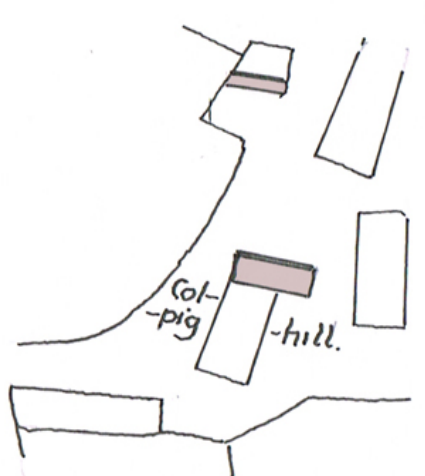
Illus. 03: A Survey of COLPIGHILL ESTATE In the County of Durham. N.D. Late 18th/early 19th century. DCRO ref. D/X/821/1.

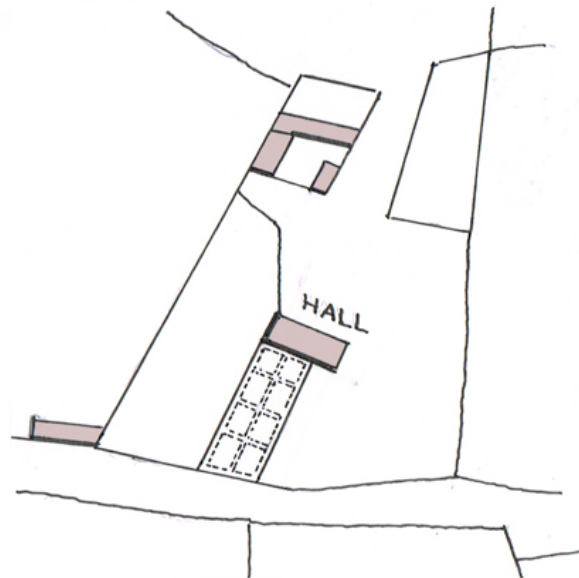
Illus. 04: Plan of COLDPIG HILL DISTRICT, 1831. DCRO ref. EP/La 38/2

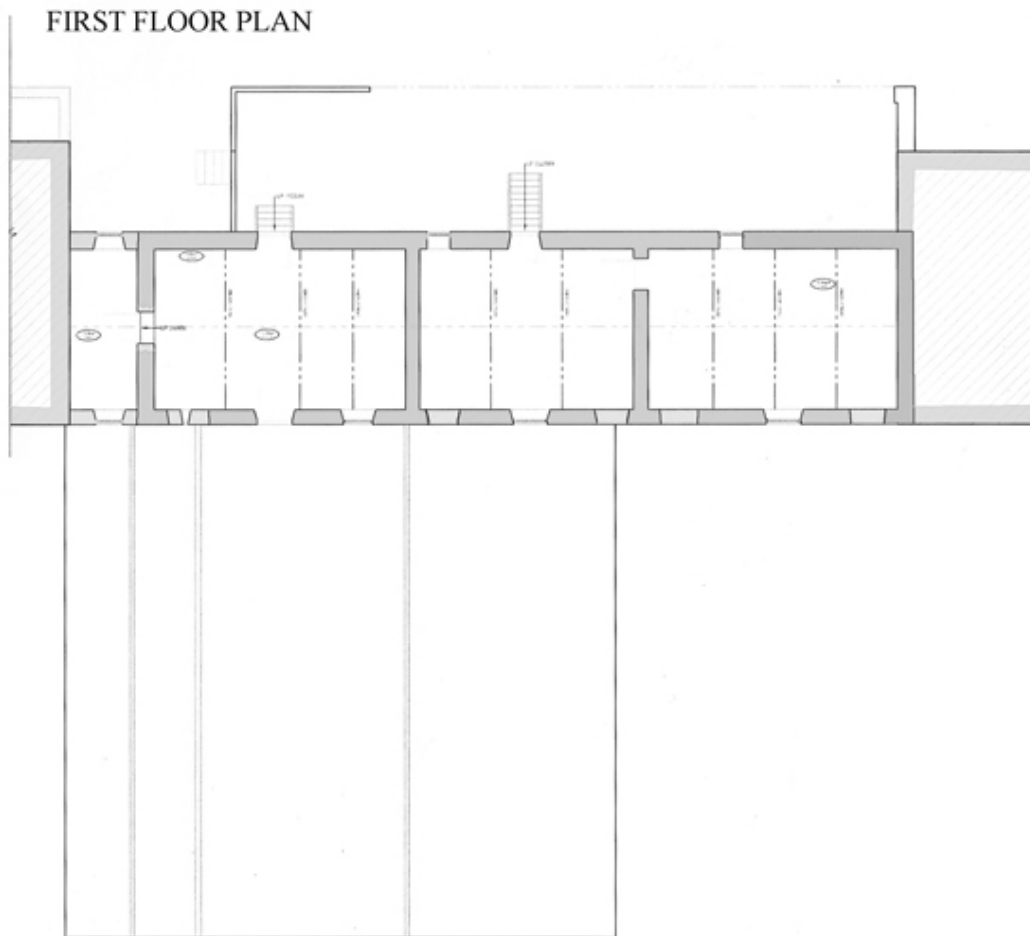
Illus. 10: First Floor Plan of Colepike Hall farmstead.

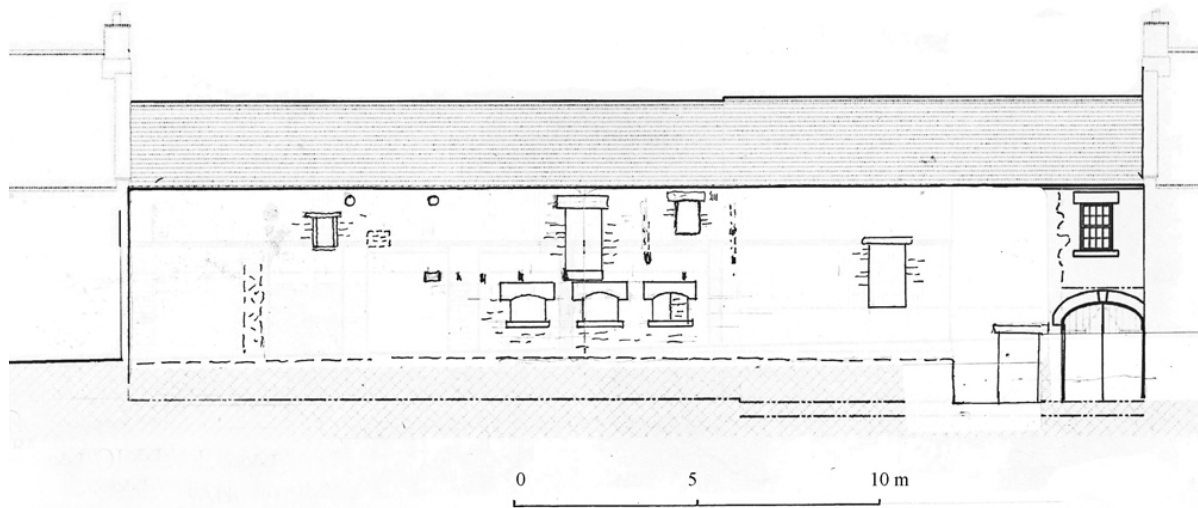
Illus. 12: North elevation of the Main Range of farm buildings at Colepike Hall (Architect's drawing with amendments by PFR).

The north wall of the range is partly covered by later sheds. Its most interesting feature, midway along, is a range of three low openings with segmental-arched heads cut into ashlar lintels, which have been rebated on the internal face of the wall (although the easternmost has been altered). Their function is not clear; they may have been associated with a horse engine or gingang which the 1st edition Ordnance Survey map of c1860 shows approximately in this position³. Above them is a door to the upper floor of the eastern part of the range; further west is another door, set rather lower, to the upper floor of the western part of the range. Immediately to the east of the three-centred archway at the west end of the range is a doorway into the western of the three ground-floor stables. There are three windows to the upper floor, an old 16-pane sash above the archway, and two plainer openings further east; there are also a variety of sockets and stub timbers relating to structures built against the wall but now removed.

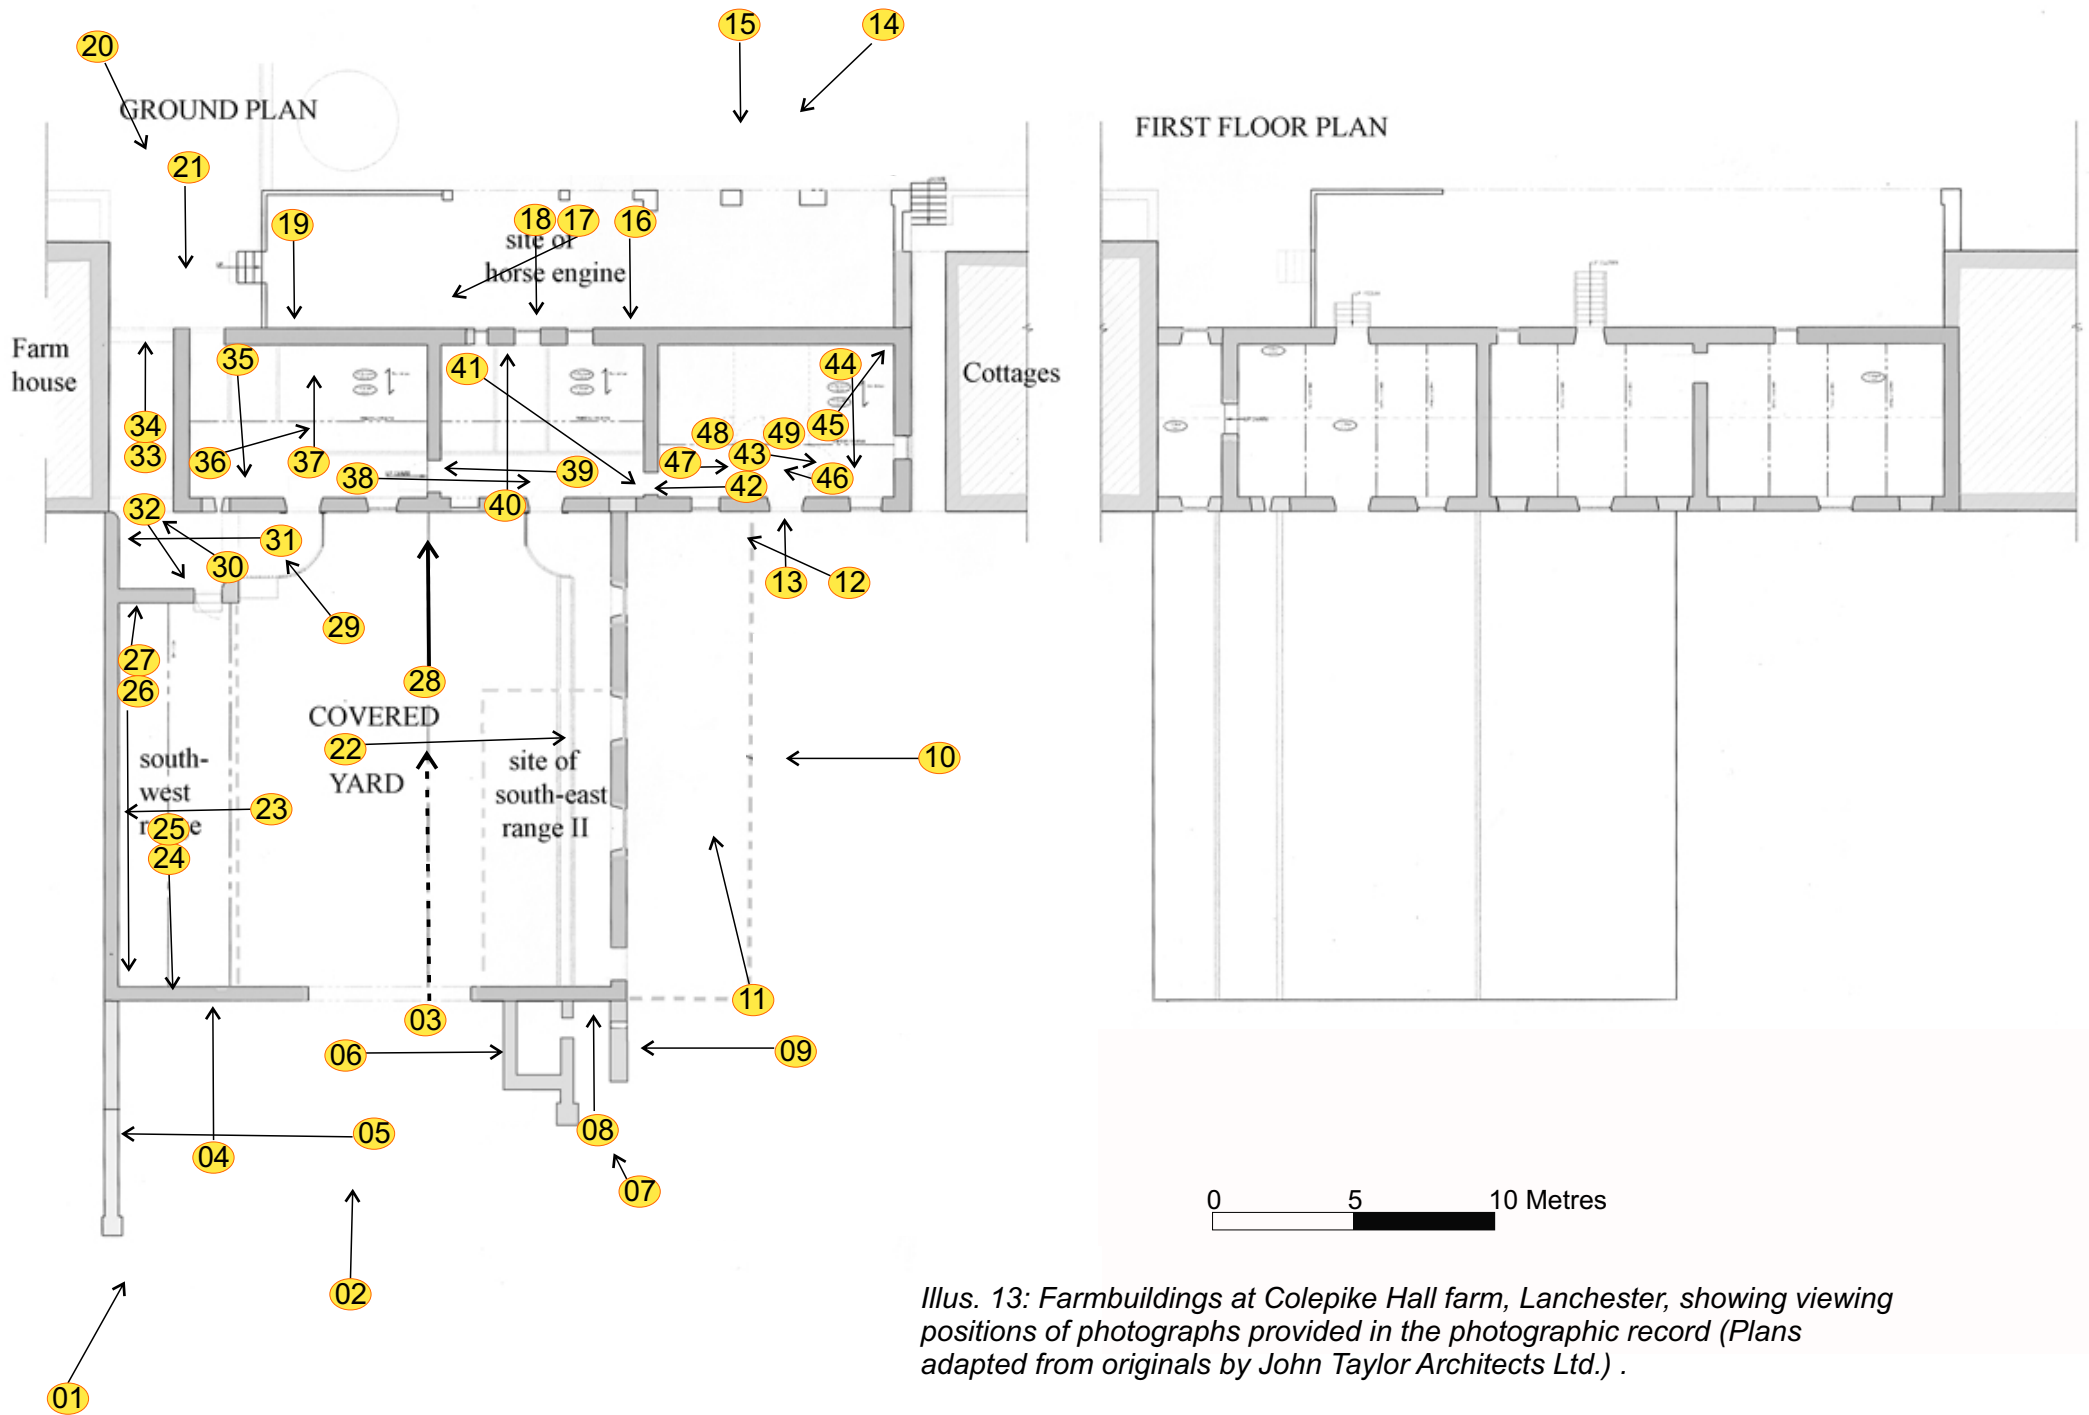
Illus. 13: Farmbuildings at Colepike Hall farm, Lanchester, showing viewing positions of photographs provided in the photographic record (Plans adapted from originals by John Taylor Architects Ltd.) .

The photographic record is keyed to a plan (*Illus. 13*, below) showing the positions of photographs taken externally and at the two internal floor levels, as follows:

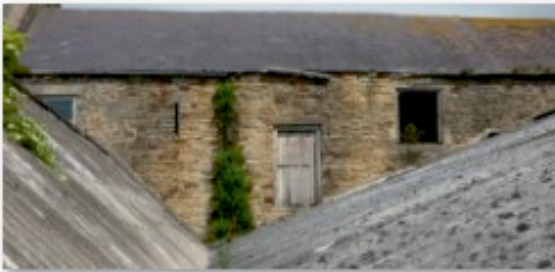
03 - S side above covered yard

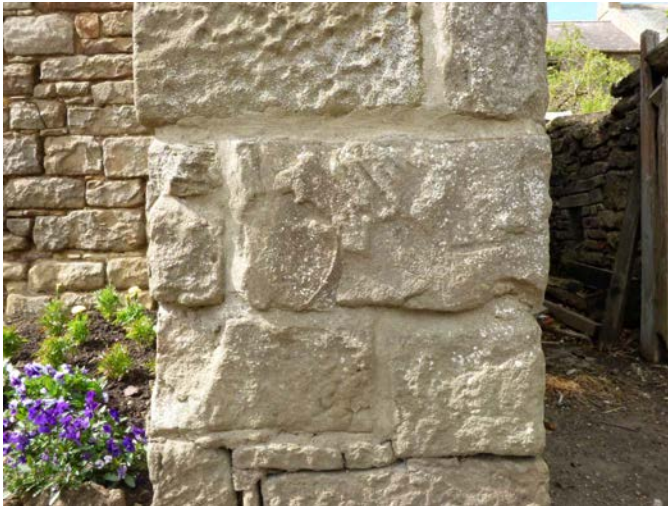
The front wall is continued a little further to the south to end in a square stone pier, the northern of a pair flanking the rear entrance of Colepike Hall. Re-used in the south face of this pier 0.5 m above the ground is a gritstone block 50 by 290 mm with what appear to be remains of carving, difficult to interpret but *possibly* depicting an eagle; bearing in mind the proximity of the Roman fort at Lanchester, and its aqueduct running close to the road south of the site, this may well be a Roman piece, and merits preservation.

Illus. 14: Carved stone on the south face of a gate pier adjacent to the 'Poultiggery'.

In contrast to the main range, the south-west and south-east ranges seem fairly humble and prosaic single-storey structures, which only survive in part, subsumed within the 20th-century covered yard, which itself is very characteristic of County Durham farms of this period although of minimal aesthetic merit. The pigsty/henhouse ('poultiggery') which has been retained at the south end of the original south-east range is of more interest, but again a common form; it retains the stone slab roofing that may once have covered all the buildings⁷. Incorporated in the gate pier adjacent to it on the south is a puzzling carved stone, perhaps of Roman date, which should certainly be retained if the pier is removed.
