WEST CHEVINGTON FARM NORTHUMBERLAND

HISTORIC BUILDING RECORD

JANUARY 2018

Historic Buildings Record

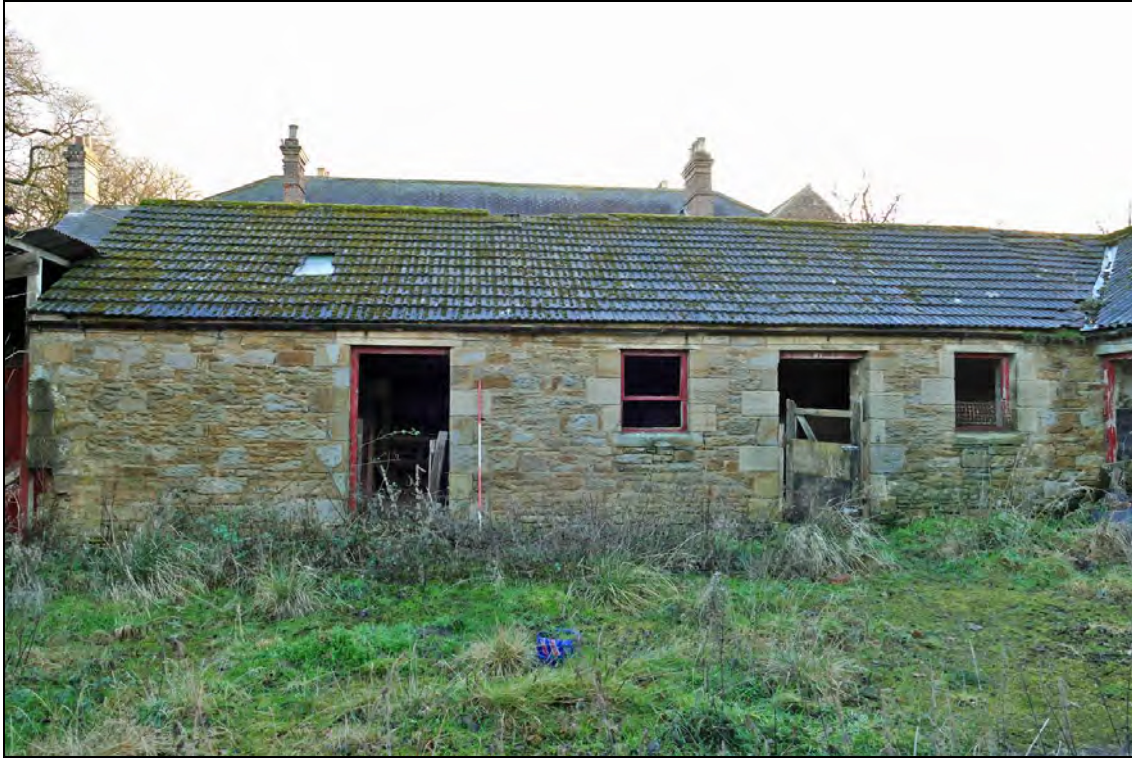
Illus. 18: The South Range viewed from the north.

On the south side of the southern yard is the single-storeyed South Range which is built of coursed roughly-squared stone, with quoins and alternating-block surrounds to its openings, which have a rough pecked tooling; the roof is of modern corrugated tiles. The larger western compartment has a door with a window on both sides and the unlit eastern a single door. At its west end the north wall of the range continues for c 2 m inside the adjacent South- West Range, suggesting that the South Range is the older and that its original west end, and the west end of its south wall, have been removed.

To the east the range ends short of the South East Range and there has formerly been an open entry from the farmhouse to the south, although a relatively recent wooden structure has been built within it, obscuring much of the west end of the South range and the central part of the west elevation of the South-East Range. In the east end of the South Range to the north of this structure are a series of four slit vents, low down, and higher up near the north end a small blocked square-headed window.

The south side of the range, facing the garden behind the farmhouse is of neatly-coursed and squared stone (partly hidden by small outbuilding in buff brick with an asbestos roof); towards the east end there is a boarded door in a stone alternating-block surround, its dressings being set slightly proud of the wall.

The interior of the range is divided into two compartments. The eastern compartment has two stalls, with a brick partition between them, set against the east wall, with a passage to the west between an opposed pair of doorways (that on the south now blocked). The western compartment has had stalls as well but the partitions have been removed; the floor is concrete and there is a boarded door at the north end of the west wall, into the south compartment of the South-West Range. The internal walls are all plastered and the roof is of five bays (two over the eastern compartment and three over the western) which have principal rafter trusses with collars set low, halved and bolted on to their east faces, carrying two levels of purlins and a square-set ridge.

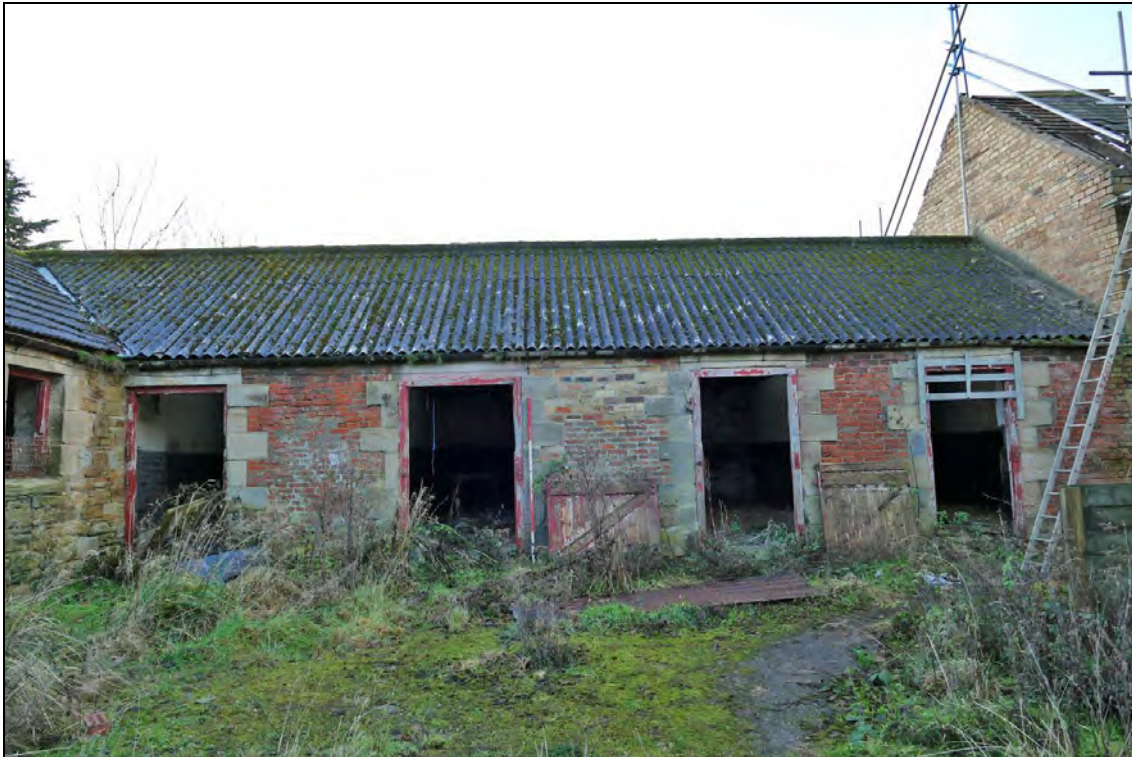
Illus. 19: The Southern Part of the West Range, viewed from the south yard.

The west range is in two parts, a single-storeyed southern section (which extends south beyond the South Range and links to the farmhouse) and a two-storeyed northern part which incorporates the Engine House in the centre of its west wall.

The southern part of the range is of old orange brick (English Garden Wall Bond 1 & 4) with cut stone dressings, except for the rear wall which is faced in roughly-coursed stone; there is a corrugated asbestos roof. Its northern part has an elevation towards the yard that has four doors, each in a rough alternating-block surround which are set slightly proud of the wall; there is some evidence of alteration, the third door having a rebate cut into the central section of its lintel. Its southern part appears to be of one build with the Farmhouse; at its south end is a broad opening (now divided into a window and a door) that has an old stone lintel over its original north part (the door); further north are two windows in neat tooled-and-margined alternating-block surrounds, the second hard up against the south wall of the South Range.

At the north end of the rear elevation it appears as if the original angle quoins have been removed when the northern part of the range was added (or rebuilt); further south there is a blocked doorway with an alternating-block surround.

The four compartments into which the doors open are divided by thin walls (which rise only to eaves level) which are clearly secondary, butting up against the side walls and constructed in a larger brick of more recent character. The roof has collar-beam trusses with the collars halved in from the north, carrying the levels of purlins, the upper set so high so as to constitute a form of ridge. The walls are painted black to c 1.2 m and white above that. The internal face of the rear (west) wall is in similar brick to the front wall. The third compartment from the south has the base of an old stone trough set against its north wall and the north wall of the fourth (the end wall of the two-storeyed northern part of the range) is in thinner old brick.

The southern part of the range is entered either by a door from the west end of the South Range, or an external doorway near the south end of its east wall. The main compartment has two small windows on the east, with to the north of them, set close to the doorway into the South Range, a lower blocked doorway with a timber lintel. At the west end of the south wall is a stable door into the small end compartment of the range, containing a doorway on the east into the yard behind the farmhouse. The roof of the main compartment is of six bays with collar-beam trusses, their collars bolted on from north and three levels of purlins, the uppermost set close together so as to form in effect a ridge. The southernmost compartment has two more bays of a roof of the similar type.

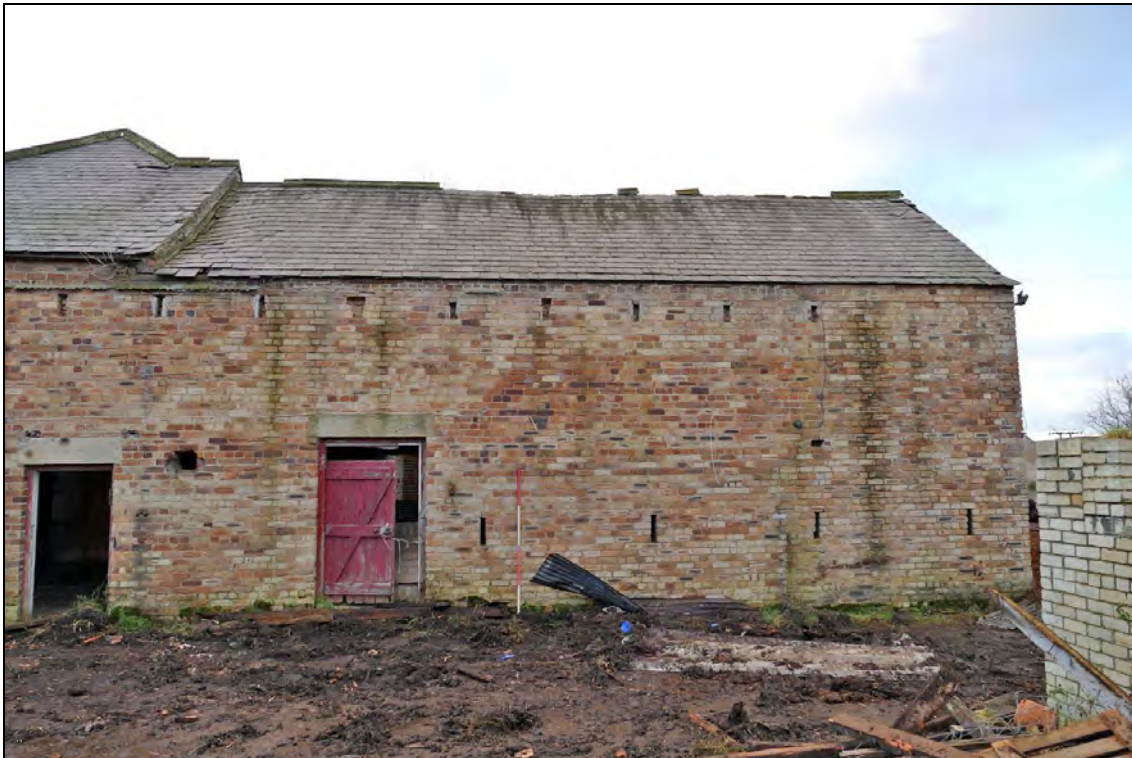
Illus. 20: The Northern Part of the West Range, view of the east side.

The two-storeyed northern part of the range is itself in two parts, the northern having its roof at a slightly lower level than the south. It is largely built in pale buff brick of earlier-20th century character, in English Garden Wall Bond 1 & 3, with cut stone dressings and a Welsh slate roof. The southern has a central stable door under a cut stone lintel, between two windows with cut stone lintels and sills; at the north end of this part is a second doorway. The northern lower part of the range has a taller and wider doorway and a range of four slit vents, low down, with a series of slots higher up that must relate to the roof of some adjacent structure. Its north end has a cart entrance under a heavy timber lintel, formerly fitted with a sliding door; the north-west corner of the range sits on top of the west end of an older brick wall which extends some distance to the west. The west elevation of the northern section of the range is divided into two by the projecting Engine House. To the south of this there is a large cart entrance which is clearly an enlargement of an earlier opening as some big alternating stone blocks survive on the lower two-thirds of its north jamb. Above the present timber lintel is a broad window with a tooled-and-margined stone lintel; further south is a window (a 20th century casement) in a stone alternating-block surround.

North of the Engine House and set close to it there is a doorway with a stone lintel, and beyond that four slit vents at a low level, like those in the east wall. From the north-west corner of the range a ruinous brick wall extends westwards; this is 2.5 m high with an

The internal walls of the range are in old orange brick, clearly re-used as there is the occasional course of buff brick. The southern part of the range has had an upper floor, now removed (the sockets for its upright-section beams survive) ; above is a band of cement on the wall, suggesting that the upper floor served as a granary; such cementing is common in granaries, to prevent gaps against the wall in which dust and chaff could accumulate. The lower part of the south wall is in older brick than the remainder of this part of the range, and seems to represent the north end of the earlier single-storeyed southern part of the range; it has a blocked opening low down, east-of-centre, which has a projecting sill, and set right-of-centre a little higher another blocked opening, as well as a blocked doorway at the west end of the wall, cut across by the (removed) floor. The three openings on the east – doorway and flanking windows – have relieving arches above their internal lintels.

Inside the range, close to the east wall of the Engine House, is a surviving piece of farm machinery consisting of two tall boxed-in structures, then northern of which can be seen to enclose a vertical belt to which small scoop-like receptacles are fixed, suggesting that it may have been some form of grain or feed elevator.

c 2m north of the doorway in the east wall there are large sockets in both side walls for a heavy transverse beam. Flush with the north jamb of the second doorway a cross-wall has been cut away, except for a rather precarious stepped arch of brickwork carrying the roof timbers and forming the step-down between the two sections of roof, both of which have roofs of close-set collared rafter pairs, without any longitudinal timbers. The northern part of the range has sockets for a light upper floor or loft.

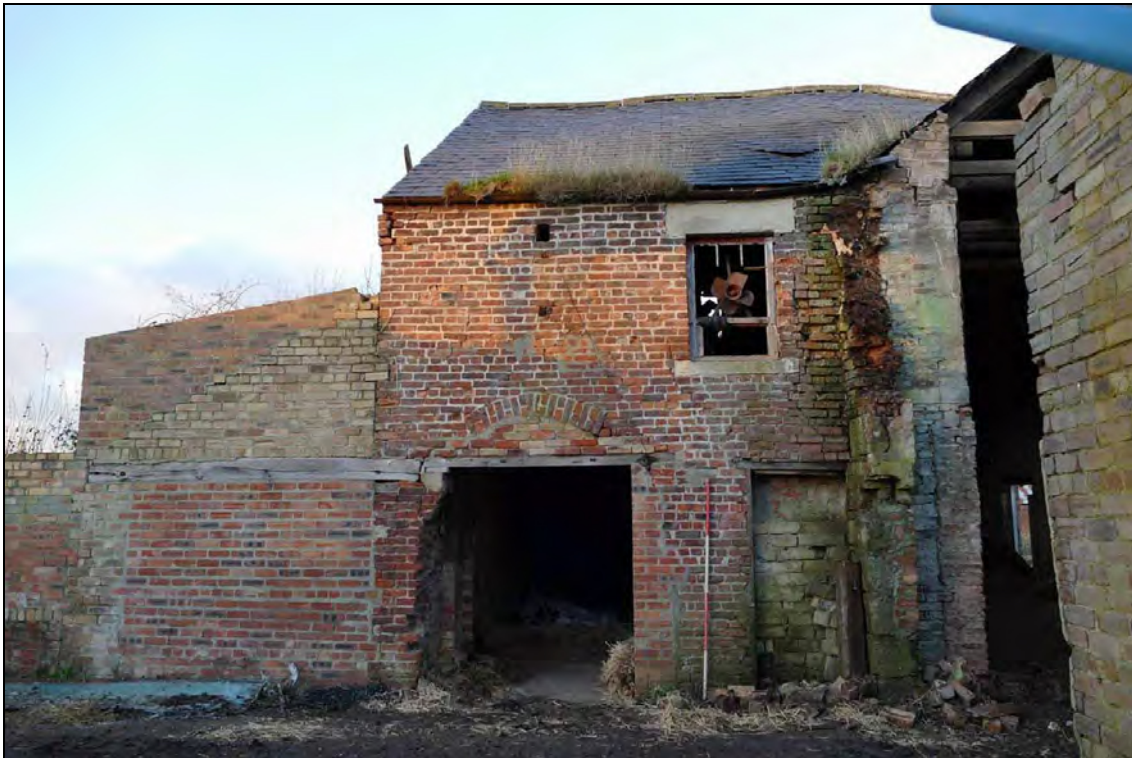
Illus. 21: The Engine House, viewed from the south.

This structure clearly pre-dates the rebuilding of the northern part of the East Range, and is in older orange brick in English Garden Wall Bond 1 & 3, with a Welsh slate roof. On the south there is a widened opening, now with a timber lintel, beneath a segmental arch which at first looks like a relieving arch but may have been the head of an earlier opening; east of this and hard up against the wall of the adjacent range there is a blocked doorway. Beyond the wall continues for another metre or so, as the Engine House projects internally in the rebuilt range, and in this section there is a straight joint, not immediately interpretable; higher up the south-east angle of the structure has some large stone quoins. At first floor level on the south there is a blocked window – more easily visible internally – directly above the present doorway, and east of that a window with a tooled-and-margined stone lintel.

The west side of the Engine House has a broad gable, of old orange brick to the level of the side wall and then more modern buff brick in the gable. At first-floor level there is a part-slatted window set slightly north-of-centre in an opening with a tooled-and-margined stone lintel.

There has been a later building attached to the southern half of this wall, in 20th-century buff brick, with a broad opening under a timber lintel in its south wall, infilled in more recent orange brick. The wall seems to show the line of a pent roof, before a more recent heightening in orange brick, although the west wall seems to show traces of a gabled roof to this structure, or perhaps a predecessor in the same position. The west wall of the pent-roofed building has gone; lower brick walls continue the lines of its end walls some distance to the west.

On the north of the Engine House there is a projecting chimney stack, set back a little way from the north-west corner, with slightly tapering sides which rises to c 2m above

the Engine House eaves and then has a slightly-projecting flat-topped stone coping. On its north side is a tall ragged opening infilled with smooth-faced orange brick of no great age. East of the stack is a ground floor window with a stone lintel.

Inside the Engine House the east wall survives intact, projecting a little into the adjacent West Range. Its internal face shows two doorways, both with timber lintels and both partially infilled with more modern brick. A little above and to the north of the southern is an opening, apparently for a drive shaft from the engine to the thresher within the main body of the range, and above the south jamb of the northern is what looks to be the scar of a cut-away cross wall. North of the northern door is a vertical pair of stub ends of projecting beams. At first floor level in the same wall is a first-floor doorway hard up against the south end of the wall. On the north there is a tall ragged opening into the stack, with relatively recent blockwork facing its north wall, with to the east another cut-away cross wall and then a window opening with a renewed lintel and more blockwork above it. At the south end of the west wall is a blocked doorway with a timber lintel. Two large cross girders at a level half way up the first floor window on the west look like later insertions. The roof structure is of collared rafter pairs.

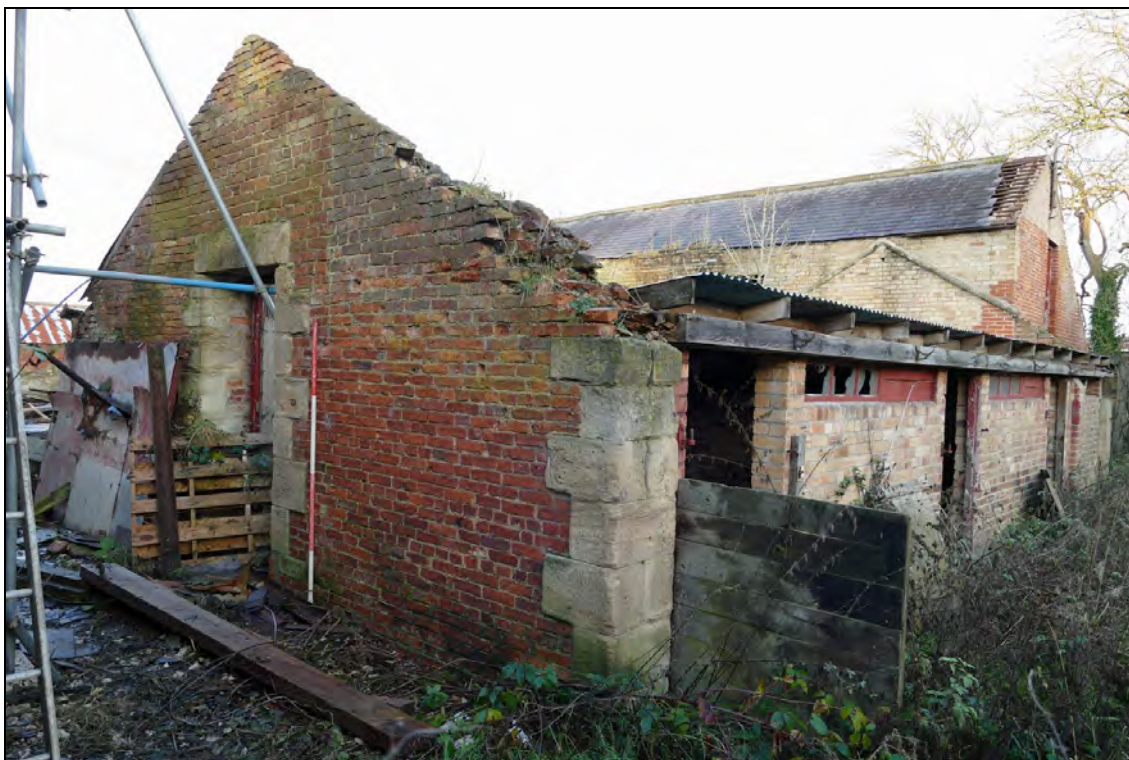
Illus. 22: The Central Range, viewed from the south-west.

Set between the small southern yard and the two covered yards, this is attached to the East Range and stops short of the West Range, allowing access between the yards. Its gabled west end is in old orange brick (English Garden Wall Bond 1 & 4) with cut stone quoins and dressings, and has a central doorway. The north side of the range was open, carried on a series of square stone piers; it is not clear what the original arrangement was on the south; it may have been similar but has been replaced by a series of three loose-boxes opening to the south, built in buff brick and with a pent roof sloping down from south to north, with their rear wall set just south of the central axis of the original range.

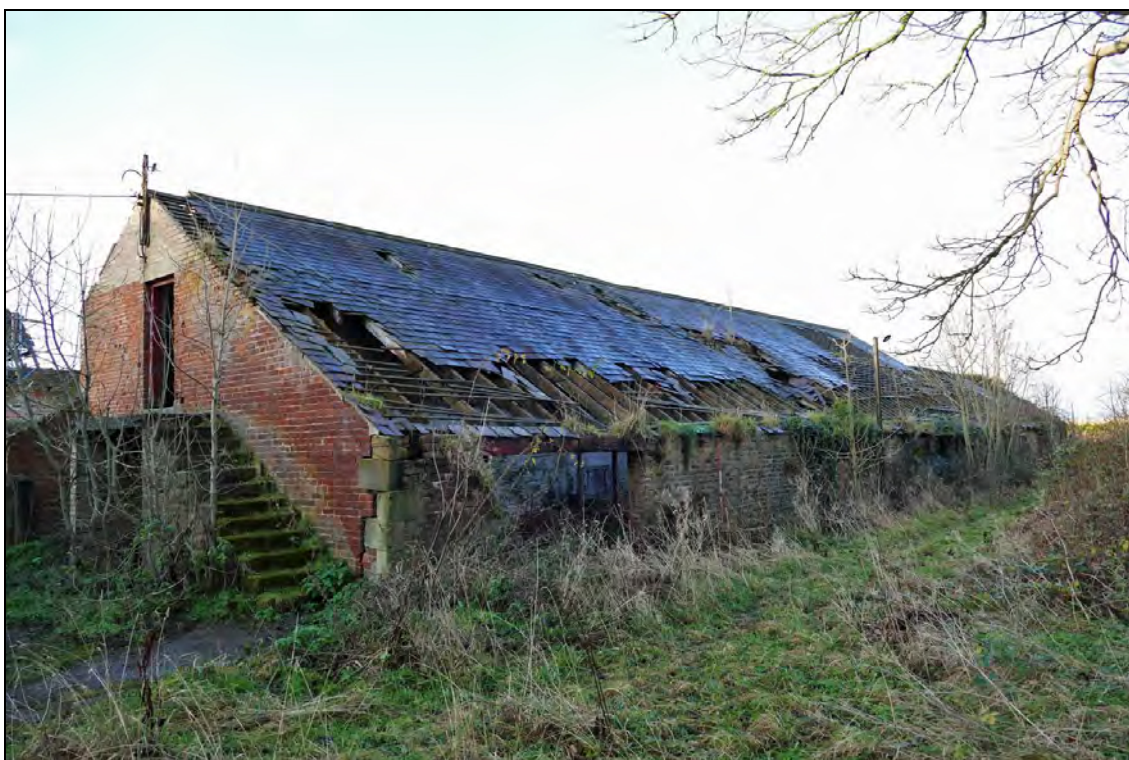
Illus. 23: The East Range, viewed from the south-east.

Apart from a section at its north end this is a two-storeyed range; its ground floor and parts of its gable ends are of old brick largely in stretcher bond, a continuous outshut on the west is later browner brick, and the upper floor is light buff brick of earlier 20th-century character; the roof is of Welsh slates.

The front (west) face of the range, partly concealed by the two covered yards, has a boarded door near each end, a window a little south of the northern door, and five segmental-headed arches – two pairs and a single – between, whilst on the upper floor are two groups of three windows, with stone lintels and sills, and a central pitching door with a heavy stone lintel under a gablet. On the ground floor the door near the south end of the wall opened on the axis of the Central Range and above it, and within the gabled roof-line of the range, the ends of the close-set upright-section joists which carry the upper floor of the range are exposed in the wall face (as they are at the rear within the outshut).

The south end of the range is of the older orange brick up to eaves level, but the gable in the later buff brick. It has an external stair, in buff brick, rising to a boarded door with a roughly tooled-and-margined lintel; a second door, to the ground floor, beneath the stair, looks like a secondary insertion. On the east is a straight joint between the original end wall and the added outshut, which has heavy squared stone quoins (now toppling out of the wall) at its south-east corner.

The north end of the roofed part of the range shows the remains of tumbling for an earlier and lower gable, with below it the gabled roof-line of the single-storeyed north end section of the range. This is now quite ruinous; towards the yard it seems to originally have had a pair of arches but only the outer jambs survive, the northern having some old alternating blocks (and the springing of its arched head. Its rear wall, still in old brick (English Garden Wall Bond 1 & 4) is much taller than the single-storeyed range, and with an additional heightening of a metre or so in 20th-century buff brick it now rises to the level of the eaves of the main section of the range. It has various rows of sockets, suggesting the roof of this part had been remodelled more than once.

To the rear the outshut, clearly an addition, has oldish brick (English Garden Wall Bond 1 & 4) in its south end and on the east as far as the south jamb (with old stone dressings) of a broad opening which is set opposite the segmental arch in the west wall. The remainder of the wall is in 20th-century buff brick; further north is a broad cart entrance later converted into a window, and then two doorways and three low windows (metal-framed casements) in the sub-divided northern section.

The ground floor of the two-storeyed section of range is divided into four compartments, all with ceilings of sawn upright-section transverse joists. The southernmost has an interesting old brick floor, with a raised concrete step in front of a blocked doorway at the west end of the north wall. There is a doorway on the west into the Central Range, and on the east a broader segmental arch (all in stone), with an external rebate, opening into the rear outshut. The next compartment has a pair of arches now opening into the Southern Covered Yard, and the following one a single arch, with a doorway opposite in the east wall. The fourth compartment has a pair of arches and a blocked door at the east end of its north wall, as well as a trapdoor into the granary above. The north wall has a thin course of stone c 1 m above the floor, and higher up a series of features which might be blocked slit vents or sockets for a joisted ceiling at a lower level. The south wall here is clearly secondary, being butted up against the front wall. The fifth and last compartment has a door on the west and a large sliding door into the outshut on the east; there is a partially-blocked door at the west end of the north wall into the ruinous northern section of the range.

The upper floor of the range is reached by the external stair at the south end; its boarded floor (with a series of trapdoors) is in poor condition and its walls are rendered; the roof structure (like that over the two-storeyed part of the West Range) is of close-set collared-rafter pairs.

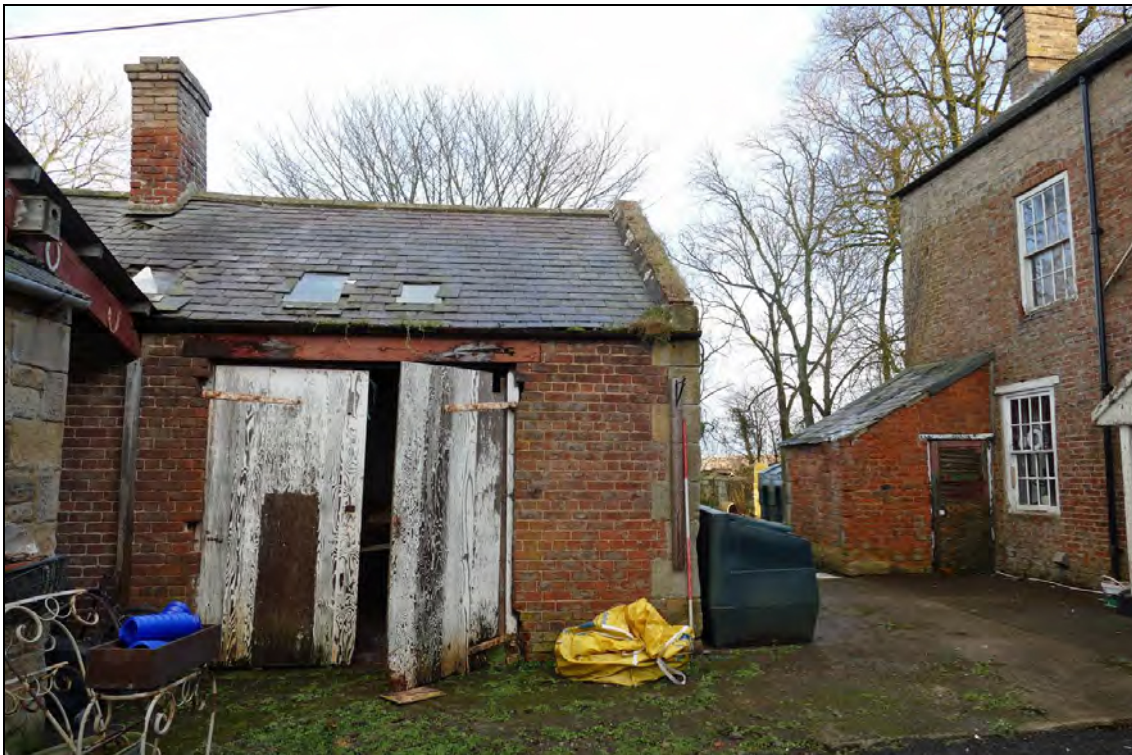
Illus. 24: The South-East Range, south part viewed from the west.

The Southern Yard can be entered from the east at its north-east corner; to the south of this open entry is the single-storeyed South-East Range and to the north the much longer two-storeyed East Range. The South-East Range is built of orange brick in English Garden Wall Bond 1 & 3, with roughly tooled-and-margined stone quoins, except for the rear wall which is of coursed roughly-squared stone; it has a Welsh slate roof with a brick ridge stack, with a stepped cap, around a third of the way from the south end. At the north end of the west elevation (towards the yard) there is a doorway, then to the south a blocked door with a flat-arched lintel, and a second door in an altered opening, perhaps also originally a window, which also has a flat-arched head; then comes a stable door again with a flat-arched head, in an opening that looks to have been widened towards the north, and finally a pair of boarded double doors under a timber lintel.

The south end of the range has a central window, under a soldier lintel, and a slit in the gable, which has tumbled-in brickwork. The north end of the range also has a tumbled gable and a blocked slit in the gable. The rear elevation is featureless except for a single small window and there is another single window in the south end, towards the farmhouse.

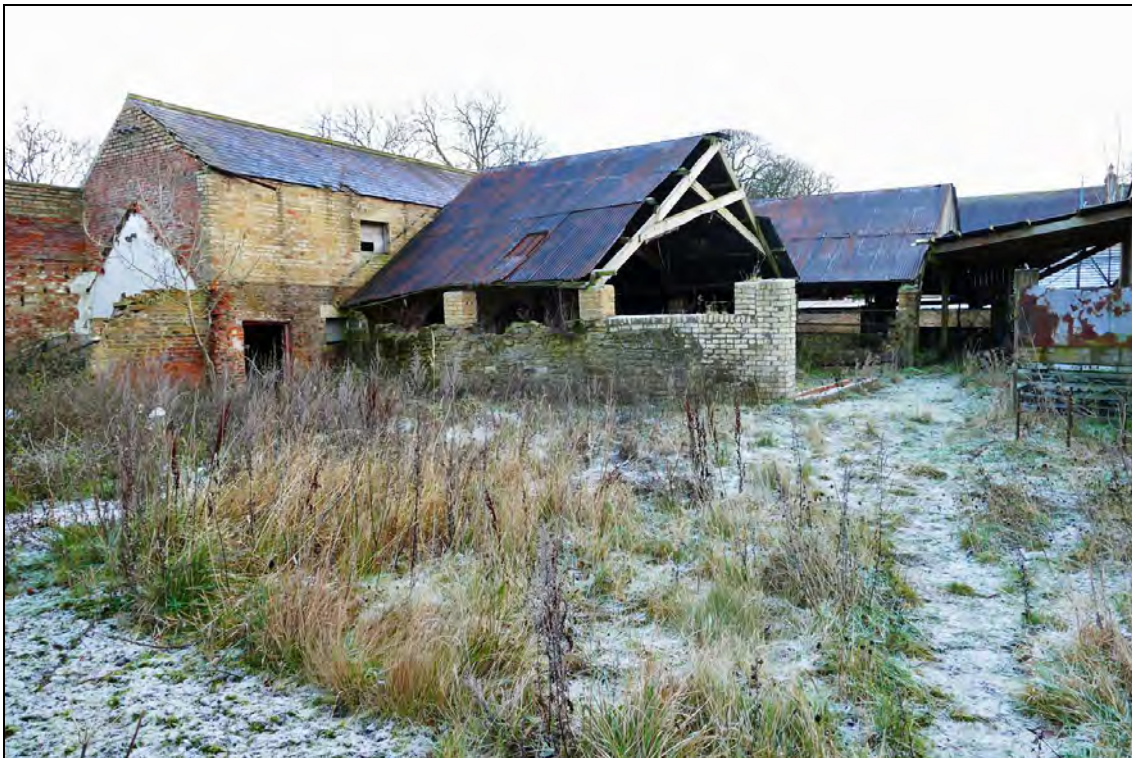
Illus. 25: The Covered Yards, viewed from the north-west.

Map evidence shows that there were two walled yards here before they were covered over in the earlier 20th century; their walls, of roughly-coursed stone and c 1.2 m high, remain, with piers in buff brick raised on top of them to carry the roof structure of the yards, which consists of three bays (the outermost bay over the northern yard now fallen) of scissor-braced trusses; each has had four trusses, the innermost set against the wall of the East Range. There is no south wall to the Southern Yard, where the trusses are now set on the stone piers on the north side of the Central Range. The missing outer truss of the Northern Yard was carried on the north by a double pier of white brick, which still stands.

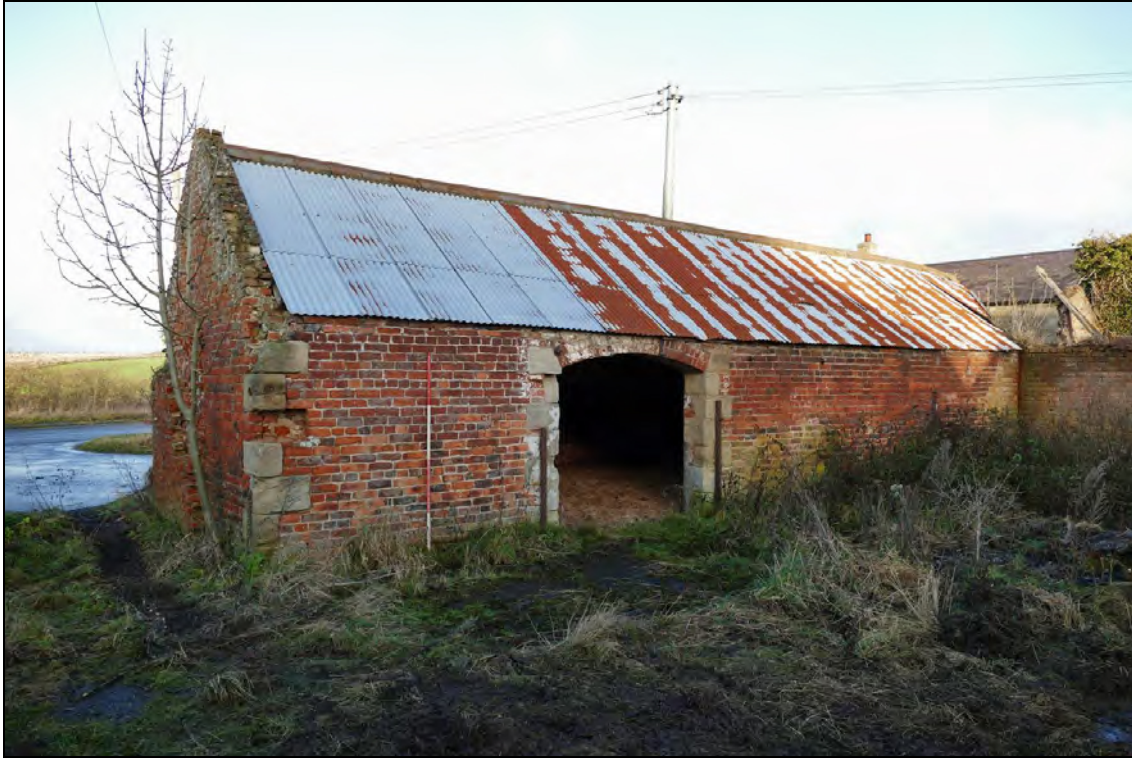
Illus. 26: The North Range, viewed from the south-west.

This is a single-storey range, its front wall, west end and the western half of its north wall are in old orange brick (English Garden Wall Bond 1 & 4) and the east end and eastern half of the north wall in larger brick (English Garden Wall Bond 1 & 3); there are stone quoins and dressings and a Welsh slate roof. Towards the yard there is a

single opening, set west-of-centre, a segmental arch with alternating jambs of stone and a head of two courses of brick. The west gable end, which lies adjacent to the entry to the yard from the road on the north and has now lost its coping, seems to have had a projection or thickening on its northern part, which has been roughly cut back – this may be a remnant of a structure built against it, destroyed when the northern entry into the yard was formed. The roof is hipped at its east end; the north wall has a blocked doorway with an alternating-block surround.

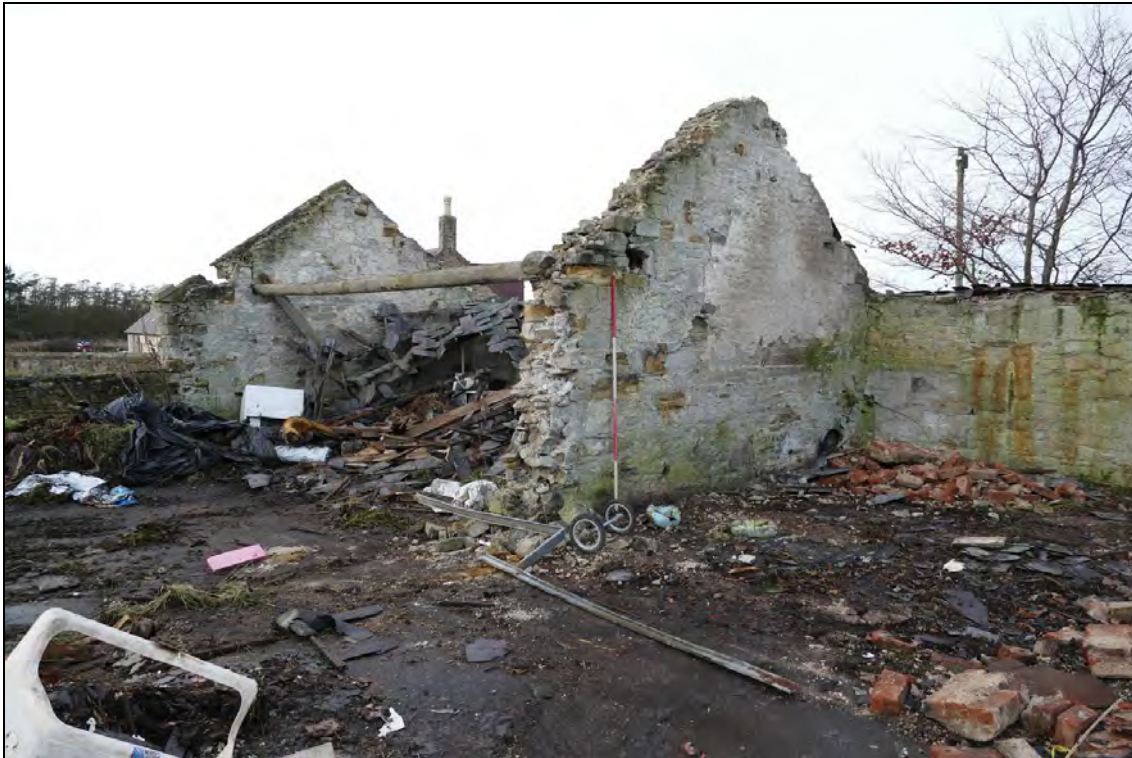
Illus. 27: The North-West Range, viewed from the south-east.

On the west of the northern entry to the yard is an old brick wall (English Garden Wall Bond 1 & 3) c 2m high, that has been heightened in yellow brick; it returns westward alongside the road, with a straight joint after c 5 m with thinner and probably older orange brick (in the same bond) beyond. This links to the north-east corner of the North-West Range which consists of a pair of buildings which seem to have had open fronts facing south onto the small North-West Yard. Its east gable end is in brick, and part of the same L-plan wall linking to the north-west corner of the West Range. The remainder of the buildings are of roughly-coursed snecked stone of later-19th century character, with tooled-and-margined quoins and the roofs of Welsh slates, with a ridge of ceramic tiles. The roof of the eastern structure – of four bays with simple collar-beam trusses, carrying two purlins on each slope and a diagonally-set ridge -is now in a state of collapse whilst the similar roof of the western is more or less intact, except that its lower purlin on the south has been replaced by a circular-section pole, probably so that the roof could be retained after the collapse of the original wall-plate or arcade. The west end wall shows substantial quoins; the gable coping has been lost, other than its

southern footstone which is shaped and notched to take the first coping slab. Roughly-tooled snecked squared stone tooled and margined quoins at NW corner of NW range.

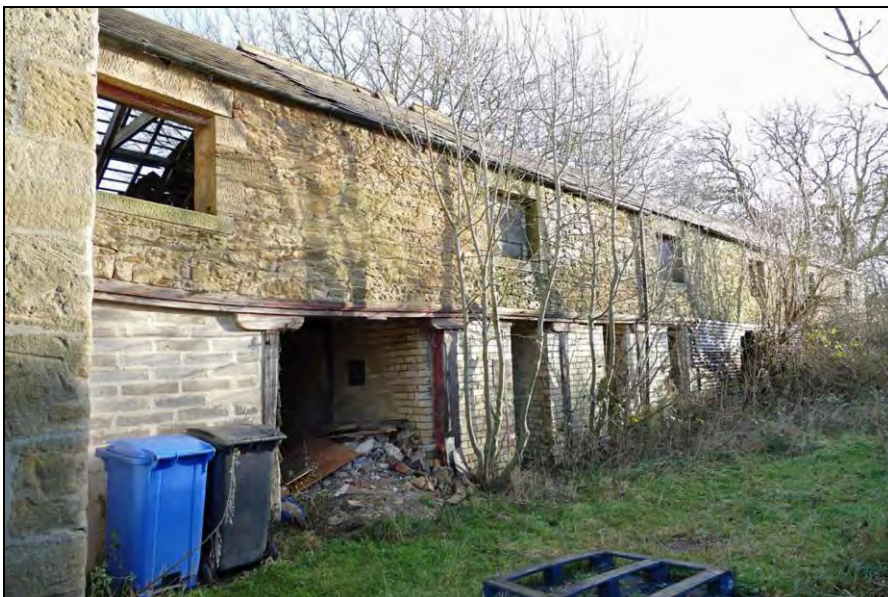
Illus. 28: The Outer East Range, view looking south-east.

This adjoins the south end of the pair of cottages, and is of two storeys, being built of roughly-coursed rubble with crudely tooled-and-margined quoins and dressings. The front has a long arcade of eleven bays of timber posts carrying pads which support the timber plate, above which there are six windows, originally slatted, in alternating-block surrounds, some now blocked. Parts of the lower arcade are infilled, usually in white brick, or concealed by metal sheeting. Some at least of this infill seems to be a response to structural failure.

The south end of the range has a stone external stair rising to a boarded door into the granary, to the west of which is a slatted window in an opening with an odd canted head. The rear wall has five windows to the granary, similar to those on the west but all now blocked.

The first-floor granary extends over the southern six bays of the range, with a wall of buff brick dividing off the northern section which was only accessible by ladder from below; the floor is now unsafe. The eleven-bay roof of the range has collar-beam trusses with the collars bolted on from the south, carrying three levels of purlins, with a ridge set diagonally carried between the overlapped ends of the principals.
