TWEED DOCK JETTY  
TWEEDMOUTH  
NORTHUMBERLAND

ARCHAEOLOGICAL DESK BASED ASSESSMENT

TWEED DOCK JETTY AND GROYNE  
TWEEDMOUTH  
NORTHUMBERLAND

Archaeological Assessment

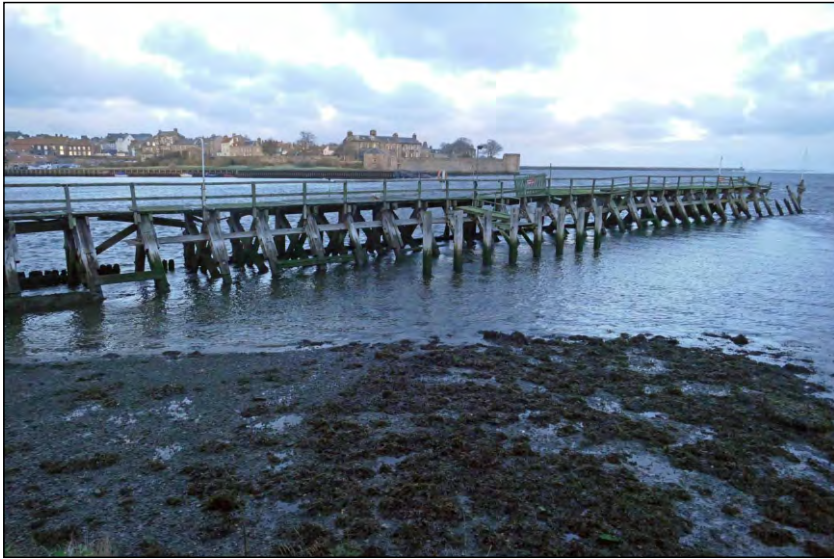
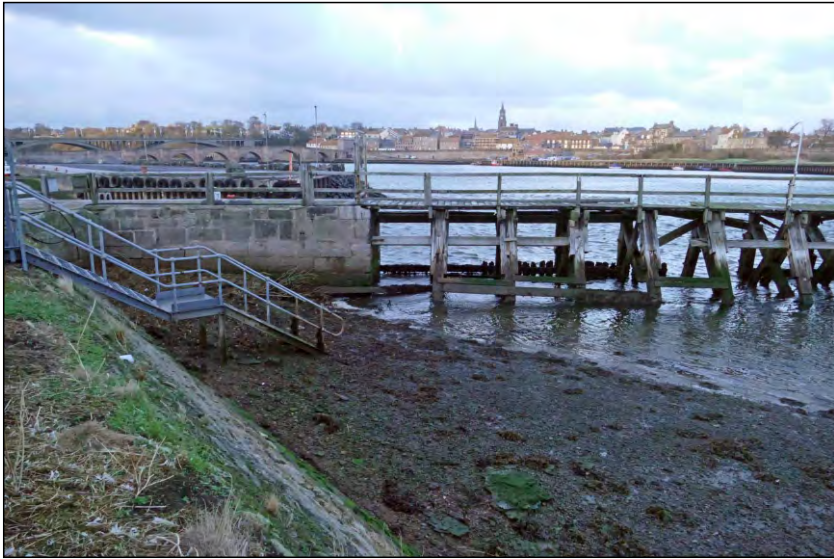
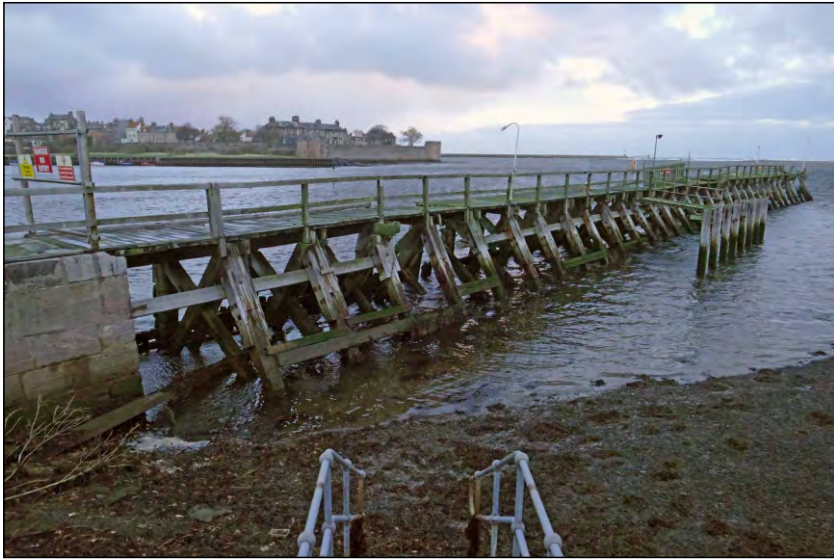
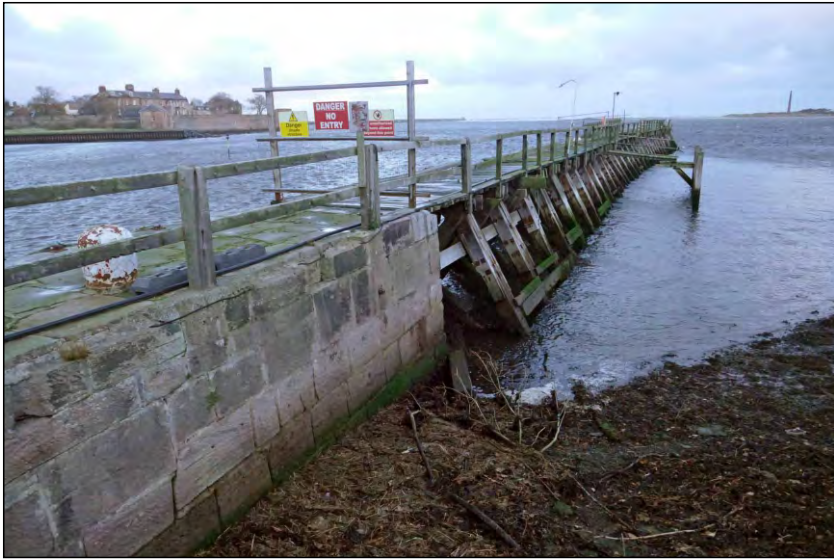
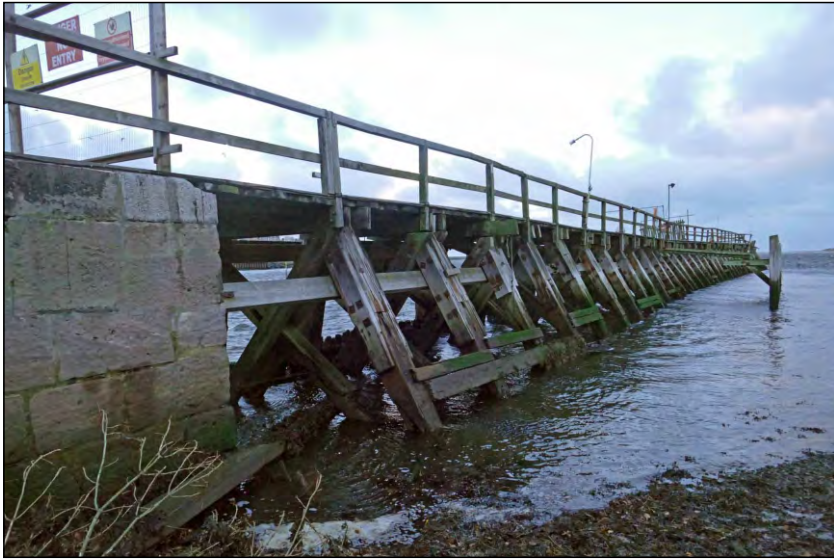
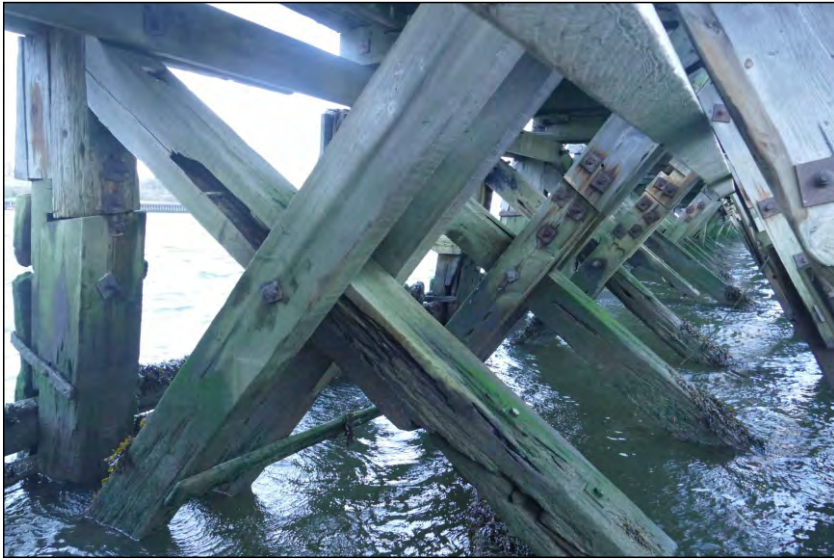
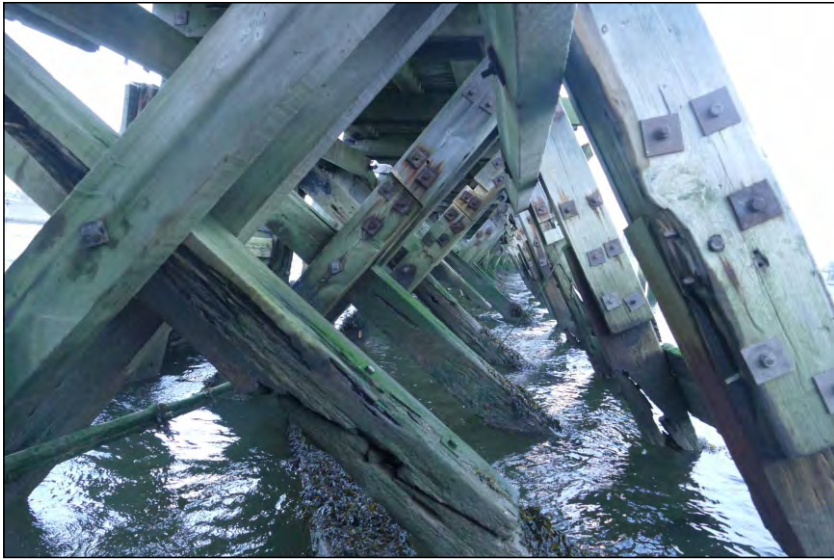
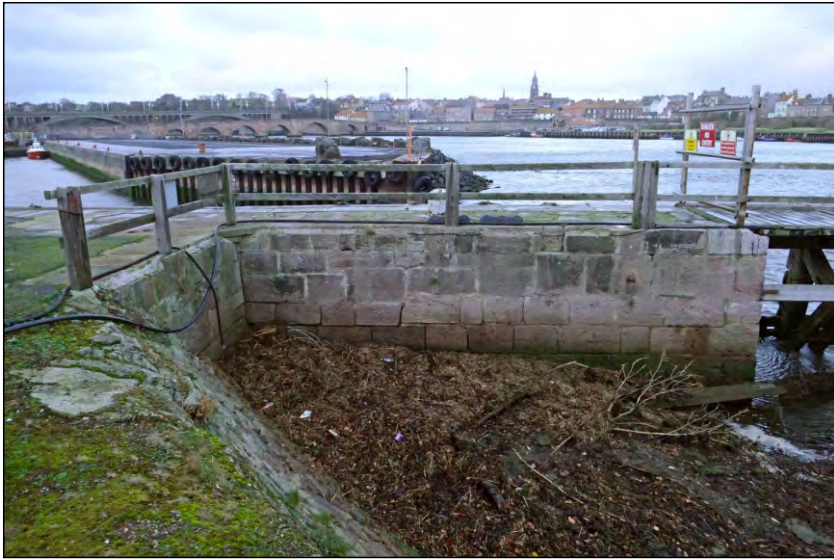
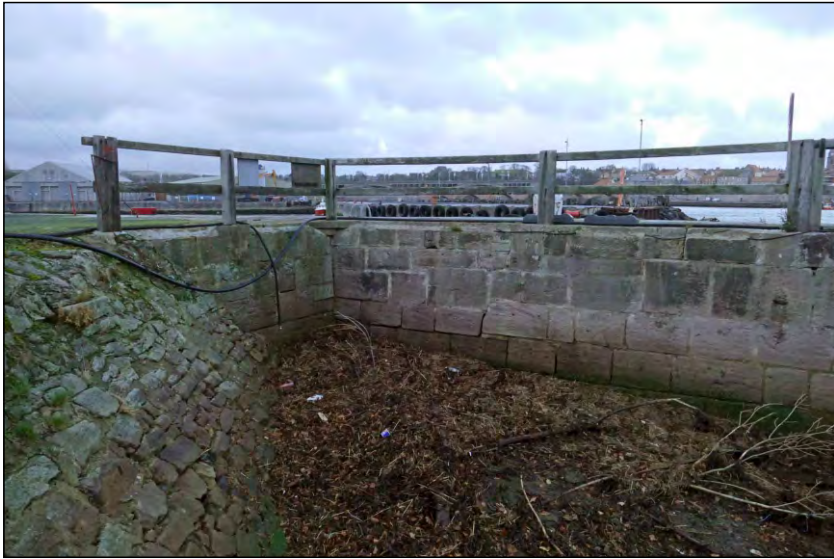
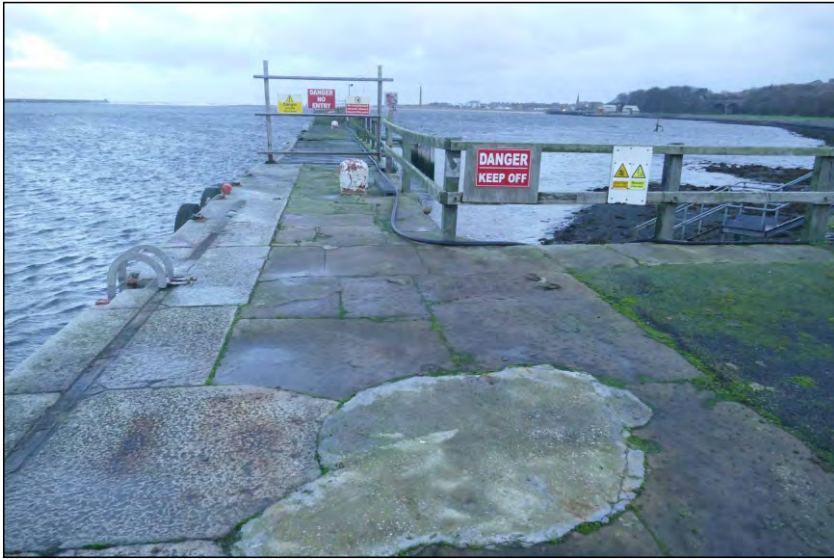
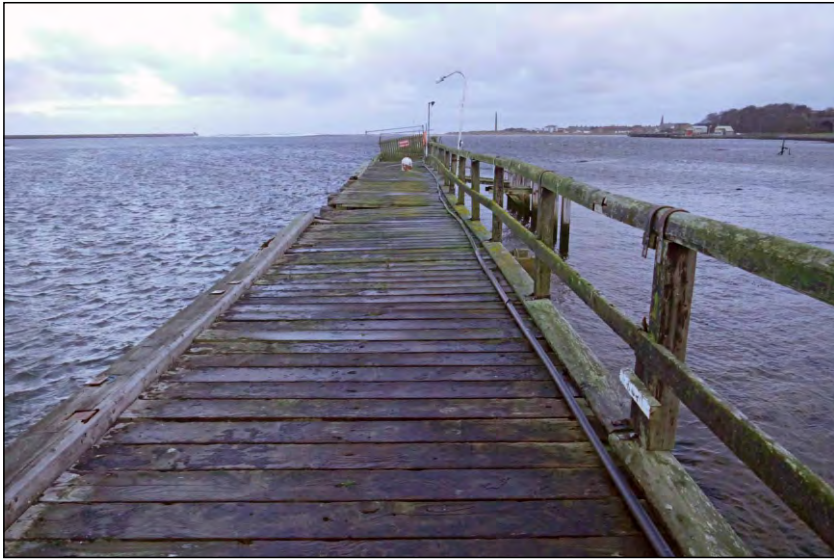
1-11: Views of the jetty from the south side.

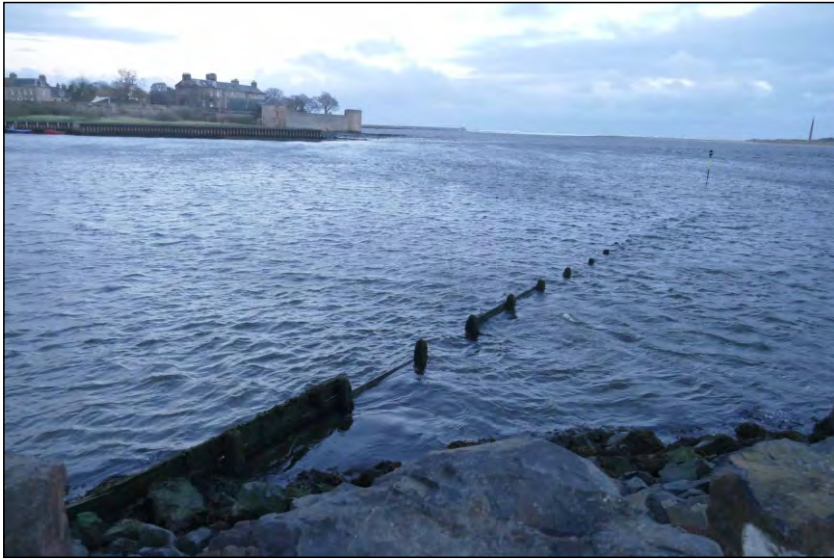
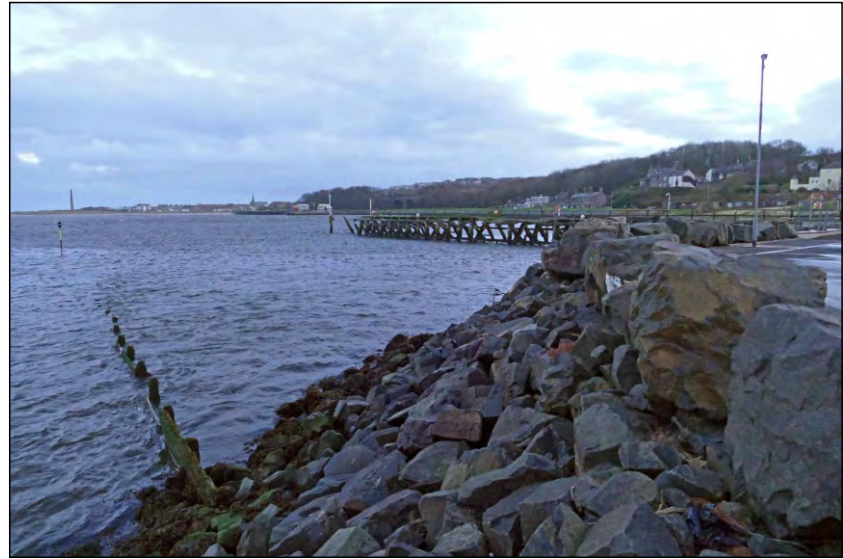
21-22: Views of the groyne from the quayside on the north side of the dock entrance.

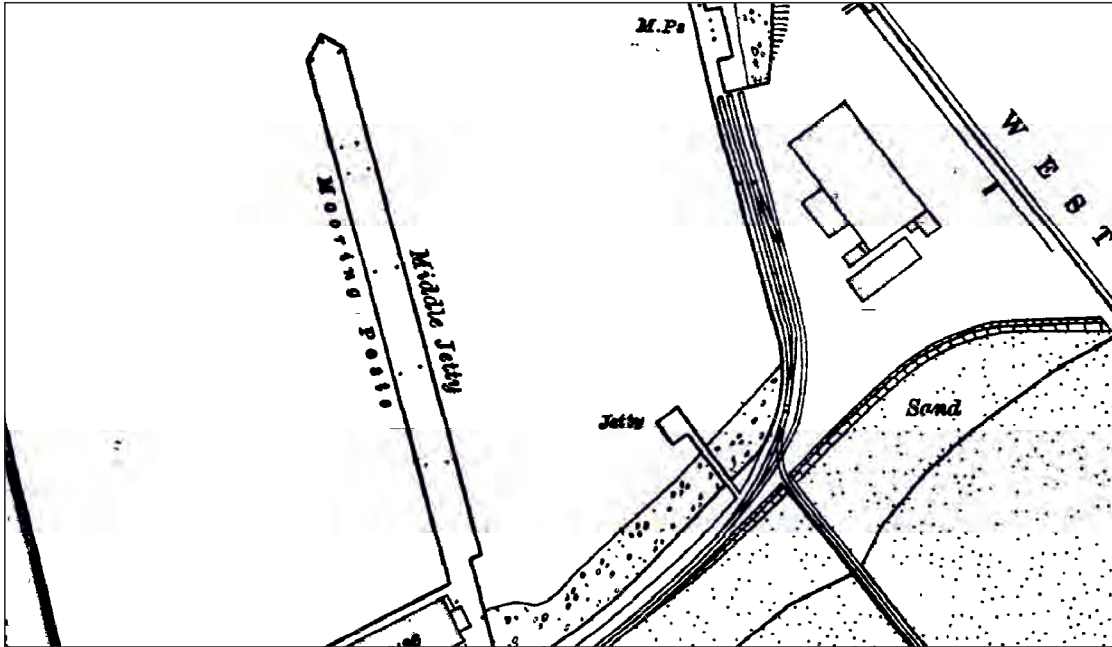
Historic North-East Coast Jetties (top to bottom):  
Blythe 1920s, North Shields 1890s and Hartlepool 1890s.

Both forms of structure, but particularly jetties, were once common on the north-east coasts (see APPENDIX 2: *Historic North-East Coast Jetties*), principally at the entrances to, and within, docks such as Tyne Dock and the Albert and Edward Dock on the Tyne and Sunderland North, Hudson & Hendon Docks on the Wear as well as those on the Tees, including Hartlepool. Such jetties were particularly common in relation to coal staithes, notably at Sunderland and, particularly, Tyne Dock at Jarrow, once the greatest coal port in the world, where coal-carrying railway waggons were carried to elevated staithes on the dock-side, emulating earlier arrangements found on the Tyne and Wear in relation to 17<sup>th</sup> and 18<sup>th</sup> century coal-carrying waggonways. Jetties associated with staithes on the riverside end of 18<sup>th</sup> and 19<sup>th</sup> century waggonways include those recorded at the south end of the Backworth Waggonway

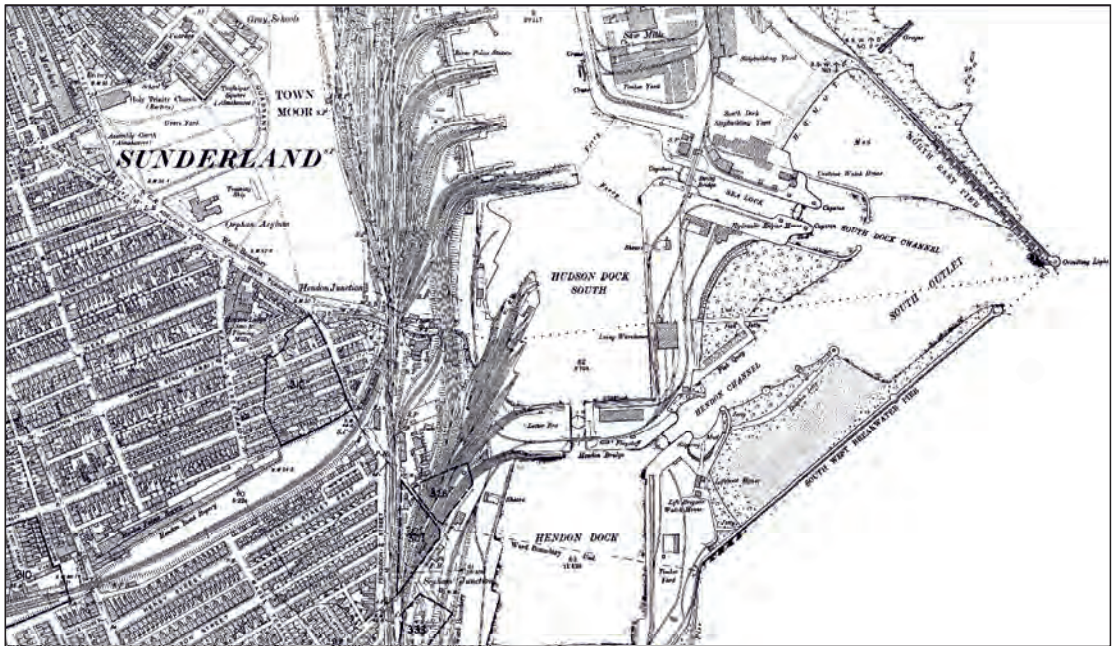
Historic North-East Coast Jetties (top to bottom):  
 Sunderland Harbour entrance and North Dock 1890s, Sunderland Hudson & Hendon  
 Docks 1890s and Tyne Dock jetties, 1940s.
