CHURCH OF ST. HELEN
MANOR ROAD, ST. HELEN AUCKLAND
COUNTY DURHAM

~ ARCHAEOLOGICAL MITIGATION WORKS
FOR NORTH EXTENSION ~

FEBRUARY-JUNE 2018

REPORT ON A PROGRAMME OF ARCHAEOLOGICAL MITIGATION
CONDUCTED DURING EXTENSION WORKS IN 2018

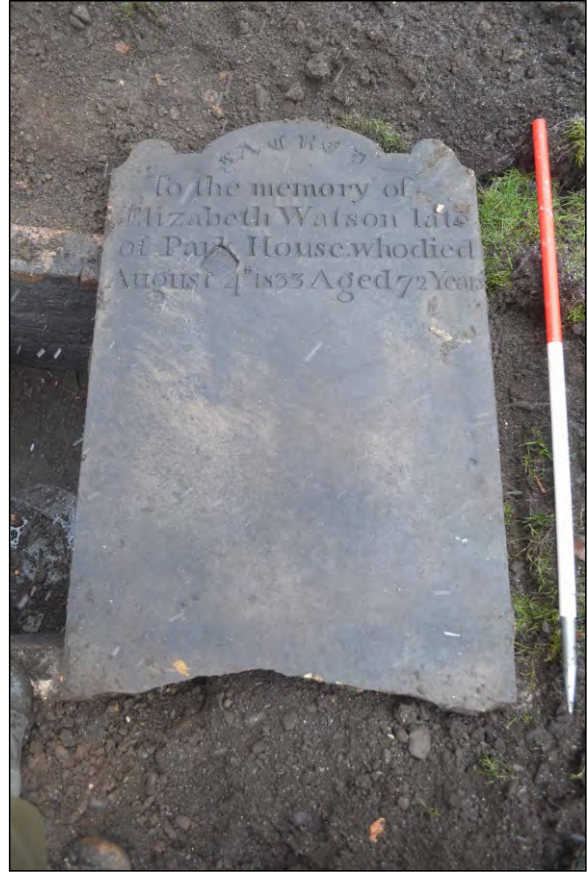
Photo 28. Detail of reused grave-marker from [03], dedicated to Elizabeth Watson, 1833.

A brick built tank for a soak-away drain [03] running from a down-pipe extending from the church roof has been interpreted as late 19th century or early 20th century in origin. A reused sandstone grave-slab, acting as lid for the drainage tank, was observed to be dedicated to Elizabeth Watson, dated 1833.

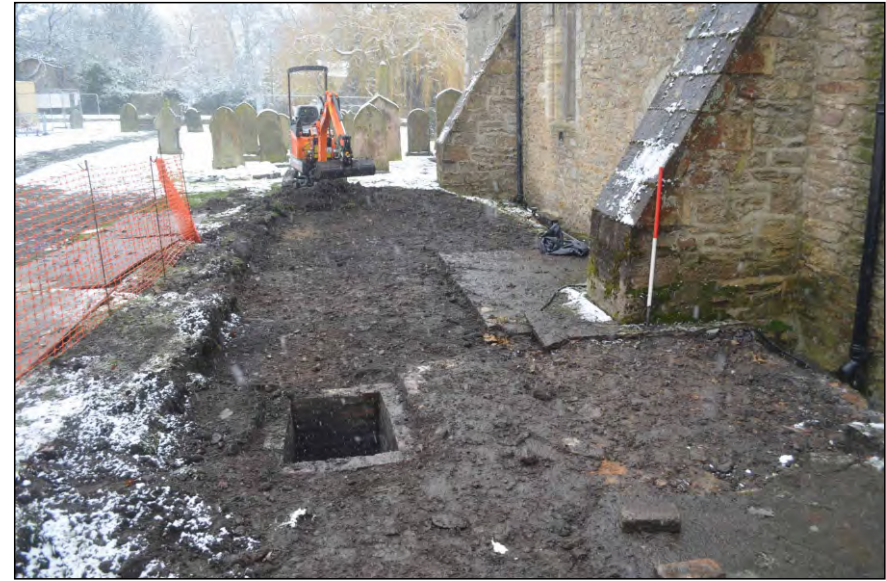
Photo 32. Clearing turf from the extension area revealed a brick soak-away drainage tank [03]. View looking east.

- [03] Soak-away drainage tank, rectangular red-brick box with reused grave slab acting as lid (dedicated to Elizabeth Watson, 1833). Located on same axis as and a distance of 3.15 m north from an existing cast-iron down-pipe extending from the church roof guttering, observed on the west side of the western buttress along the north wall of the church. Interpreted as a late 19th century or early 20th century tank for a soak-away drain, draining rain water from the north-western part of the nave roof.
See Photos 27-28, 32-33 and Illus. 04 for further details.

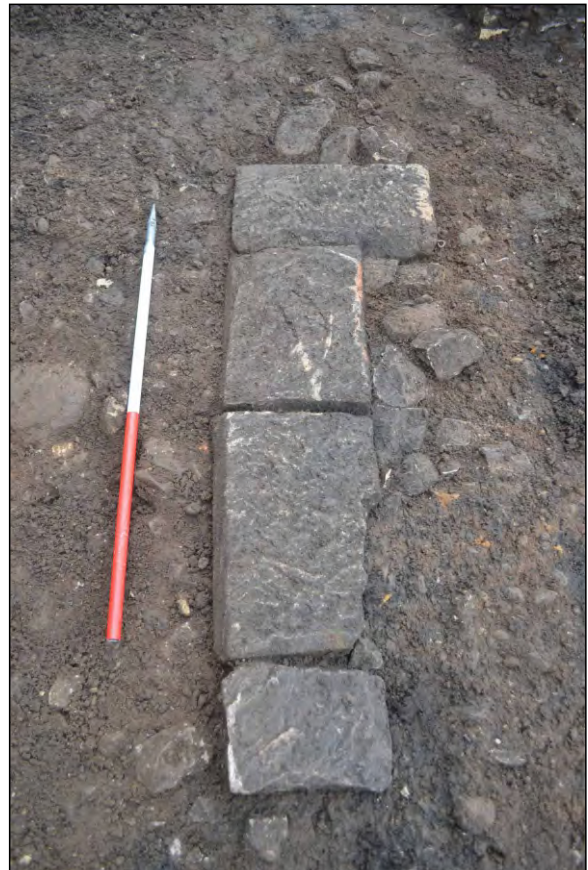
A linear feature of sandstone slabs/shallow blocks without bond and associated cobbles [04] was observed 0.70 m to the north of the western buttress. The feature has been interpreted as a possible grave marker/surround – and does not appear structural. Remains of two burials (SK1-2) were discovered immediately beneath the west end of this feature.

Photo 38. View looking west along sandstone linear feature [04].

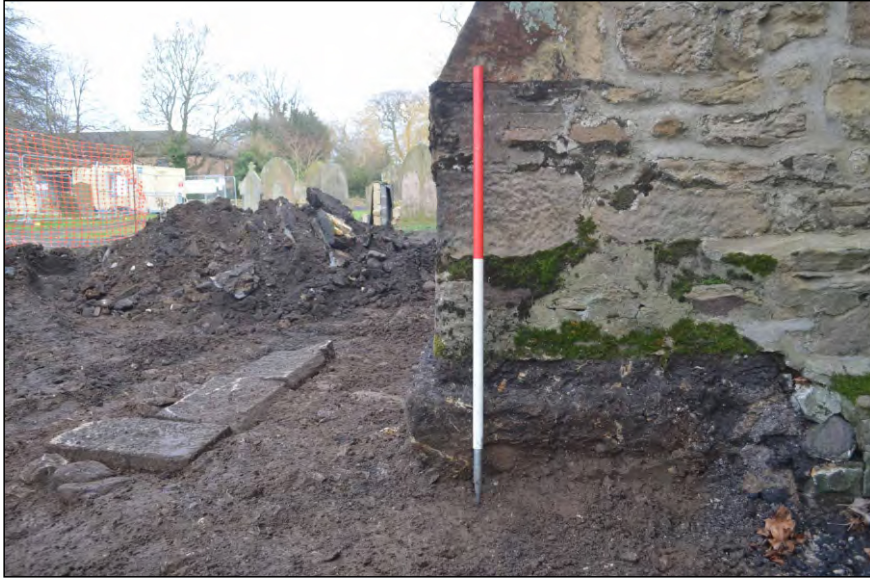
Photo 39. Exposed foundation of western buttress along the north wall of the church. View looking east.

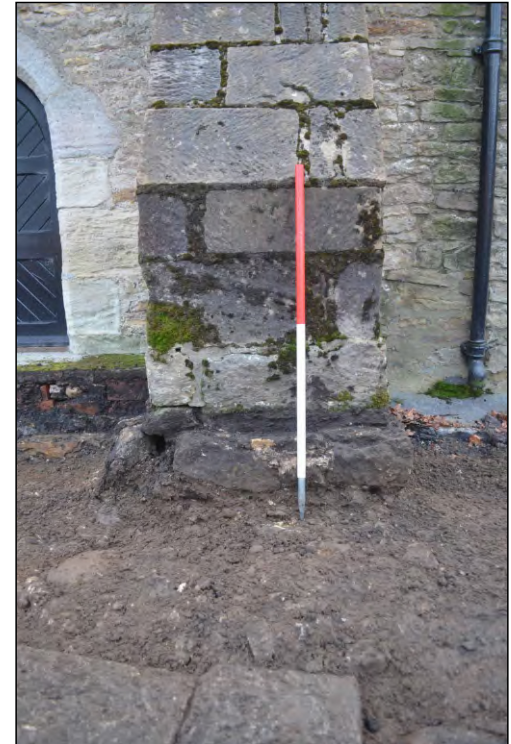
Photo 40. Exposed foundation of western buttress along the north wall of the church. View looking south.

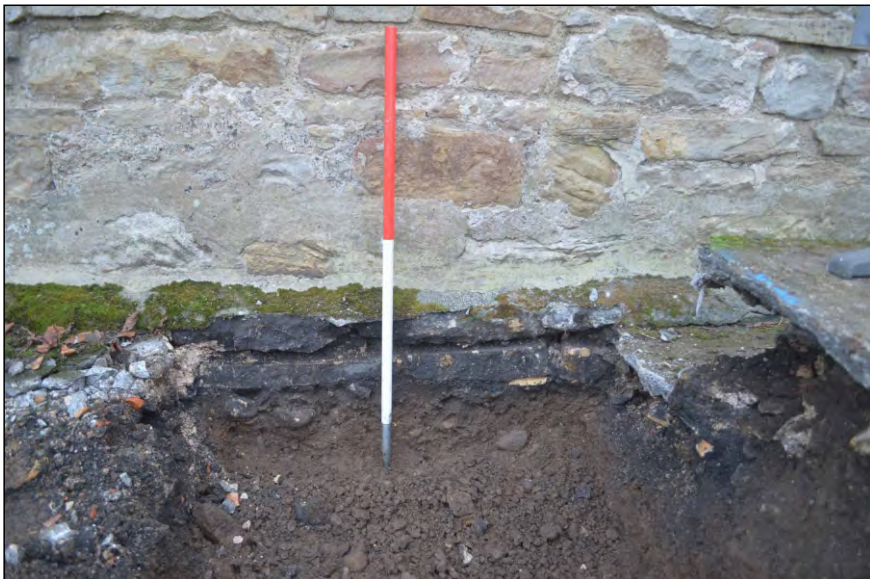
Photo 41. Depth of Church north wall foundations revealed during excavations at the west end of the extension area.

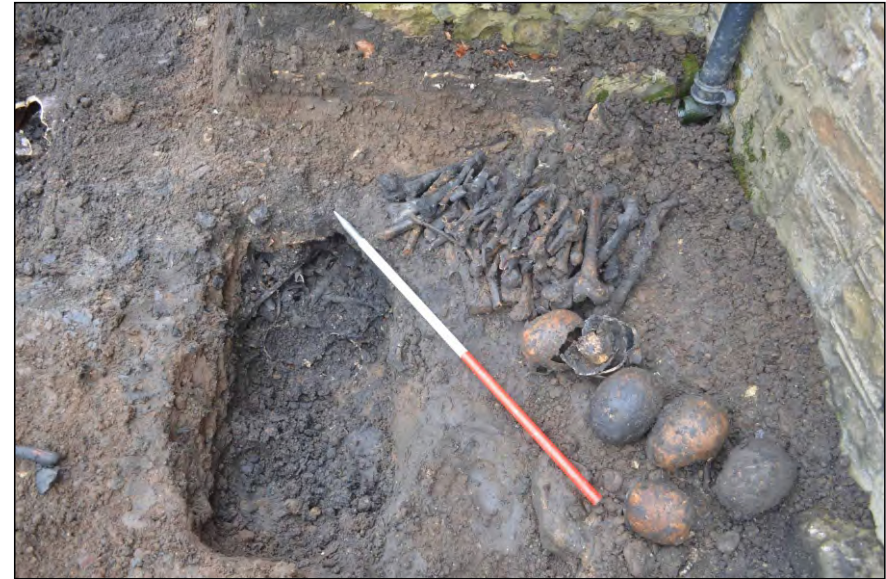
Photo 44. Location of charnel pit [05] on the west side of the eastern buttress of the church north wall. View looking east.

- [05] Charnel material, comprising a large concentration of compacted disarticulated human bone (mainly long bones and skulls), representing the remains of at least 6 individuals, observed on the western side of the eastern buttress of the north wall of the church. Exhumed and reinterred within a new 'charnel pit' [06]. Interpreted as a charnel pit resulting from 19th century graveyard clearance.
See Photos 43-44 and Illus. 04 for further information.

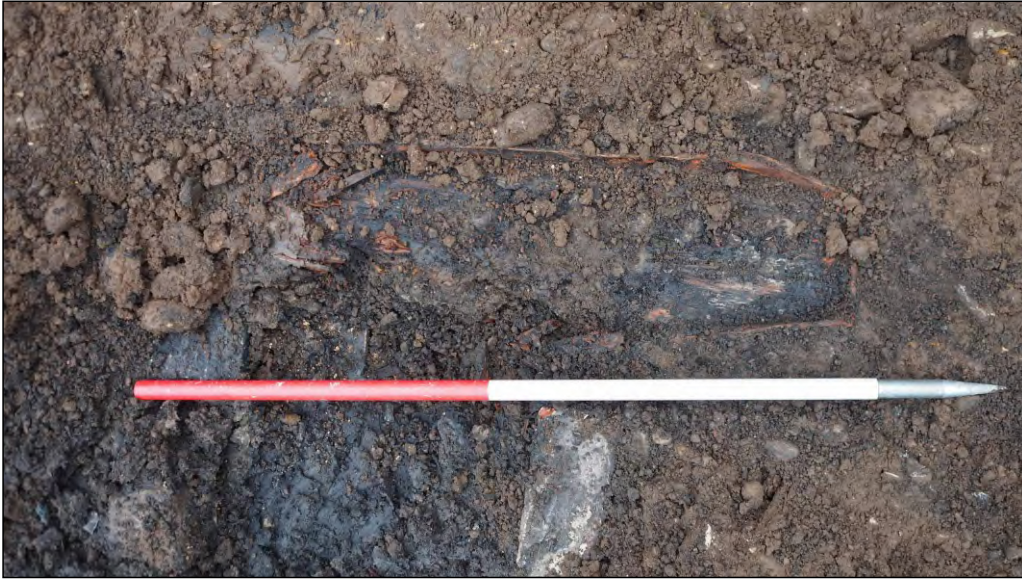
- [07] Decayed remains of a (presumed) late-19th or early 20th century timber coffin burial, observed upon an E-W alignment and located immediately south of brick soak-away drain [03] 2.85 m to the north of the north wall of the church and 0.50 m west of the western buttress along the north wall of the church. The coffin was left in situ.
See Photos 51-52 and Illus. 04 for further details.

Photo 51. Remains of timber coffin burial [07], view looking north.

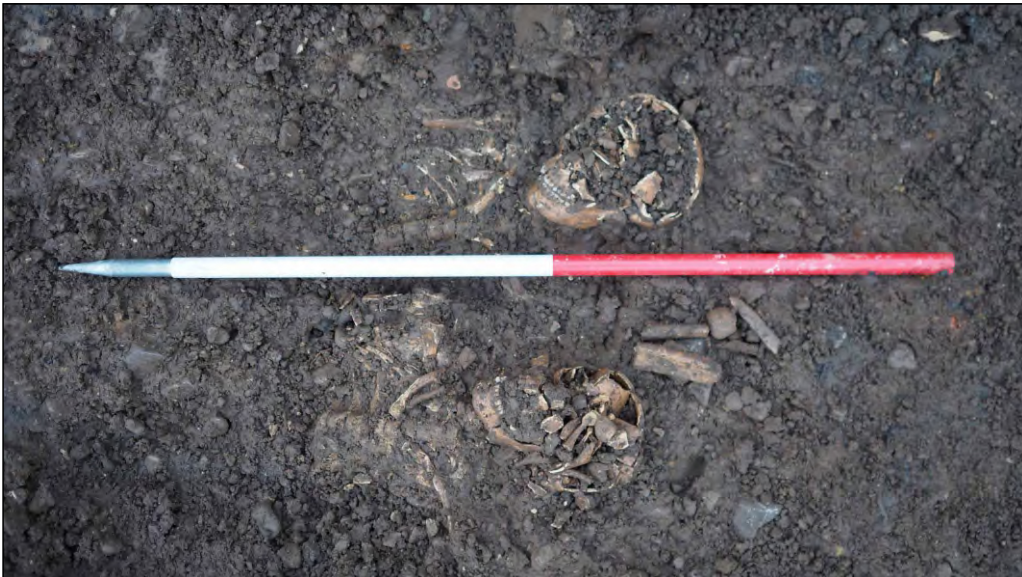
- [SK1] Located beneath the west end of linear stone feature [04] at a distance of 1 meter north of the western buttress. Aligned E-W. Only the upper torso and skull were exposed by excavation. Multiple cranial compression fractures. The north portion of skeleton appeared truncated by SK2 which lies immediately parallel and partly overlaps. Left in situ and undisturbed.
Dimensions (exposed): 0.32 m (length E-W) x 0.16 m (width N-S).
See photos 53-54 and Illus. 04, 09 for further details.
- [SK2] Located immediately parallel to and slightly overlapping/truncating the north side of SK1. Aligned E-W. Only the upper torso and skull exposed – which has multiple cranial compression fractures. Left in situ and undisturbed.

Photo 53. Remains of SK1-2, view looking south.

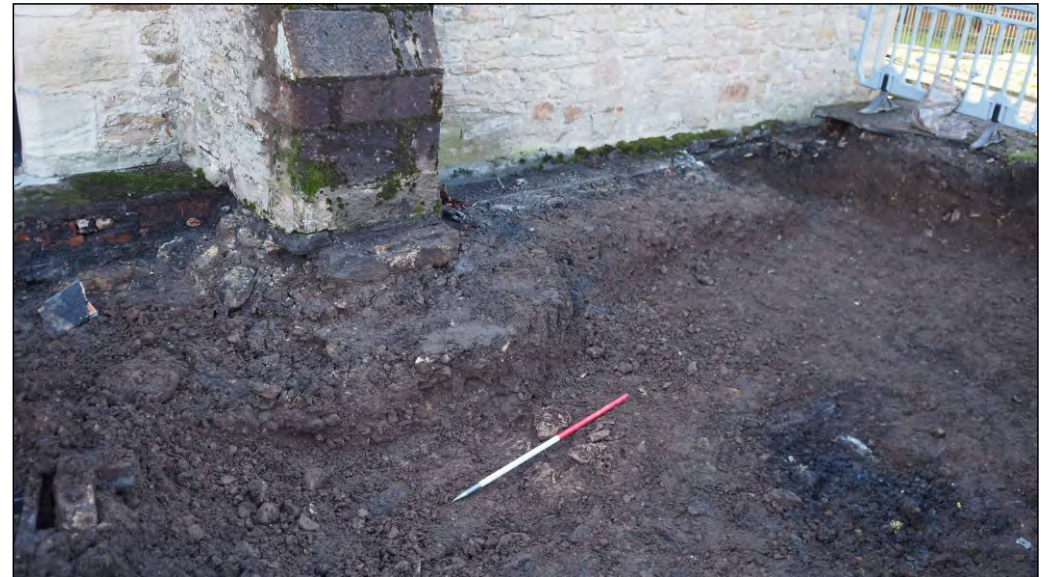
Photo 54. Remains of SK1-2, broad view looking south-west.

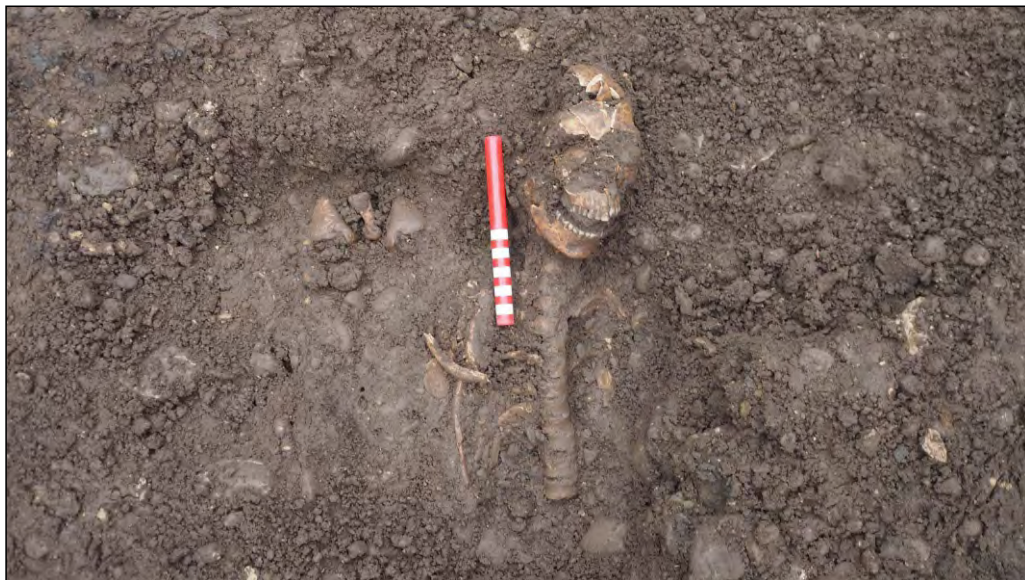
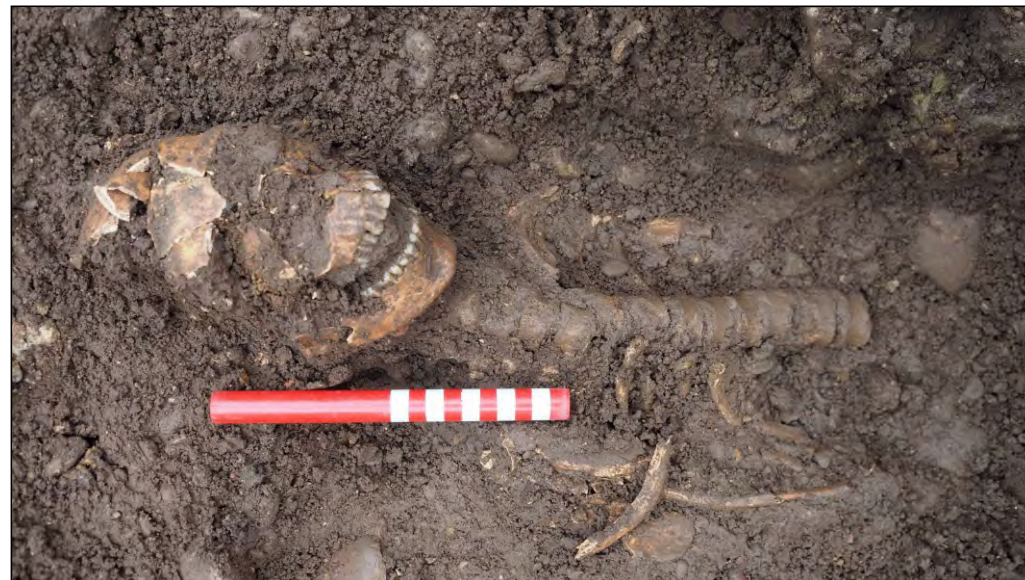
- Dimensions (exposed): 0.33 m (length E-W) x 0.22 m (width N-S).
See photos 53-54 and Illus. 04, 09 for further details.
- [SK3] Located beneath relocated gravestone of Elizabeth Wright, a distance of 4.40 m north of the Church north wall and 3 m east of the western buttress. Aligned E-W. Only upper torso and skull exposed. Frontal cranial compression fractures. Its associated grave-cut was observed running parallel to the skeleton on both north and south sides. Left in situ and undisturbed.
Dimensions (exposed): 0.50 m (length E-W) x 0.35 m (width N-S).
See photos 55-56 and Illus. 04 for further details.

Photo 55. Remains of SK3, view looking west.

Photo 56. Remains of SK3, view looking north.

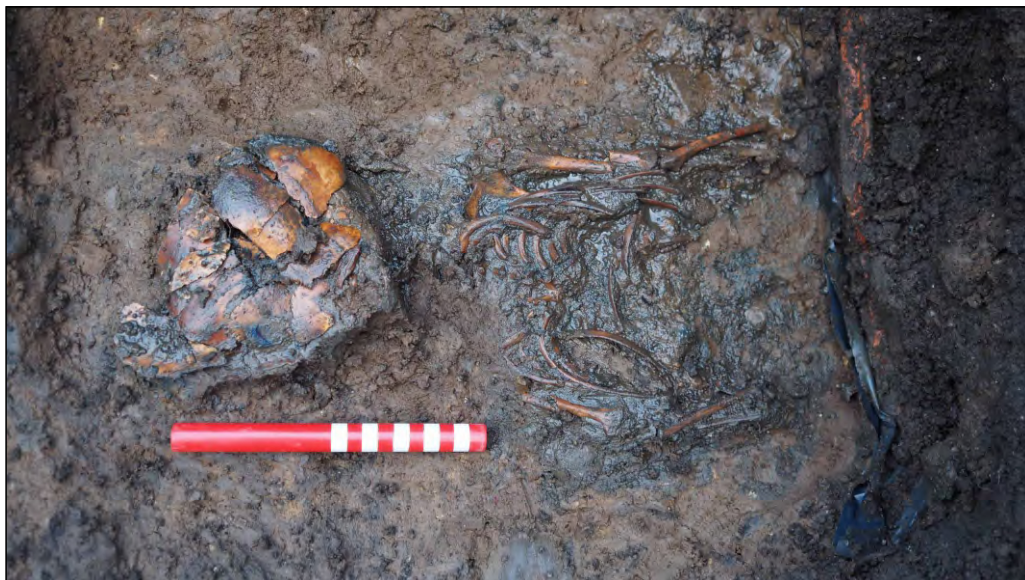
- [SK4] Equivalent to 2016 Evaluation SK1. Partial articulated inhumation of infant; upper torso, upper limbs and cranial remains only, missing pelvis and lower limbs. A set of 13 small silver shroud pins were associated with the burial discovered during evaluation in 2016, along with timber coffin fragments with attached nails and a lead nugget. Located at the SE side of the extension area, approx. 0.80m north of the eastern buttress along the north wall of the church. Observed at a depth of 0.65 m below ground level. Remains were recorded and left in situ. Interpreted as a partially disturbed but in-situ infant burial of probable C19th origin.
See photos 57-58 and Illus. 04 for further details.

Photo 57. Remains of SK4 (Eval SK1), view looking north.

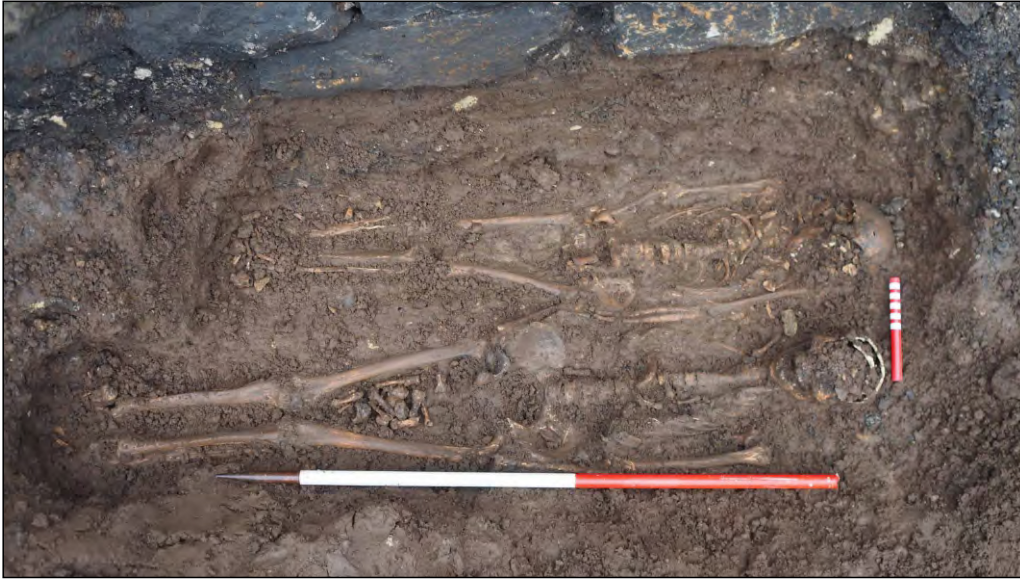
- [SK5-6] Two skeletons laying side by side on an E-W alignment, almost abutting the north wall of the church, located 1.12 m east from the north door. Both skeletons were fully exposed and both had cranial compression fractures.
SK5 dimensions: 1.20 m (length E-W) x 0.30 m (width N-S).
SK6 dimensions: 1.56 m (length E-W) x 0.30 m (width N-S).
See photos 59-60 and Illus. 04 for further details.

Photo 59. Remains of SK5-6, view looking south.

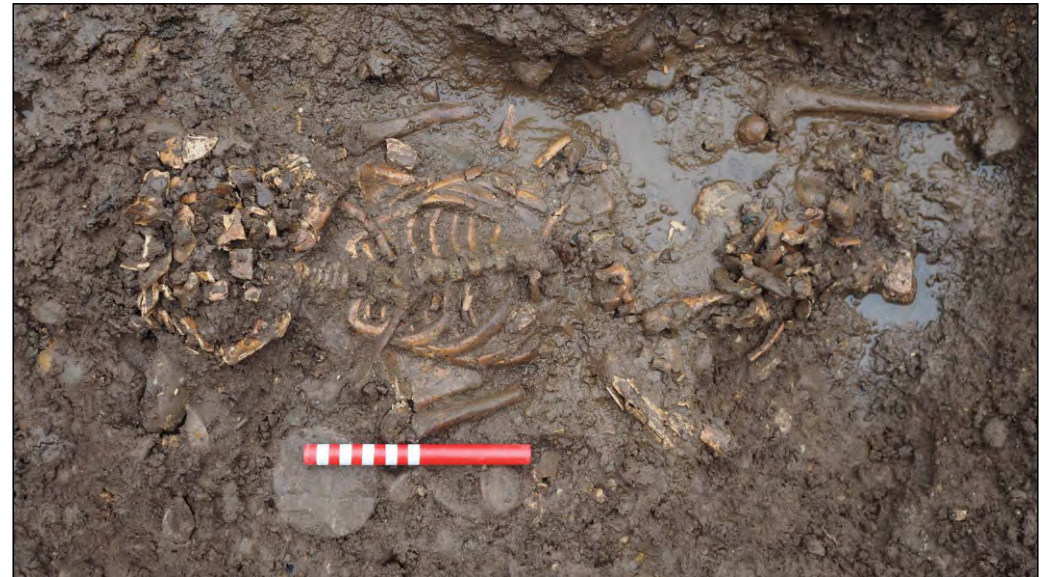
- [SK7] Infant burial, located 2.72 m north of the north wall and 1.05 m east of the north door of the church. Aligned E-W. Truncated from the lower legs onward. Cranial compression fractures.
Dimensions: 0.70 m (length E-W) x 0.28 m (width N-S).
See photos 61-62 and Illus. 04 for further details.

Photo 62. Remains of SK7, view looking north.

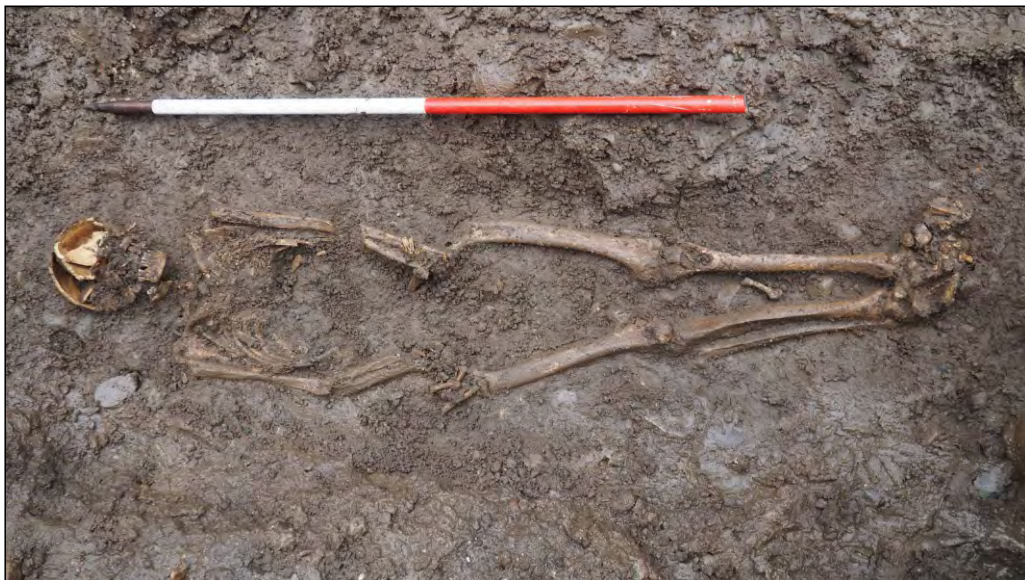
- [SK8] Located 1.10 m north of the north door and 0.92 m east of the western buttress. Aligned E-W. Entire skeleton exposed, but lower rib cage, back vertebrae and pelvis missing/truncated. Multiple cranial fractures.
Dimensions: 1.55 m (length E-W) x 0.55 m (width N-S).
See photos 63-64 and Illus. 04 for further details.

*Photo 63. Remains of SK8,
view looking north.*

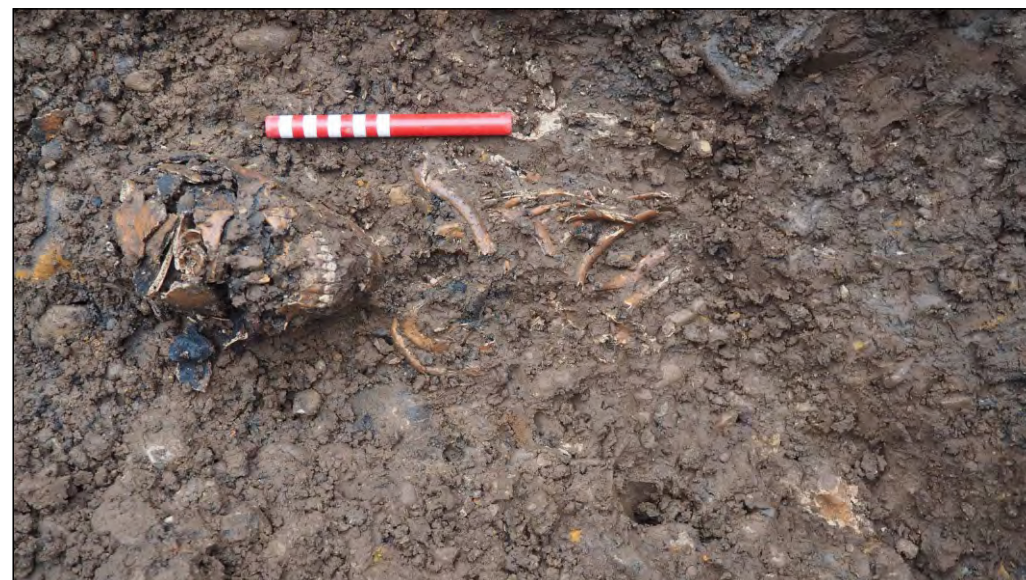
Photo 66. Remains of SK9, view looking north.

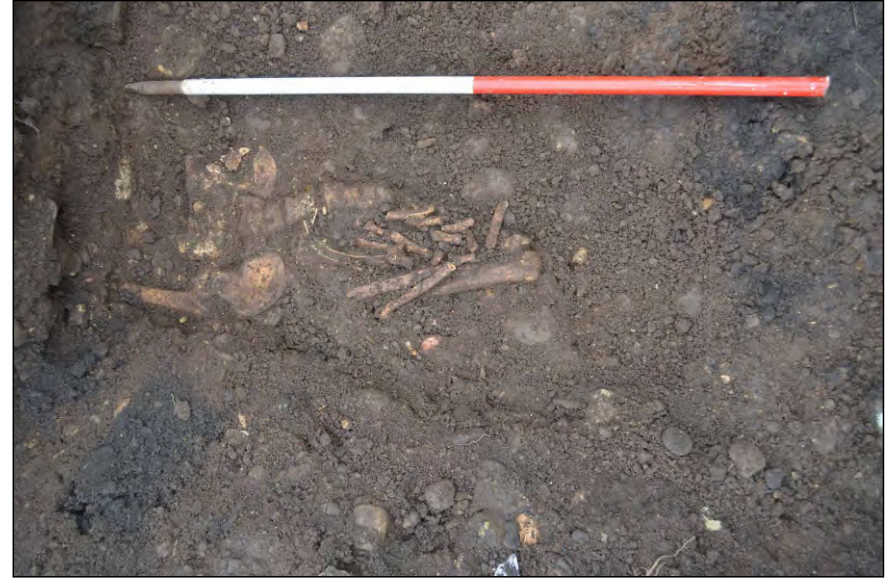
- [SK10] Located beneath removed grave-marker of George Wrangham, 5.60 m north of the north wall and aligned with the east side of the north door of the church. Aligned E-W. Badly truncated articulated skeleton, with only pelvis, left femur, $\frac{3}{4}$ of back vertebrae, left ribs, left arm and a few finger bones surviving.
Dimensions: 0.75 m (length E-W) x 0.31 m (width N-S).
See photos 67-68 and Illus. 04 for further details.

Photo 68. Remains of SK10, view looking south.

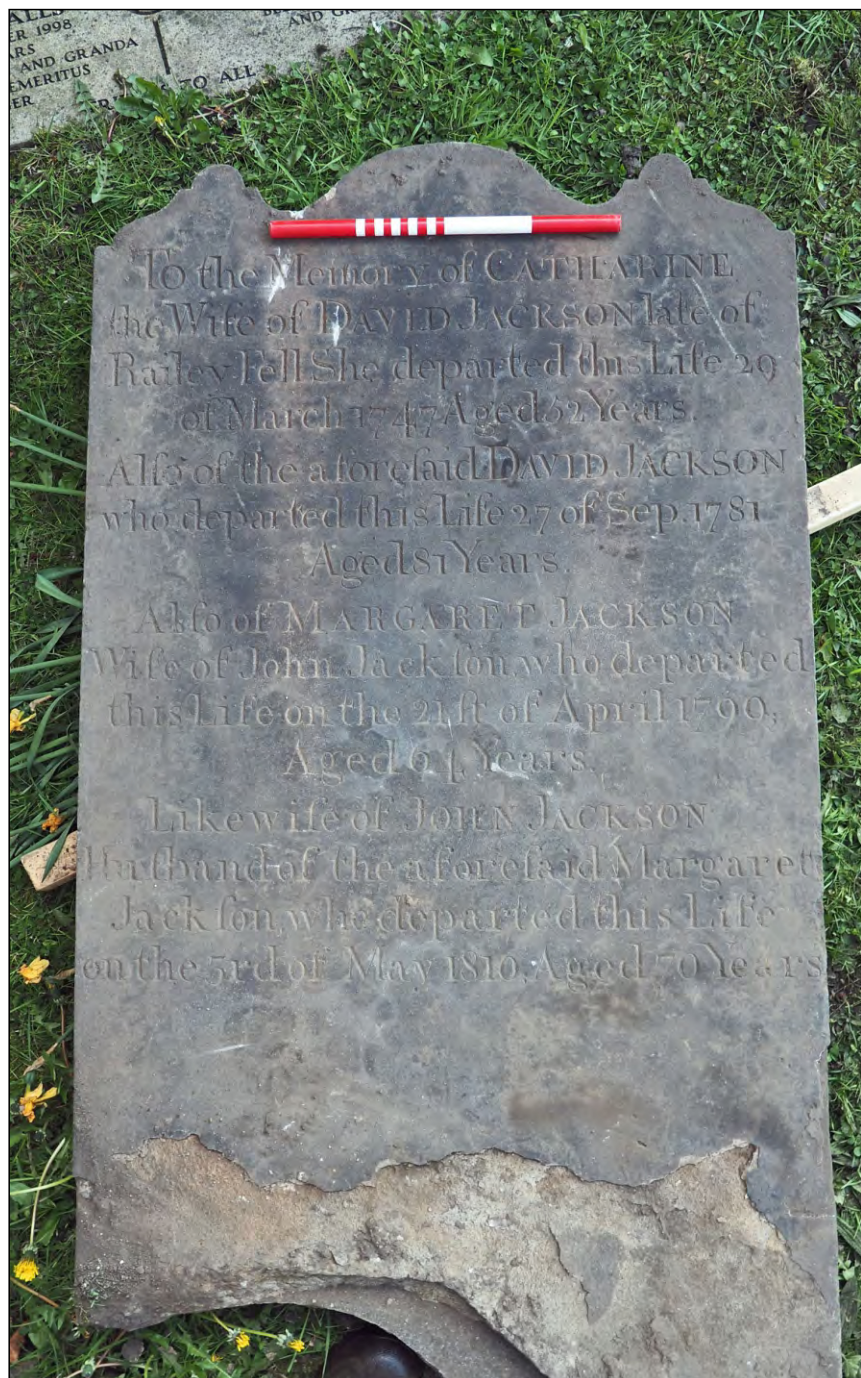
6.4 Provision for a new gas and water service connecting the new extension to an existing supply at the west end of the Church Porch, recovered a fallen gravestone, dedicated to Catherine Jackson and family, dated 1747 (*see Photos 80-81* and Section 4.4 above). No other archaeological remains were observed within this services trench.

Photo 81. Grave-marker of Catherine Jackson and family, 1747, recovered during excavation of services trench connecting to west end of Church Porch.

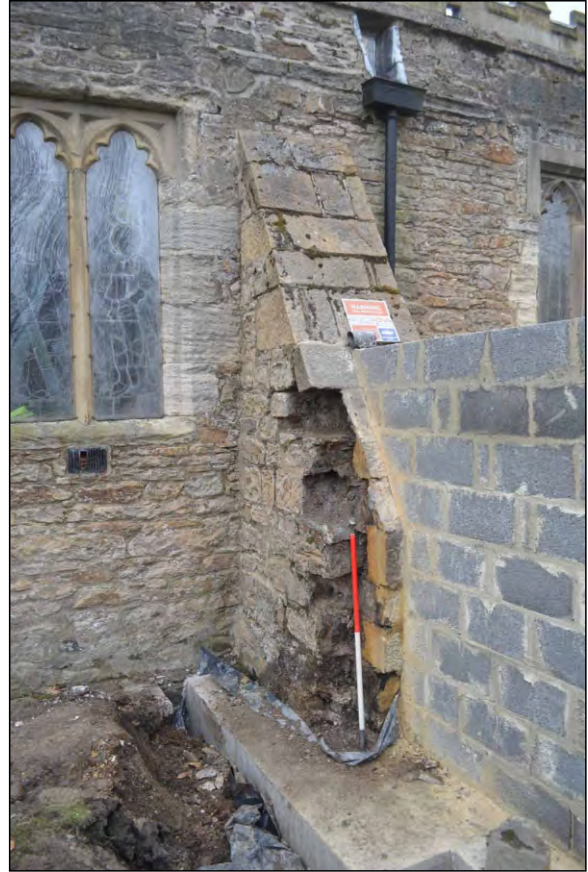
Photo 83. The eastern buttress after removal of facing stones on east side of front elevation.

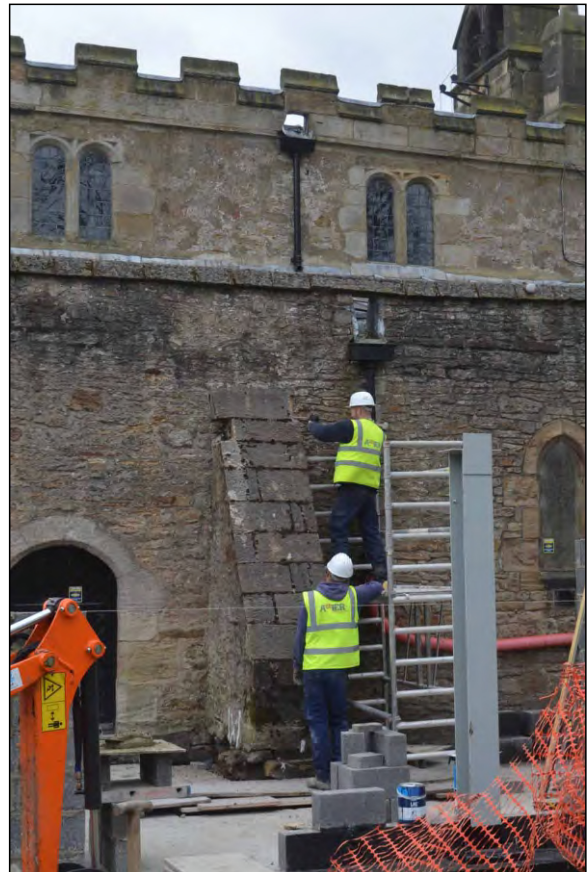
Photo 85. The western buttress at the beginning of reduction works.

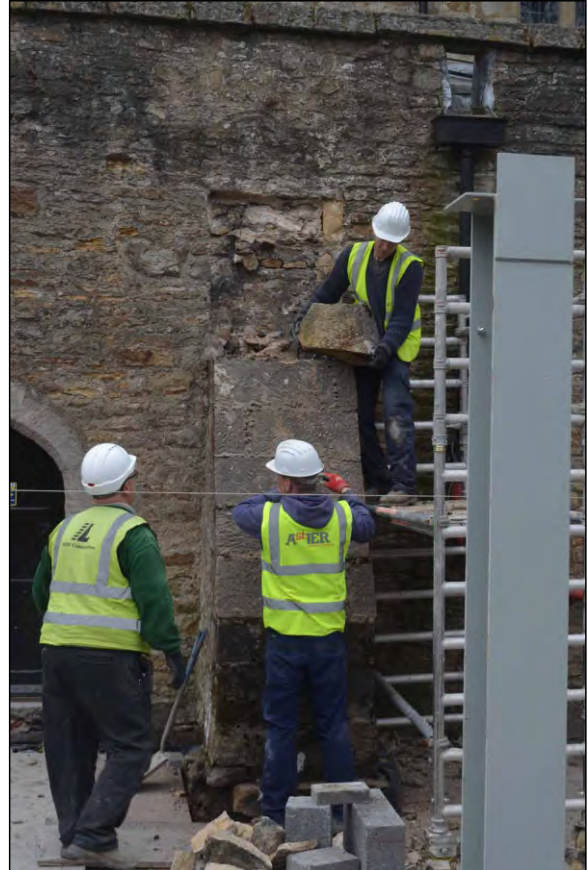
Photo 87. The western buttress during further removal of upper courses.

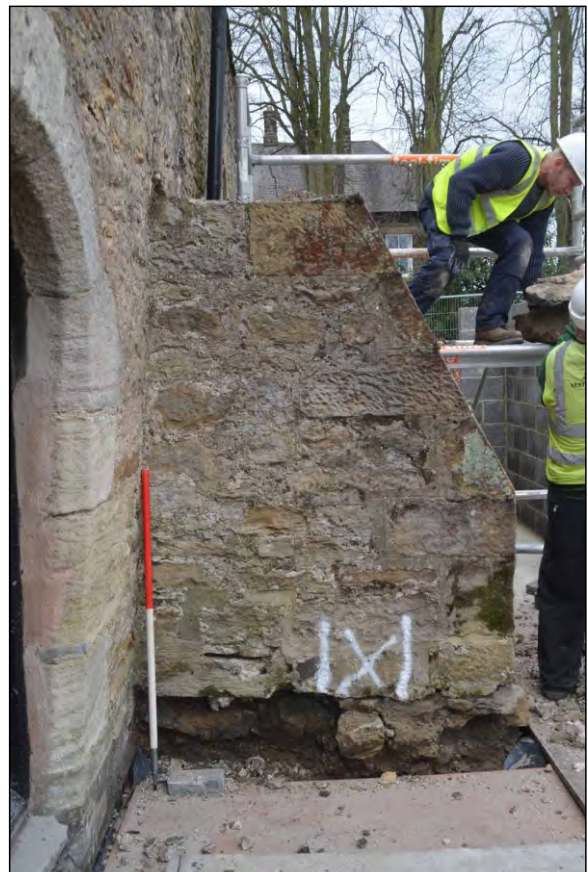
Photo 89. The western buttress after removal of upper courses.
