WALWICK COTTAGE & CAMBERWICK
WALWICK, HUMSHAUGH
NORTHUMBERLAND

~ ARCHAEOLOGICAL WATCHING BRIEF ~

MARCH 2019

REPORT ON AN ARCHAEOLOGICAL WATCHING BRIEF

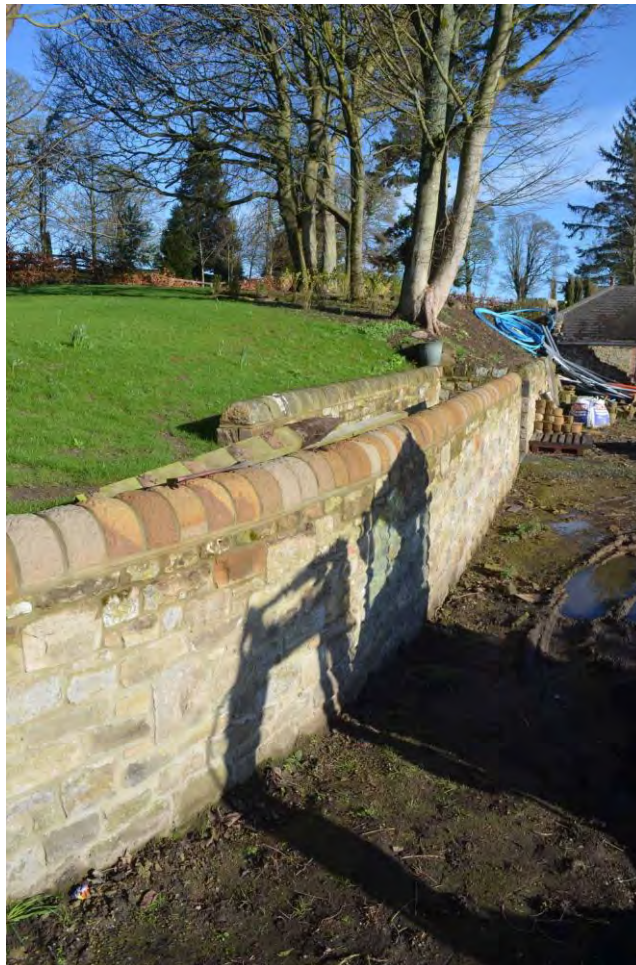
Frontispiece: *A retaining boundary wall on the west side of the Walwick Cottage plot, illustrating a substantial variance in ground level relative to the neighbouring plot of Walwick Hall, evidence of significant landscaping in the 18th-19th century.*

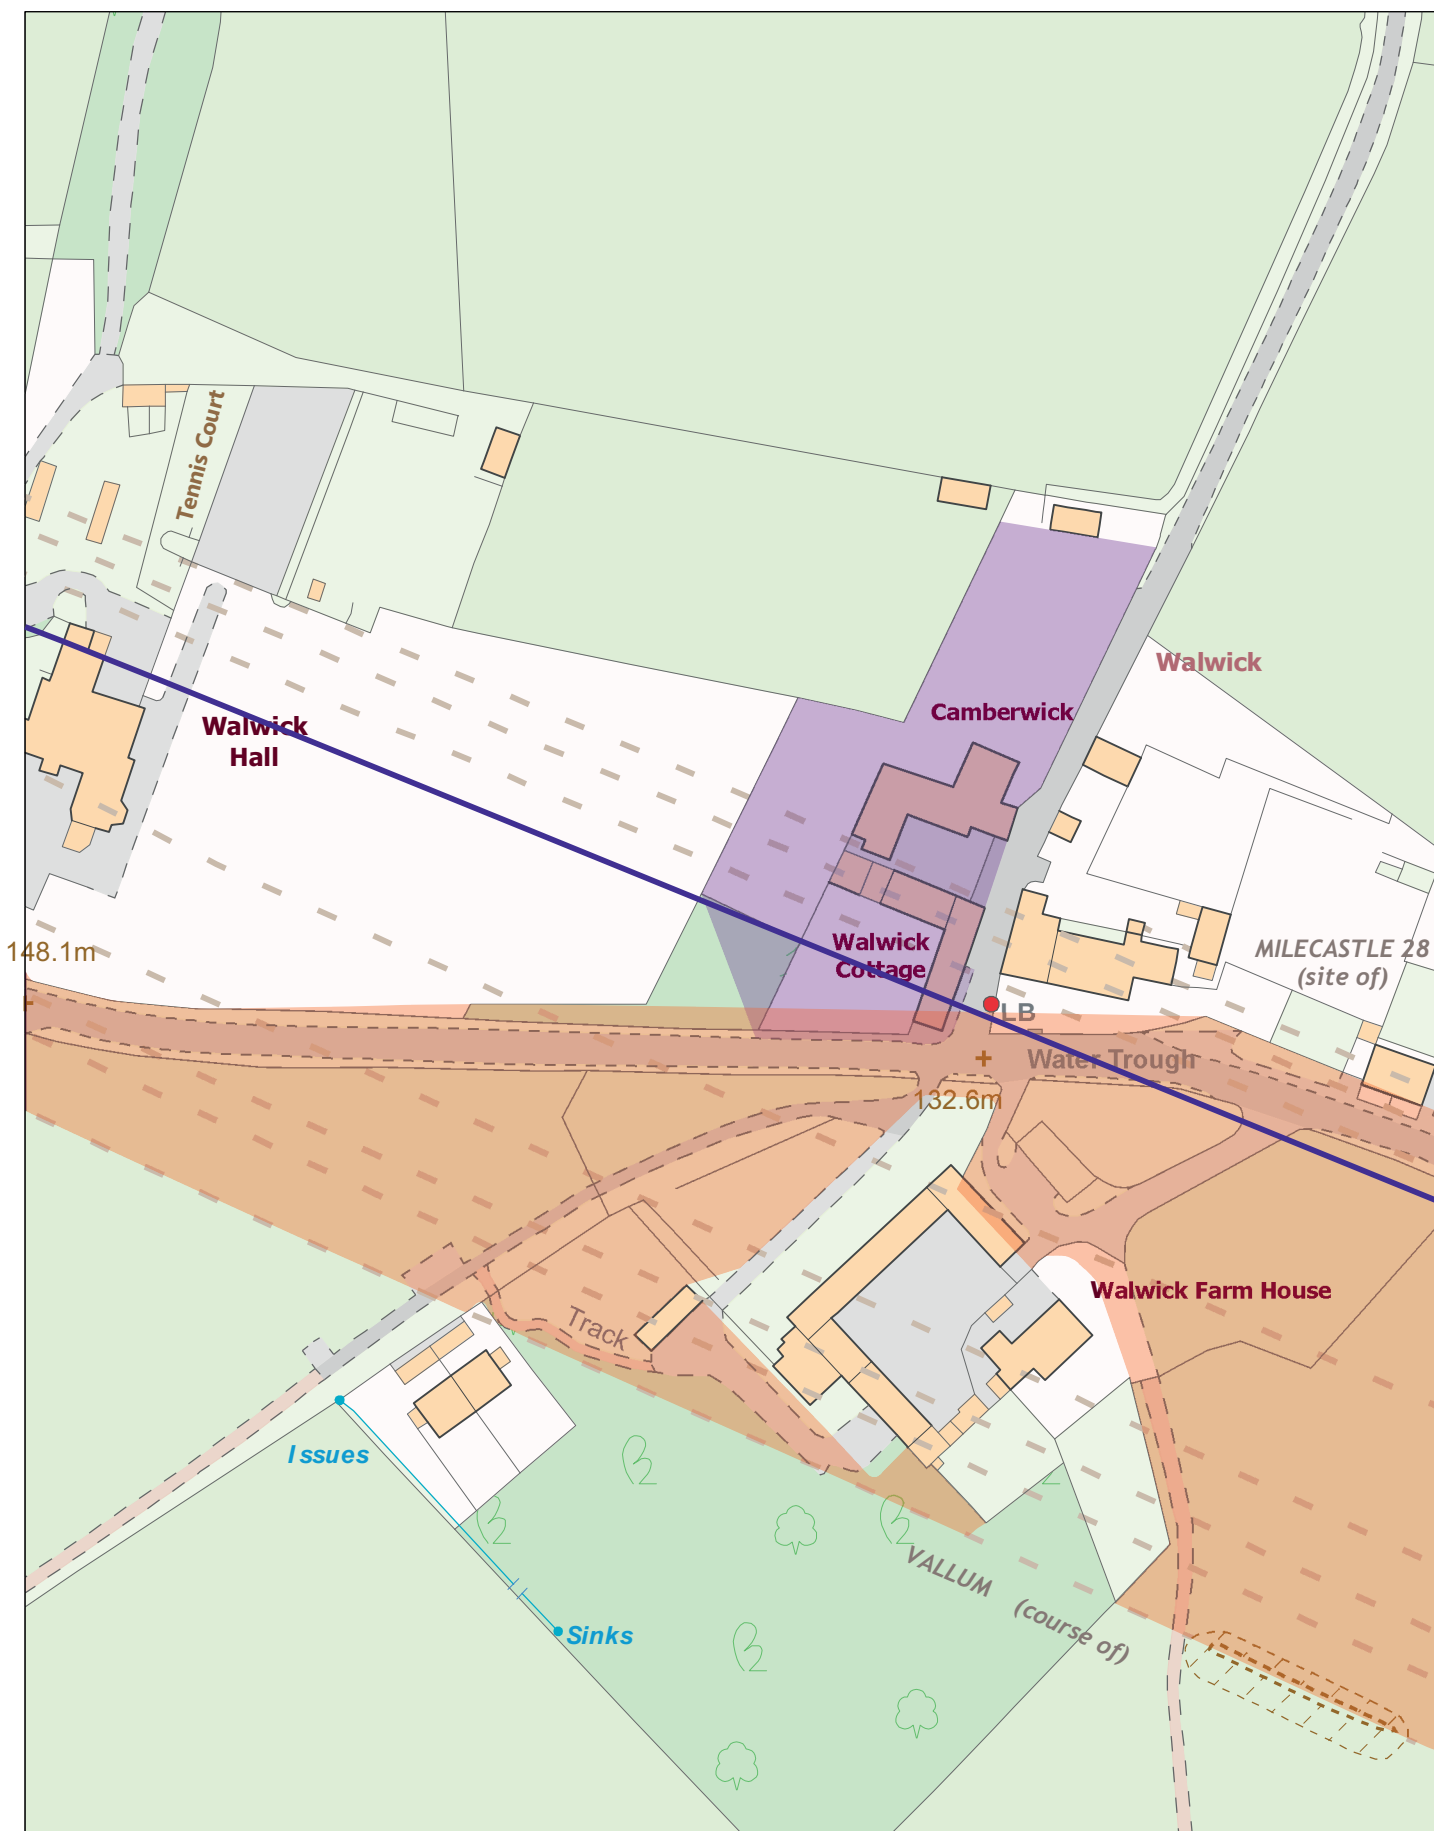
Illus. 03: Site view, showing the location of the watching brief site (shaded in purple) at Walwick Cottage & Camberwick, with the line of Hadrian's Wall (shaded in blue) and the extent of the scheduled monument (shaded in red).

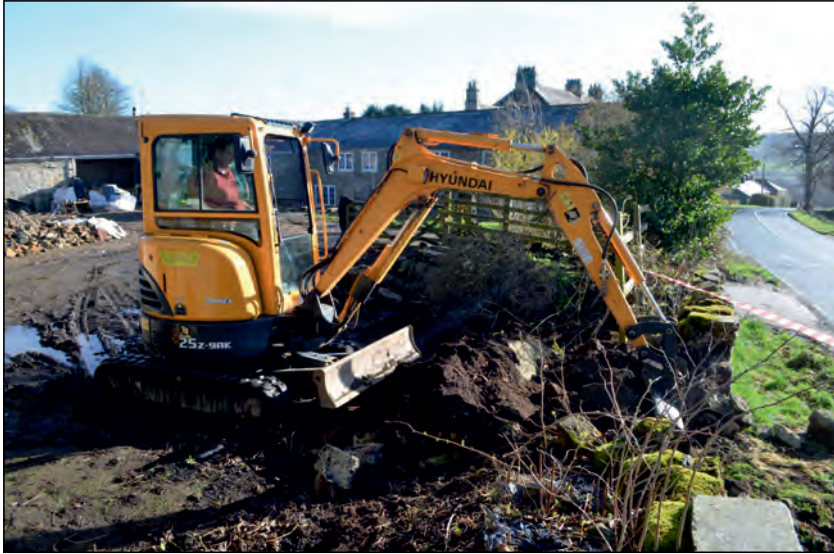
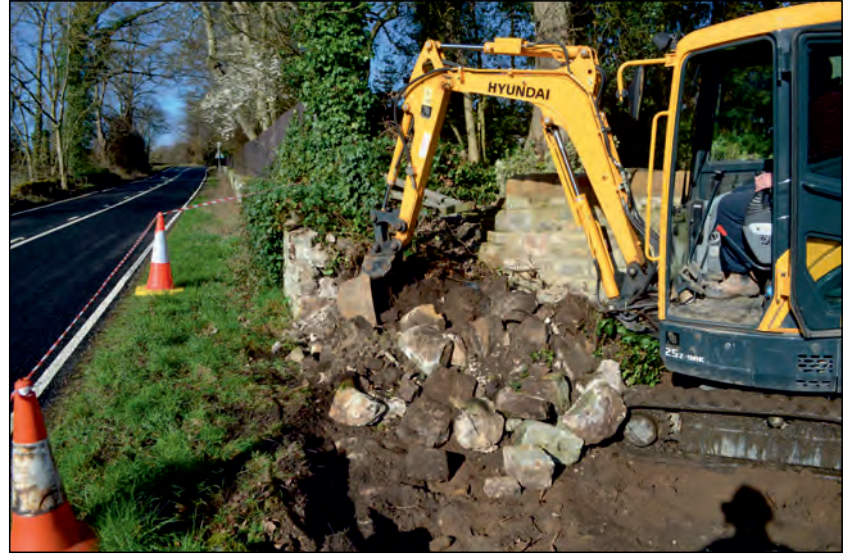
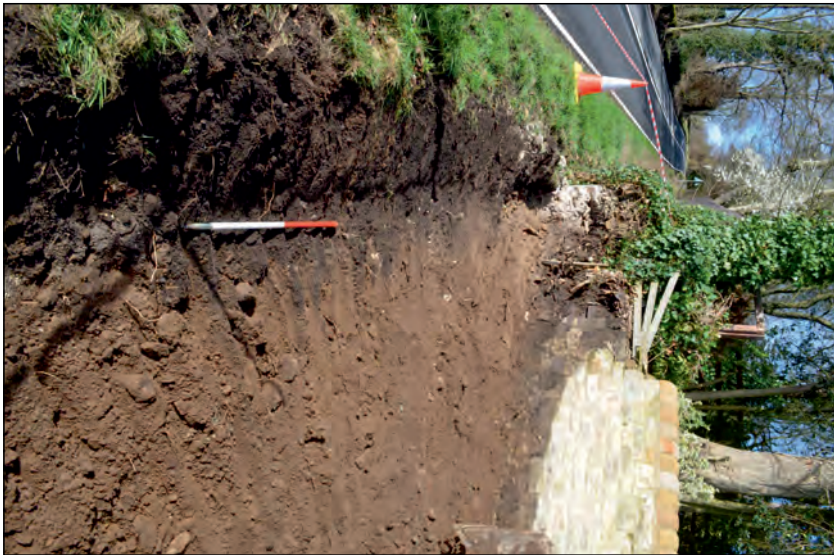
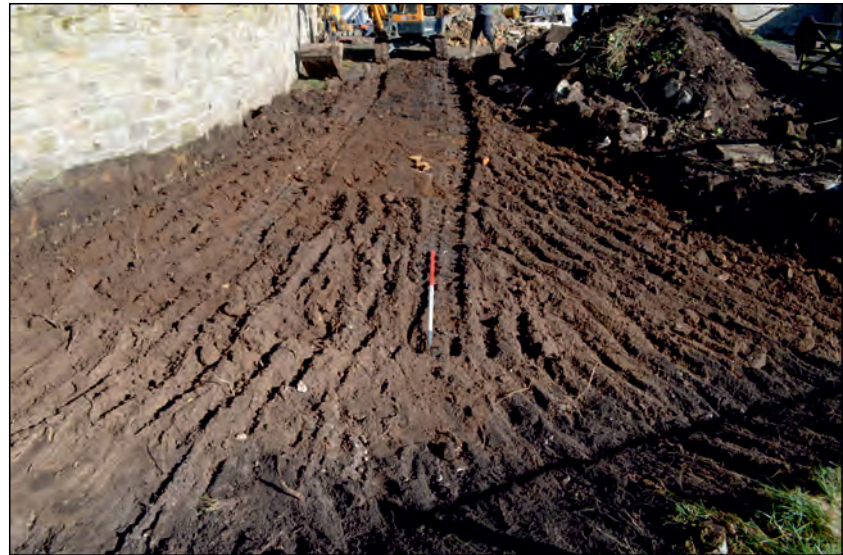
3.1 Demolition of western end of southern boundary wall fronting the Military Road verge and grading of adjoining land to the north to sufficient depth for new driveway/access (*Photos 1-4*).

Photo 1. View looking east during demolition of the southern boundary wall, fronting on to the Military Road verge.

Photo 2. View looking west during demolition of the southern boundary wall, fronting on to the Military Road verge.

Photo 3. View looking west after demolition and removal of southern boundary wall and shallow grading of the surface for new driveway in.

Photo 4. View looking north after demolition and removal of southern boundary wall and shallow grading of the surface for new driveway in.

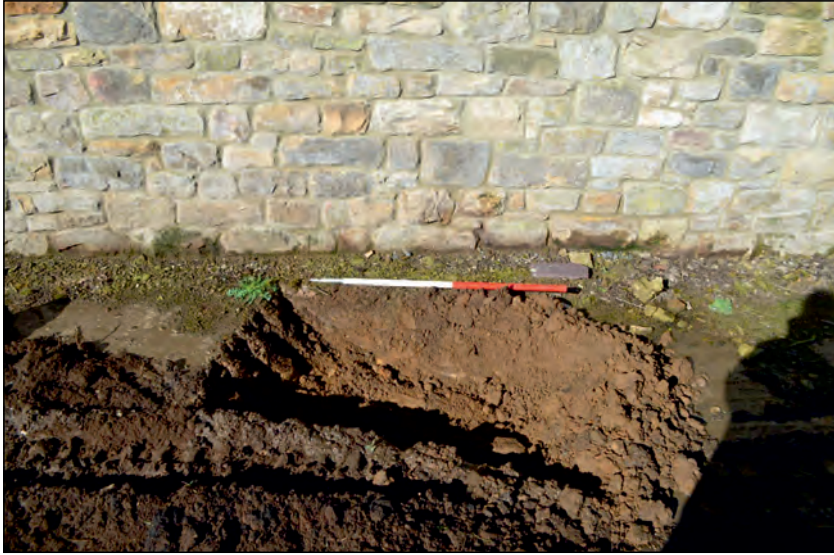
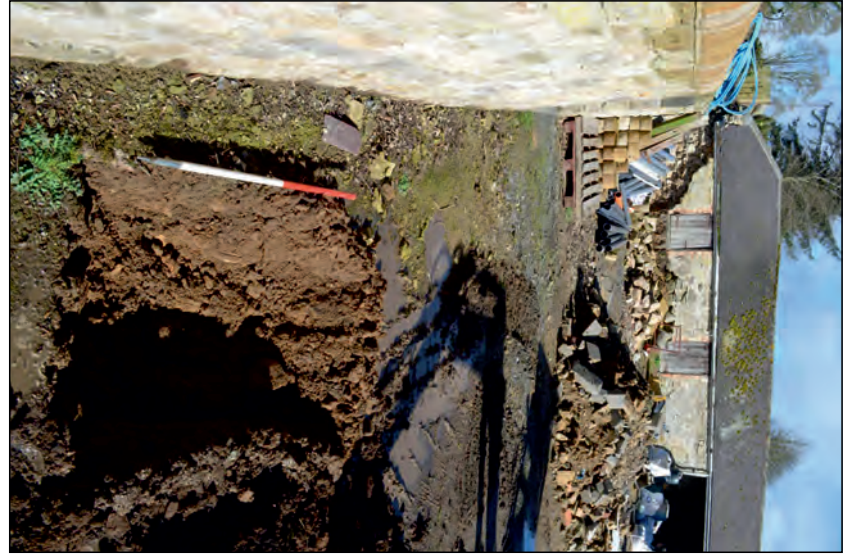
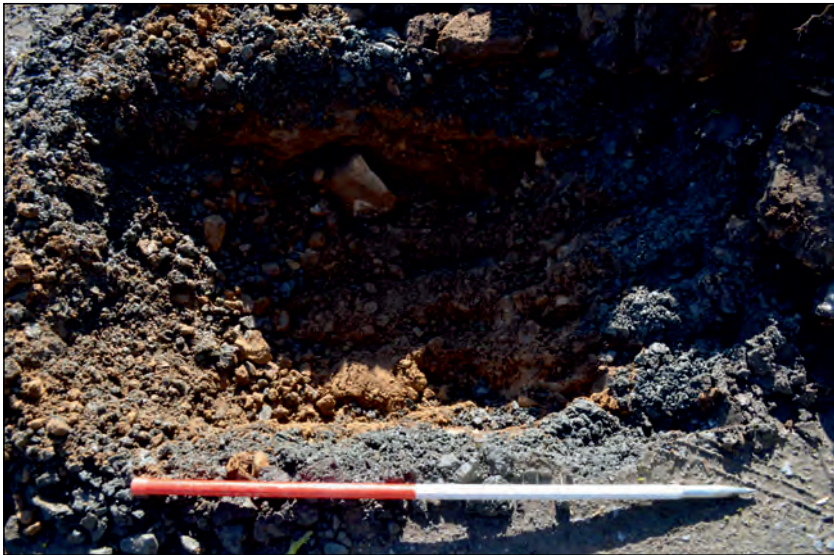
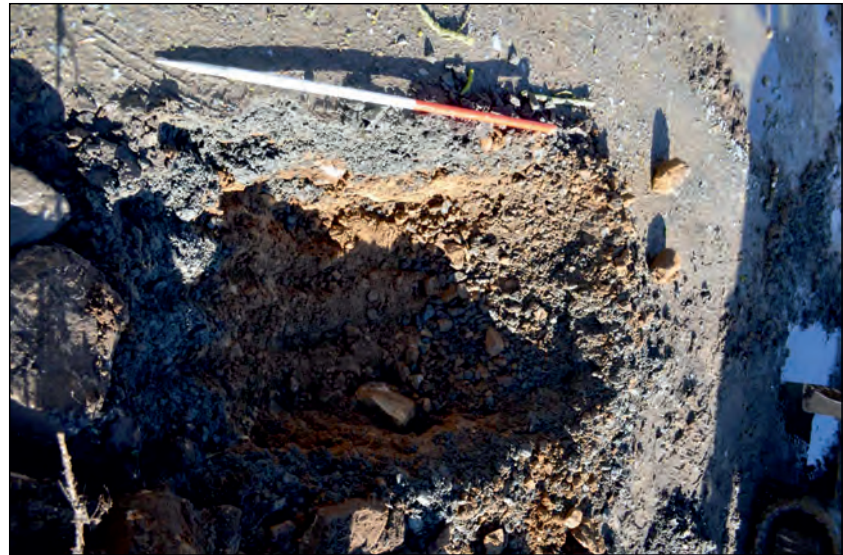
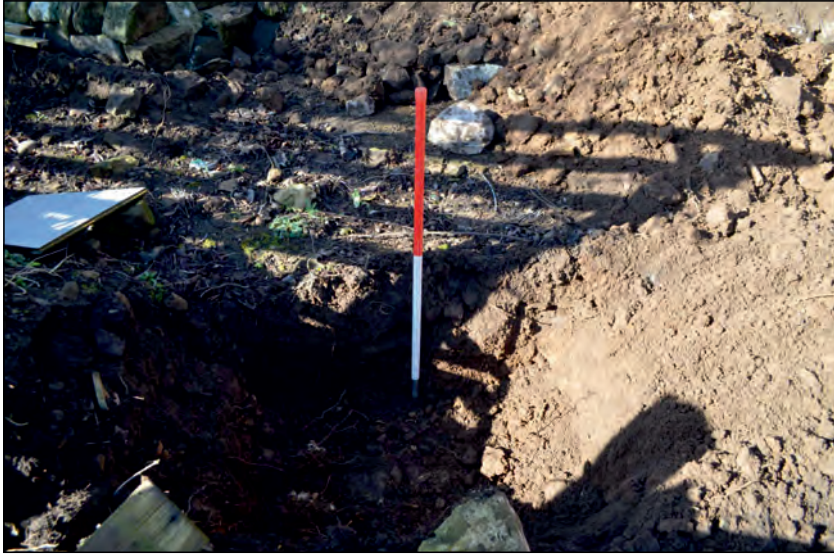
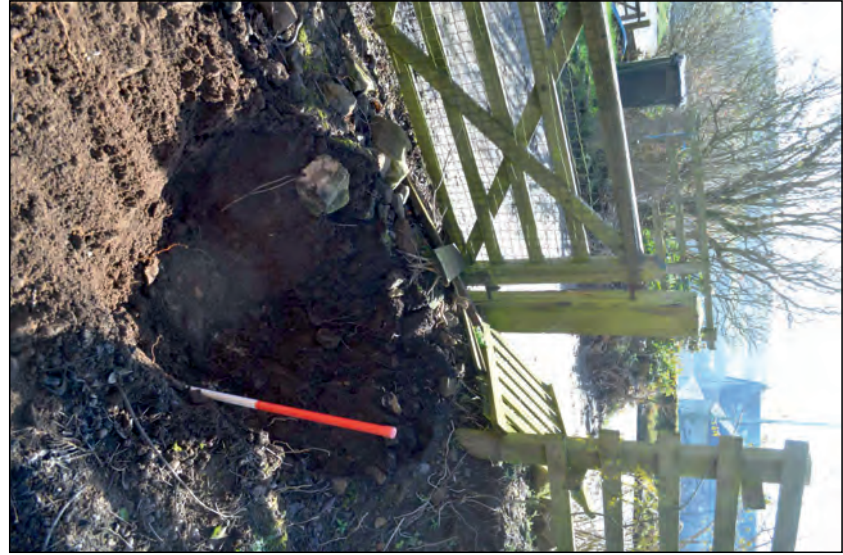
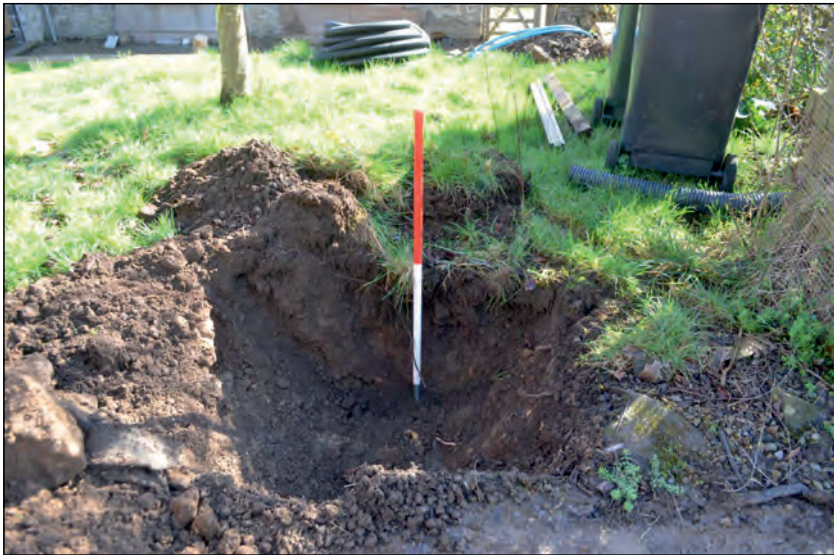
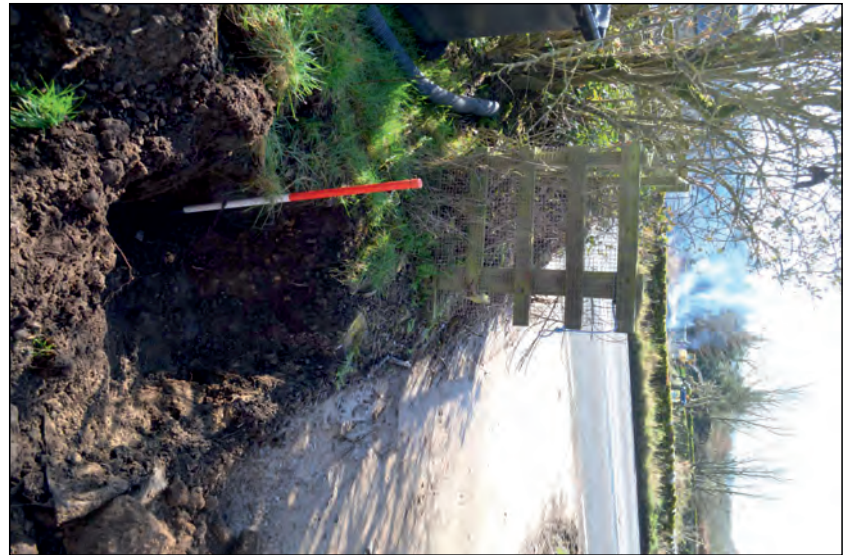
3.2 Excavation of four small pits for the provision of new stone gateposts (*Photos 5-12*).

These four sondage pits were positioned over the locations for proposed stone gateposts near the entrance to the site. Each pit measured 1m (length) x 0.85m (width) and was excavated down to natural sandy bedrock – a depth of 0.30-0.40m for the pair of western pits (Gateposts 1 and 2) and 0.50m for the eastern (Gateposts 3 and 4). The stratigraphy for the western pits demonstrated a shallow, negligible layer of modern loamy-topsoil before a natural coarse sandy/stony matrix sitting above fractured and crumbly sandstone bedrock. The eastern pits had a greater depth of rich silty-loam topsoil, as witnessed at the southern boundary wall (see 3.1), of a depth approx. 0.30-0.40m before reaching natural levels. Again, this topsoil was clean and of modern origin. No archaeological remains were observed.

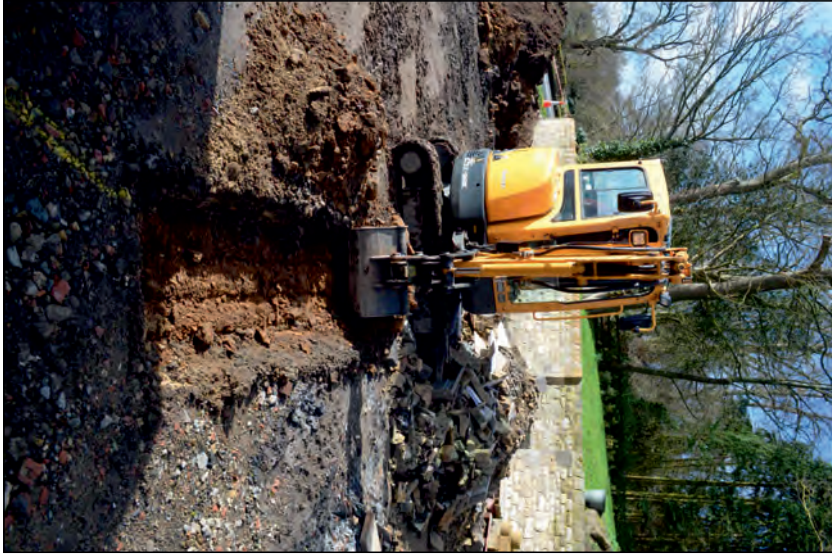
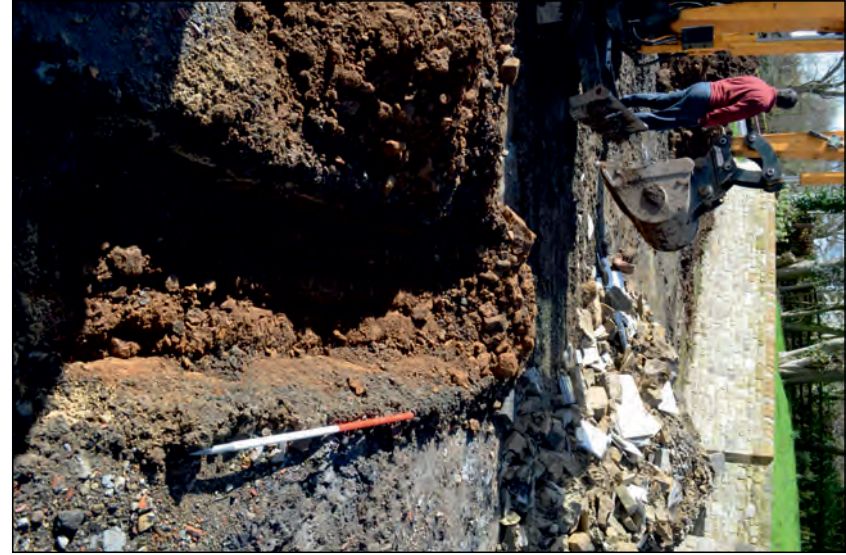
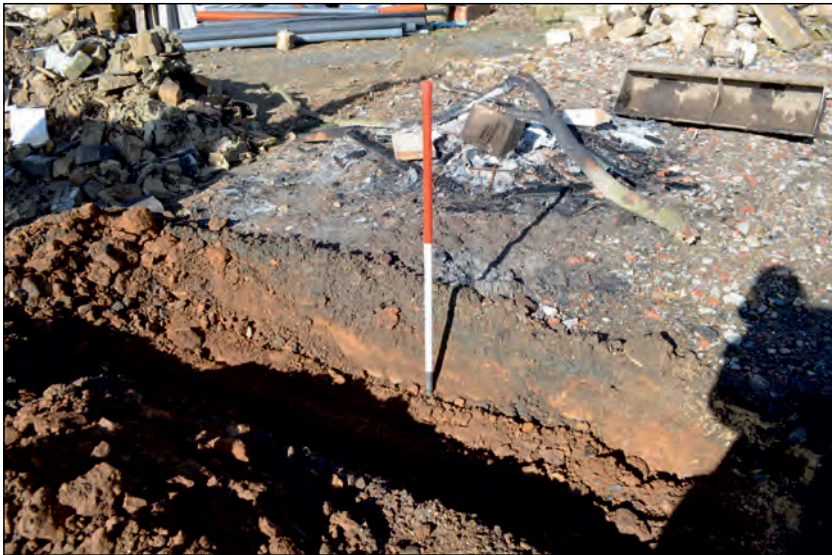
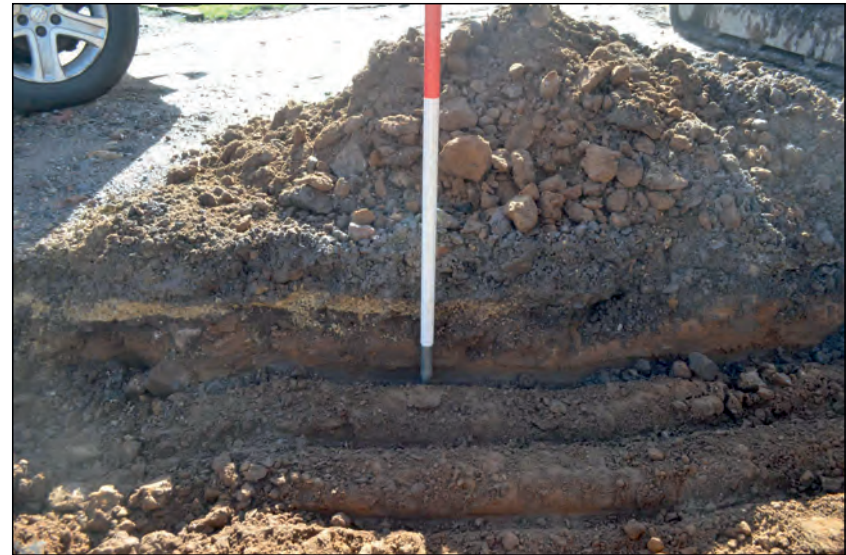
The area proposed for new driveway resurfacing is to be divided into two separate plots, with a railed fence to be set up as the boundary. A portion of trench was positioned mid-way along this fenceline and excavated down to natural levels. The trench measured 2.50m (length) x 0.85m (width) x 0.25m (depth). The stratigraphy of the trench comprised of the following layers: [01] existing driveway gravels, observed to a depth of 0.08m; [02] yellow dolomite, observed to a depth of 0.12m; [03] oily mixed clay and modern gravel, observed to a depth of 0.20m; with [04] natural

sandy-clay thereafter with common sandstone fragments throughout. No archaeological levels or remains were observed.

Photo 13. View looking west-southwest during excavation of portion of property boundary fenceline trench and driveway area.

Photo 14. View looking west-southwest along of portion of property boundary fenceline trench and driveway area.

Photo 15. South-southeast facing section of portion of property boundary fenceline trench and driveway area.

Photo 16. North-northwest facing section of portion of property boundary fenceline trench and driveway area.

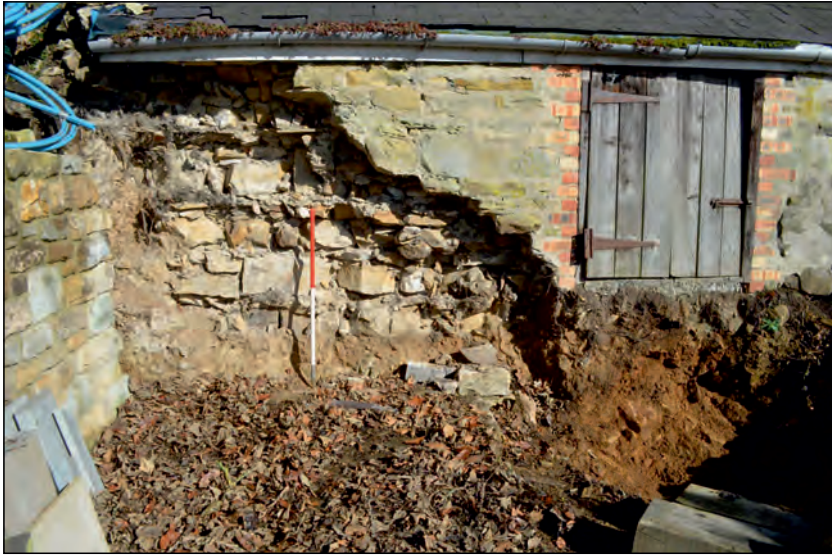
Prior to the watching brief, a large tree-bowl had been removed from the northwest corner of the plot, which had significantly damaged the outer skin of the west end of the south wall belonging to the barn structure proposed for conversion. The remaining fabric of the wall, at the end of the barn, was to be removed and a new way-through created. The demolition would not go deeper than the base of the existing concrete plinth, which was observed to a depth of 0.28m below the wall foundation. A trench measuring 1.50m (length) x 1.30m (width) x 1.05m (depth below the barn door-hatch), was excavated abutting the east side of the concrete plinth and the south wall of the barn, and the composition of its stratigraphy recorded. It became evident that more significant landscaping had occurred in modern times at this end of the site, with the base of the existing barn foundations sitting approximately 0.20m above the present ground level. Under the barn-hatch door, the foundation rubble could be seen for a depth of approximately 0.40m before reaching the natural sandy and fractured sandstone mix, as elsewhere. All archaeological horizons predating the barn have been truncated in this area and no remains were observed.

Photo 17. SSW facing elevation of damaged walling at west end of barn, to be demolished.

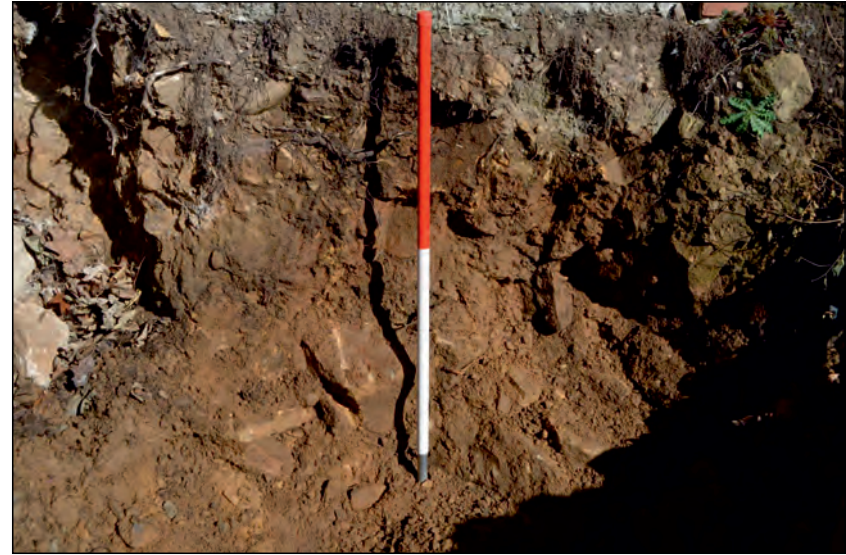
Photo 18. SSW facing section of small trench excavated immediately east of damaged wall area to be demolished at west end of barn.

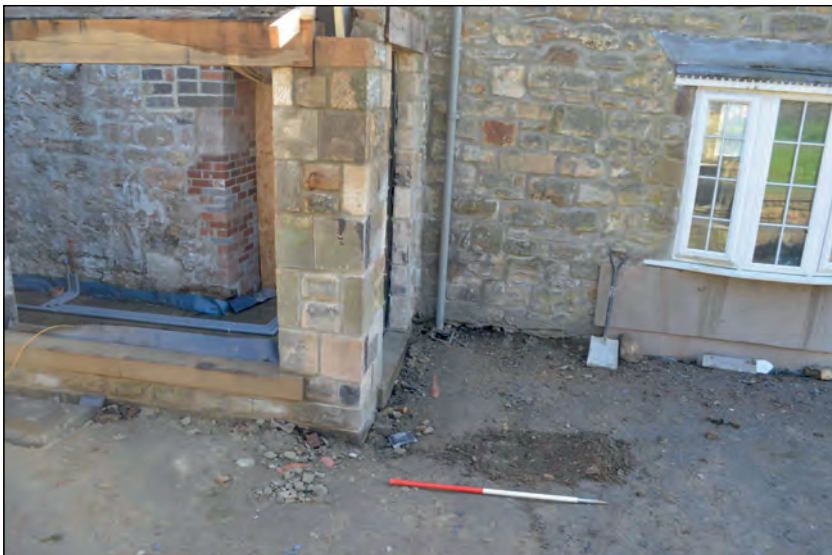
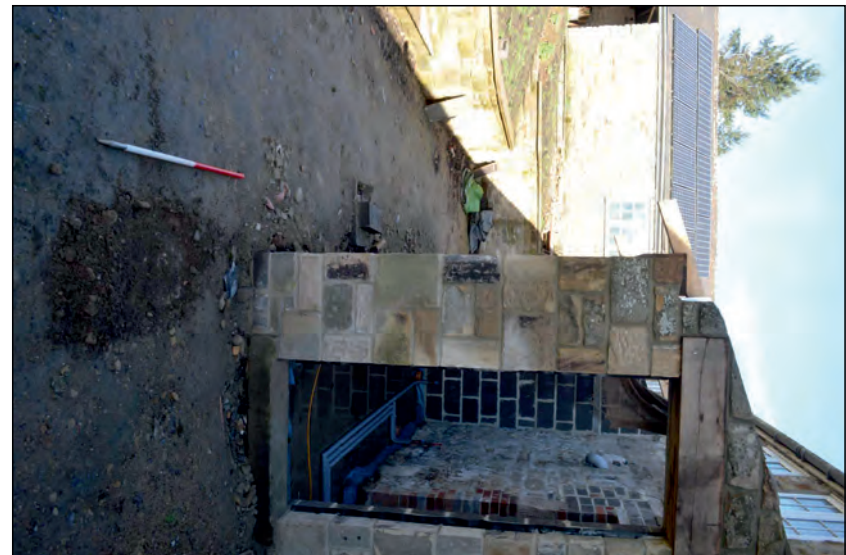
Shallow slots for post-pads were scraped into the modern gravel/hardcore surface surrounding the porch, a depth of no more than a few centimetres. No archaeological levels were reached and no remains observed.

Photo 19. View looking east-southeast at post-pad location for new porch timber.

Photo 20. View looking north-northeast at post-pad location for new porch timber.
