FORT HOUSE, OLD HARTLEY  
NORTHUMBERLAND,  
~ ARCHAEOLOGICAL EVALUATION ~

JULY 2019

# FORT HOUSE, OLD HARTLEY, NORTHUMBERLAND

## REPORT ON AN ARCHAEOLOGICAL Evaluation

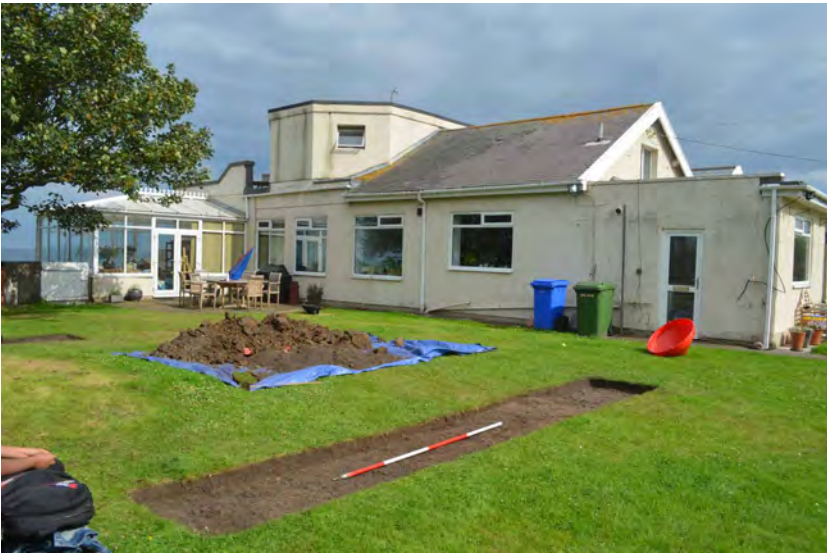
Trench 1 was a 6.10 m long, north-south trench located in the eastern part of the site, to the north of Fort House itself, positioned to investigate the site of a trackway between two blocks within the original fort compound. Immediately beneath the modern turf and topsoil [100] lay the weathered upper surface of the original trackway [101]. The width of this concrete path continued beyond both the eastern and western edges of excavation, although there was a marked camber on the surface, with a higher central line (*Illus. 05*). Towards the southern end of the trench, the concrete surface changed slightly in character, being slightly more fragmentary [102] and set upon a sandstone pebble and rubble sub-base [103]. This

*Illus. 09: Trench 1, general shot looking southeast*

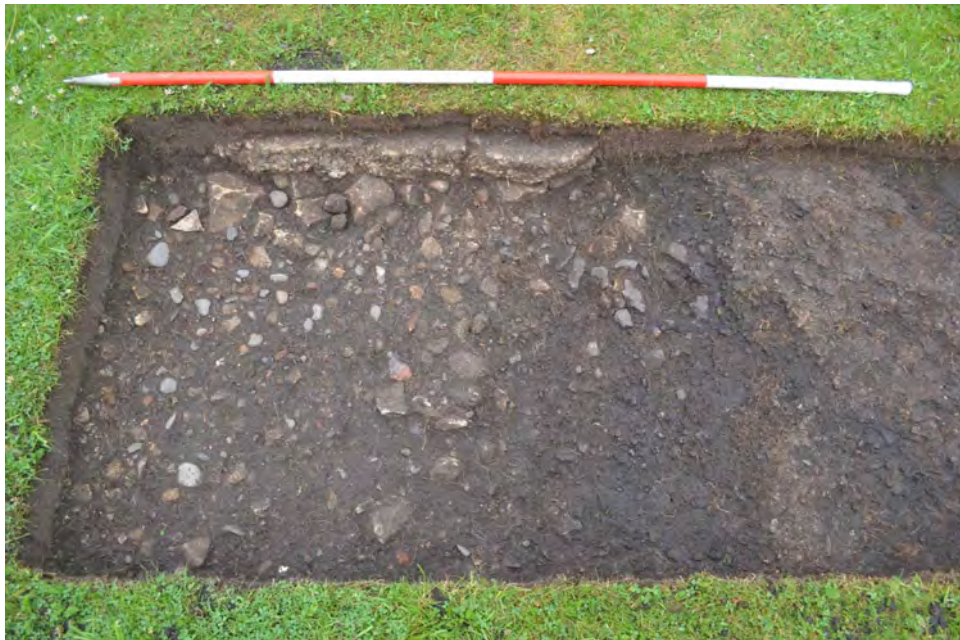
*Illus. 11: Southern end of Trench 1, showing area to south of path*

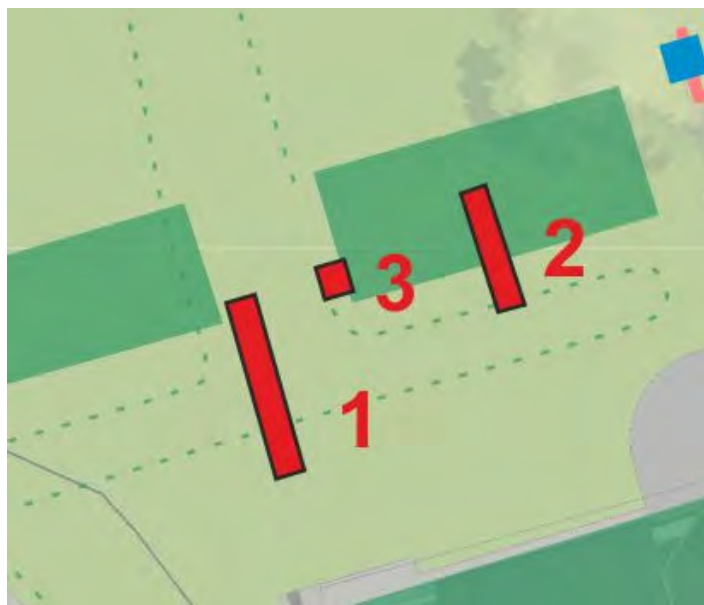
**Illus. 13:** Trench location plan showing Trench 1 over the line of the original path (green dashes).

corresponded with the original plan, where this trench can be seen to overly the southern edge of the path at this point.

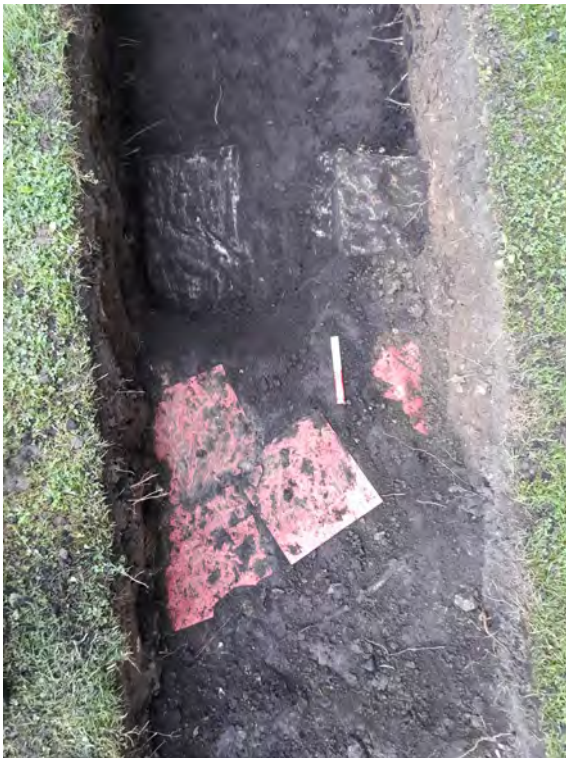
Surrounding these posts, and underlying the above-mentioned clay and soil levels, was a 0.30 m deep mixed deposit of burn coal, coal dust, ash, and clinker [204]. This seems to have been deposited during the demolition and levelling of the former shower block. Contained within the upper part of this layer were a number of 0.30 m (12") square red lino tiles. These may have been part of the original flooring of the shower block, thrown back in during the demolition of the building.

**Illus. 16:** Trench 2, showing lino tiles recorded during excavation

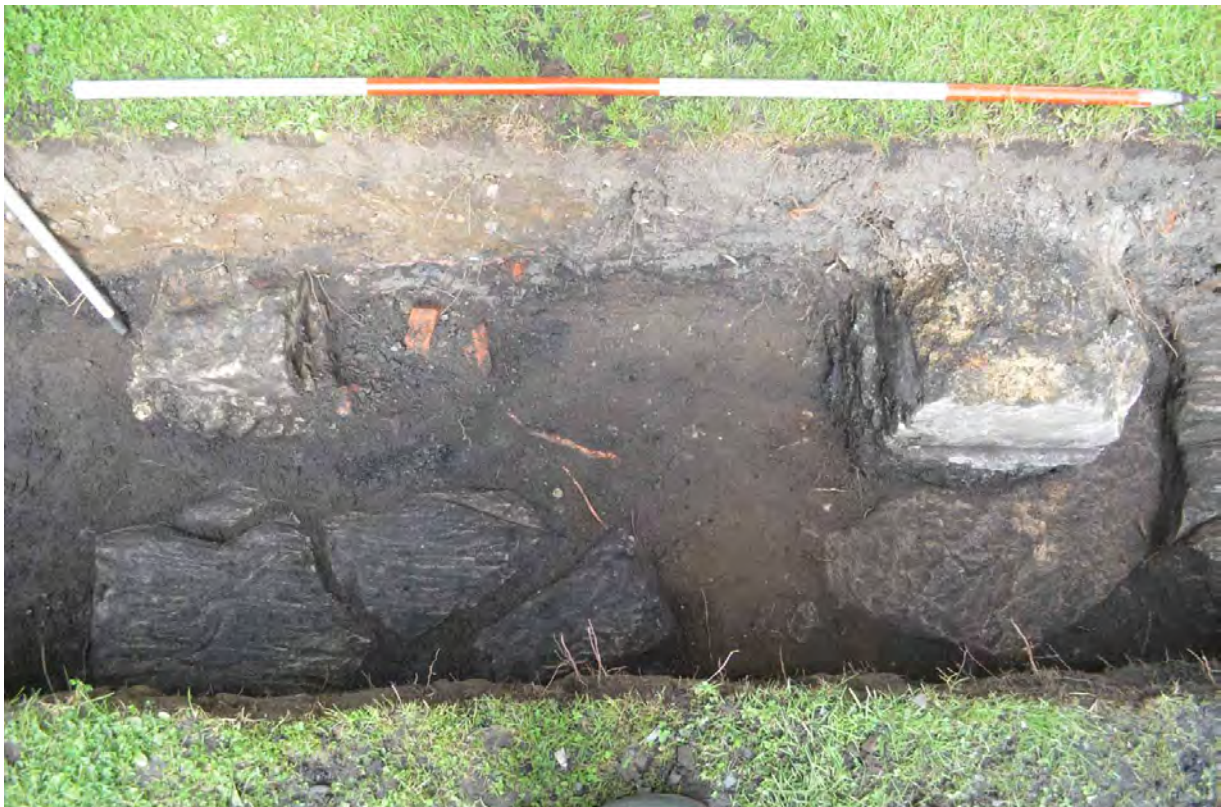
Beneath these layers was the demolished remains of the former shower block, again represented only by two concrete foundation posts [205] surrounded by demolition material. The posts had been set upon the underlying striated natural sandstone bedrock [206], which lay at a depth of 0.70 m below the modern ground surface. The northernmost post was on the same alignment as that within Trench 3, and was also of similar size, measuring 0.30 m (12") square. The post survived to a height of 0.12m, and was set upon a 0.46m wide, 0.20 m deep cobble and pebble foundation. The second post lay 1.20 m south of this and measured 0.43m (17") square. This post survived to a height of 0.29m and was set upon a 0.20 m deep cobble and pebble foundation of approximately the same 0.43m width as the post. At the base of the post, a small horizontal skirt may have represented the original ground level of the shower block (0.50 m below modern ground level).

**Illus. 18:** Pillar bases for buildings in Trench 2

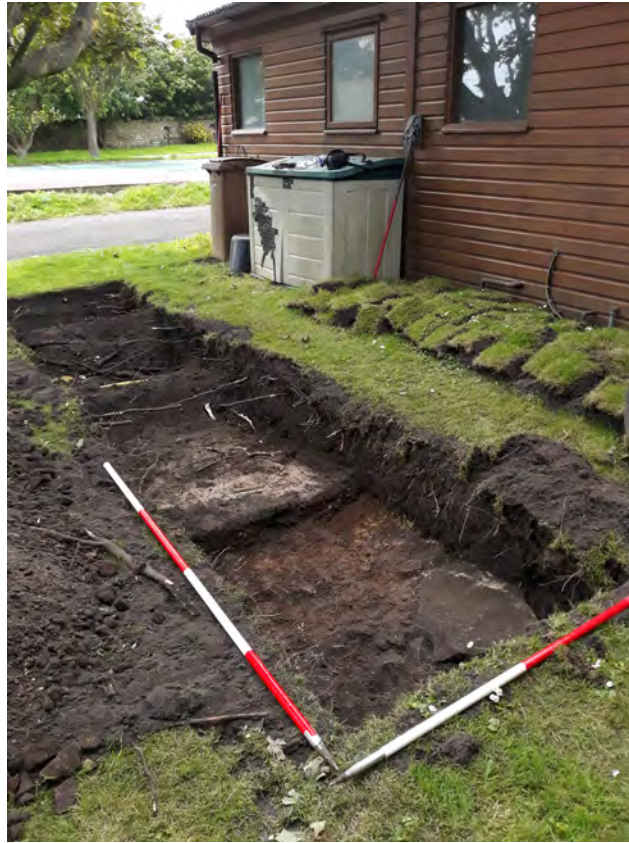
These trenches (5.80 m and 4.60 m long respectively) were positioned over the sites of two barrack buildings in the north central part of the site. Neither of these trenches recovered any surviving evidence of the original structures, both containing only turf and topsoil overlying a redeposited soil level, which in turn lay over the natural sandstone bedrock (at approximately 0.50 m below modern ground level in each trench). It would appear from this that all remains of the former barrack blocks in this area have been removed.

***Illus. 21: Trench 4, looking south***

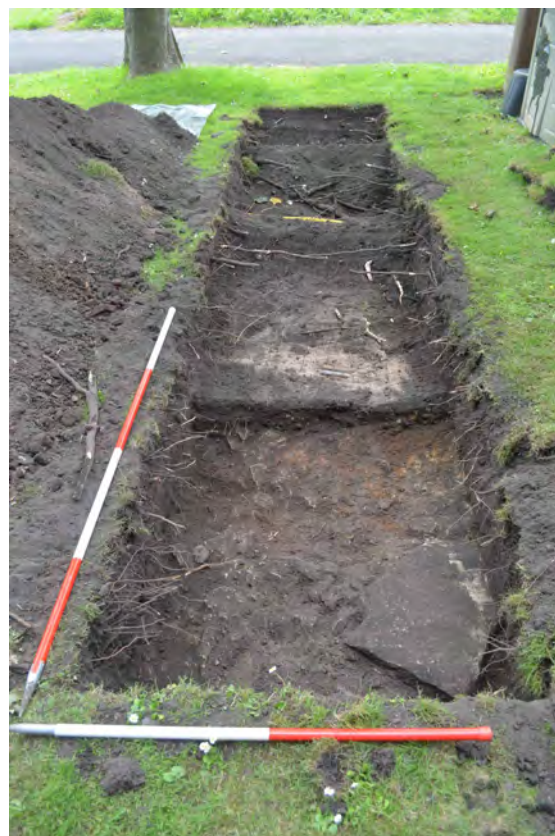
***Illus. 22: Trench 5, looking south***

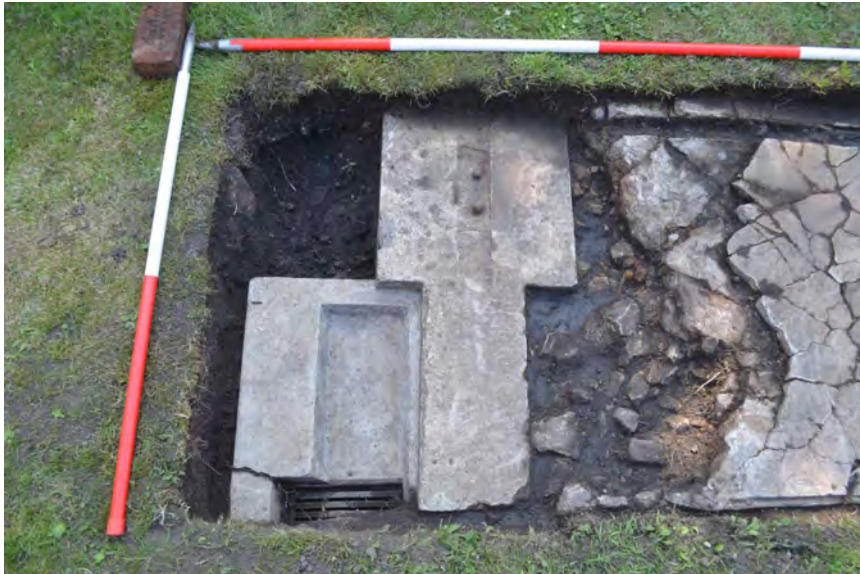
Both the northern and southern edges of the building were uncovered and consisted of a concrete wall base line. A metal drain was set against the external face of the southern wall, which would have collected rain runoff from the building roof.

*Illus. 27: Trench 6, southern end showing building wall and drain*

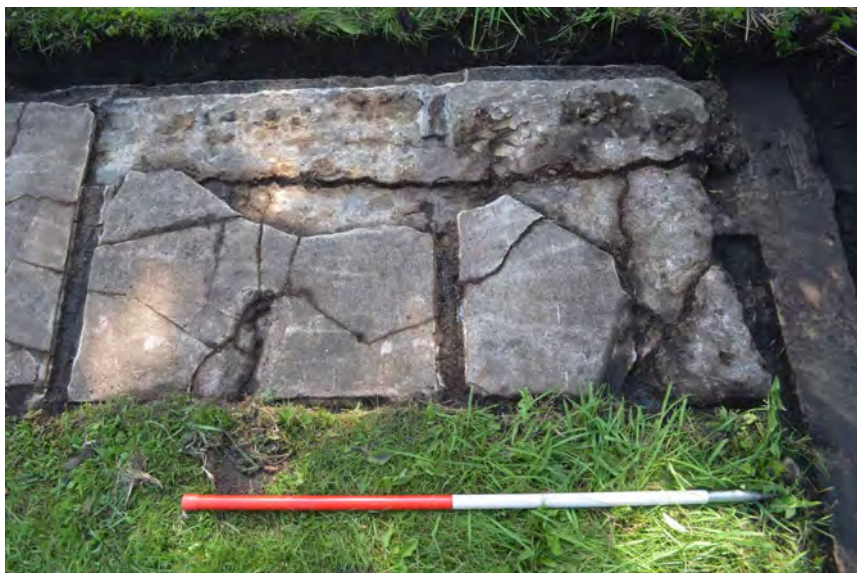
This 5.10 m long trench was situated to the immediate north of Trench 5 over a building described on the officer's plan as containing the bath/boiler/drying rooms. The concrete floor surface [601] of this structure lay immediately beneath the modern turf and topsoil [600] and was visible as a slightly raised earthwork beneath the surrounding grass. The trench appears to have been sited across the east-central part of the structure, which can be interpreted as the drying room. A series of partitioned cubicles were visible within the concrete floor surface, separated by east-west orientated drains. Each cubicle also had an off-centre larger 'plug hole' which presumably fed into this drainage system. These are interpreted as individual cubicles designed to hold wet clothing, which would then drip dry in the warm air provided by the adjacent boiler room.

*Illus. 28: Trench 6, showing drainage channels in drain*

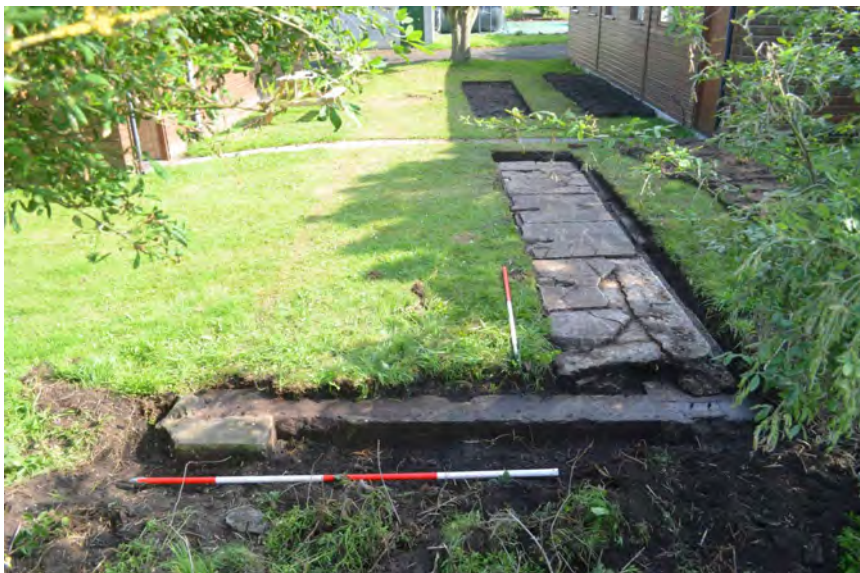
*Illus. 29: Northern end of Trench 6 showing building wall foundations*

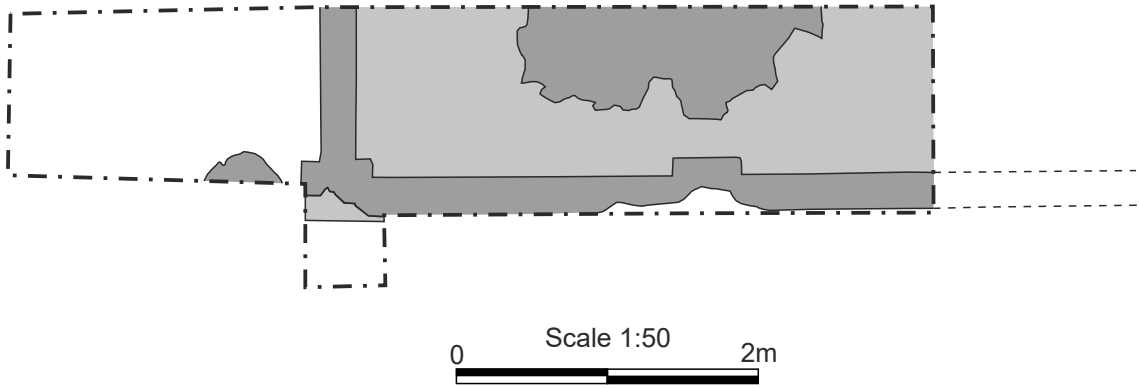
***Illus. 30: Plan of Trench 7***

This 7.00 m long trench was situated within the south-eastern part of the site over the southern part of a building described on the Officer's Plan as a Guard Room. As with Trench 6, the concrete floor surface [701] for this building lay directly beneath the modern turf and topsoil levels [700]. A north-south running wall footing along the eastern edge of the trench, with an east-west return across the southern part of the trench marked the edge of the building. Within that, the trench lay over what was annotated as 'clerk' on the Officer Plan, the southern of several subdivisions within the building – a relatively featureless, somewhat weathered concrete floor being all that remained of this room. To the immediate south of the building, a path ran east-west to a block marked as 'stores' on the Officer Plan and sometimes now known as 'the gaol'. Several unfired and unloaded bullets (i.e. without the casing or

powder associated with a loaded shell) lay on this surface, raising the possibility that the store originally held ammunition, or munition components, for the base. Certainly the 0.30 m (12") thick walls complete with loopholes would imply a secure, defensible structure.

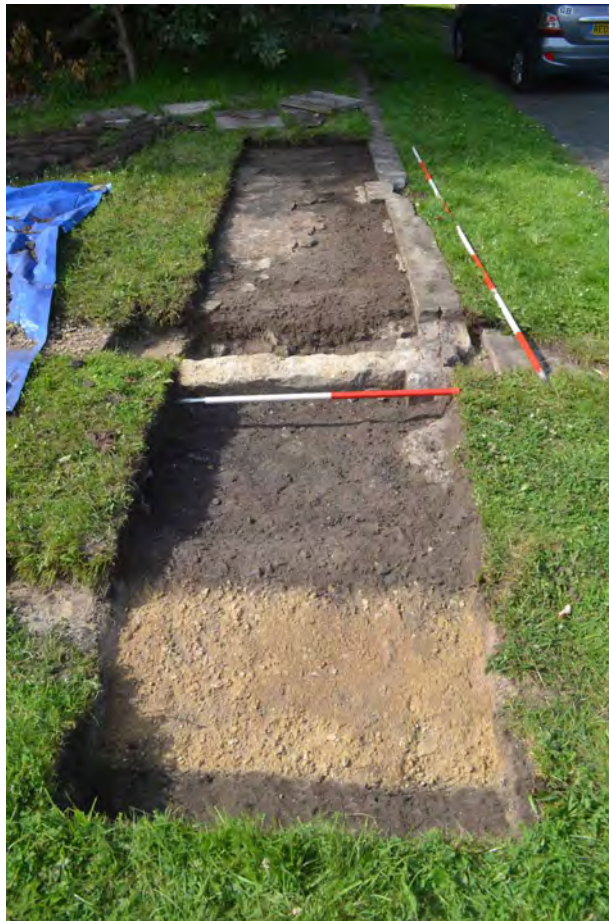
*Illus. 33: Trench 7, showing path at southern end*

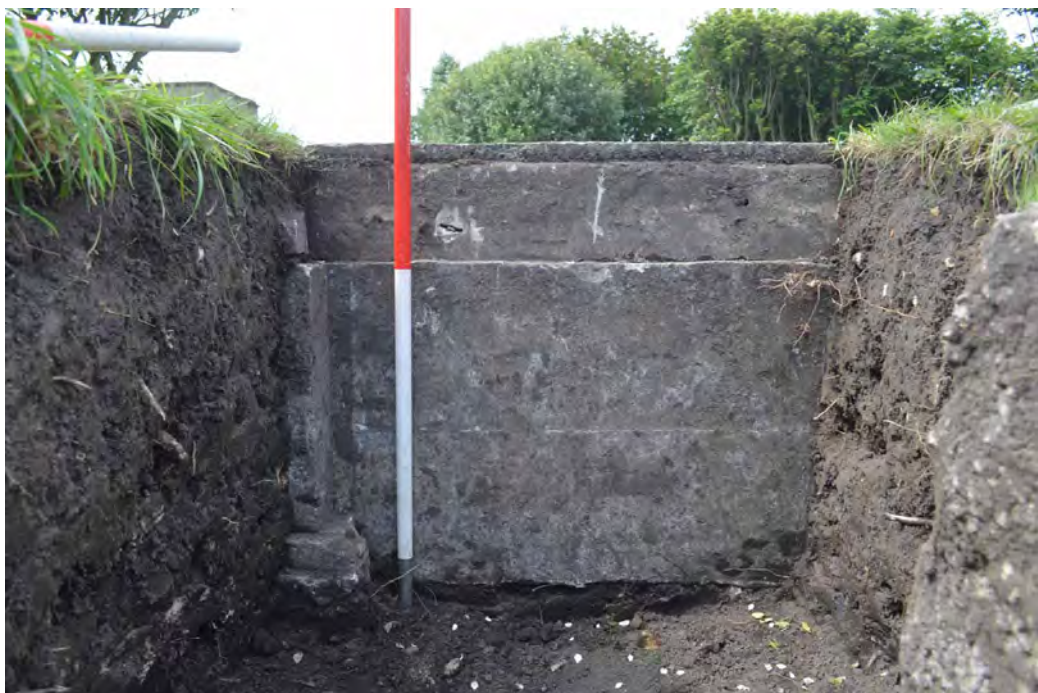
Directly beneath the eastern edge of the tennis court lay a 0.80 m high vertical concrete wall. Only the eastern face of this wall was visible, with a narrow step out some 0.17m below current ground level. At the point where this wall continued beyond the southern edge of excavation, the corner of a pillar or buttressing post was visible, projecting 0.10 m out from the line of the wall. A step in this pillar some 0.64m below the current ground level, may represent the original ground level associated with the building.

This concrete wall most likely represents the eastern edge of the former fort building. The fact that this building, if this is so, has not been reduced to foundation levels as is commonly the case elsewhere on the site, indicates that there may be a greater amount of surviving material preserved within this central area.

*Illus. 35: Trench 8, showing concrete wall*

**4.3** The wall within Trench 8 (*Illus. 35*) was visible only in the end section of the trench, but it did imply the survival of contemporary remains continuing beneath the modern tennis court in the centre of the site, which may have implications for any future groundworks in that area.

**4.6** With respect to the likely impact of the proposed development upon the remains uncovered by evaluation trenching, given their shallow depth it is likely that most will be destroyed or significantly damaged.

**4.7** Therefore, it is recommended, with respect to the currently proposed programme of works, that, where the structures can not be preserved by means of engineering solutions, they should be preserved by record.
