NEWTON COTTAGE, HIGH CALLERTON NORTHUMBERLAND

Archaeological Building Assessment

JUNE 2019

PROJECT: Historic Building Recording and Assessment
LOCATION: High Callerton, South Northumberland
CLIENT: Mr James Gilbert
SITE GRID REF: NZ 1615 7048
FIELDWORK: June 2019
OASIS REF: thearcha2-374906
PLANNING REF: 19/00348/PREAPP

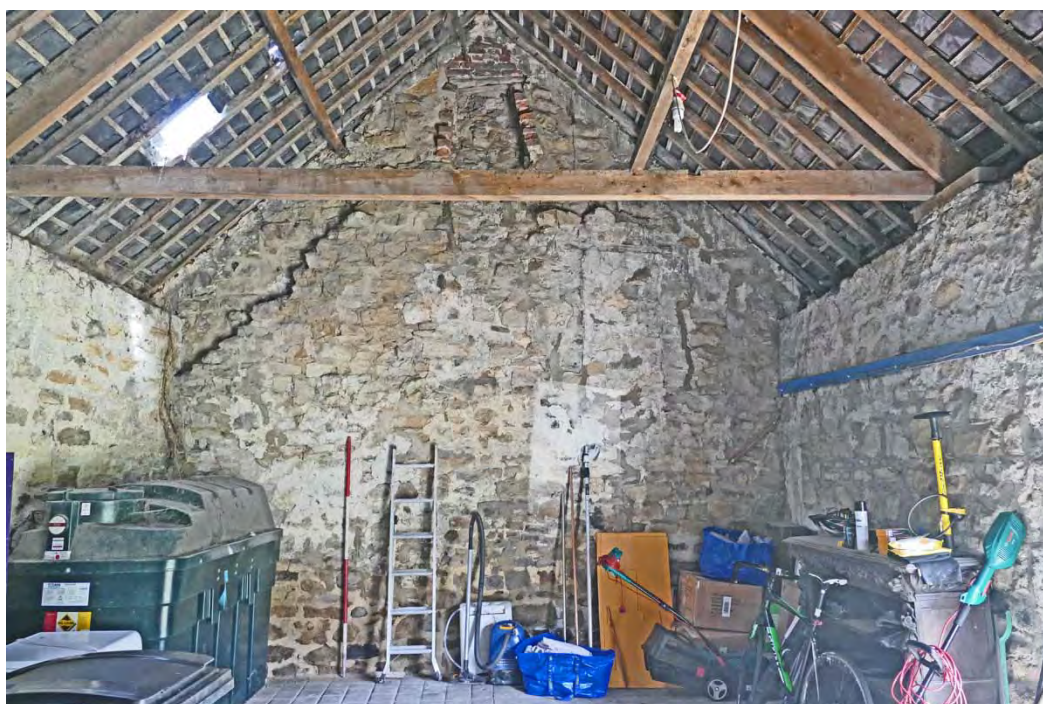
Frontispiece: View of the west face of the internal east wall of the barn at the east end of the range.

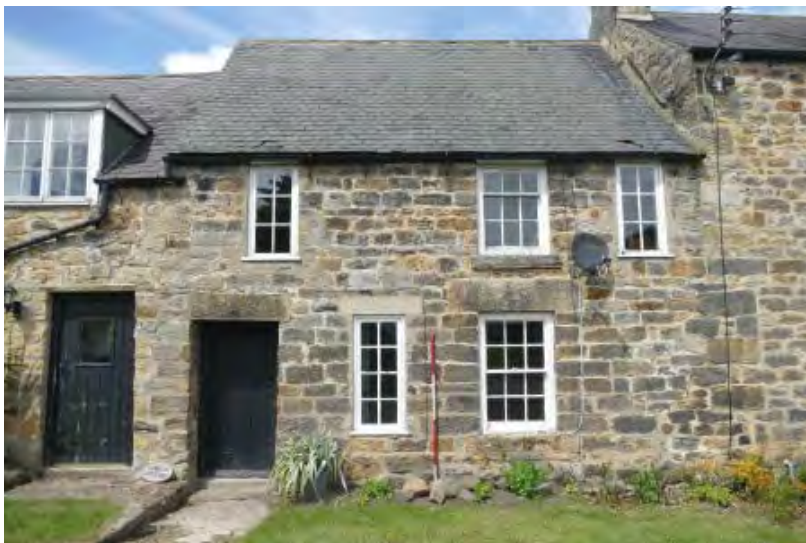
Illus. 08: South elevation of the east part of the cottage.

The third section of the range (above) is the tallest, as the ground falls away to the east. It has clearly originally been a single -storeyed structure, and its original south-eastern quoins are visible, rising to mid-height, above which they are overlapped by the-western end quoins of the adjacent house. The ground floor of this section has an old triple-planked door at its west end, with fleur-de-lys hinges, under a tooled-and-margined lintel; east of this is a modern 8-pane casement and then an older 12-pane ash, under a heavy squared lintel. The upper floor has an old 9-pane shortened sash directly above the 12-pane sash on the ground floor, with a modern 6-pane casement to either side. These are set in a section of wall constructed of rather better-squared bluish sandstone, which clearly post-dates the adjacent house to the east. How this relates to the fabric further west is not clear; there seem to be a straight joint in line with the western jamb of the doorway, a short distance to the east of the step-up in eaves level.

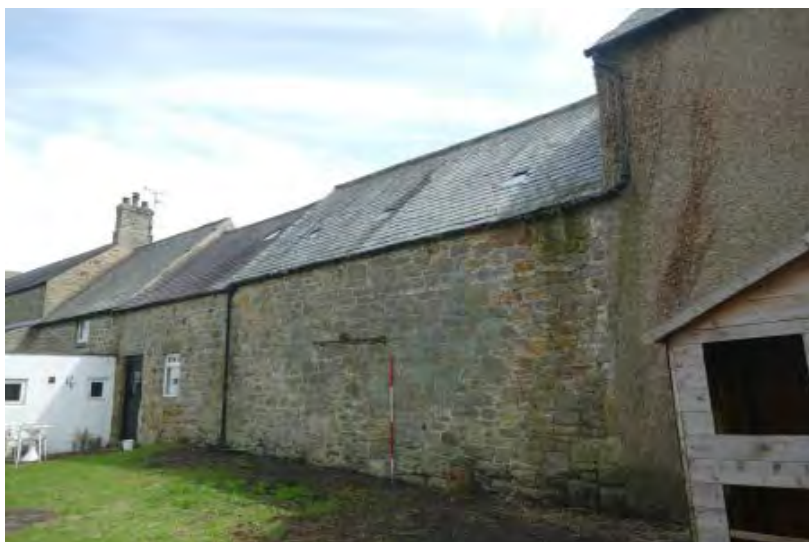
Illus. 09: The north elevation viewed from the north-west.

The rear (north) elevation (above) is less instructive. To the right (west) is the barn, with a blocked central doorway under a timber lintel. There are old quoins at the west end (partly concealed by the roughcast of the adjacent property) but at the east end it looks as if the quoins have been removed (Bar the lowest two) to tie in with the walling of the second section. This part has a doorway under a renewed concrete lintel, with a window to the right (probably a relatively recent insertion) with a modern pecked sill. The third (eastern) part of the range is partly concealed behind a single-storeyed mid-20th century extension, which has a flat roof and is rendered and whitewashed. Above this there is a single window of uncertain date; the walling here is heavily mortared and its relationship to that in the central section not clear.

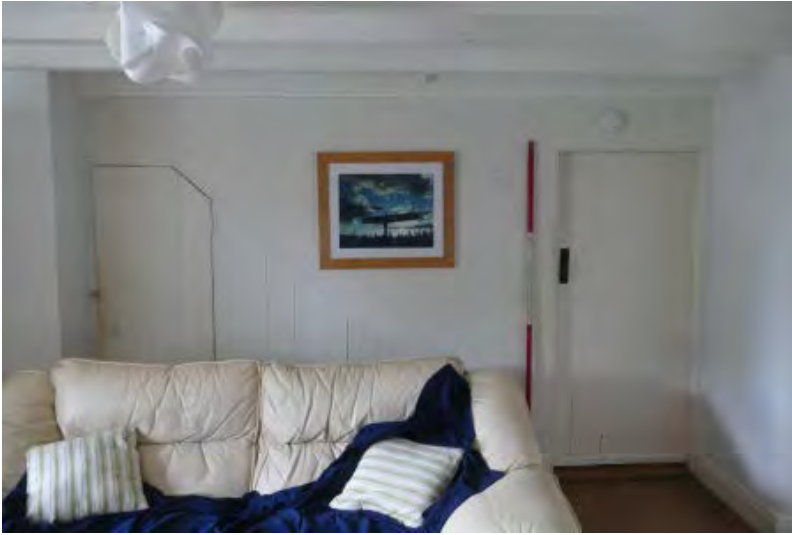
Such pre-20th century features as survive are largely in the eastern section of the range. The large ground-floor room here has sawn upright-section transverse joists, one at the north-east corner having a cut-out for some feature, perhaps a cupboard or grandfather clock. A large chimney breast on the east is now fronted by a mid-20th century fireplace; a cupboard to the south has panelled doors and could be of late 19th century date. The 1`2-pane sash window on the south has moulded glazing bars, of a different section to the ovolo mouldings of the 20th century windows. The back door (into a kitchen in the mid-20th century extension) is an old (19th century?) one made up of four broad planks, with old fittings. On the east of the room is a boarded partition to the stair (below), probably [late 19th century in origin](#), which is entered at its north end and rises southwards.

Illus. 10: boarded partition between GF living room and stair.

A similar partition, of vertical quite narrow boards, separates the stair from the eastern bedroom, which has a chimneybreast projection, curving back in depth towards the top, in the centre of the east wall.

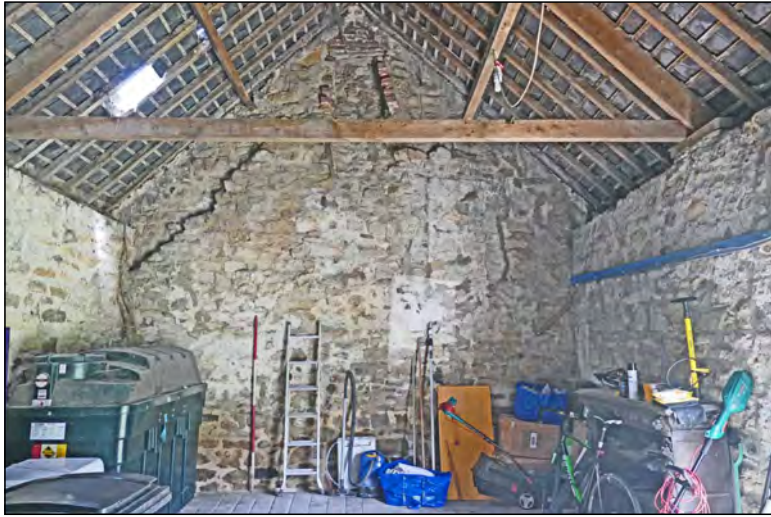
Photo 37.

37	View looking east to the west face of the internal east wall of the barn.
38	Detail of recessed flue and first-floor level blocked doorway, with a timber lintel (to right of view) in the internal east wall of the barn.
39	Old brickwork around the top of the recessed flue in the internal east wall of the barn.
40	Internal east end of the south wall of the barn, with blocked slit vent to left of view.
41	Internal west part of the south wall of the barn, with recess created from former slit vent to right of view.

The lack of significant historic features of pre-19th century origin and the level of proposed impact upon them means that no specific mitigation measures are recommended with respect to the proposed remodelling of the building interior. However, care must be taken to avoid significant impact upon existing stonework structure, particularly the north and south facades and internal walls of the current garage structure, a structure of probable 18th century origin, the east internal wall of which, in particular, retains interesting features.

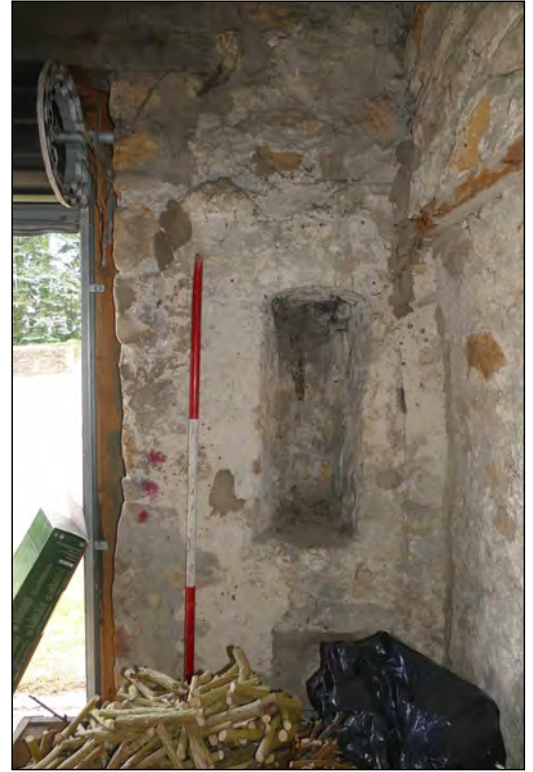
Photo 42.

42	View south to recession formed from a former slit vent (blocked from the south side) in the internal south wall of the bar at its west end.
43	The internal east face of the west end wall of the barn, showing part of the barn roof structure.
44	Blocked door at the south end of the west wall of the barn.
45	Internal view of the north wall of the barn.
46	Blocked door with wooden lintel in the north wall of the barn (see Photo 13 for exterior view).
47	View from the west along the interior face of the north wall of the barn, showing stone projections.
48	View from the west of grooved concrete barn floor, with central row of three posts.

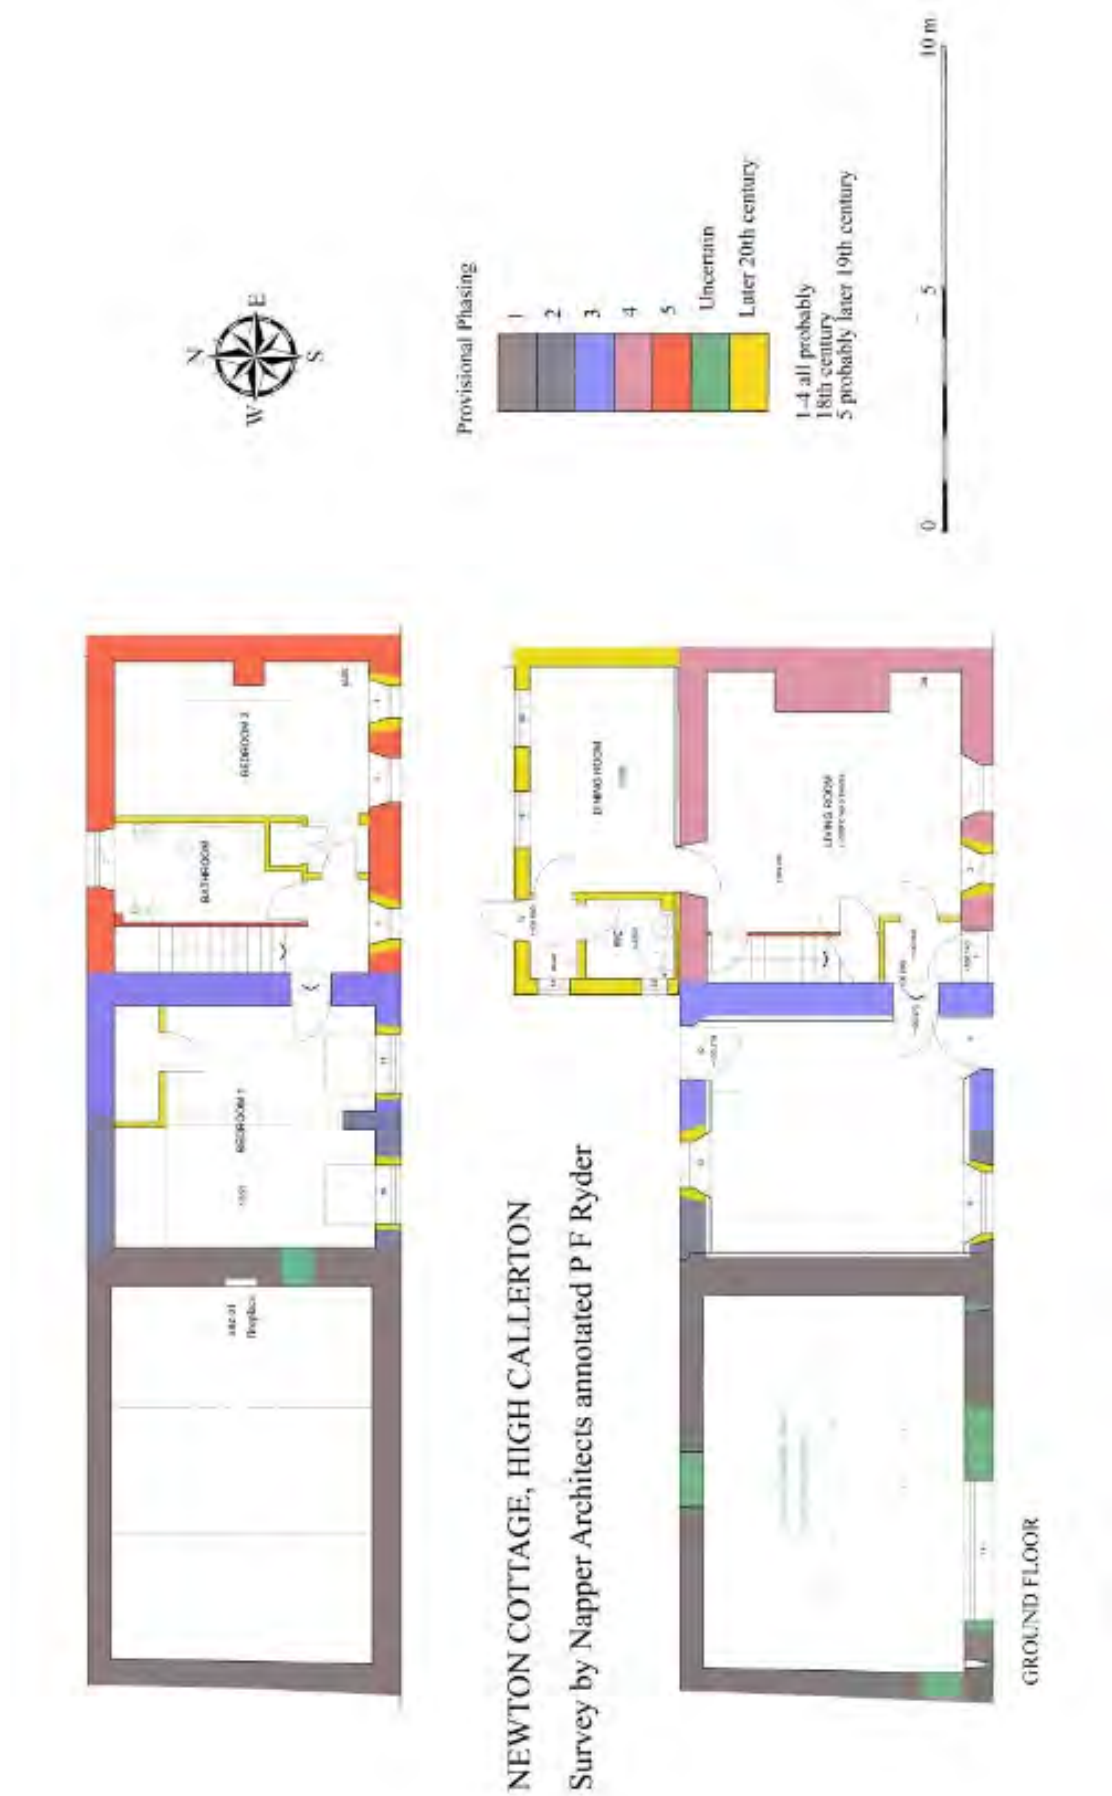
The Cottage is a complex building, and is actually an agglomeration of at least three older buildings. This complicated history is best read (in as far as it can be) in the front (south) elevation; the rear (north) elevation and the interior are less forthcoming when it comes to providing useful evidence of dating and development.

Illus. 11: Phased Plan by Peter Ryder (based on a survey by Napper Architects)
