WELLBAR HOUSE  
GALLOWGATE  
NEWCASTLE UPON TYNE

ARCHAEOLOGICAL WATCHING BRIEF

APRIL 2008

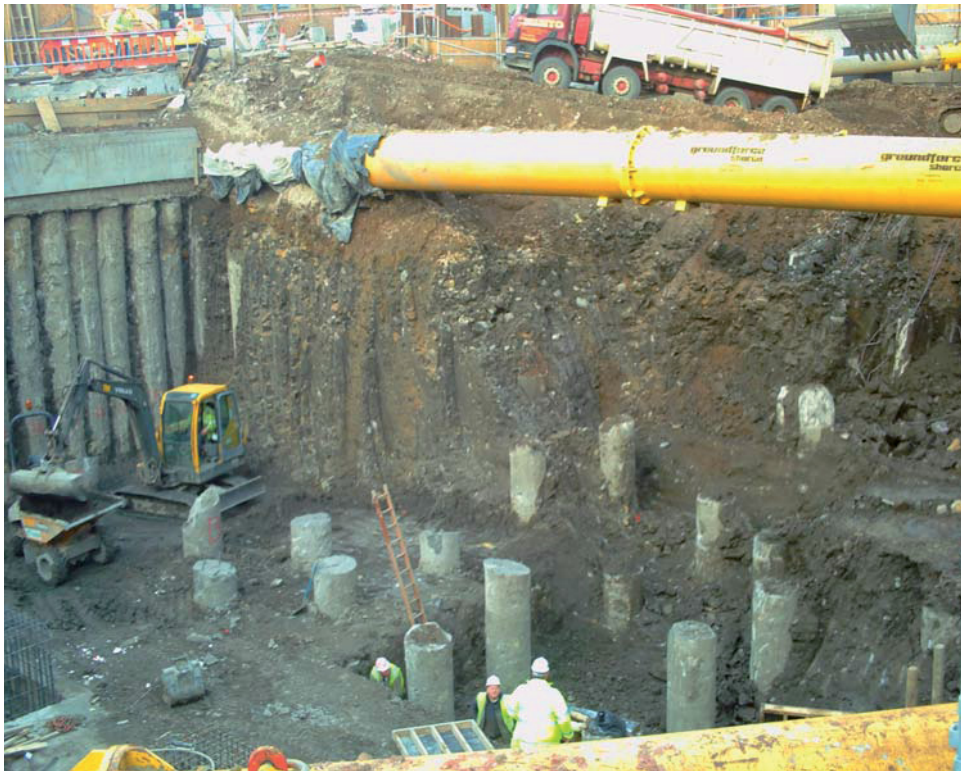
*Cover: The development site looking north-west during removal of clay to exposing the 1960s pile foundations of Wellbar House in-situ.*

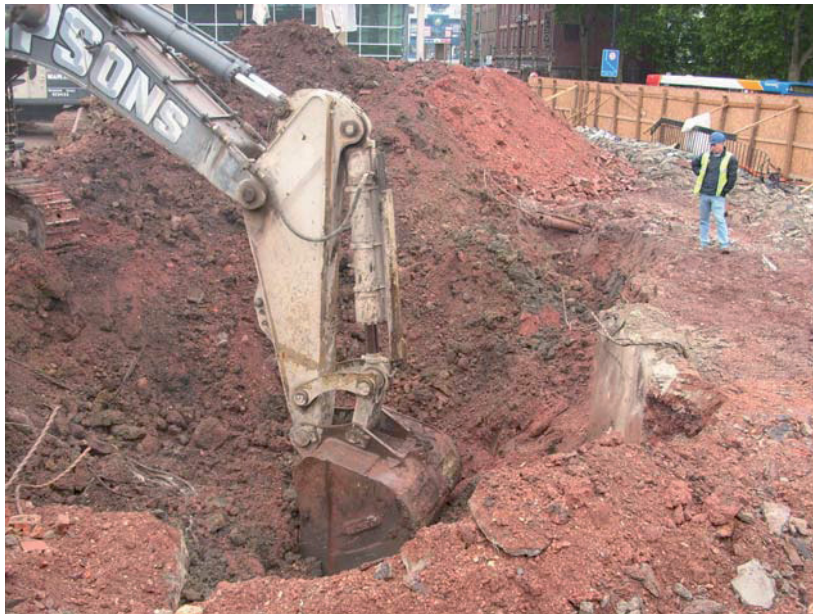
***Frontispiece:*** *The removal of the red shale in July 2007, which acted as a leveling dump as part of the foundations of Wellbar House*

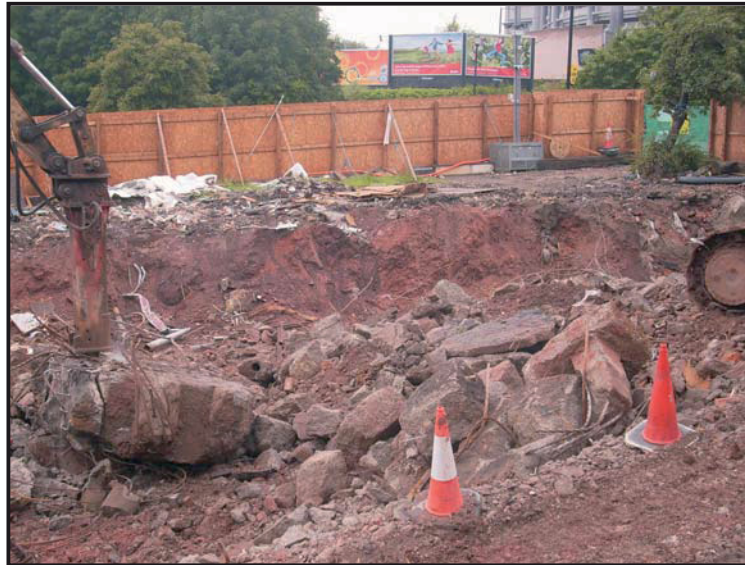
*Illus. 09: The removal of rubble after the demolition of Wellbar House, looking north-west.*

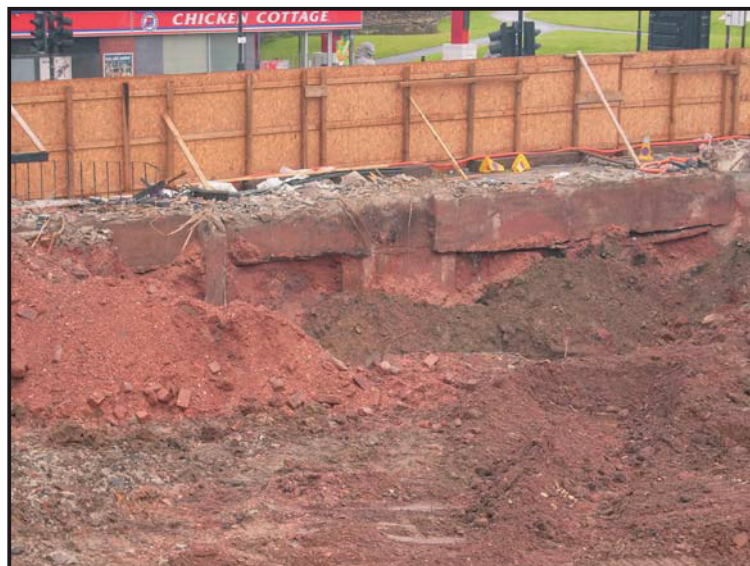
During July 2007 the existing foundations of Wellbar House were removed in sections daily and backfilled immediately as were the test pits. A permanent presence was maintained on site during this time. After the removal of the demolition rubble, a low-level toxic red shale was unexpectedly exposed. Approximately 2 metres deep, it had been used as a foundation for the 1960s office block. In the south east corner the red shale was mixed with a large amount of broken red brick; as this was the deepest corner of the site, it appears the red brick was mixed in to give a more solid foundation to Wellbar House. The red shale was cleared from the site in two halves, starting in the south-east corner and working westwards. The red shale was then replaced with stone fragments. This process was repeated at the northern end of the development site. A modern concrete base, 2.5m in diameter and of unknown function, was uncovered within the red shale in the south-eastern part of the site and was also removed, as were various red brick and concrete walls forming part of the substructure of Wellbar House and the Gallowgate street frontage along the southern and eastern sides of the site. The red brick rubble incorporated in the red shale may derive from the demolition of earlier brick walls on the site.

*Illus. 10: The foundations of Gallowgate street frontage and the red shale levelling dump, looking south-west.*

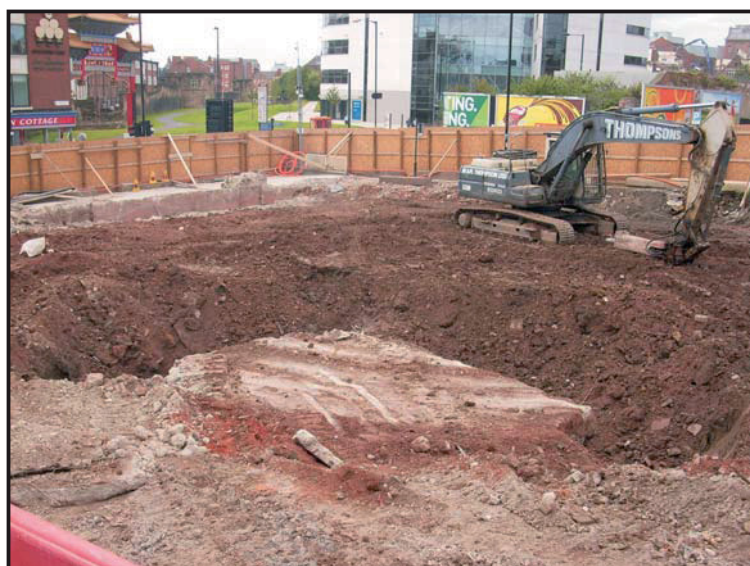
*Illus. 11: The concrete base, of unknown function, in the south-east corner of the development site, taken from the north-east.*

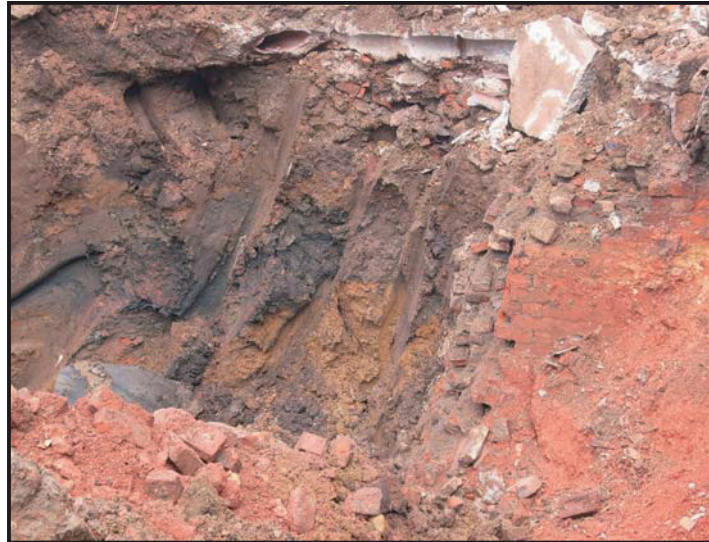
A firm, medium to dark brown coloured clay was revealed across the site during pile proving. Towards the southern end of the site, where the ground surface sloped downwards, the clay contained stone fragments suggesting it was re-deposited. This might therefore represent made ground which had been dumped as part of earlier leveling operations to counteract the unevenness of the ground surface. It is conceivable, therefore, that earlier archaeological deposits may be concealed beneath the clay in this area, though no such levels were identified. However, across the majority of the site was covered by clean, apparently natural, clay containing no inclusions.

**Illus. 12:** Cut showing section of re-deposited clay in the south-eastern part of the development site.

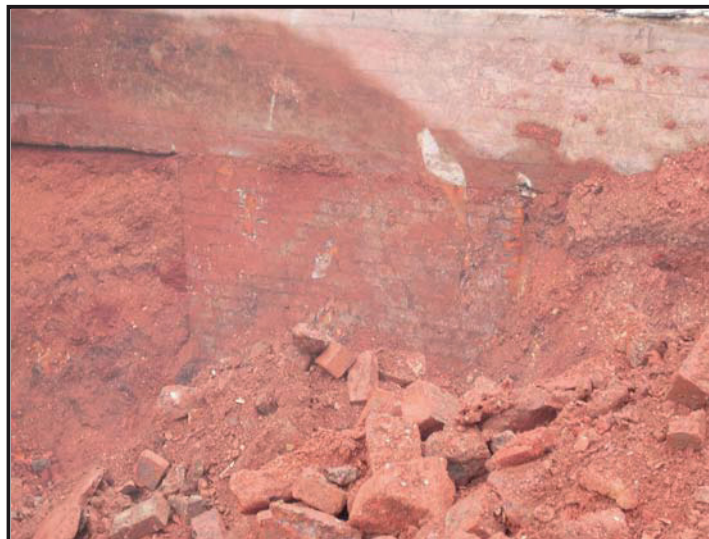
**Illus. 13:** Brick and concrete wall exposed at the southern end of the development site, forming part of the substructure of the Gallowgate street frontage.

The only structures exposed along the southern and eastern sides of the site formed part of the substructure of Wellbar House or the 20th-century street frontage of Gallowgate. The clay present in this southern part of the site, contained stone inclusions, suggesting that it may have been redeposited, and thus might potentially overlie earlier archaeological deposits. However the ground excavations did not reveal a clear interface between this possibly redeposited clay and any underlying natural clay and no features or deposits of cultural heritage significance were identified either cut into or covered by the clay in this area.

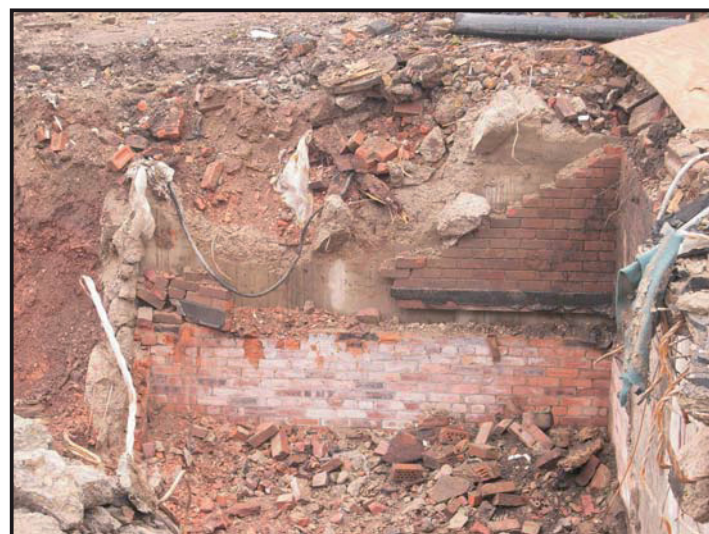
**Illus. 14:** A brick clad concrete, wall forming part of the substructure of Wellbar House along the eastern side of the development site.

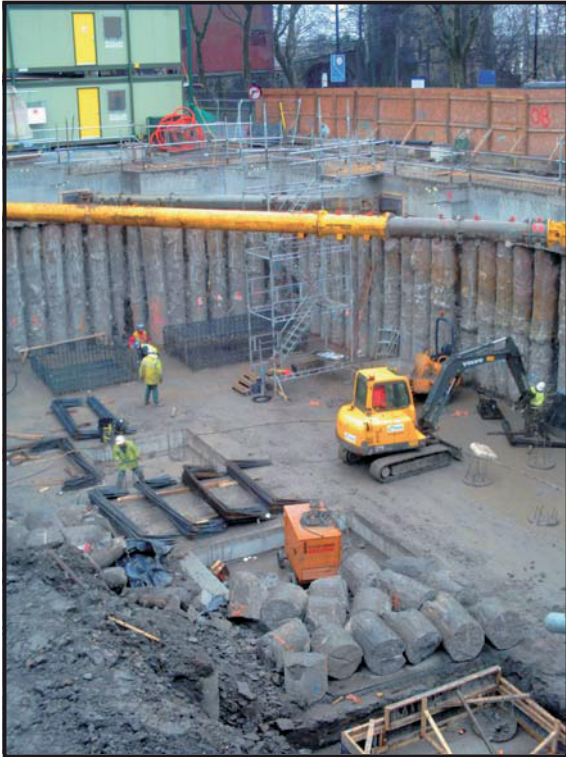
**Illus. 15:** A view of the development site showing the removed 1960s pile foundations in the foreground with the foundations for the new build in the background, facing south-east.

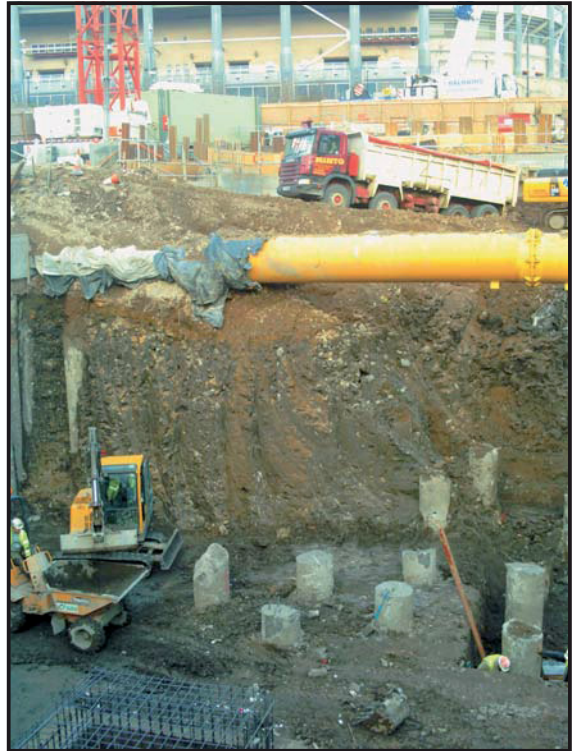
**Illus. 16:** The development site facing north showing the 1960s pile foundations of Wellbar House in-situ.

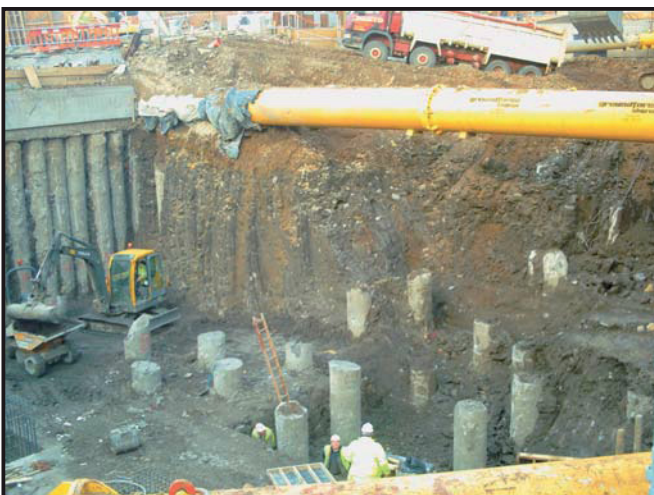
**Illus. 17:** The development site looking north-west during removal of clay to exposing the 1960s pile foundations of Wellbar House in-situ.

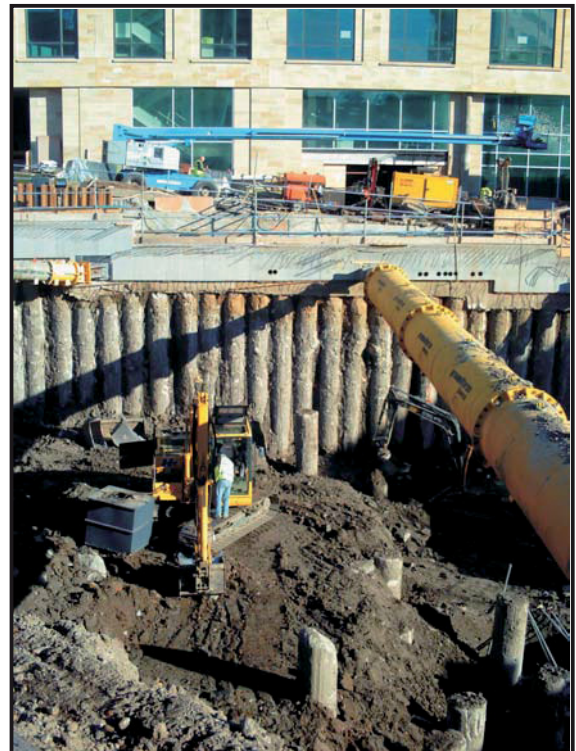
**Illus. 18:** The removal of the clay surrounding the 1960s pile foundations, facing east.

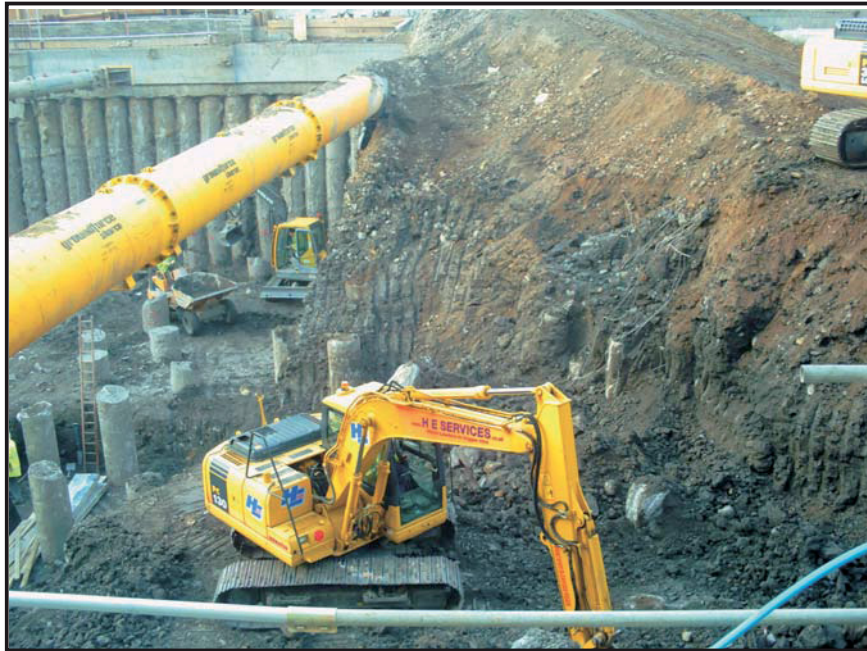
*Illus. 19: The removal of the clay in the western area of the site, with the Wellbar House piles exposed in the background, taken from the east.*

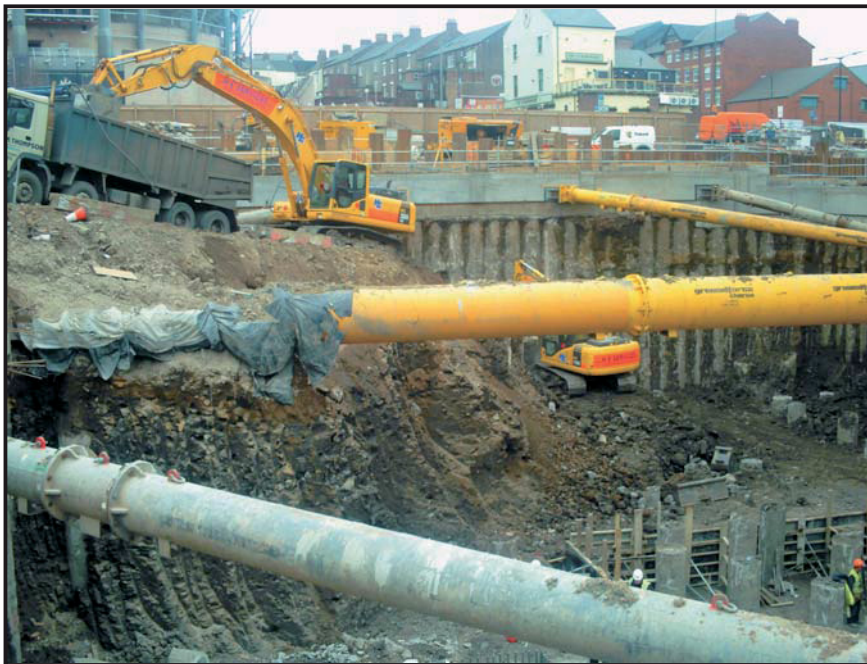
*Illus. 20: The removal of the clay in the north-eastern area of the site, taken from the south-west.*

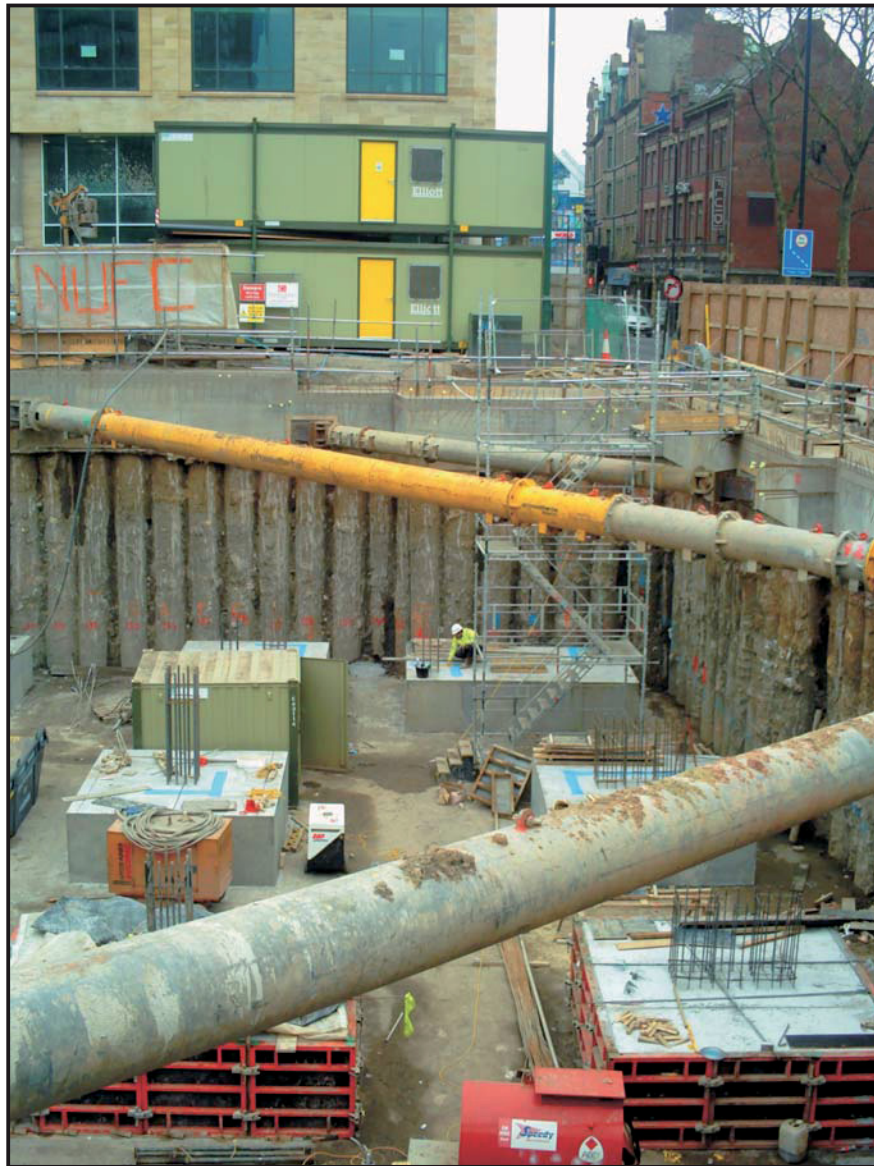
*Illus. 21: A general view of the development site facing south-east showing the level down to which deposits have been excavated with the modern foundations in place.*
