INGLEBORO
ST HELEN'S LANE
CORBRIDGE
NORTHUMBERLAND

REPORT ON ARCHAEOLOGICAL WATCHING BRIEF

PROJECT: Archaeological watching brief at Development Site

LOCATION: St Helen's Lane, Corbridge, Northumberland

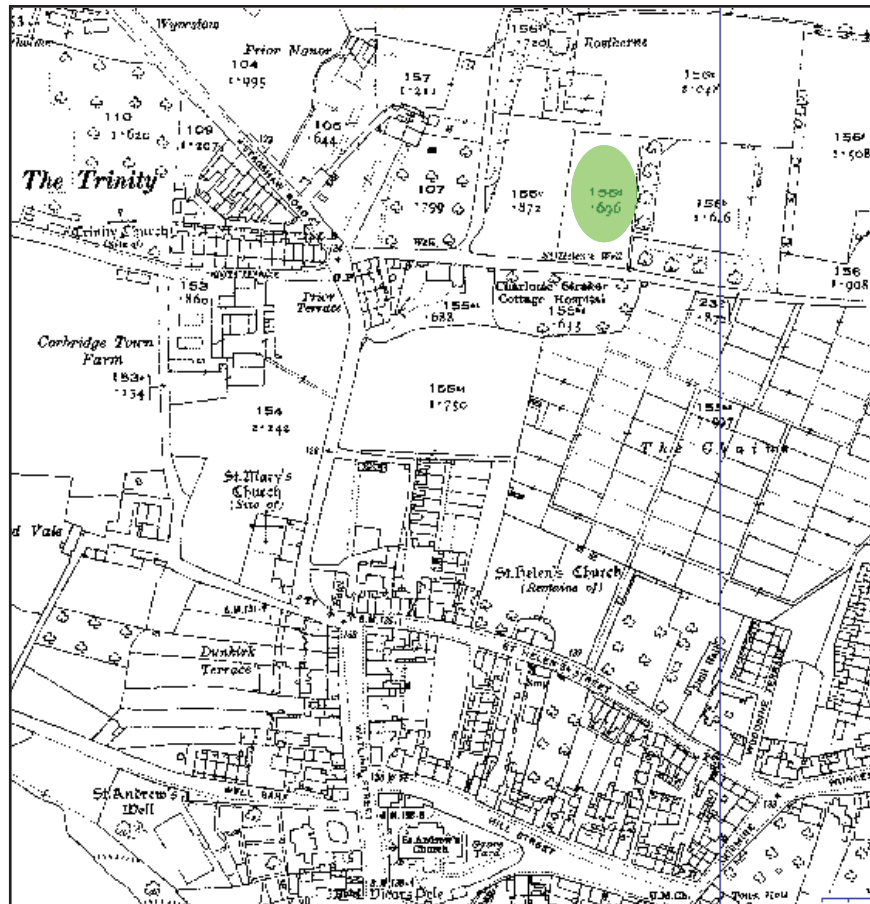
Illus. 08: Extract from the 3rd edition Ordnance Survey Plan of Corbridge (c1920), showing the development site at Ingleboro (highlighted)

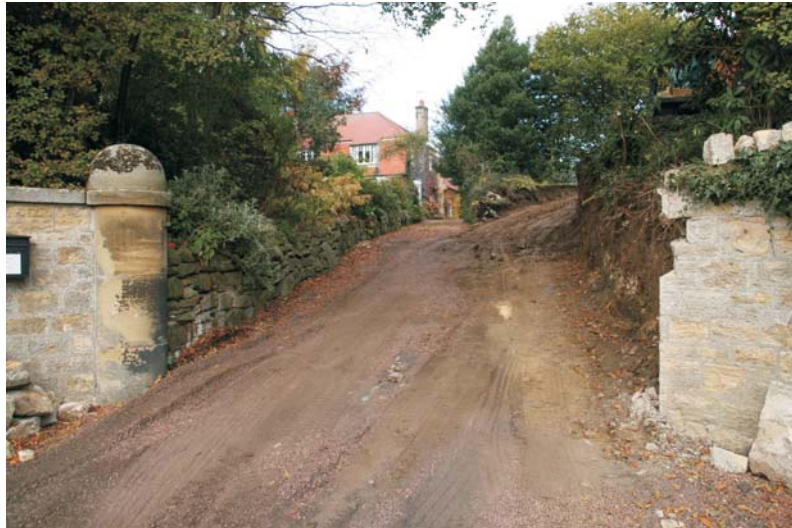
Illus. 10: View from the south of the access gate to Ingleboro from St Helen's Lane during the first phase of construction work in October 2007.

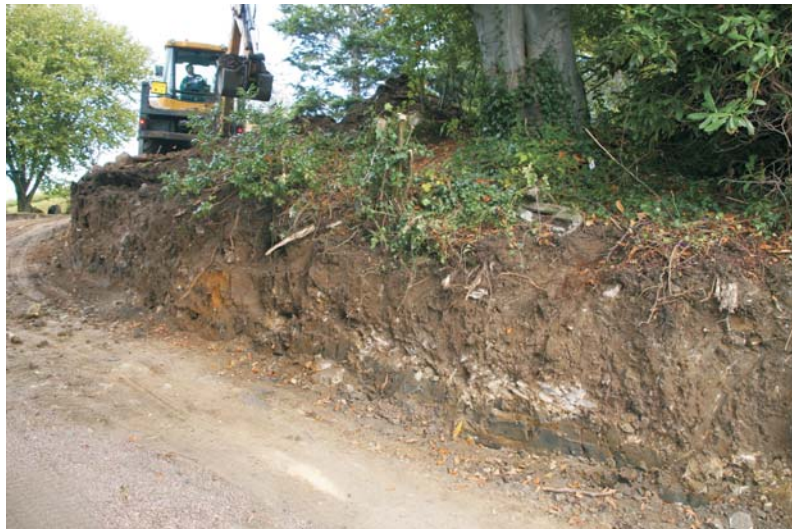
The vertically-cut west-facing bank side of the access road into Ingleboro from St Helen's Lane provided an opportunity to examine the structure of the surface deposits prior to the construction of a drystone wall. The ground, sloping to the south, was comprised of a sandy topsoil to a depth of up to a metre, below which was a grey clay, possibly part of the natural

sub-soil. Between the topsoil and clay in the area close to the site gate from St Helen's lane was a shallow deposit of sandstone fragments, perhaps a rudimentary surface, but more likely a destruction deposit. None of the deposits visible in the section were considered to be of archaeological importance.

Illus. 11: View of the vertically-cut west-facing bank side of the access road into Ingleboro from St Helen's Lane, October 2007.

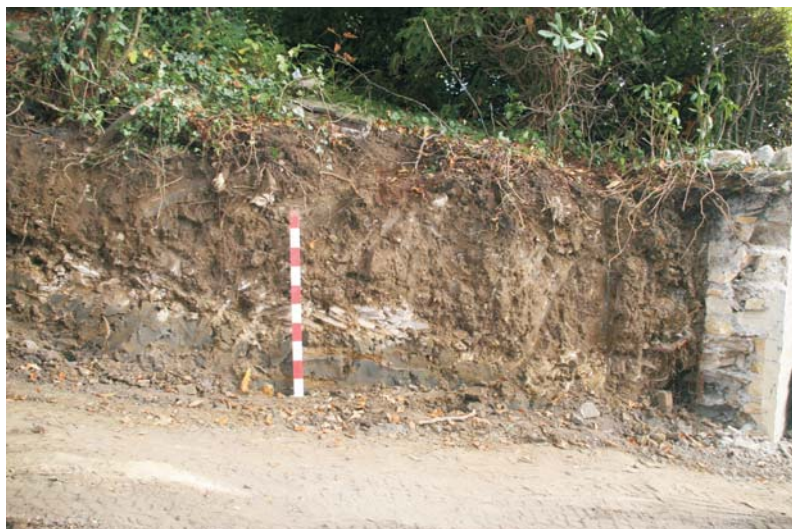
Illus. 12: Detailed view of the west side of the access road (above) into Ingleboro from St Helen's Lane, October 2007.

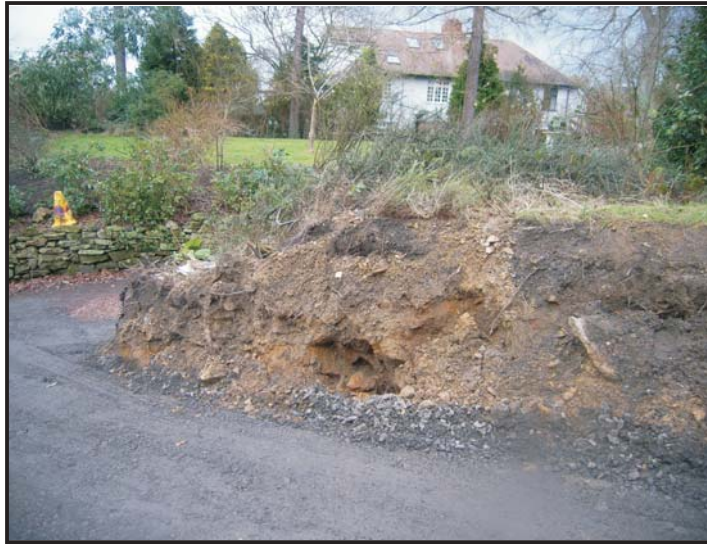
Illus. 13: View south-west from the new property access road adjacent to the new garage towards the original access road (bordered by drystone wall) showing topsoil and sandy subsoil.

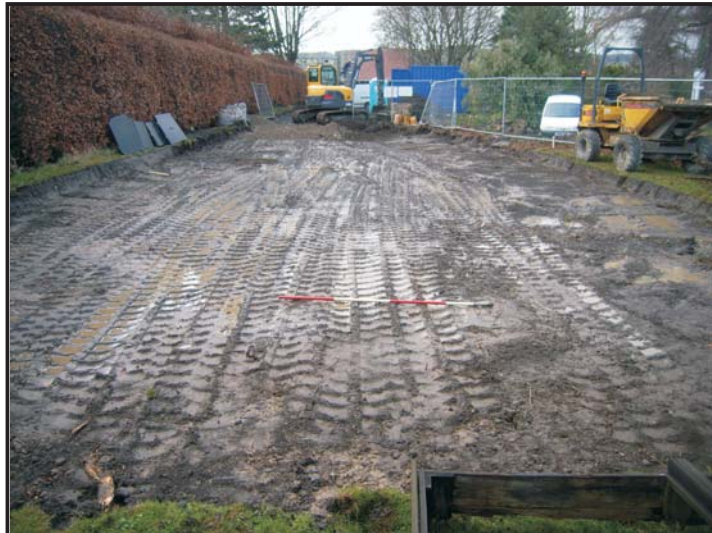
Illus. 14: View from the north of the Ingleboro site during the second phase of construction work, January 31st 2008.

Phase 2, the construction of a new dwelling adjacent to the present Ingleboro began with ground clearance in late January 2008 and the excavation of foundation trenches early in February 2008. The ground was made up of a sandy topsoil to a depth of 0.70 metres, giving way thereafter to a brown silty-clay up to a maximum observed depth of 1.75 metres. In the north-east corner of the site some rounded stone blocks, possibly part of the bedrock, were observed but remained unexcavated.

No deposits, features or finds of any archaeological significance were recorded or recovered from the observed groundworks.

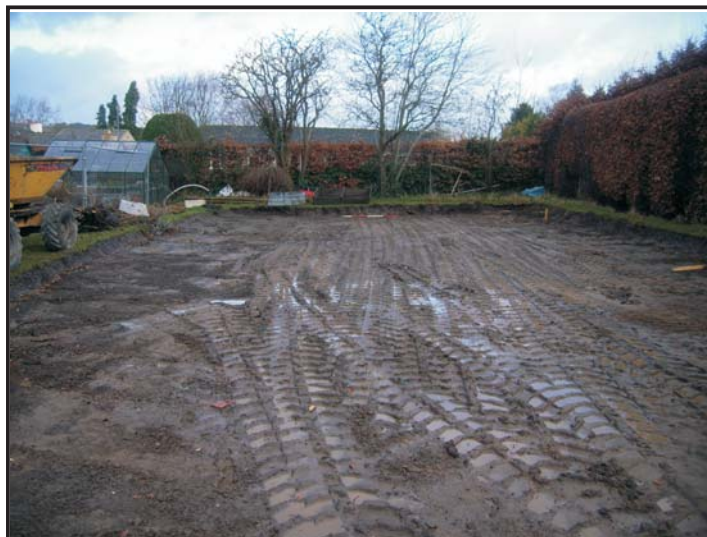
Illus. 15: View of Ingleboro site from the south during the second phase of construction work, February 4th 2008.

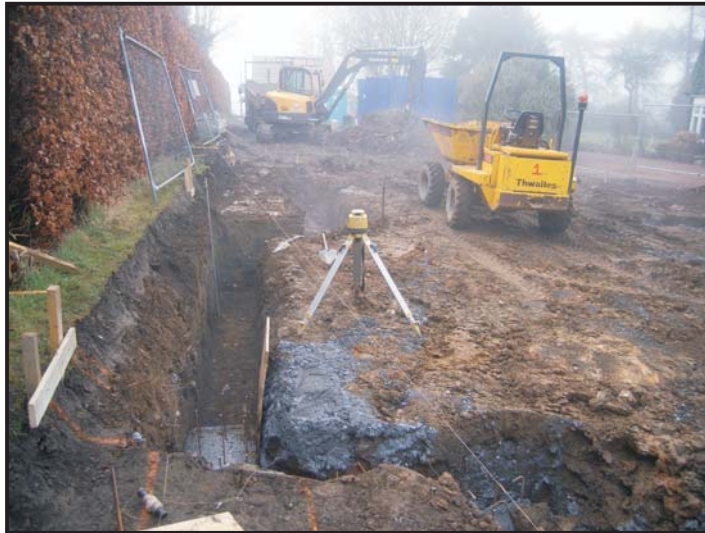
Illus. 19: View from the north of the Ingleboro site during the excavation of foundations on February 6th, 2008.

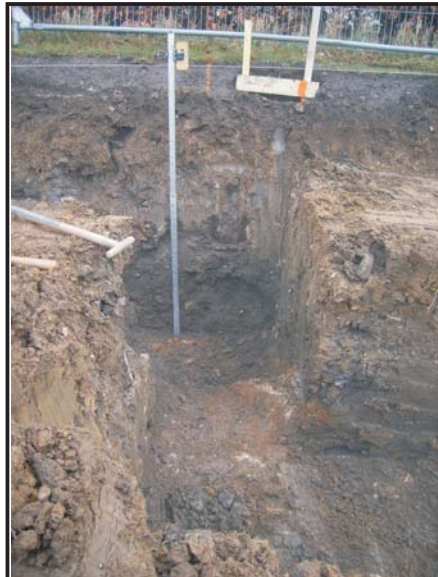
Illus. 20: View from the west of the Ingleboro site during the excavation of foundations on February 6th, 2008.

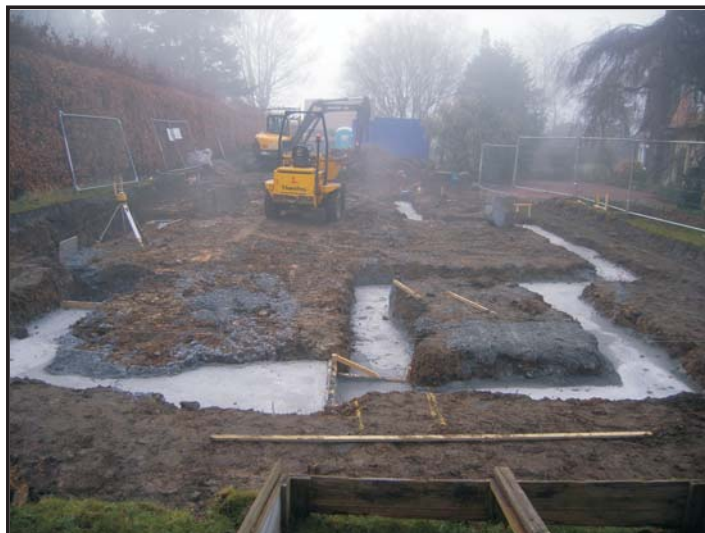
Illus. 21: View of Ingleboro site from the north during the second phase of construction work, February 6th 2008.
