86-88 FRONT STREET
BEDLINGTON
NORTHUMBERLAND

~ ARCHAEOLOGICAL WATCHING BRIEF ~

REPORT ON AN ARCHAEOLOGICAL WATCHING BRIEF

Grid Reference: NZ 26132 81827
Client: J&W Lowry Ltd.
NCC Planning Ref.: 17/02932/FUL
Date of fieldwork: November 2019 – November 2020
Project Code: AP 19/28
Oasis Number: thearcha2-415654

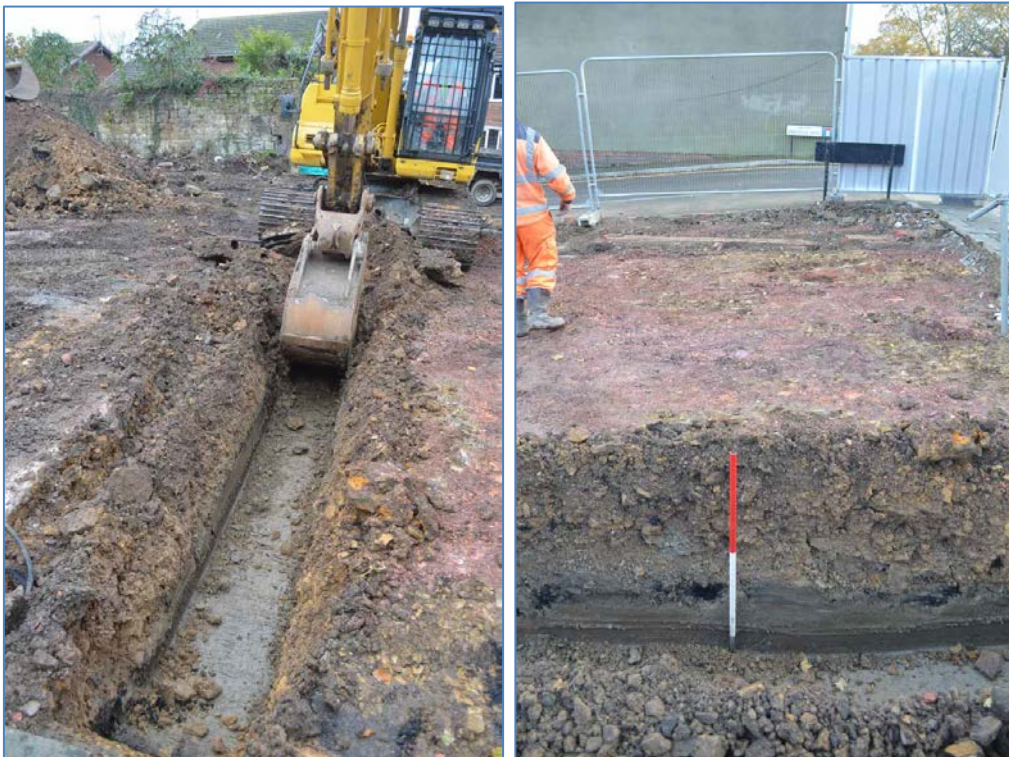
The service trench was aligned south-west to north-east and followed a line extending from points just inside inside the south-west and north-east corners of the former music shop building (no. 86 Front Street), a distance of approximately 12.2 metres.

The dimensions of the trench were as follows:
12.20 m (length) x 0.65 m (width) x 1.25 m (max depth).

(above left) Photo. 01: The excavation of Trench 4 in Phase 1 of the watching brief)

(above right) Photo. 02: Trench 4, part of the west-facing section in November, 2019

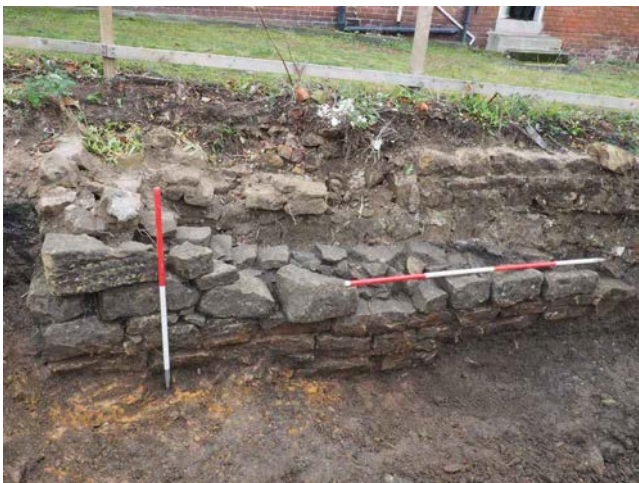
Photo 04: Wall A and underlying wall K from SE

[01] **Wall A** on site plan. Remains of an unbonded sandstone wall beneath the west boundary wall 'H'. Built of reasonably well-faced quarried sandstone, surviving up to five courses to a maximum height of 0.60 m.

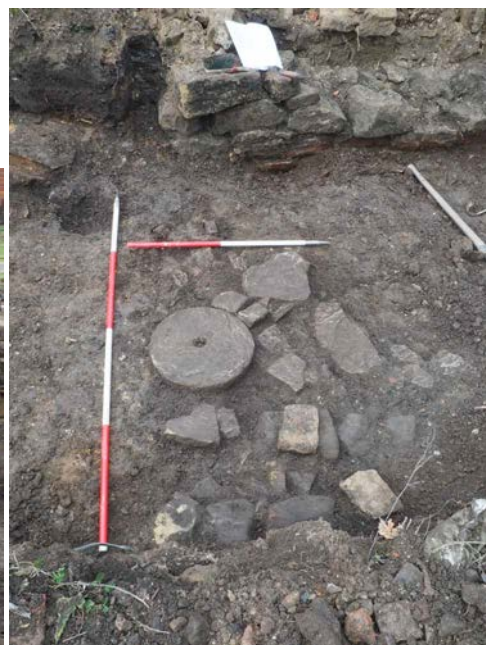
Photo. 05: Possible surface B from SW

[02] **Hard-standing B** on site plan. An area of hard standing underlying wall 'H' (2018 [105]; possibly the same as [107] recorded in the 2018 evaluation. Built of flat sandstone pieces and riverine cobbles and incorporating a large quern- or mill-stone (*Photo. 17*).

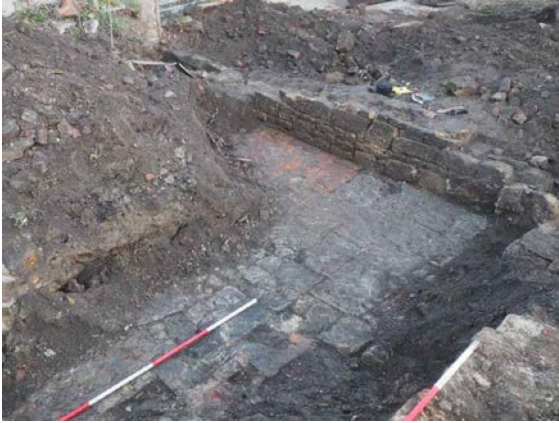
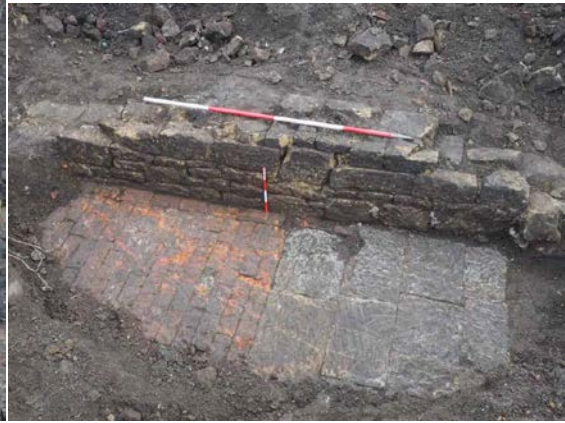
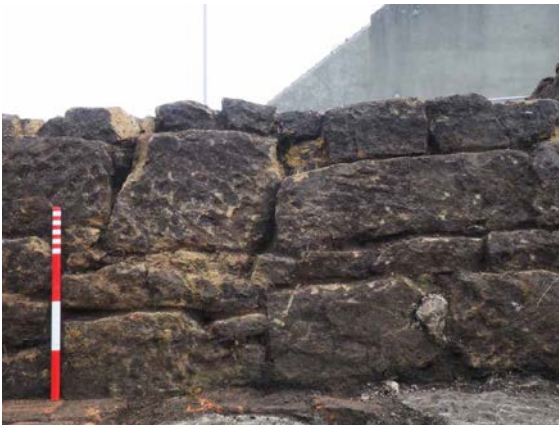
Photo 06: Wall C and related surfaces from SW. Photo. 07: Wall C during excavation, from SW

Photo 08: Wall C detail, including tooling Photo. 09: Wall D during excavation, from south

[03] **Wall C** on site plan. A wall abutting the east side of a flagged sandstone and brick floor, continuous with a N-S boundary on the north side of the current north site boundary wall. Built of well-faced quarried sandstone blocks in random courses, bonded with a coarse pale mortar, it survives up to 0.50 m high. Wall C sits on the grey silty-loam also observed beneath wall A.

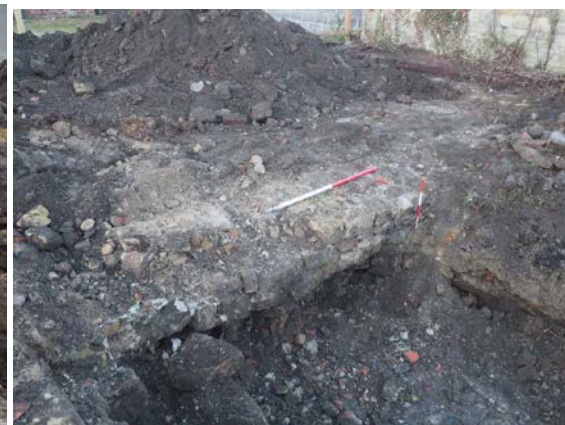
[04] **Wall D** on site plan. A wall of quarried s/s in random courses, bonded with off-white hard mortar. It rests on the demolition material of wall F.

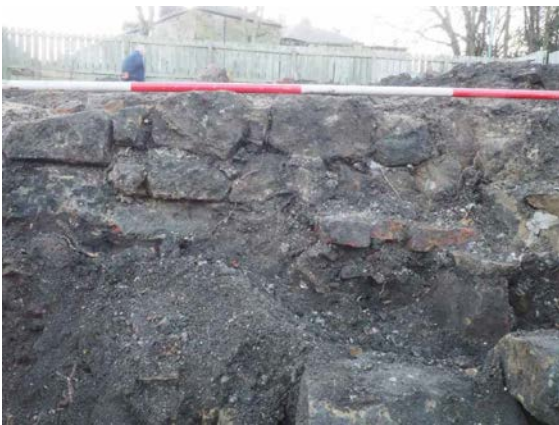
Photo 10: Wall E during excavation, from SW. Photo. 11: Possible post-pad 'G'

[05] **Wall E** on site plan. A wall of similar build character to Wall 'D', which it joins, but slightly thicker.

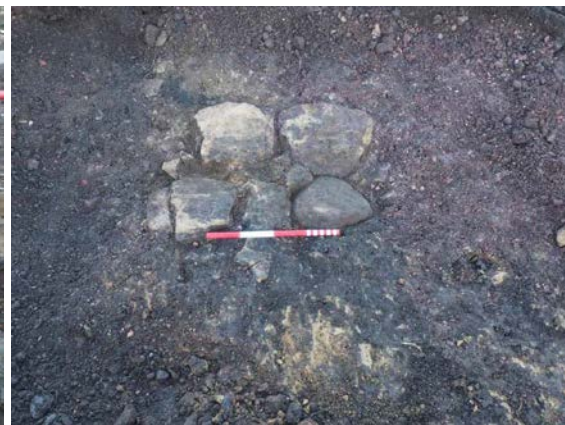
[07] **Foundation G** on site plan. A possible post-pad foundation set into the natural sub-soil, sub-rectangular and 0.40 x 0.60 m in plan, comprised of flat sandstone pieces.

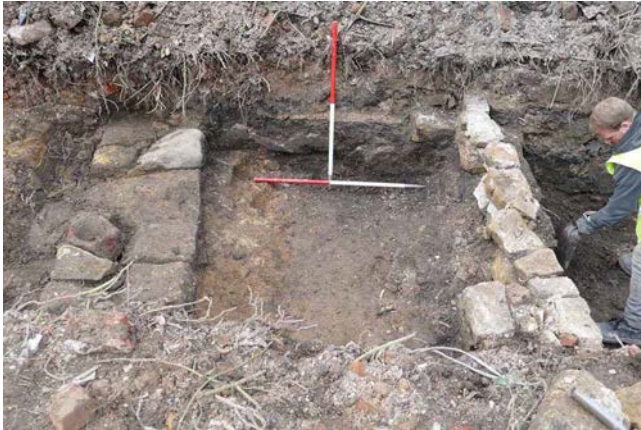
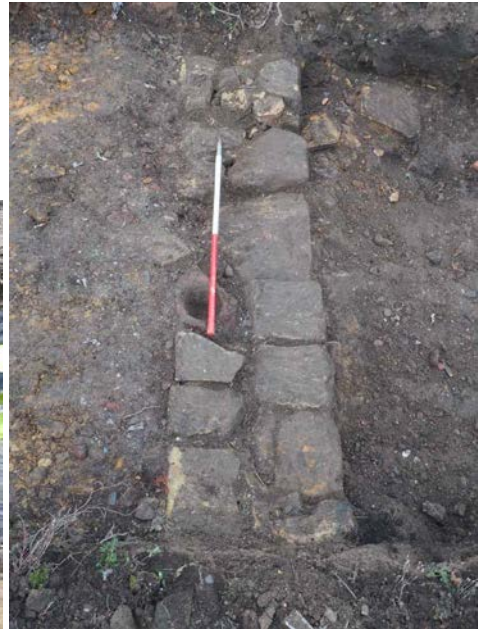
In the west part of the site, beneath the upper layers of modern demolition material and brown loam, two sandstone walls, Wall H [08] & I [09], also seen in the 2018 evaluation (104) & (105)), were encountered at depths between 0.20-0.50 m below present ground level, along with a possible truncated stone floor surface [02] (2018 [107]) sitting on earlier topsoil deposits immediately north of the northern wall. The better-preserved southern wall 'I', 0.45-0.52 m wide, sat upon sub-soil and bedrock and comprised roughly faced, unbonded sandstone blocks, incorporating on its south side the broken remains of a roughly-made stone trough of pre-modern, quite possible medieval origin. Its reused position in a wall foundation suggests that the wall is of much later origin than the trough, but no evidence for absolute dating was available in the form of artifacts or ecofacts.

Photo 12: West part of Walls H & I from south-east. Photo. 13: West part of Wall I from SE

[08] **Wall H** on site plan. Sandstone wall ([2018 [105]) located 1.32 m south-west of and parallel to wall 'I', aligned SE-NW, built of roughly hewn stones and small boulders, it is 0.65 m wide and one-course deep, double-skinned with no core material. A reused socketed stone was present in the centre of the south face. Built upon a natural outcrop of sandstone bedrock [109], traces of the wall can be seen extending across most of the south part of the site. The west end of the wall sits upon a roughly-made floor, or sub-base - hard-standing area 'B', above - which includes a probable quern- or mill-stone (see *Photo. 16*). The 1st Edition OS map of c.1864 suggests this wall ('H') formed the north wall in a range of possible 18th-19th century terraced cottages located here.

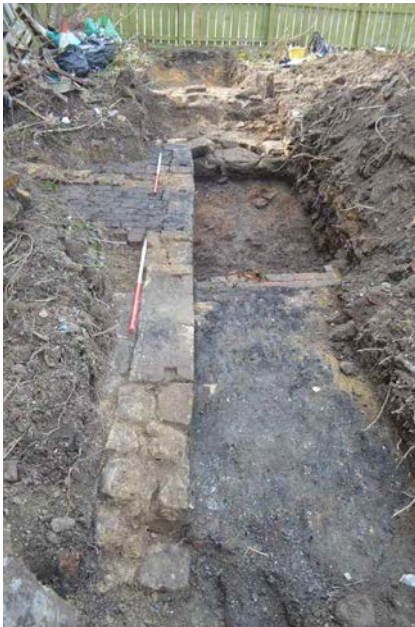
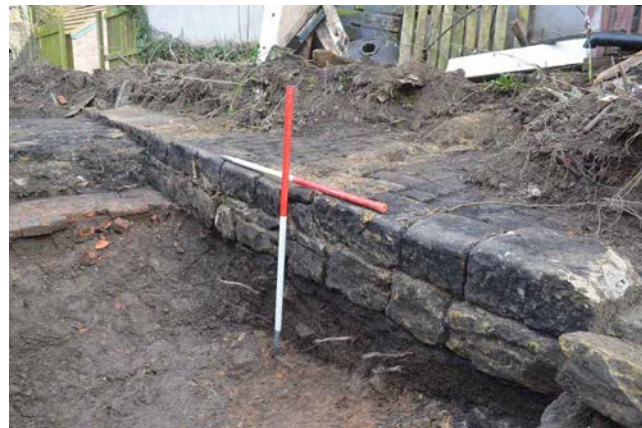
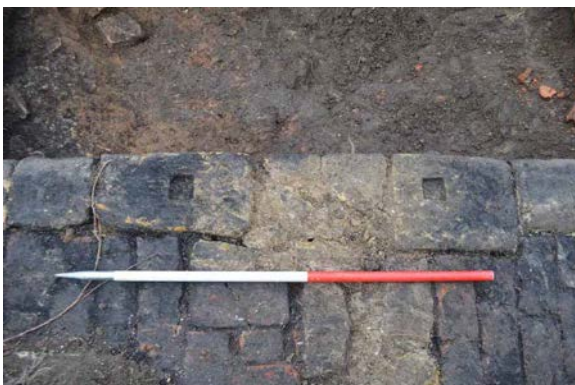
The building remains grouped as site J [10] comprise a main north-south wall and another adjoining at right angles with, on the west and east sides of the main wall areas of brick flooring a metre or so below current ground level. These features, partially exposed in 2018, are interpreted as modern remains dating to the 19th or early 20th century, although again they were associated with few, if any artifacts to allow close dating. The fact that the main N-S wall of group [10] ends at the north face of wall [09], as if abutting it, suggests that the latter was in existence when Building J [10] was constructed, probably forming part of the same ensemble.

Photo 14: Feature J from the north. Photo 15: Feature J seen from the west

Photo 16: Detail of railings settings, Feature J

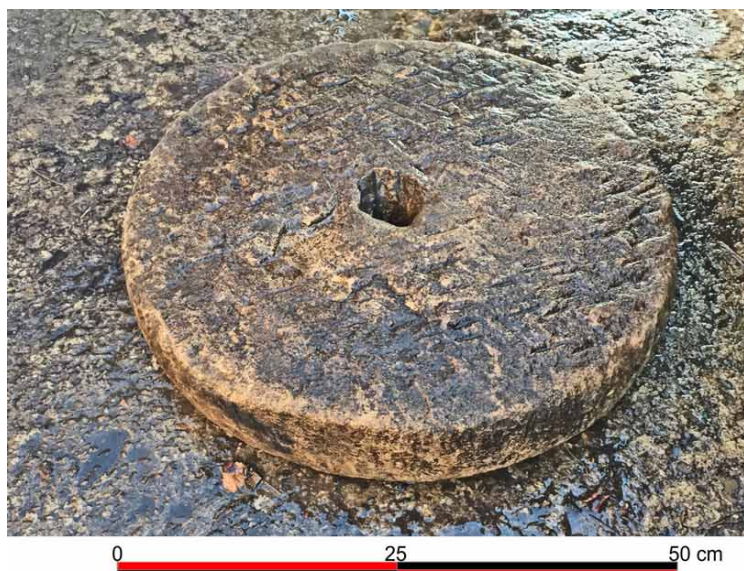
Photo. 16: Perforated stone - probably a quern- or mill-stone, but potentially a grindstone, fly-whel or press - in medium-yellowish sandstone. Peck or chisel marks visible on both faces, which perhaps counters the quern/millstone option. Central perforation sub-circular. Dimensions: 0.50 m diam; 0.09 m high

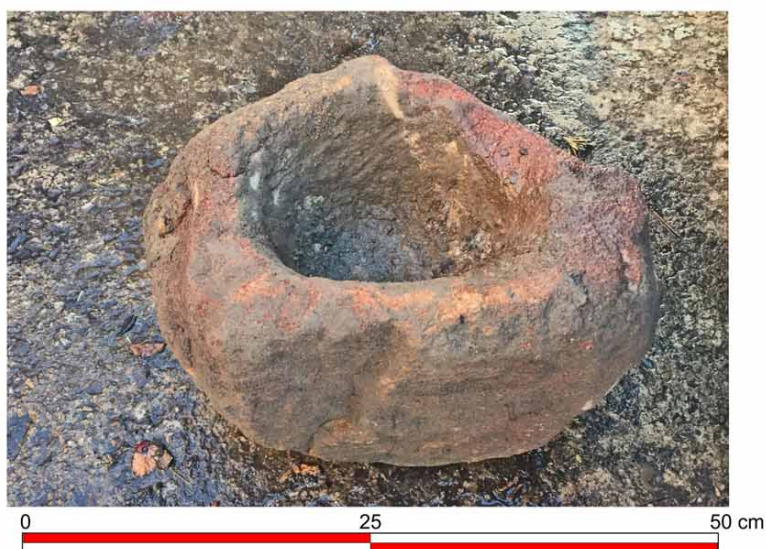
Photo. 17: Stone trough or mortar in a coarse sandstone, reddish in colour and friable (as if burnt). Four straight-sides of uneven length with rounded, or perhaps eroded, corners and a circular bowl showing signs of pecking internally. Dimensions: 0.38 m max. length; 0.25 m high; 0.20 m bowl diam. at opening; 0.12 m interior bowl depth.
