**A1-A192 LINK ROAD,
SOUTH EAST NORTHUMBERLAND**

ARCHAEOLOGICAL EVALUATION

April 2003

A1-A192 LINK ROAD
ARCHAEOLOGICAL EVALUATION

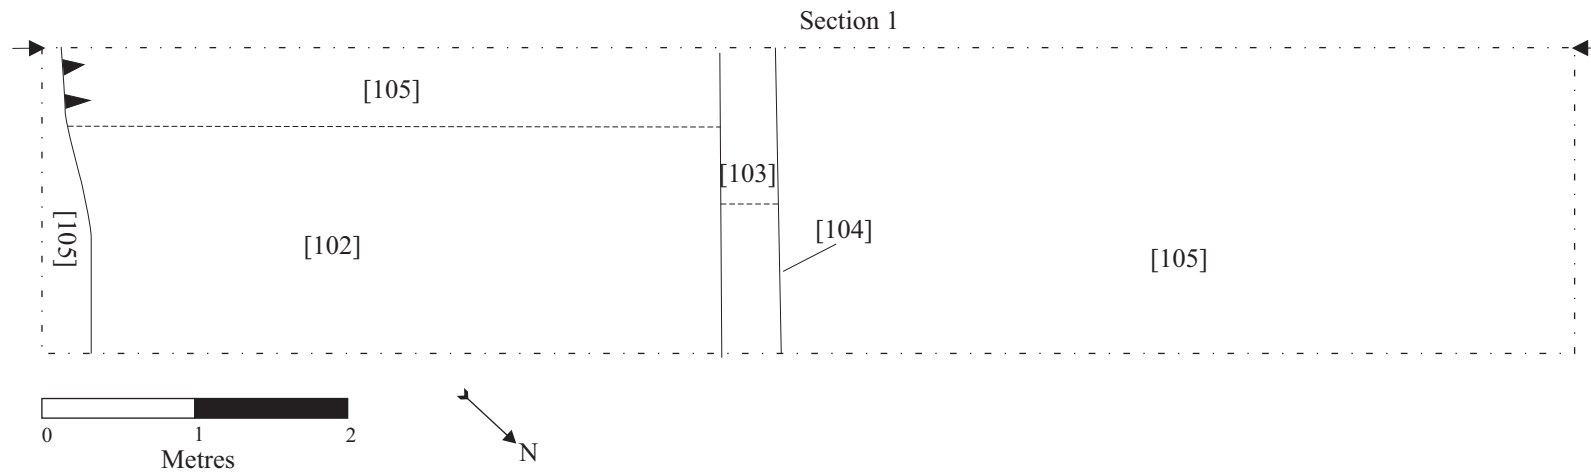
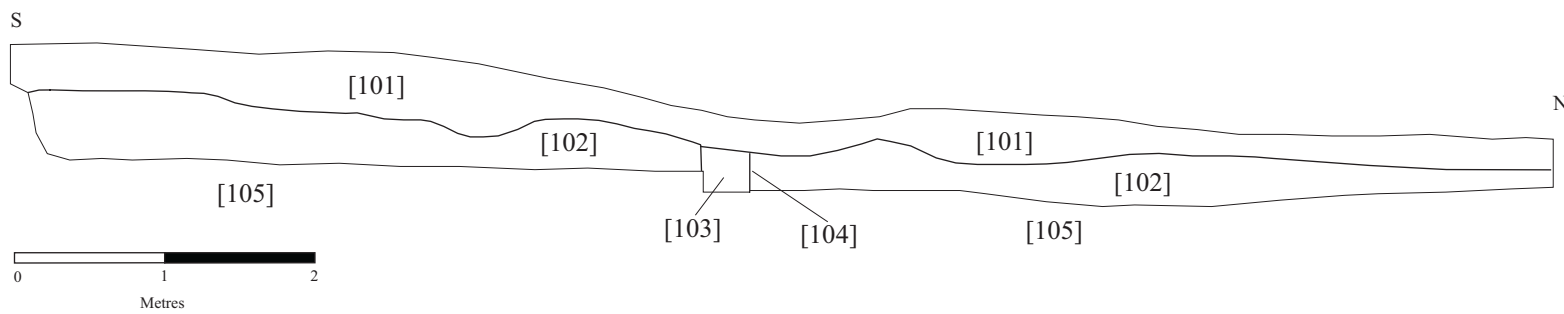
Figure 3: Plan & Northeast facing Section of Trench 1.

Underlying the turf and topsoil was a heavy orange/brown silty clay (102). This deposit overlay the natural subsoil composed of cleaner yellow-orange clay (105). The surface of the natural was seen to step down abruptly at the south end of the trench. Cutting through all these layers, midway along the trench, was a narrow slot (104) containing a terracotta field drain. This was set at a depth of 1m in a fill of brown silty clay (103).

Fired material like the terracotta pipe of the field drain produces a strong signature in a magnetometry survey and probably accounted for the principal geomagnetic anomaly. The second geomagnetic lineation probably reflects the sudden drop in the level of the underlying natural subsoil at the southern edge of the trench presumably caused by transition between one former ploughfield and another. Deposit 103 may be interpreted as a buried ploughsoil formed by the gradual build up of material at this edge of the southern field as a result of prolonged ridge-and-furrow cultivation, whilst, conversely, in the field to the north, the same process continually cut into the accumulated bank of ploughsoil and the underlying natural, dragging soil northward down the slope into the dip in the centre of the field.

Trench 1, measuring 10m x 1.5m, was cut across the distinct NE– SW oriented lynchet in the field immediately to the west of West Lane End Farm, with the aim of providing a record of the feature's structure and profile. The lynchet sloped downward from south to north and coincided with a pair of closely-spaced linear anomalies identified by the geophysical survey (f1/f21).

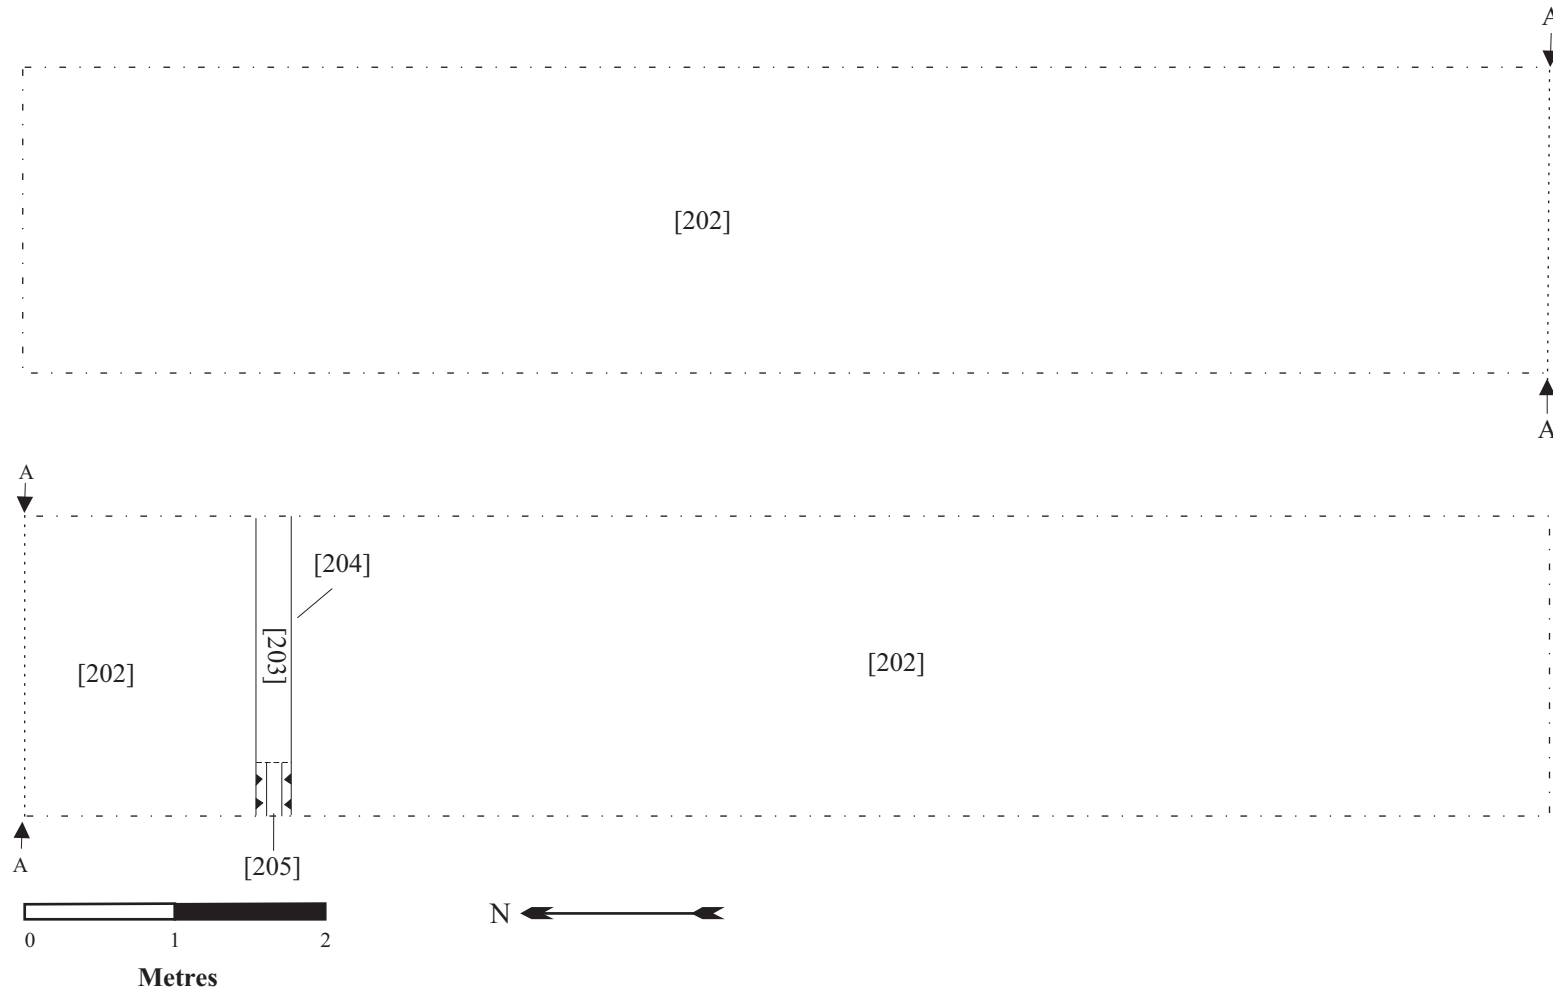
Figure 4: Plan of Trench 2

Trench 2 was aligned NNE-SSW and measured 20m x 2m. It was positioned to overlie linear anomalies, f1/f18, and f1/19, a putative fired structure suggested by the geophysical survey. Removal of the turf and topsoil revealed a subsoil of orange brown/grey silty clay (202). Approximately half way along the trench, a narrow band of orange gritty clay (203) was evident crossing the trench. Investigation revealed this to be the fill of a cut (204) containing a relatively modern terracotta field drain.

Pipe trench and drain evidently represent the more southerly of the two parallel linear anomalies identified by the geophysical survey. The second lineation, which had weaker signatures than the field drain in the geophysical survey, was not revealed.

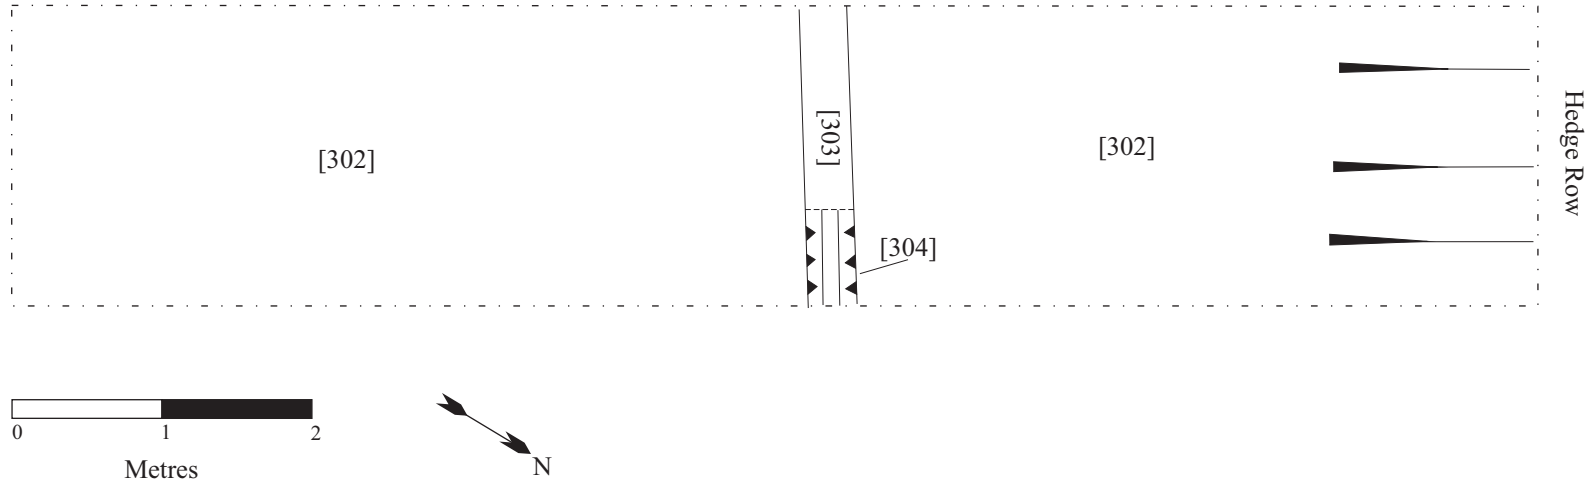
Figure 5: Plan of Trench 3

The geophysical survey for the area of trench 3 showed a linear anomaly running ENE-WSW across the field (f2/6-7). Trench 3, measuring 2m x 15m, was aligned NNW-SSE to bisect this anomaly at 90°. Removal of the topsoil revealed a yellow/orange silty clay sub-soil (302). Cutting across this was a narrow band of darker clay (303) which, upon excavation, proved to be a pipe trench (304) occupied by a modern field drain like those encountered in trenches 1 & 2. Towards the north end of the trench, the surface of the subsoil dipped downward as it approached the hedgeline, reaching a depth of 0.75m, pointing to the existence of an infilled ditch running beneath the present hedge.

Excavation demonstrated that anomaly f2/7 shown on the geophysical survey plot was a field drain, rather than a masonry feature, such as a stone wall footing, as previously inferred. The hedge immediately north of the trench formerly marked the boundary between Spital Hill and Benridge

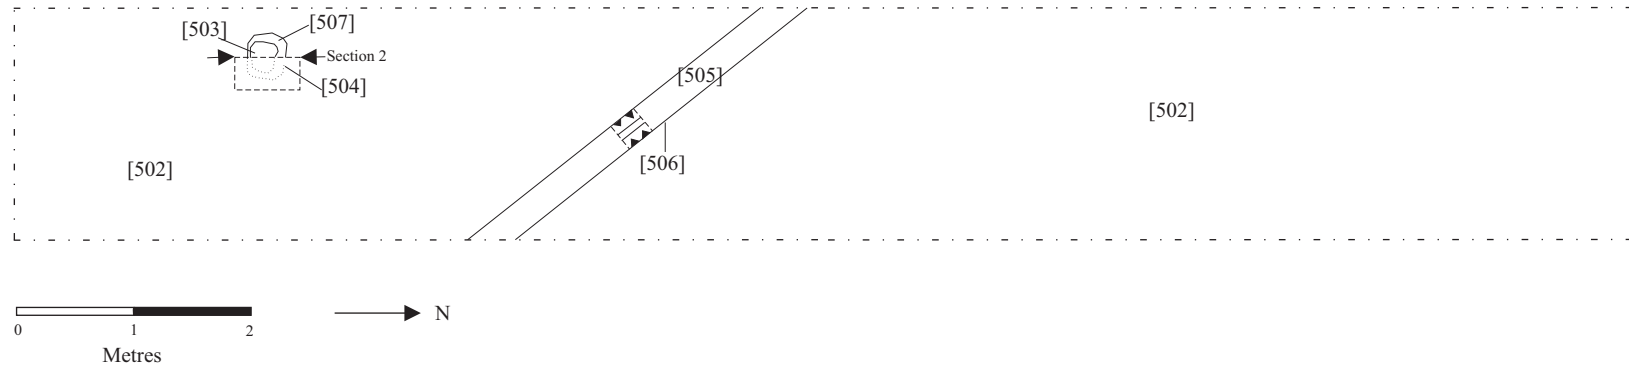
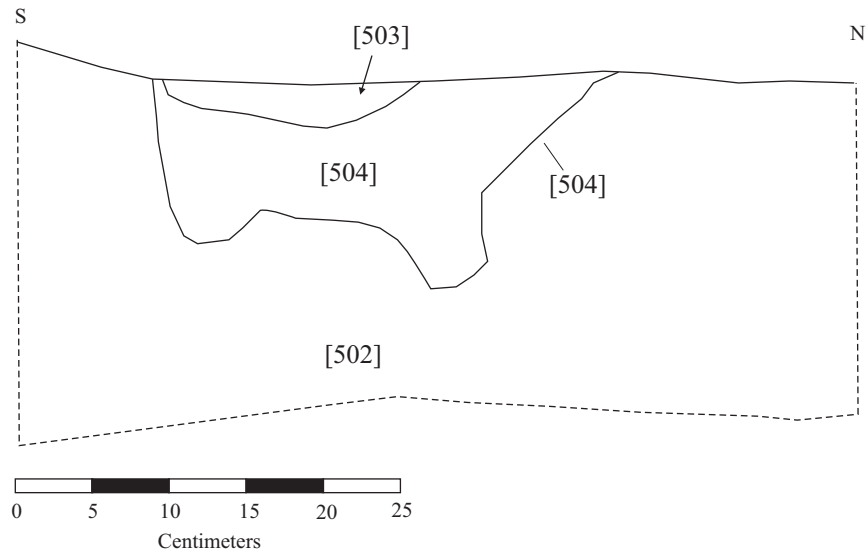
Figure 7: Plan of Trench 5 (a) with section through feature 504 (b).

The geophysical survey results show a linear feature approximately 10m in length on an E-W alignment, bisecting a tentatively identified circular feature (f2/15) in Area 5 of the geophysical investigation. Trench 5 was positioned so that it overlay the linear feature and part of the supposed circular feature. It was aligned N-S with dimensions of 14m x 2m. Removal of the topsoil revealed a heavy orange/brown clay subsoil (502) within which two features were apparent, neither of which clearly relate to the features suggested by the geophysical survey. The first feature, a small patch of charcoal (503), was revealed 2m from the south end of the trench. Subsequent excavation revealed a very shallow deposit of charcoal extending to a depth of approximately 10cm, overlying a pocket of light grey clay (507) extending to a depth of 40cm. The second feature, a band of orange/grey clay (505) approximately 20cm in width, crossed the trench at 45° in a NW – SE direction. This was excavated to reveal another modern terracotta field drain (506). No evidence of a circular feature was uncovered.

Deposits 503 and 507 appear to fill an irregular cut or depression (504). The feature is most convincingly explained as the residue of 'slash-and-burn' clearance activity - cut 504 probably represents the site of a tree uprooted after the vegetation had been burnt off, whilst the fills (503, 507) comprise soil enriched by that burning process and redeposited in the tree bowls by subsequent

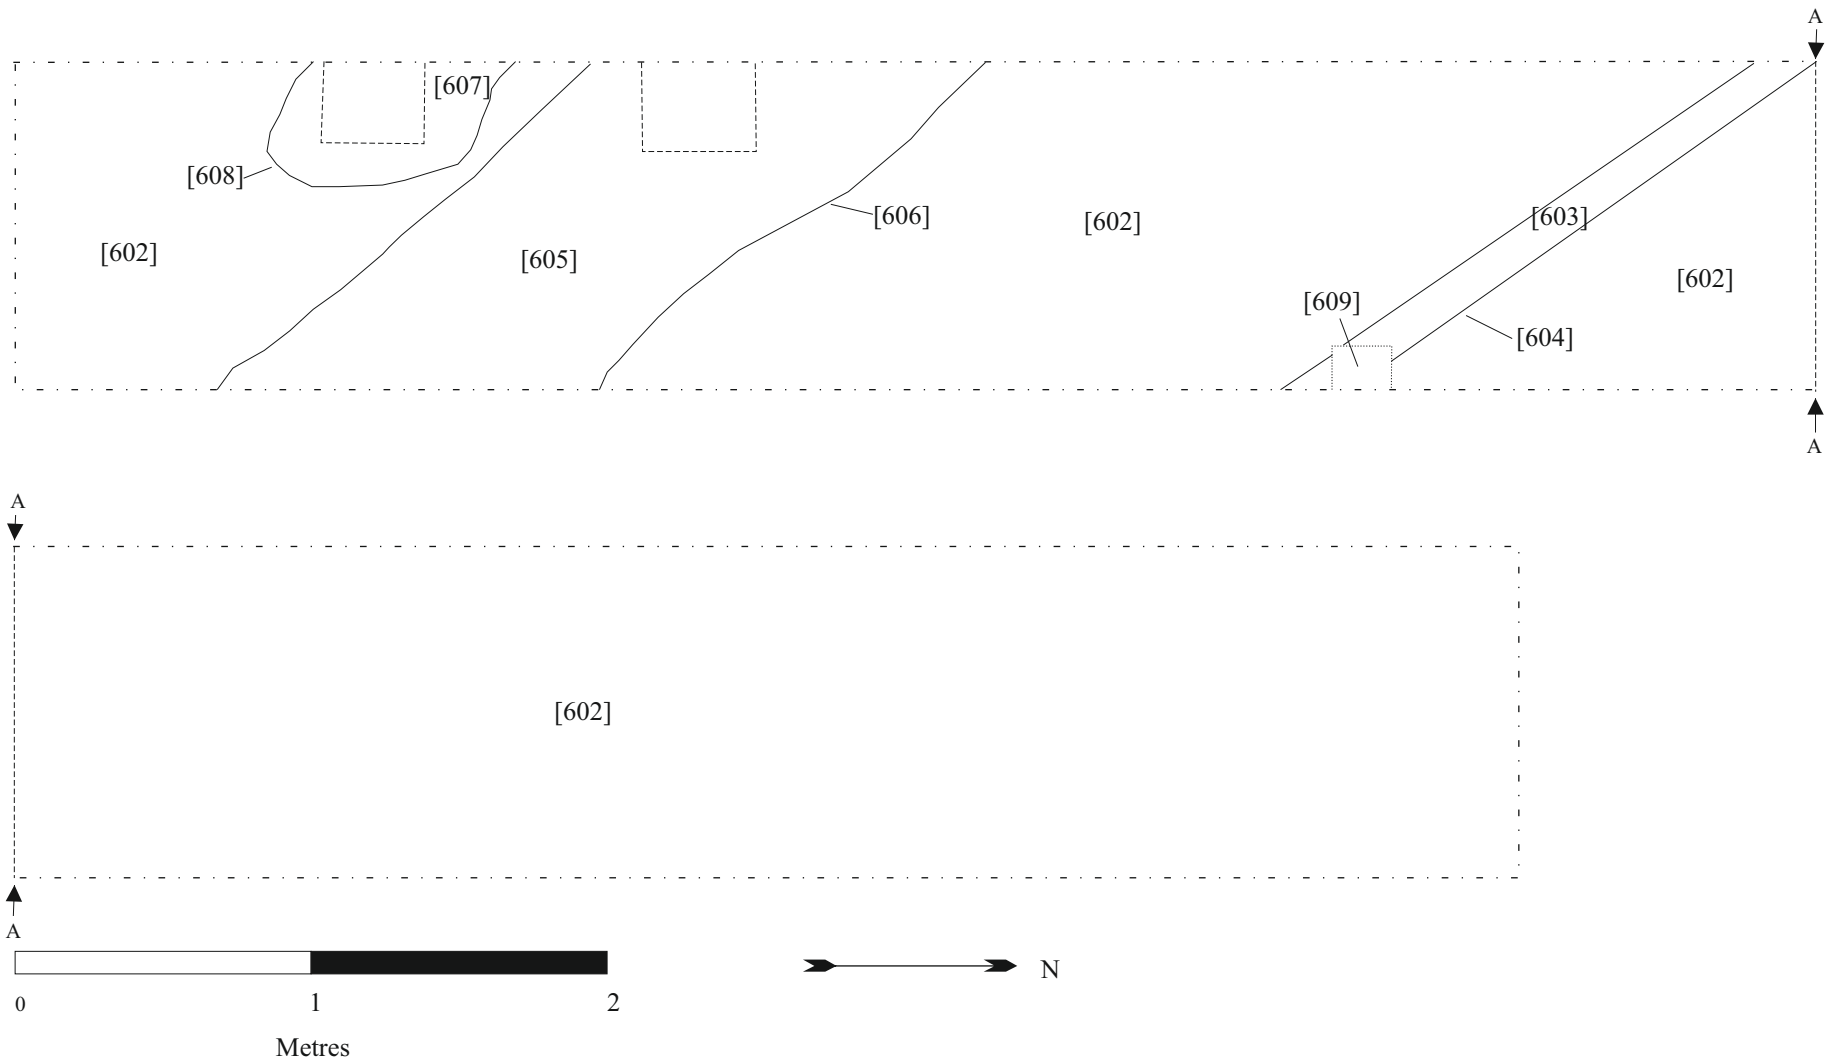
Figure 8: Plan of Trench 6

Trench 6 was laid out to intersect a linear geomagnetic anomaly (f2/14), which was plotted as running W-E before curving gently SE. Trench 6 was aligned N-S with dimensions 2m x 11m. Excavation revealed a subsoil of yellow/grey silty clay (602) beneath the topsoil. Three features were apparent. Towards the south end of the trench, a patch of gritty, sandy dark-brown soil, which included some yellow grey clay and burnt inclusions (607), was noted. This deposit filled a shallow cut or depression (608), only c. 0.05m deep. Adjacent to this was a broad linear band of sticky grey-yellow clay (605) running across the trench at an angle of c. 45°. Excavation revealed this feature (606) was no more than 0.3m deep. Cutting across the centre of the trench, again at an angle of 45°, was a third feature (604), marked by a narrow strip of darker clay (603) approximately 20cm in width. This cut was found to contain a terracotta field drain (609) similar to those found elsewhere on the site.

The shallow deposit of dark material with burnt inclusions (607) can be compared to feature 503 from trench 5, interpreted as representing a burnt out tree root relating to a clearance episode. The adjacent linear feature was clearly a plough furrow. Its NW-SE orientation is precisely that of the pattern of ridge and furrow recorded by the geophysical survey (as anomaly f2/13) and still visible on the surface as rows of very shallow linear depressions which retained noticeably more moisture than the adjacent flattened 'ridges'. This moisture retention accounted for the sticky quality of the clay fill (605). The pattern of land drains in the field - exemplified by 609 recorded here - evidently followed the alignment of the ridge and furrow, as was commonly the case.

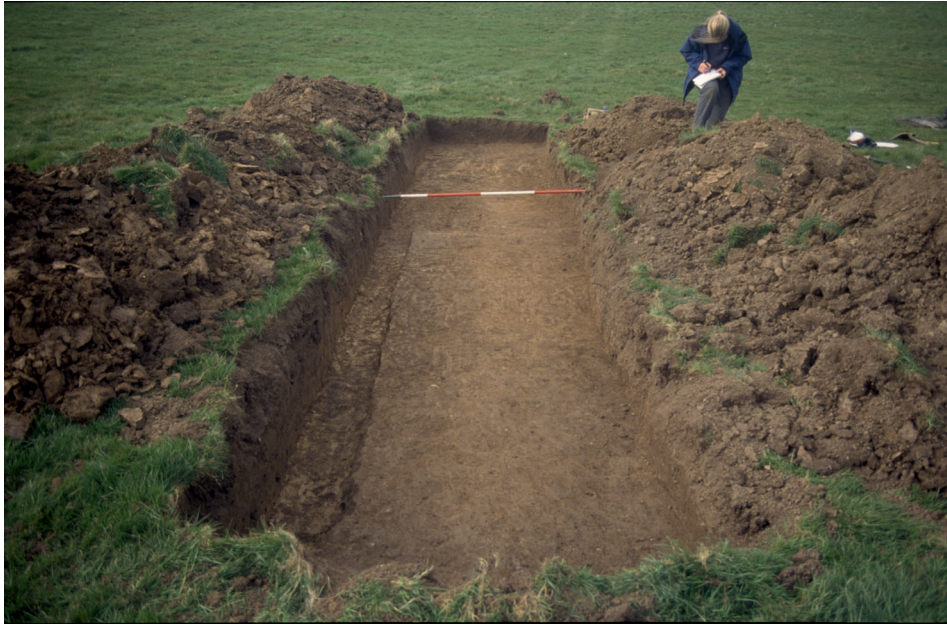
Plate 1: Trench 1 from the south with section cut down west side.

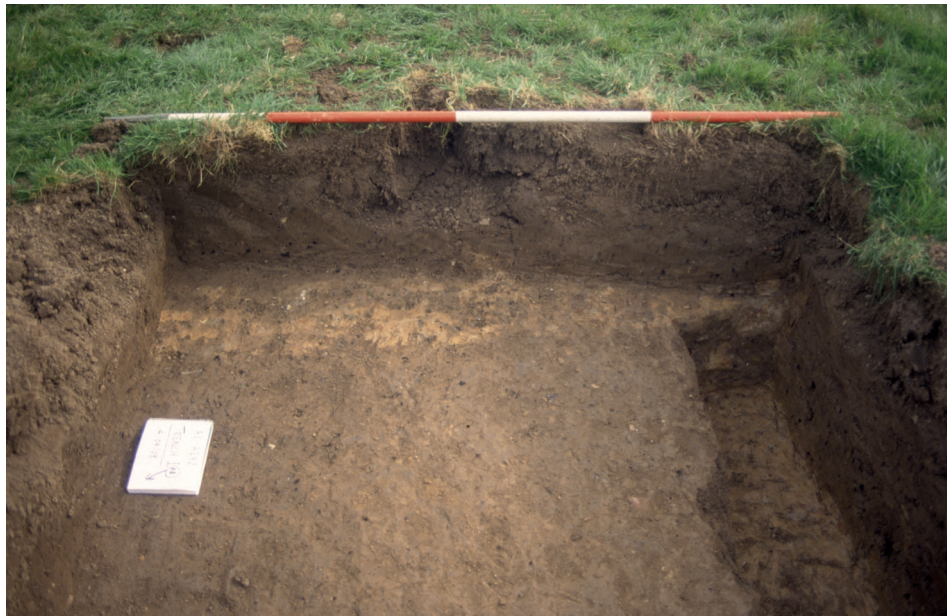
Plate 2: South end of trench 1 showing ploughsoil deposit 102 and lynchet scarp cut in the underlying clay subsoil (105).

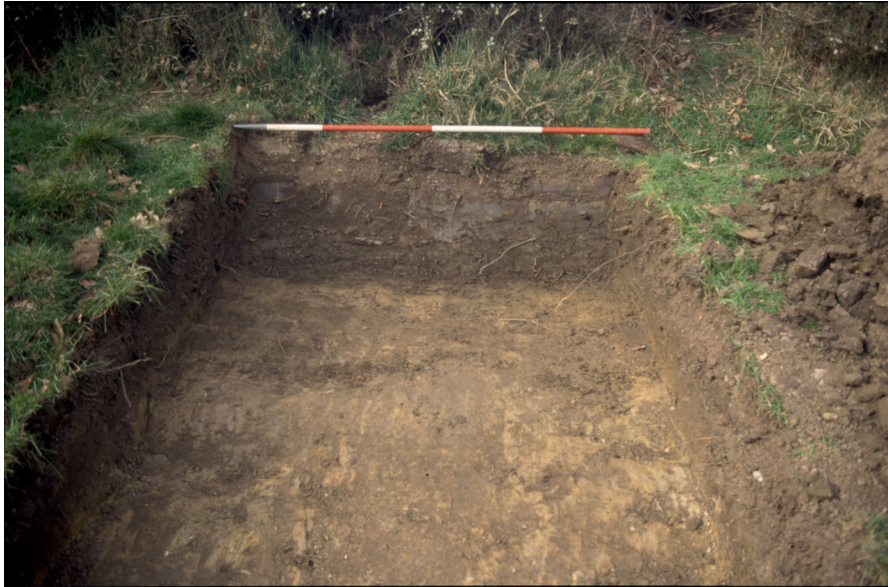
Plate 3: North end of trench 3. Note subsoil 302 dipping downward beneath hedgerow, suggesting the boundary was previously formed by a ditch.

townships. The excavation results indicate this boundary was previously marked by a ditch instead of the current hedge.

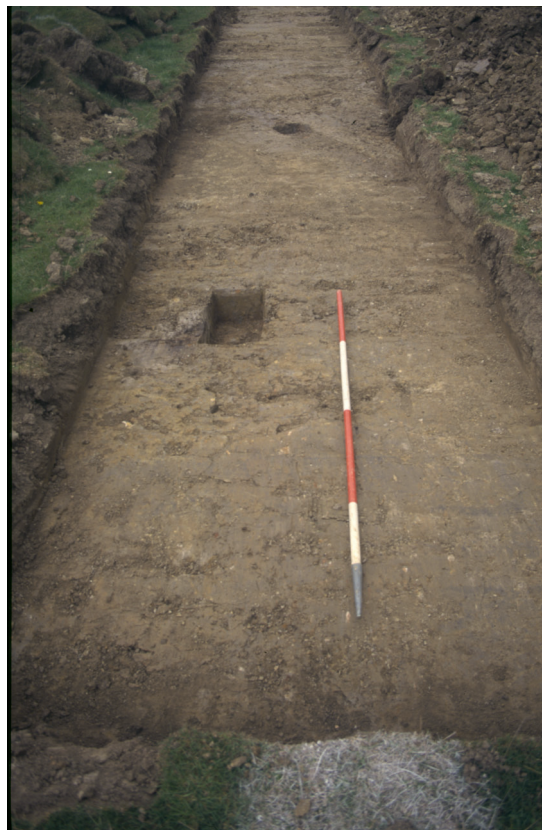
Plate 4: Trench 5 from the south, showing features 506 and 504 after sectioning.

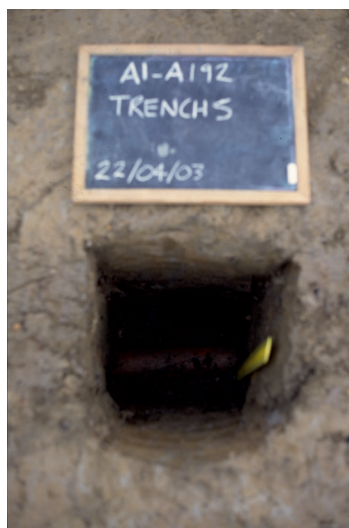
Plate 5: Field drain 506 in Trench 5.

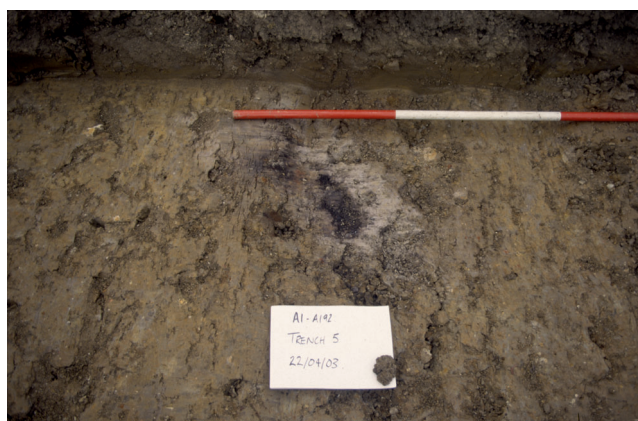
Plate 6: Deposits 503 and 507 in trench 5

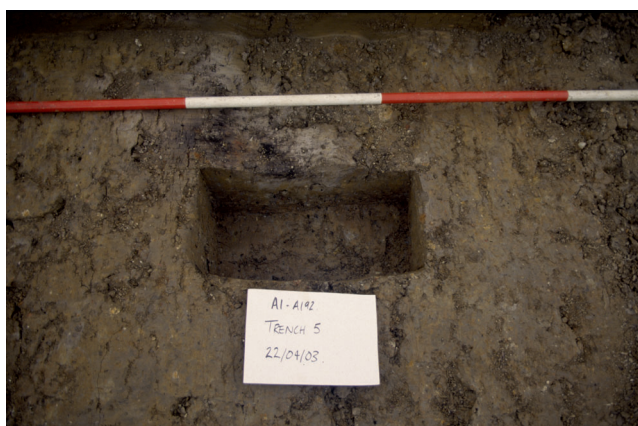
Plate 7: 503 and 507 in section.
