6-8 CHARLOTTE SQUARE,
NEWCASTLE UPON TYNE

ARCHAEOLOGICAL MITIGATION RECORDING
BY WATCHING BRIEF

March 2003

Report on an Archaeological Watching Brief

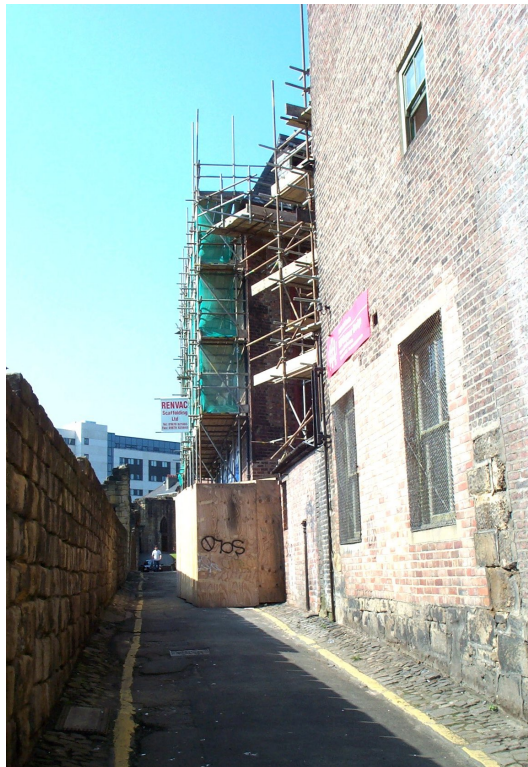
Frontispiece: North-west side of Charlotte Square facing the town wall, showing the site of works with original eighteenth century house in foreground, nineteenth century and later buildings to rear

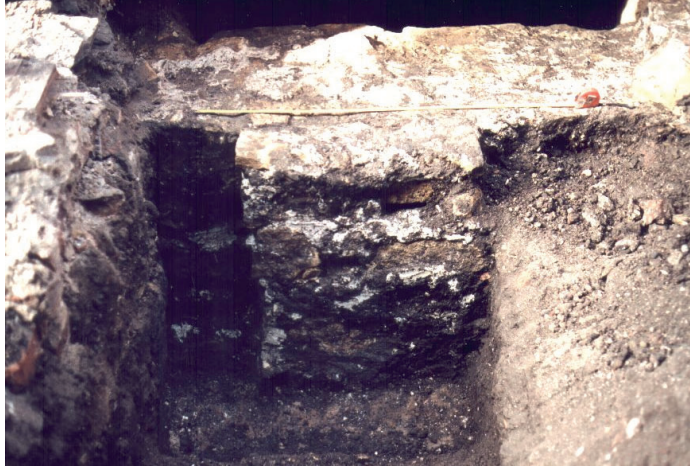
Plate 2: View of stone foundation wall from the south

A heavily-mortared stone wall was discovered during monitoring of excavations into the lower walls and footings of a nineteenth century building, the shell of which has been left largely intact behind the listed eighteenth century former house structure. The wall, which appeared to have been faced rather better on the north-west than the south-east side, was some 0.75 metres high and 0.65 metres wide, but an extension to its rear (south-eastern) side (probably to accommodate a hearth) increased its width to 0.80 metres along a 0.60 metre section. Excavations in front of both faces showed that the wall sat upon an apparently natural deposit of clay.

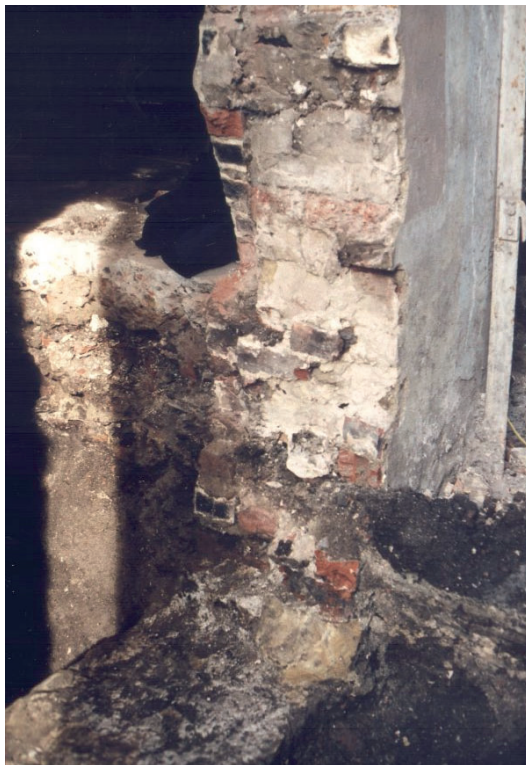
Plate 3: View from E of stone foundation directly underlying brick wall

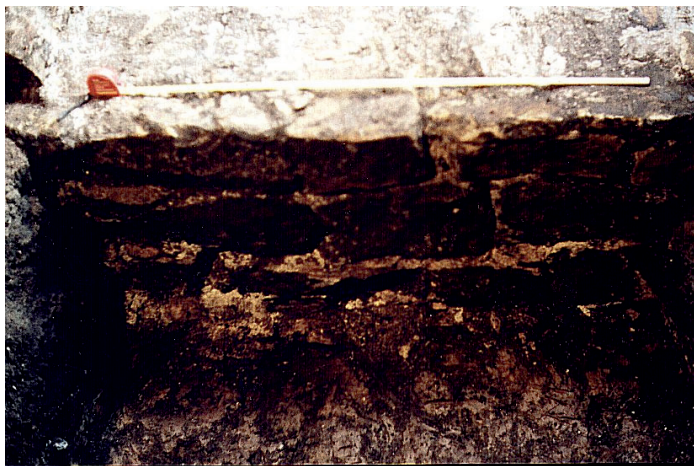
Plate 5: Close-up view of stone foundation wall from the north
