CHESTERS ROMAN FORT, VISITOR CENTRE PROPOSALS

ARCHAEOLOGICAL ASSESSMENT

JULY 2003

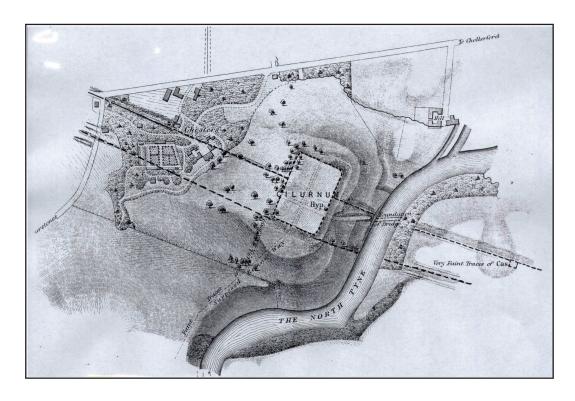
Figure 9: MacLauchlan's Plan of Chesters

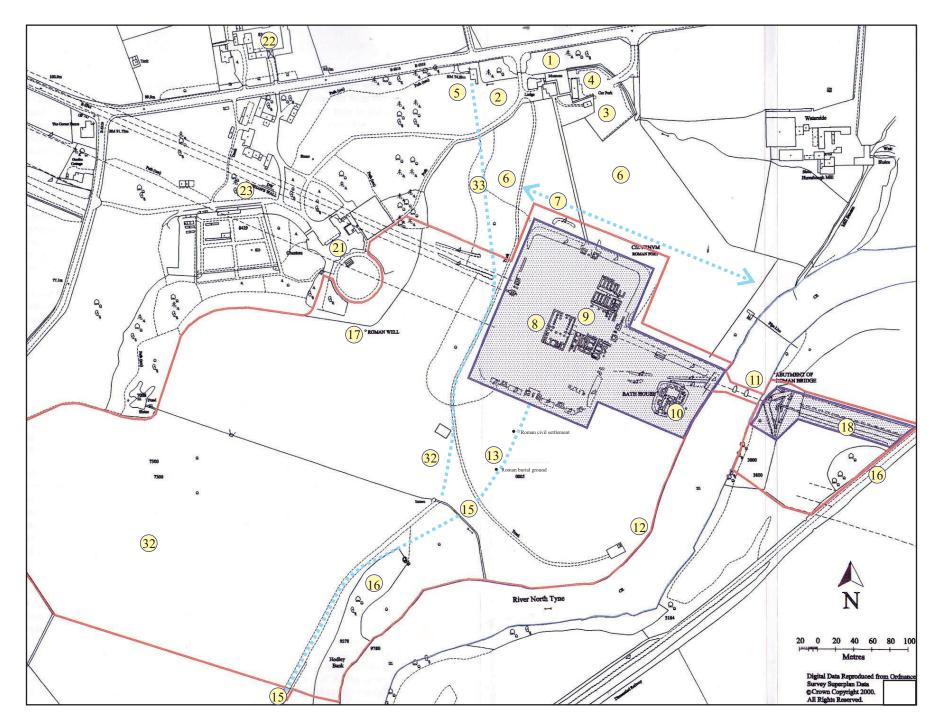
Figure 13: Sites of cultural heritage significance listed in the catalogue (Section 4): core area

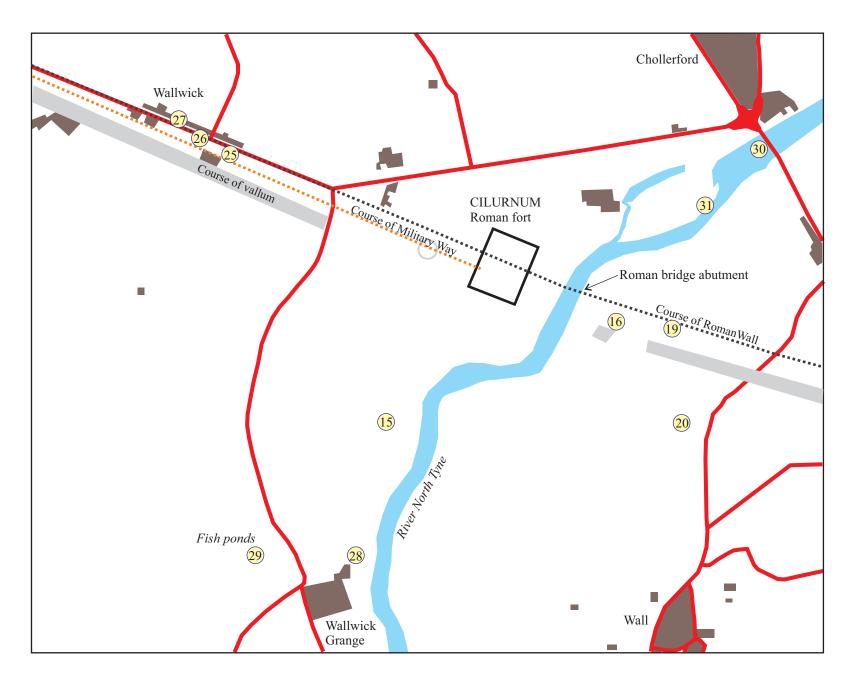
Figure 14: Sites of cultural heritage significance listed in the catalogue (Section 4): wider area

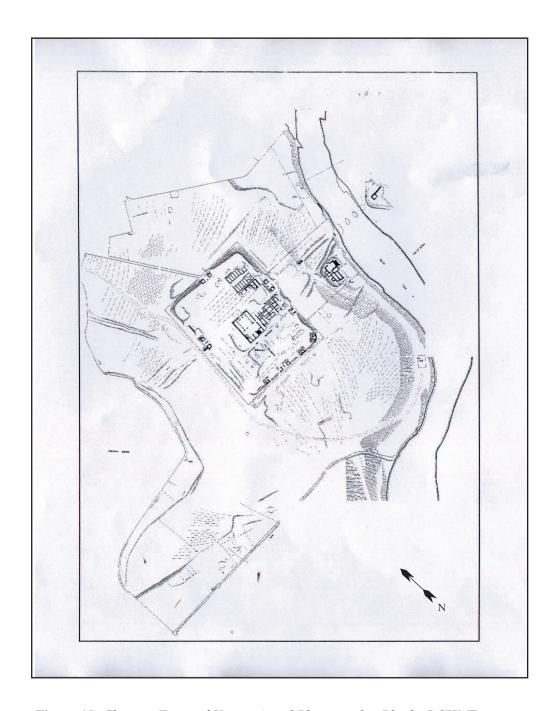
Figure 15: Chesters Fort and Vicus - Aerial Photographic Plot by RCHME

The remains of an extensive vicus were noted by 18th-century antiquarians and have been traced on aerial photography. The photographs were plotted by the RCHME in 1992-93 (see fig. 15), amplifying earlier work by Salway (1965, 78-80, fig. 8). The aerial photographic survey only revealed traces of settlement to the south, south west and east of the fort, but nowhere north of Hadrian's Wall. However, Hutchinson, whose description of the site has been termed 'the most detailed of all the eighteenth century antiquarians' (Bidwell & Snape 1993, 6), asserts that 'on the south side, without the vallum and foss, many ruins of buildings appear, and some on the north' (1778, 1, 73). The 'vallum and foss' in this context signify the fort curtain and ditch and his comments would therefore imply that traces of some buildings were evident on the north side of the fort. The existence of these structures has never been corroborated and without further information their nature and extent cannot be defined. Bruce, by contrast, stated that 'no habitations have been erected to the north of the encampment or the Wall' (1867, 155f), although the appearance of the site may have altered significantly in the century after Hutchinson had visited the site, as a result of all the landscaping work undertaken by Nathaniel and John Clayton. The presence of Roman extra-mural buildings north of the Wall is generally considered highly unlikely, but, as Bidwell and Snape (1993, 26-7) admit, Hutchinson was usually a reliable observer, with an understanding of what he was witnessing, and hence the possibility that he saw some kind of man-made features of some date cannot be discounted. The suggestion that there could be structures to the north of Hadrian's Wall associated with the fort or civil settlement in some way - funerary monuments or quarry features perhaps - is still intriguing therefore.

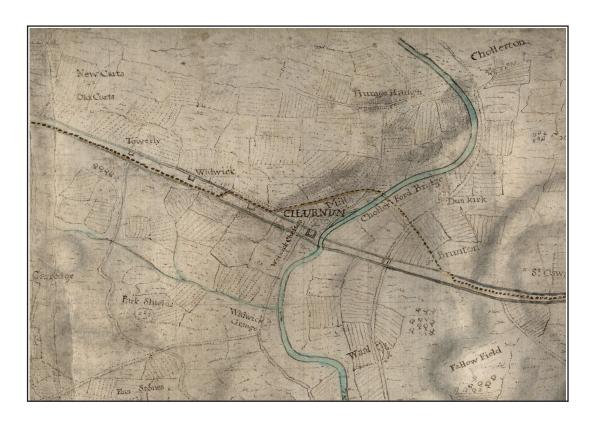
Figure 17: (ZAN MSM5) Extract from the Military Road Survey, 1749

The creation of the stretch of the Military Road immediately north of Chesters had the most significant impact on the proposed development area, prior to the building of the museum. The 1749 survey (fig. 17) suggests that this section of the route was already in existence. It may have been constructed earlier in the 18th century to connect with the new Chollerford Bridge [30], which replaced the medieval bridge after 1733 and was itself destroyed by the great flood of 1771 and replaced by the present structure in 1775. The 1749 survey reveals another trackway [7] running WNW-ESE, which also passed to the north of the fort, but on a more southerly alignment, and was probably the predecessor of the current route. This earlier lane connected Walwick with Humshaugh via Humshaugh Mill at Waterside, a short distance upstream from the Roman bridge. It may originally have led directly to the medieval bridge [31], which lay roughly midway between the Roman Bridge and 18th century Chollerford Bridge. The track is possibly to be identified with a linear ditched feature traced by geophysical survey just north of the fort. The lane had presumably developed into a sunken holloway as it passed north of the fort, like the trackway northwest of the fort [33]. The geophysical survey suggested that the feature was stone lined. Such stone might represent the remains of stone walls on either side of the lane to prevent livestock straying on to the arable land on either side, or stone cleared off the ploughland and piled along the roadside, or conceivably buildings alongside the trackway.

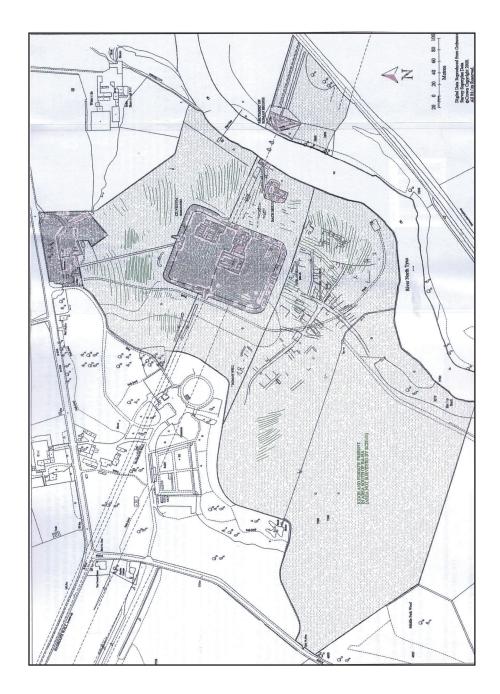
Figure 18: RCHME survey of ridge and furrow at Chesters (extract from the Chesters Conservation Plan)

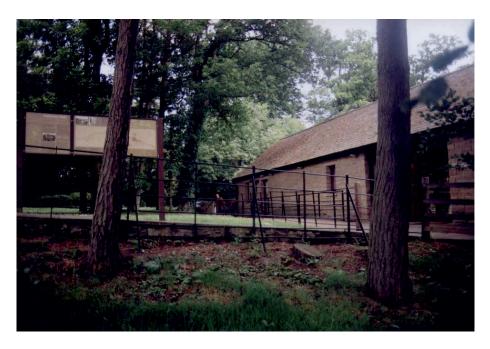
Plate 7: The open area viewed from the south, showing the rise in ground level
