# BELLINGHAM FLOOD DEFENCE BANK BELLINGHAM NORTHUMBERLAND

REPORT ON ARCHAEOLOGICAL WATCHING BRIEF

MARCH 2008

**PROJECT:** Archaeological Watching Brief on the Hareshaw Burn  
**LOCATION:** Bellingham, Northumberland  
**CLIENT:** The Environment Agency  
**SITE GRID REF:** NY 837 832  
**FIELDWORK:** March 2008  
**OASIS REF:** thearcha2-41653

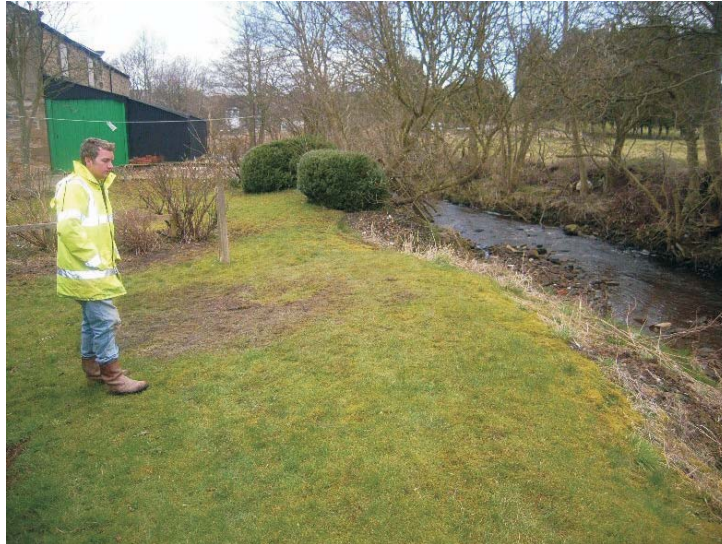
**Illus. 09:** The position of Trench 1, viewed from SSW.

Trench 1 was excavated in the centre of the town on the north-west bank of the Hareshaw burn some 150 metres north-east of its confluence with the North Tyne. A sandy loam topsoil

was excavated to a depth of some 0.60 metres until a deposit containing black cinders and lime was encountered, at which point the excavation was suspended. The origin and precise constituents of the black cinders deposit were unknown.

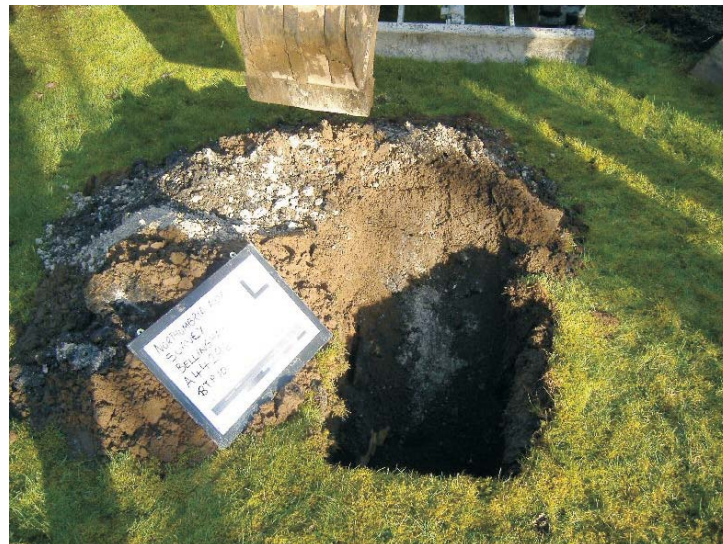
**Illus. 10:** Trench 1 following excavation.

The black deposit excavated in this trench could have been derived from domestic or industrial waste activities, perhaps originating from the former Hareshaw ironworks which lies upstream of this point. It may be that the cinders deposit formed part of the riverside bank prior to the construction of the flood prevention bank on top of it; alternatively, it could have been taken from the spoil of the Hareshaw industrial complex or another local concern in order to provide material for use in the flood prevention bank. This question can not presently be answered, but could be resolved by cutting a complete section through the bank.

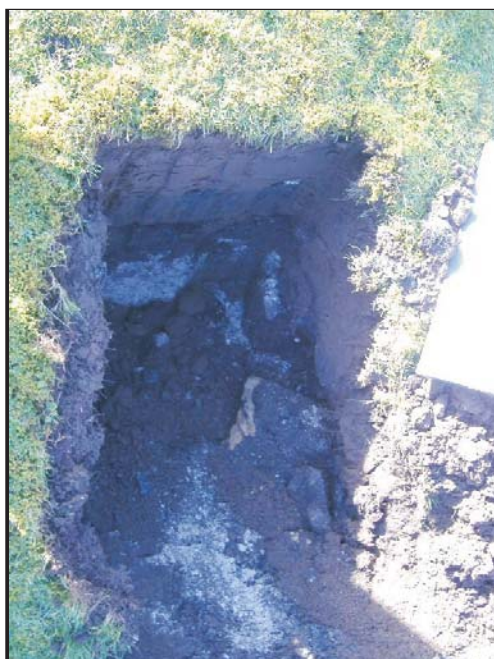
**Illus. 11:** Trench 1 following excavation - vertical view showing lime and 'cinder' deposits

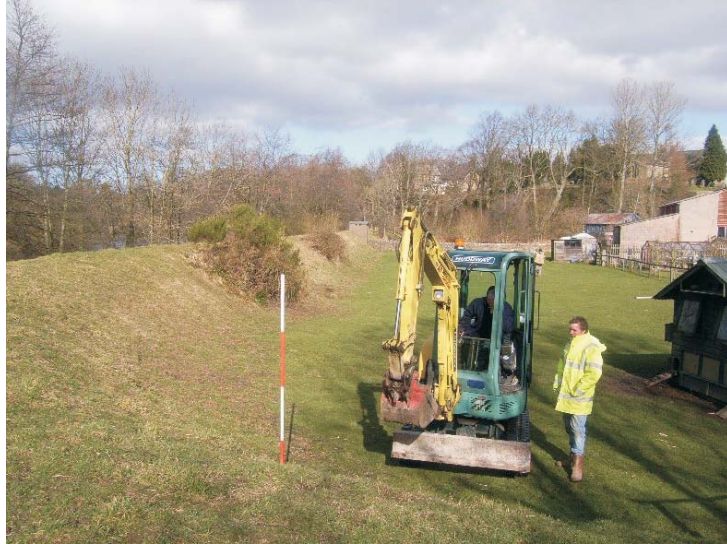
***Illus. 12:*** The position of Trench 2, viewed from the south.

Trench 2 was excavated into the curving south end of the flood defence bank which skirts the north-east bank of the lower course of the Hareshaw Burn and the north-east bank of the North Tyne above its confluence with the Hareshaw. Excavation revealed that the bank was comprised of a gravely sand to a depth of 2.5 metres, the lower part being darker in colour but of similar texture. At about 2.5 metres from the top of the bank, or about 0.10 metres below the current ground level inside the bank, was a deposit of river cobbles. This appears to be the natural sub-soil and flooded when excavated further.

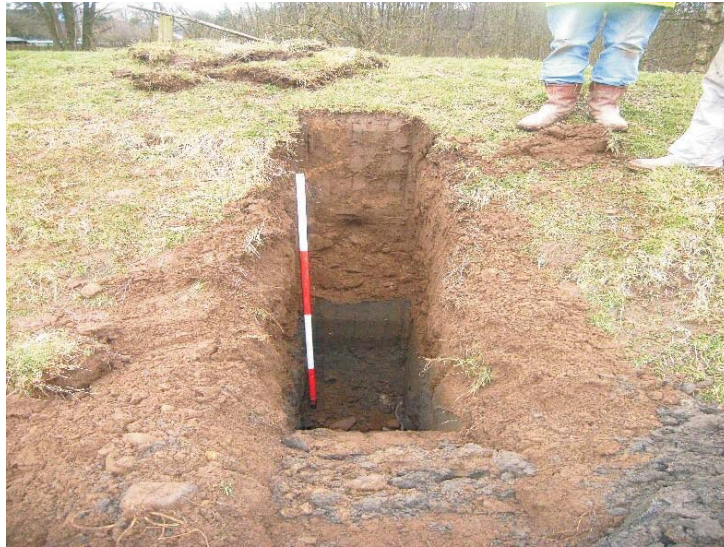
The flood defence bank has been constructed from a sandy gravel matrix possibly derived from dredging, apparently dumped upon the existing ground surface. No structures or features of archaeological significance were revealed within, underneath or inside the bank.

***Illus. 13:*** Trench 2 following excavation, viewed from the north.

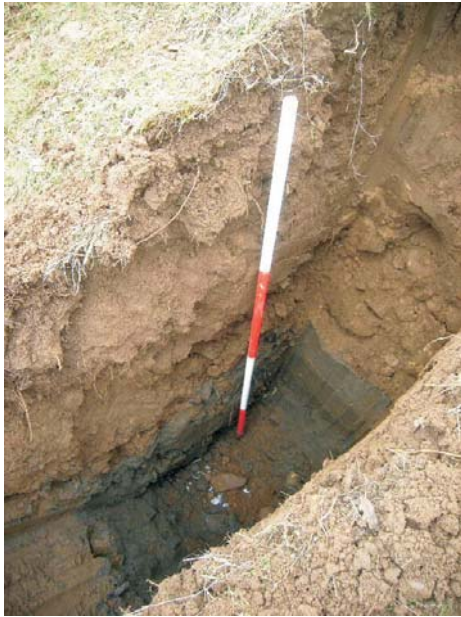
**Illus. 14:**  
*Trench 2 following excavation*

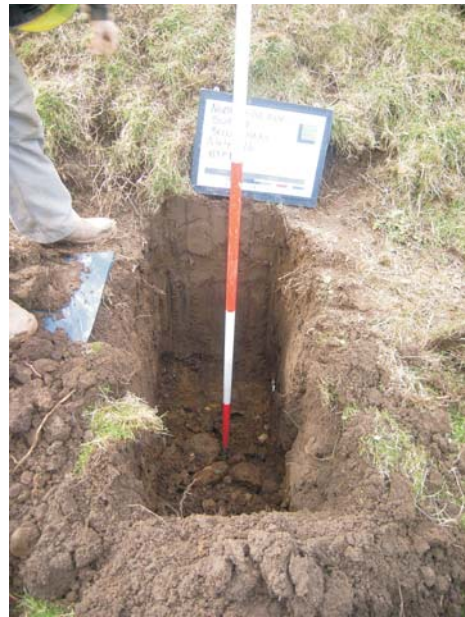
Trench 2 was excavated into the western (NNW-SSE) arm of the flood defence bank which skirts the north-east bank of the lower course of the Hareshaw Burn and the north-east bank of the North Tyne above its confluence with the Hareshaw. Excavation was carried out into the foot of the bank to a depth of one metre. This revealed that the bank, as in Trench 2 was comprised of a gravely sand. Excavation east of the bank revealed that this deposit extended underneath and outside the bank to a depth of about 0.9 metres before giving way to a deposit of river cobbles, the natural sub-soil.

The flood defence bank has been constructed from a sandy gravel deposit, possibly derived from dredging. The presence inside the bank of a deposit of sandy deposit similar in character to the bank which extended to a depth well below the foot of the bank may perhaps be explained by levelling of the sloping bankside ahead of the construction of the bank. No structures or features of archaeological significance were revealed within, underneath or inside the bank.

**Illus. 15:**  
*Trench 3 following excavation,  
viewed from ENE.*
