HEESTON BANK, KIRKWHELPLINGTON,
NORTHUMBERLAND

ARCHAEOLOGICAL MITIGATION RECORDING
BY TOPOGRAPHIC SURVEY

HEESTON BANK, KIRKWHELPINGTON, A696 ROAD IMPROVEMENT

Report on Archaeological Mitigation Recording

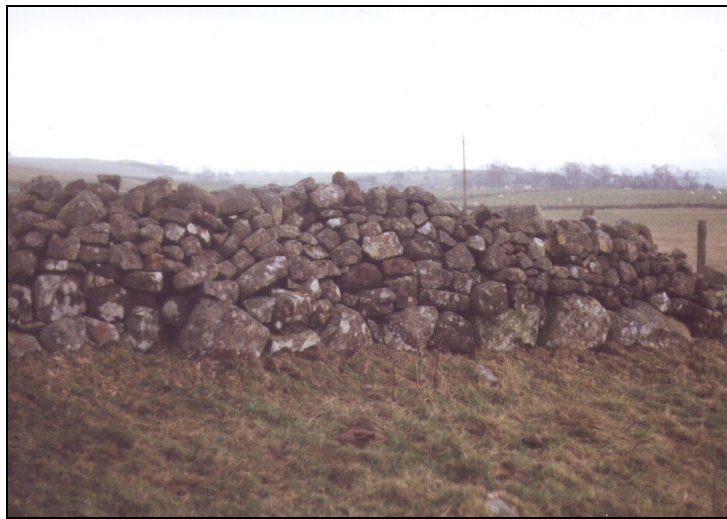
Frontispiece: Stone boundary bank marking N-E side of the survey area

Several banks and walls, probably of Enclosure period, border the east side of the southern road bend in the south-east part of the assessment area. Some appear to form part of a linear feature linking Kirkwhelpington village with a system of holloways (see *Frontispiece*).

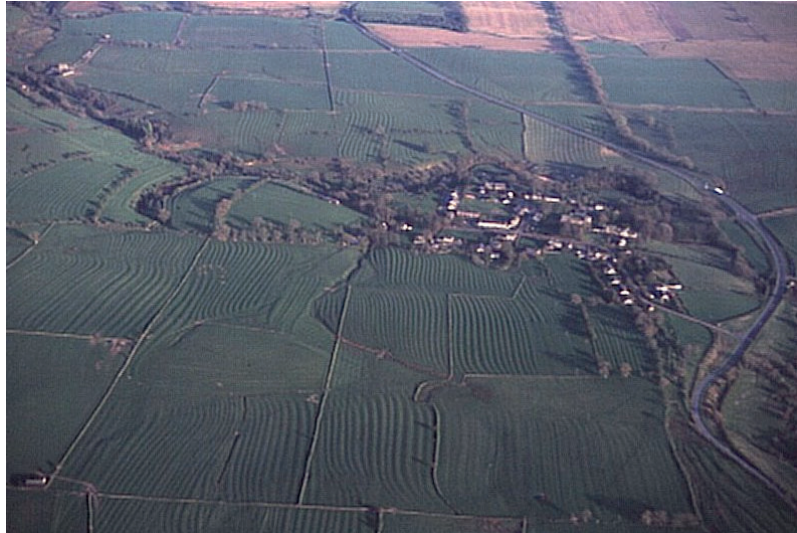
Plate 2: *Aerial view of Kirkwhelpington village and its field system from the North, including S-E part of surveyed area*

A more recent, colour view of Kirkwhelpington and its field system which includes the southern end of the holloways system (the works compound area). Similar to *TMG 3752/43* (above) but viewed from the south-east (rather than the north-east) and includes rather more of the holloways complex.

A ridge and furrow system, possibly associated with West Whitehall farm, is apparent on aerial photographs (e.g. *NU NY 9984/G*, above) and, although difficult to detect visually on the ground, may well cover the entire expanse of pasture land between West Whitehall and the present Kirkwhelpington village access road (see *Plates 2 & 12*).

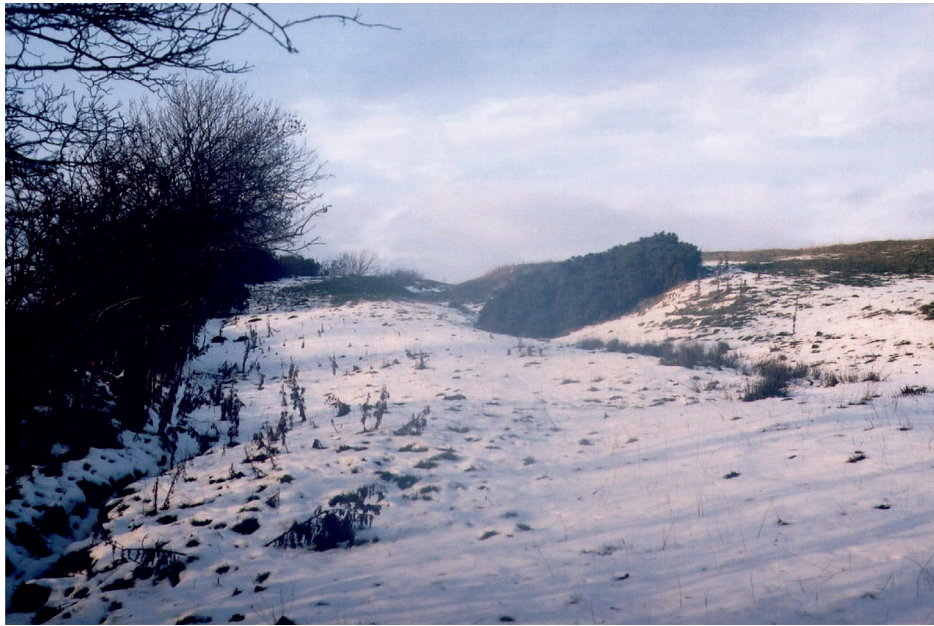
*Plate 3: Holloway feature removed during recent road improvement works
(Photographed January 2002)*

A complex system of earthworks, comprising holloways and banks, situated in the fields immediately adjacent to the east side of the northern bend in the road (see *Cover Photograph* and *Plates 3-10*). The trackways are located within a wide corridor, bounded by field banks and walls, which apparently leads north out of Kirkwhelpington village. Their steep, V-shaped profiles suggest the tracks were created by the passage of packhorses or livestock rather than wheeled traffic. They probably represent successive routes across the marshy ground of the hillside, with each being abandoned and replaced by another as it became impassable. The only such holloway occurring within an area likely to be impacted by the proposed works is close to the northern bend in the road at (approx.) NGR NY 9915 8515 (see *Plate 3*).

1. The holloway *[1]* and slight traces of underlying ridge and furrow *[2]* closest to the previous course of the highway was completely removed by cutting into the slope on the east side of the road.
2. Some features associated with the turnpike *[3]* - field walls, etc. – were impacted by earthwork operations and carriageway construction.
3. Parts of the system of holloways and related earthworks associated with the destroyed holloway *[1]* suffered limited, localised damage, principally from works vehicles, particularly in the south-east corner of the survey area, north of the village access road, where earthworks were covered by a spoil dump within the site compound.

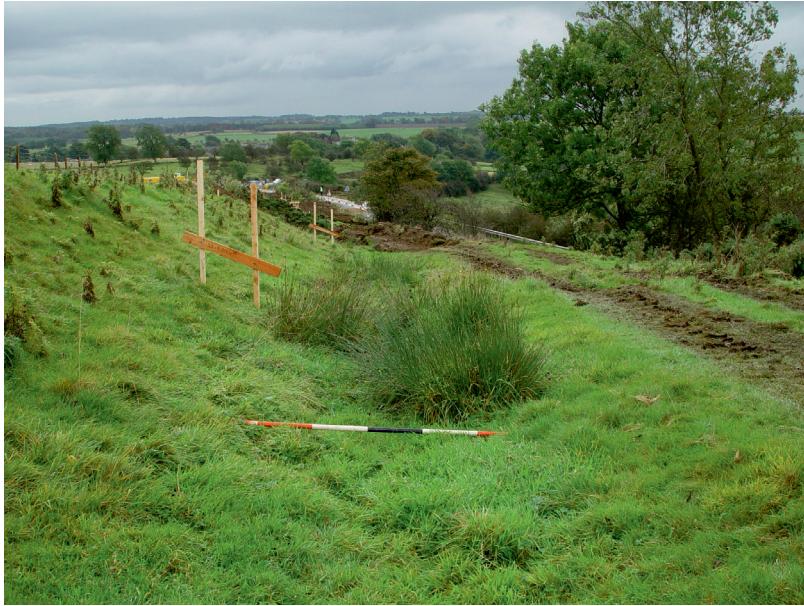
Plate 5: N-W section of holloway feature, looking S-E towards works compound

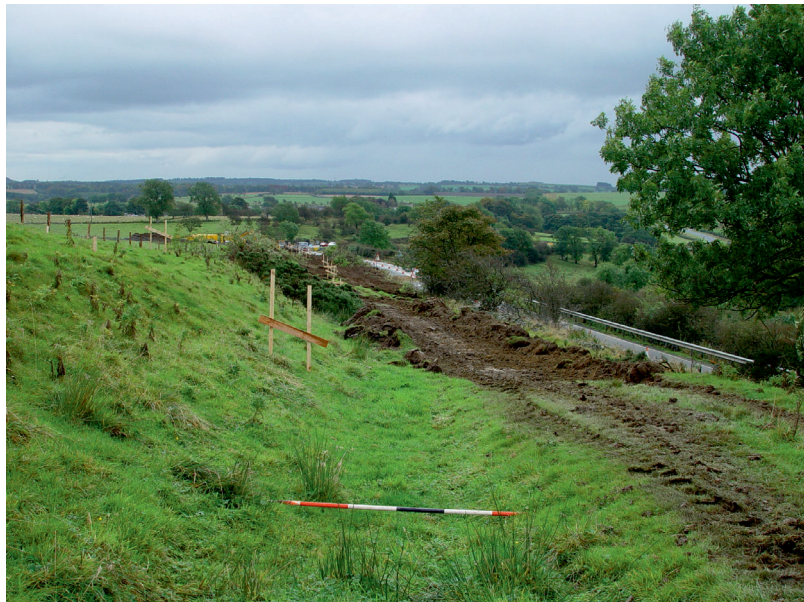
Plate 6: Middle section of holloway feature, looking S-E, with holloway partly infilled.

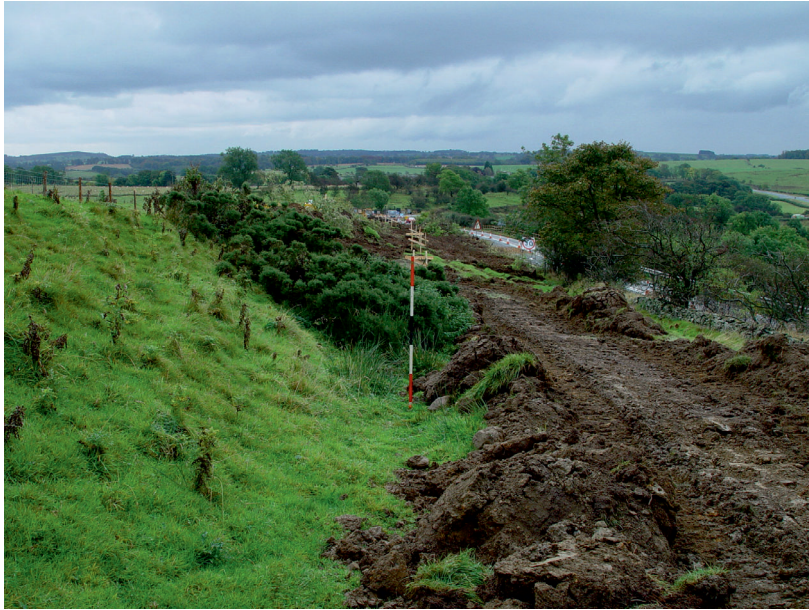
Plate 7: Middle section of holloway feature, looking S-E, showing surviving traces of holloway

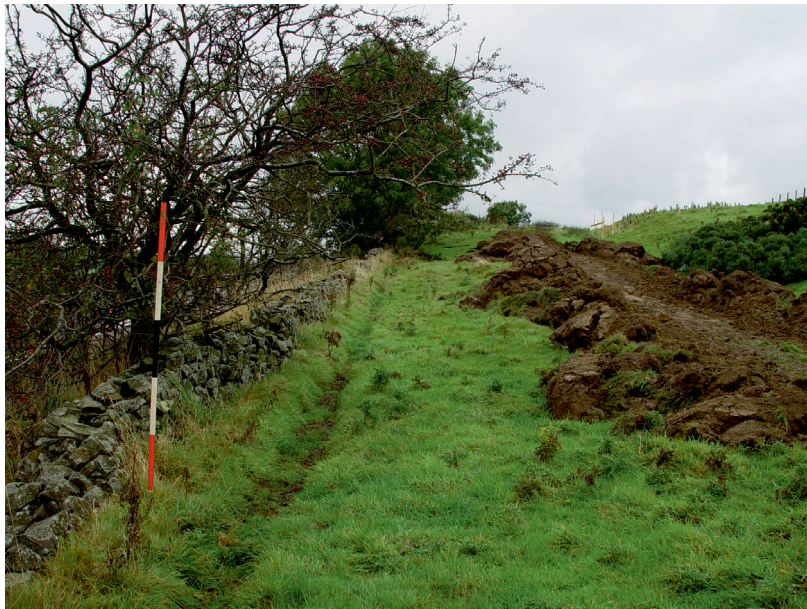
Plate 8: Roadside wall and infilled holloway, showing profile of holloway (N-W end).

mid-eighteenth century, indeed, the volume of traffic along the route had become so heavy, and the state of the road so ruinous, that a Bill was presented to the House of Commons petitioning for a law to turnpike the road from Newcastle as far as the north side of the Wansbeck (Lawson 1971, 187). This was eventually successful. In 1830 an Act was passed to alter the line of the existing turnpike, diverting it west of the previous line north of Belsay, through Kirkwhelpington and onwards into Redesdale, through Otterburn to the border at Carter Bar. Work on “The New Line” began in the early 1830s, with the stretch between Kirkwhelpington and Knowesgate probably completed in, or shortly before, 1836 (*op. cit.* 199-200). The present road represents a stretch of this new 'cut-off' route and may preserve features, such as field walls and buried surfaces, dating to the time of its inception (see *Plates 2 & 8*).

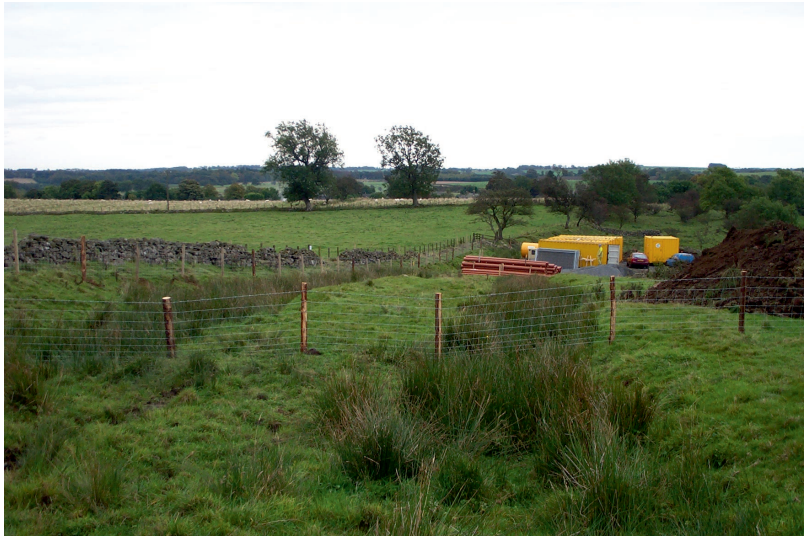
Plate 9: Holloways running S-E into works compound area, with soil dump to right

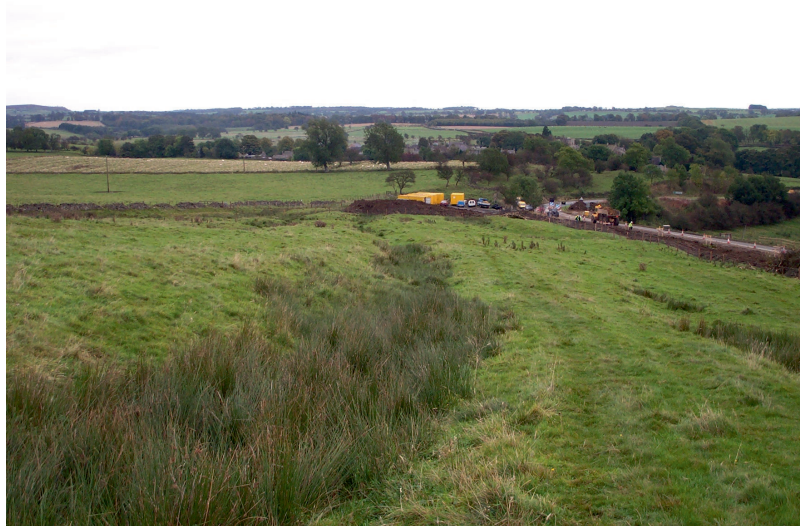
Plate 10: Holloway running S-E towards works compound

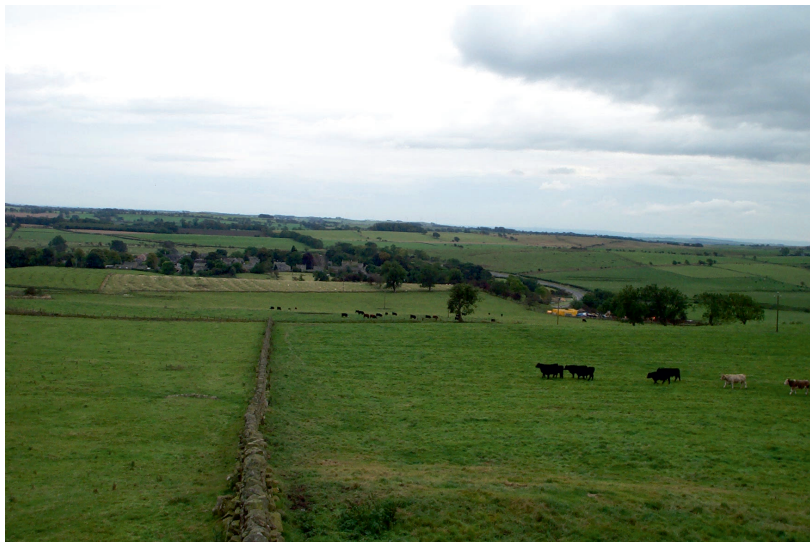
Plate 12: View from North towards Kirkwhelpington village and site works compound, with cattle standing in a field of ridge & furrow E of survey area
