ST MICHAEL AND ALL ANGELS CHURCH,
ALWINTON
NORTHUMBERLAND

ARCHAEOLOGICAL MONITORING BY
WATCHING BRIEF

May 2004

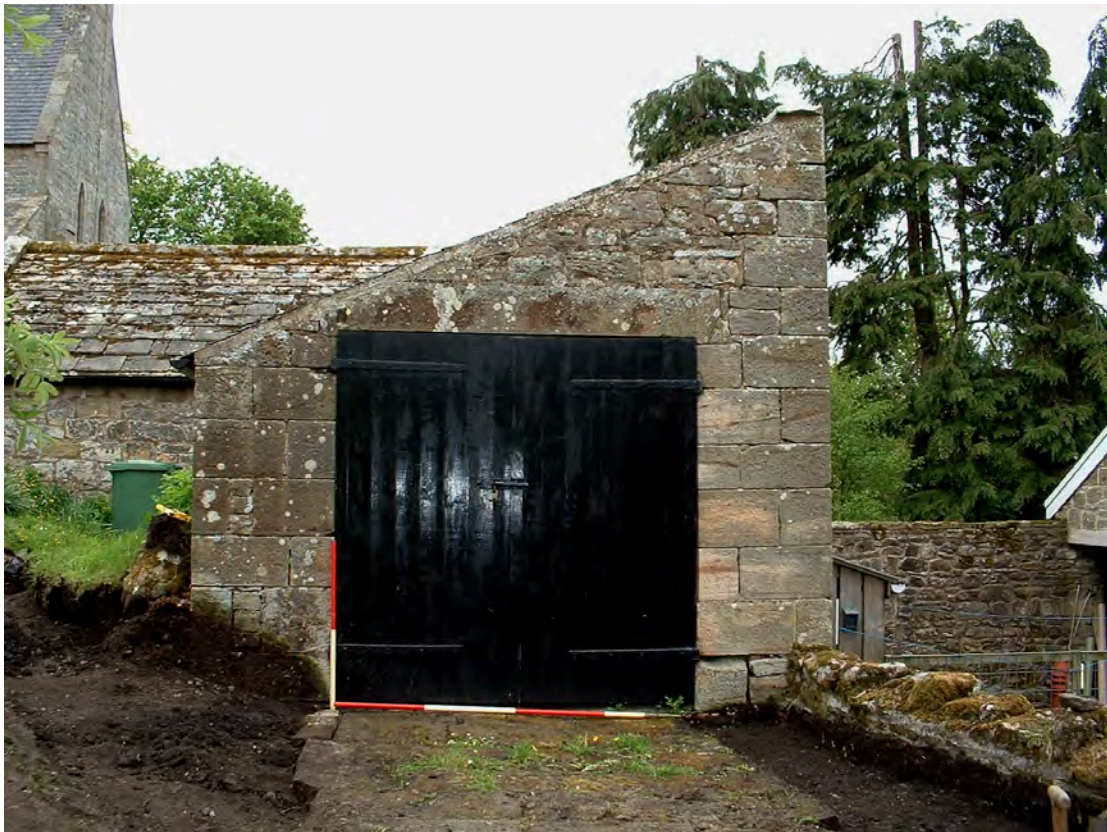
Frontispiece: The vicarage garage doors, showing removal of built-up soil from the wall

Frontispiece: View of the vicarage garage doors, south-east view.

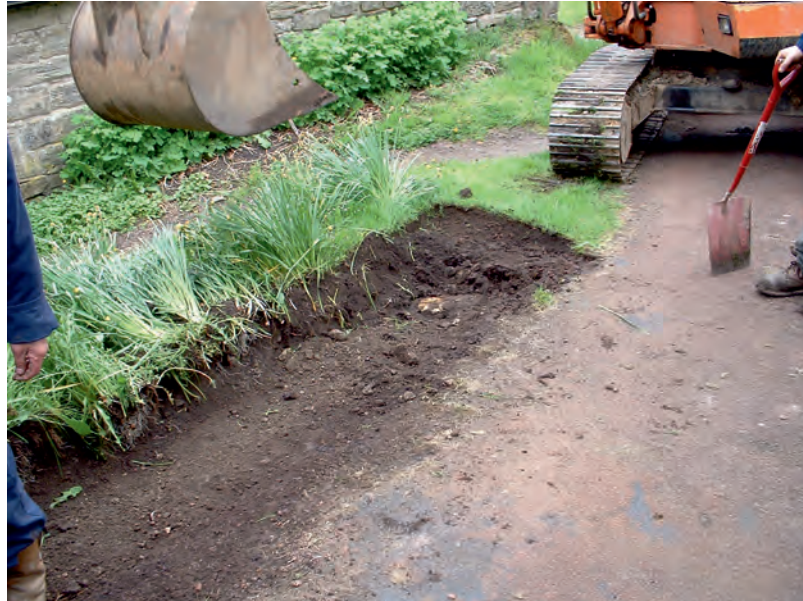
Plate 2: Overview shot of groundworks, west view.

Plate 2: Soil removal for the creation of a footpath.

Excavation of a trench to create a foundation for a footpath (*plates 2-4*), and postholes to hold a handrail (*plates 3, 5-7*) took place in a single day, with the entire operation supervised by an archaeologist. Removal of turf and topsoil [101] revealed a deposit of dark brown soil [102] that occupied the length of the trench. This deposit seems to be a dump of plough soil and appears to be the result of natural soil creep building up against the building walls. This deposit contained very few finds, however what pottery did occur was of a Victorian (or later) date. This deposit continued down to the maximum excavated depth of 0.50m (postholes for handrail supports).

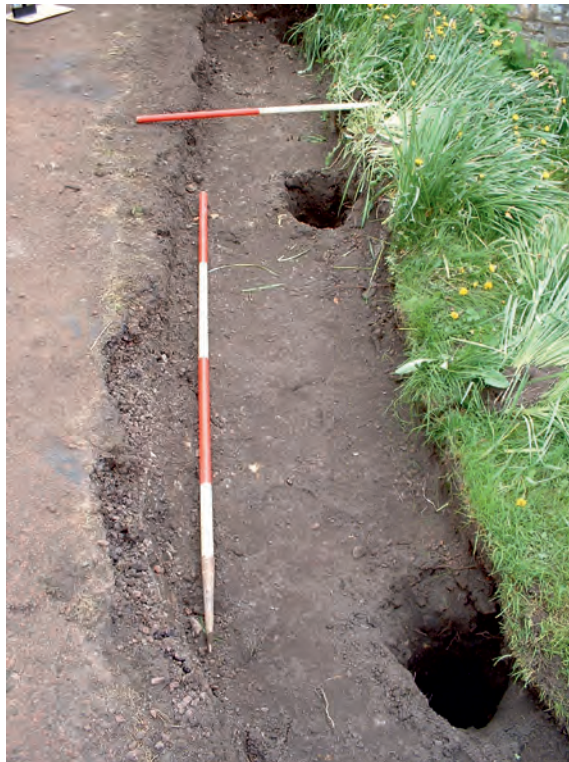
Plate 3: Overview shot of groundworks, south-east view.

Plate 3: The shallow trench excavated for the creation of a footpath, showing postholes excavated under the scheme of works.

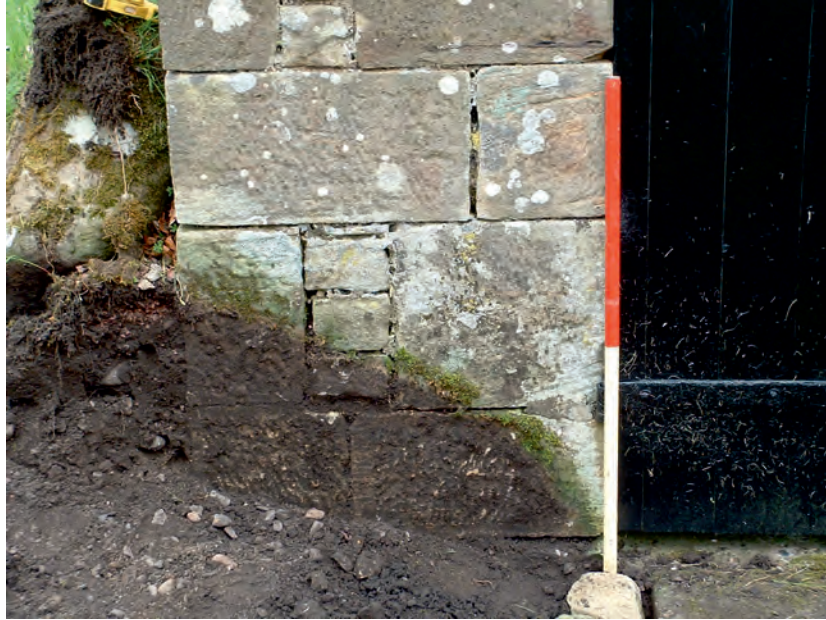
Plate 4: Soil removal from vicarage garage wall, south-east view.

Plate 4: Soil removal for the creation of a footpath, showing the build-up of soil removed from the vicarage garage wall.

The deposits encountered throughout the trench seem to suggest little activity in this area at a shallow depth. The position of the site on a slope would account for the build up of plough/garden soil against the walls of surviving structure, and the modern material recovered from this deposit would seem to suggest the build up occurred in the last 150 years.

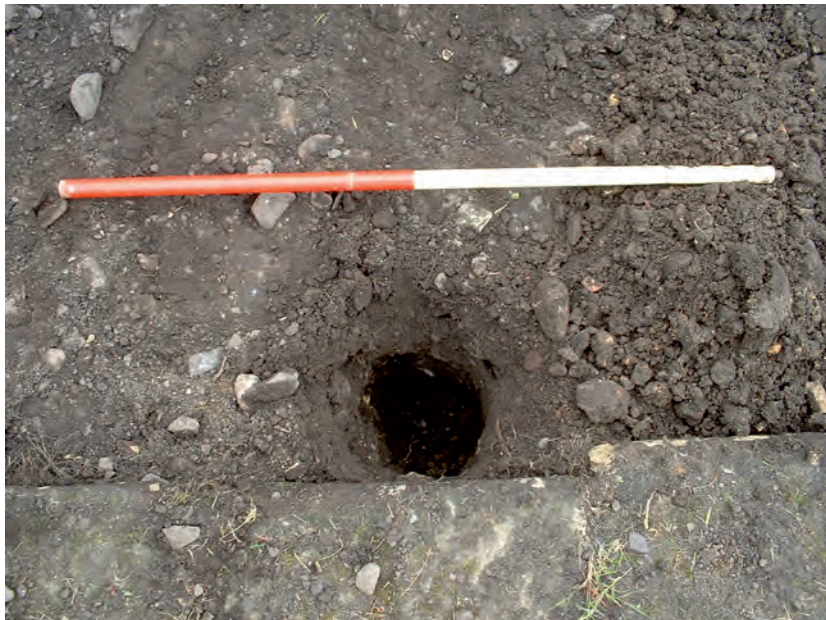
Plate 5: Shot in plan of posthole 'g', excavated under the current scheme of works.

Plate 5: Posthole 'g', excavated under the present scheme of works.

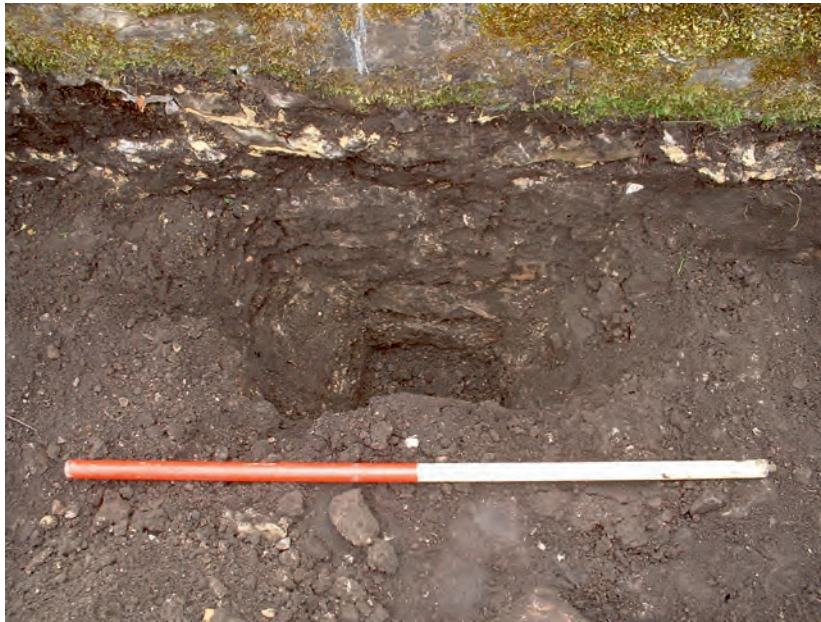
Plate 6: Shot in plan of posthole 'j', excavated under the current scheme of works.

Plate 6: Posthole 'j', excavated under the present scheme of works.

A larger concentration of roofing slate [103] (*plates 6-7*) was observed adjacent to the stone wall attached to the garage and may represent dump material from former “lean-to” structures attached to the vicarage side of this wall which have been demolished.

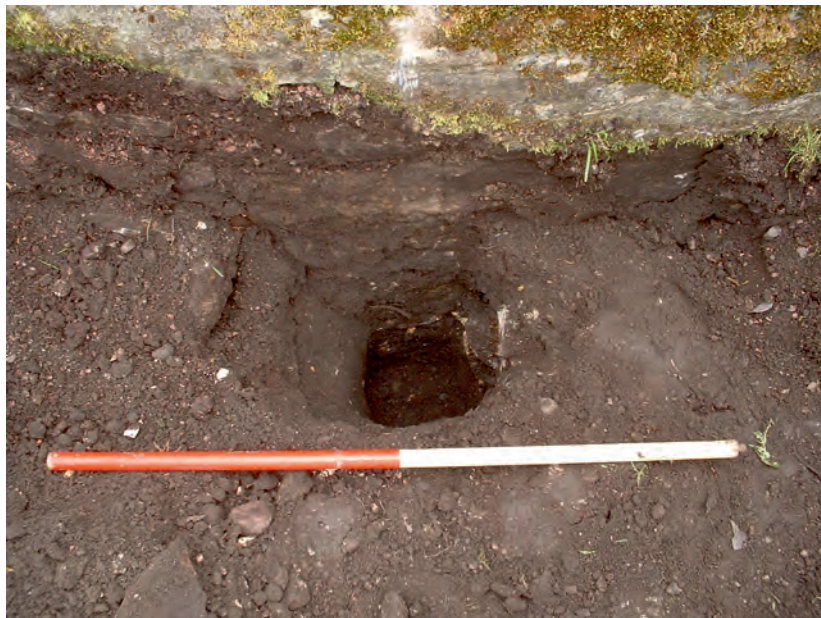
Plate 7: Shot in plan of posthole 'k', excavated under the current scheme of works.

Plate 7: Posthole 'k', excavated under the present scheme of works.
