CORCHESTER LANE, CORBRIDGE

ARCHAEOLOGICAL WATCHING BRIEF AND EVALUATION

APRIL 2004

Archaeological Watching Brief
and Evaluation

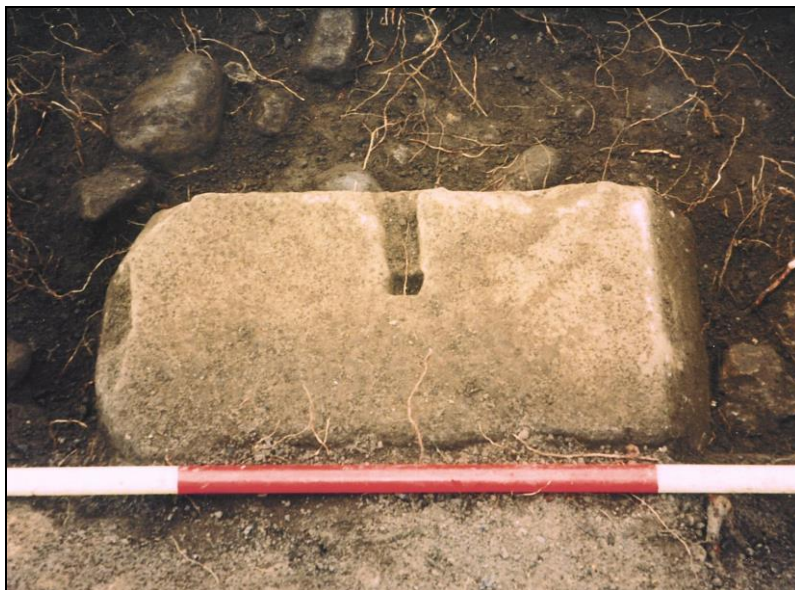
*Frontispiece: Re-used Roman masonry in wall uncovered at the east end
of the Corchester Lane works*

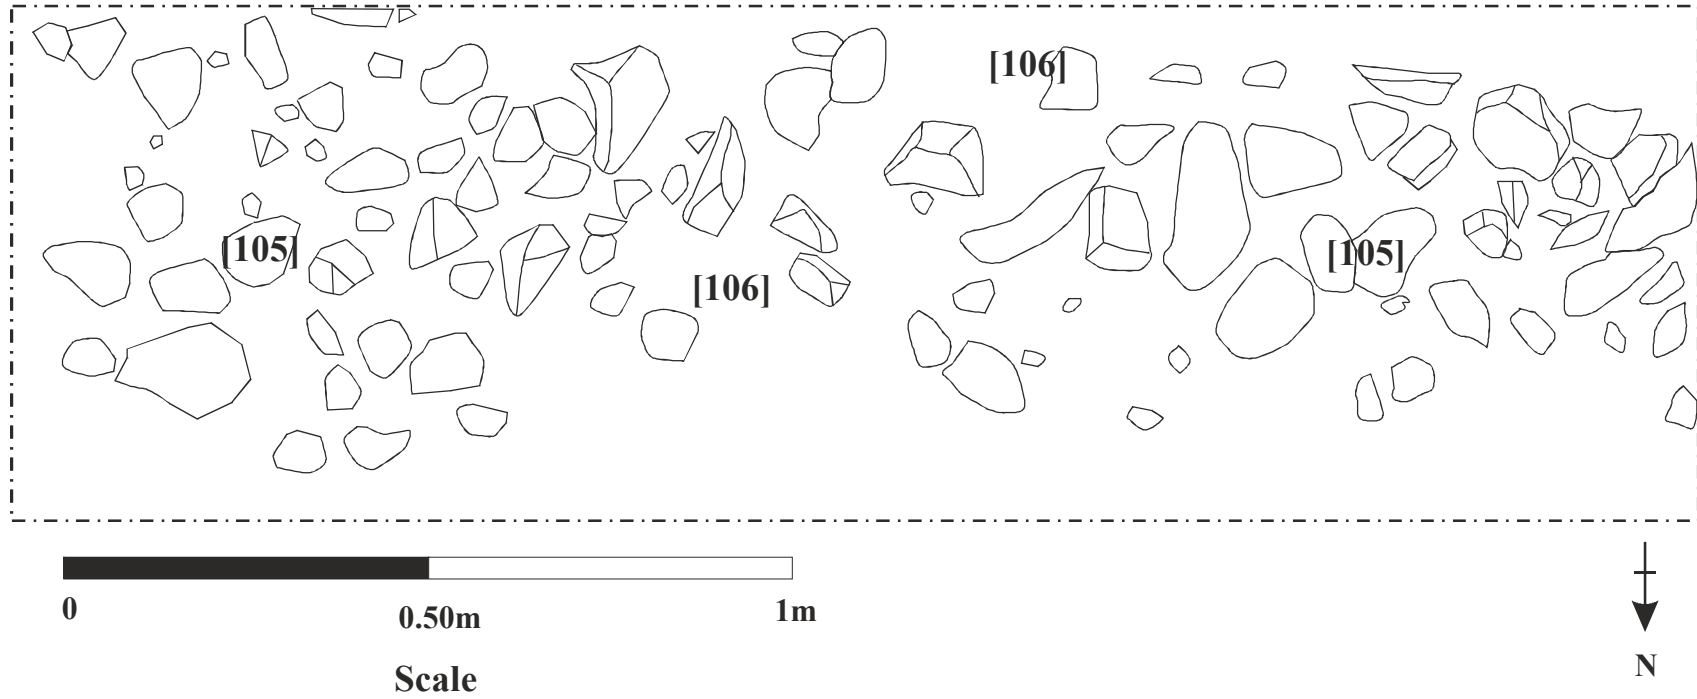
Figure 5: Plan of cobbled area uncovered in footpath foundation trench

At 33.1m from the western end of the footpath cut, an area of cobble stones [105] was encountered in the southern half of the trench (*Figure 5; Plates 3 & 4*). These river rounded cobbles were deposited about 0.10m below the present road surface, ran for about 2.50m, and held in a soil matrix [106] very similar to that encountered above (and either side of) the cobbles [102]. These stones were very loosely compacted, very uneven, and the clean matrix in which they were held suggests that they did not form a road or cobbled surface, and they may represent an episode of field clearance, or the filling of a depression in the land to create an even surface. The absence of finds of any kind made it impossible to date this feature.

The deposits encountered in the majority of the trench do not suggest significant activity in this area. The cobbled area [105] might represent an episode of field clearance, however their river-rounded appearance might also hint at their use as a method of levelling. Such methods can often be used when a field entrance has been used for a prolonged period, and the resultant erosion causes a depression that requires filling/levelling.

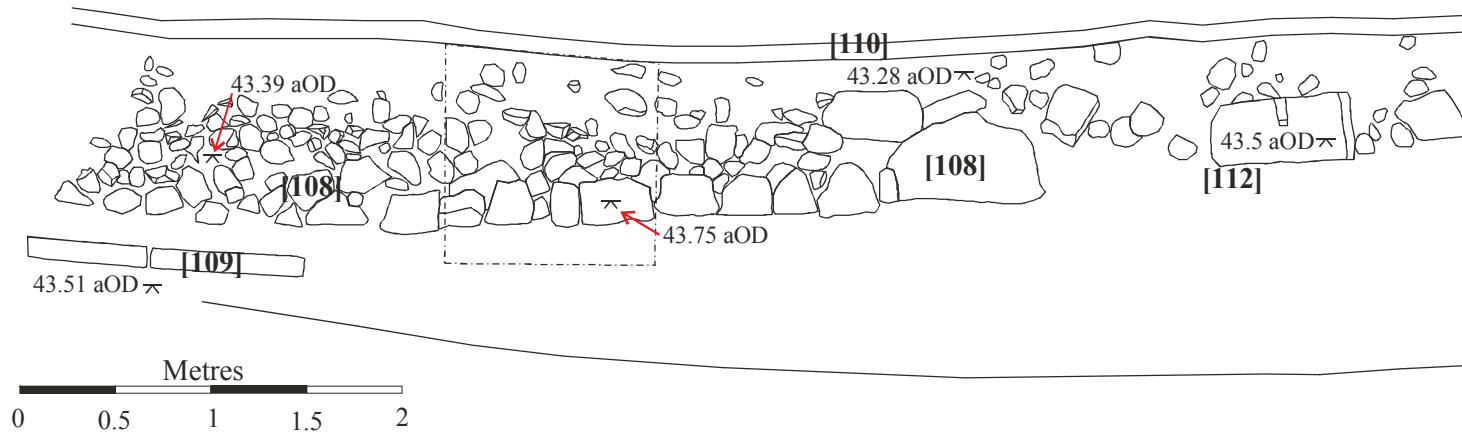
Figure 6: Plan of wall feature at East end of pathway, showing position of evaluation slot

Where Corchester Lane bends to enter the town of Corbridge, a length of stone wall [108] running for about 8.50m was uncovered (*Figures 6 & 7; Plates 5-8*). This wall consisted of roughly worked sandstone facing blocks (on the north side), with what appeared to be a rubble core surviving in places. The southern facing had been completely removed, possibly when a water pipe [110] was inserted. A cut was opened across the wall and revealed three or four courses of facing surviving to a depth of 0.40m below the present road surface. To the south of the wall, excavation revealed a guarded electricity cable [111] in between the water pipe and the surviving wall core,

There was no evidence of a mortar bonding, with the stone set in a dark brown compact soil. Due to the lack of finds (one small fragment of Roman pottery and a few fragments of post medieval/ modern material) it is impossible to date the wall, however the re-use of a Roman stone (one with a Lewis hole) in the wall [112] suggests a late/post Roman structure.

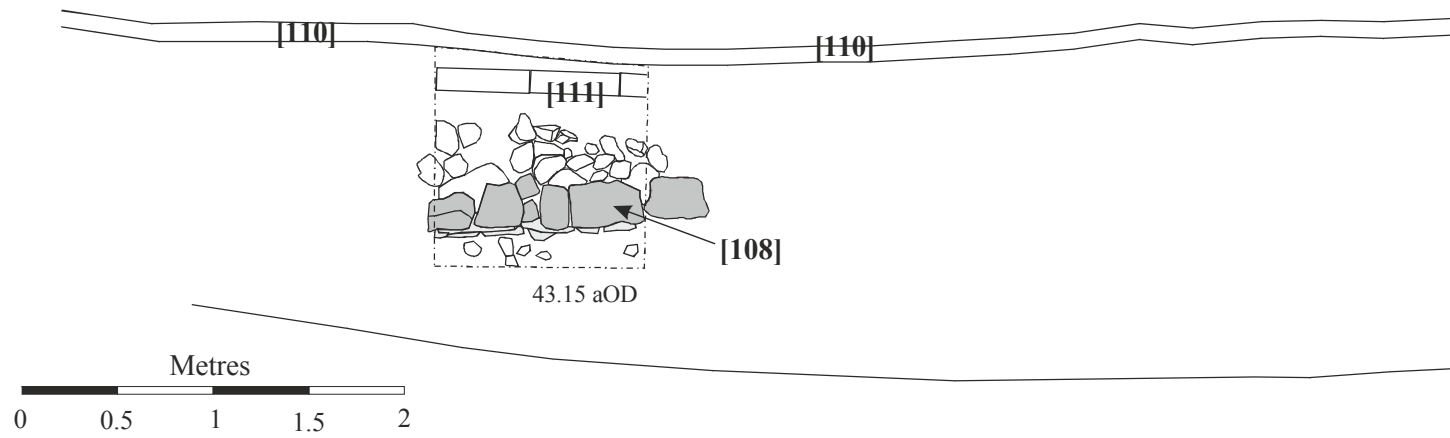
Figure 7: Plan of evaluation slot in wall feature at East end of pathway

The appearance of a wall at the eastern end of the trench is a more significant discovery. Although disturbed by the insertion of services, the wall survived, and appears to have been quite substantial (at

least *c.* 0.75m wide). Although no datable material was recovered from the wall deposits, the re-used Roman stone suggests a post- (or possibly late-) Roman structure. Although disturbed on the south side, enough survived to show that the wall had been a substantial structure, massive enough perhaps to have served as a boundary wall. It is interesting to note that the wall is not marked on any of the earlier plans of Corbridge, and there are no associated walls evident on plans compiled from crop mark and excavation results.

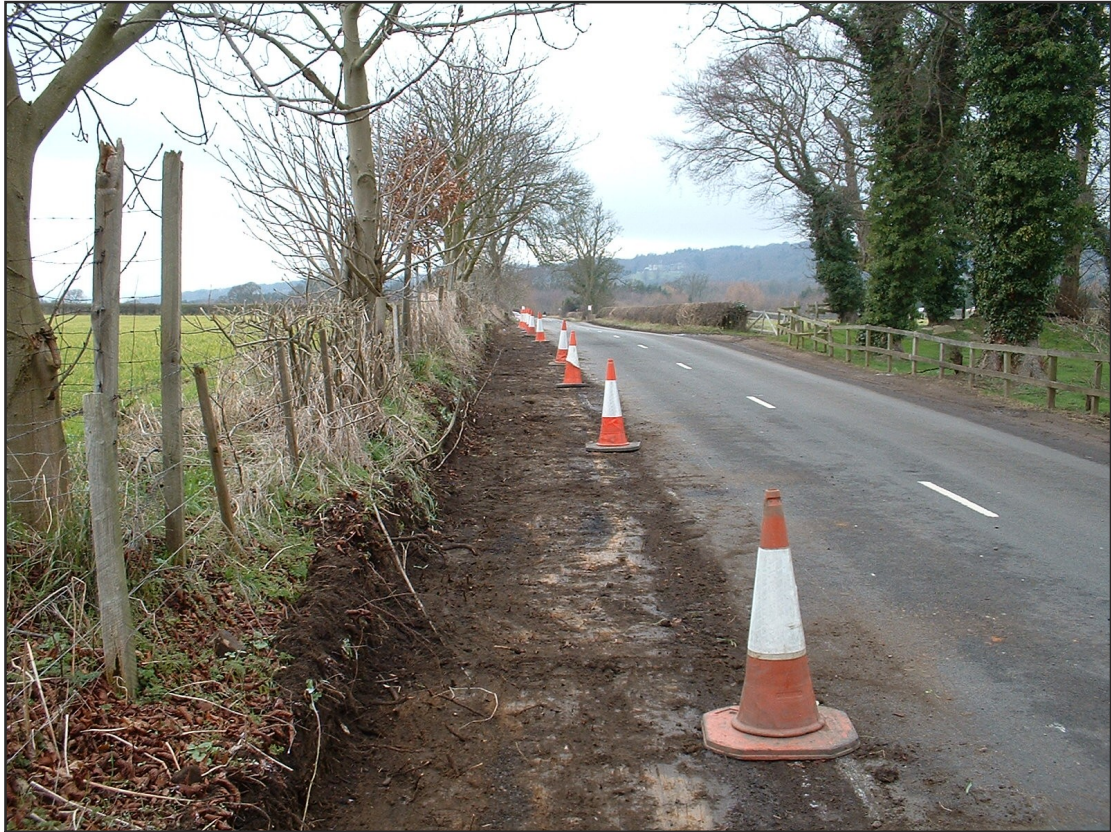
Plate 1: General view of the strip of land excavated to make way for the new footpath (facing west towards the English Heritage Visitors Centre)

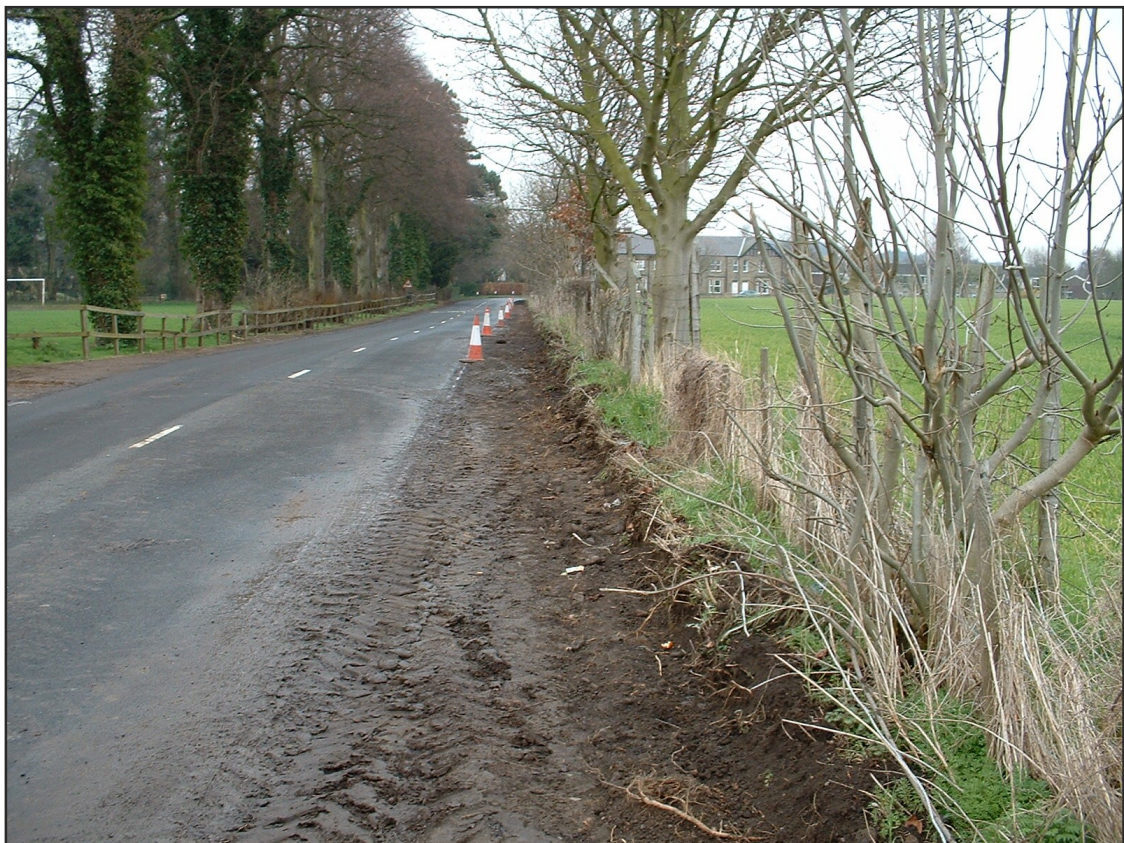
Plate 2: General view of the strip of land excavated to make way for the new footpath (facing east towards Corbridge)

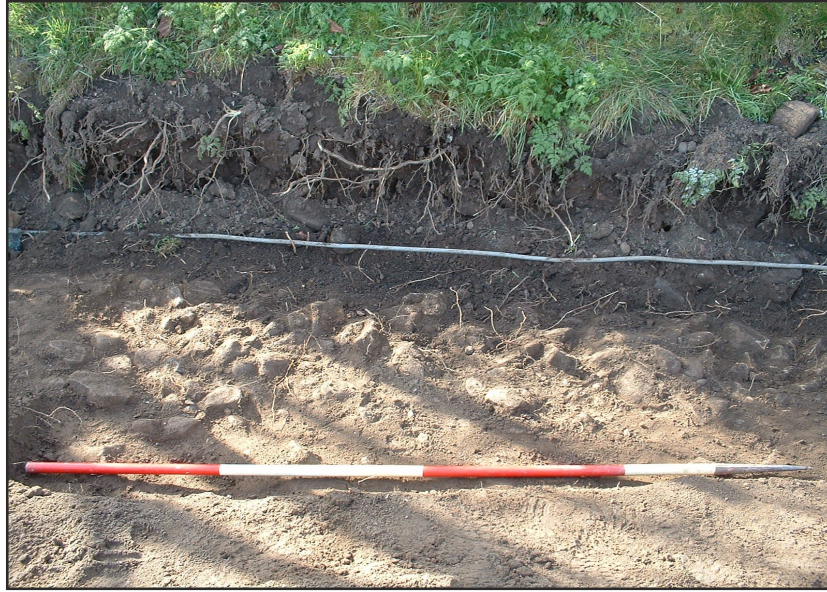
Plate 3: Deposit of rounded stones or cobbles [105], possibly the product of field clearance or land levelling

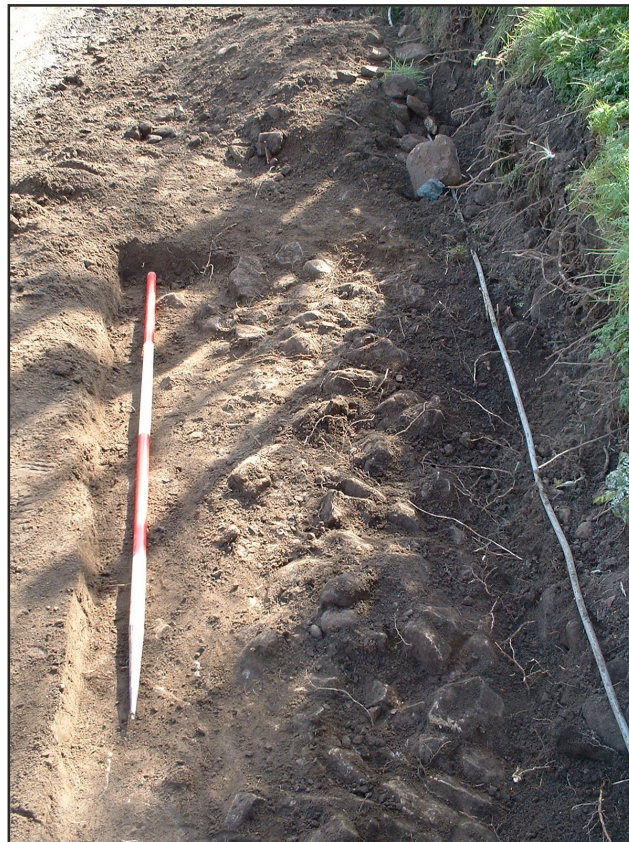
Plate 4: Deposit of rounded stones or cobbles [105]

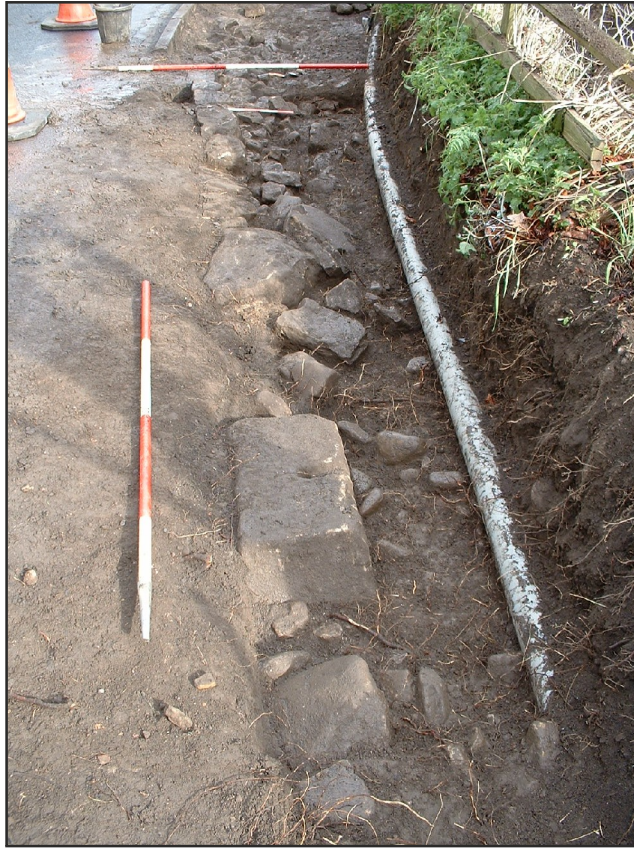
Plate 5: View eastwards of Wall [108] incorporating a re-used Roman masonry block

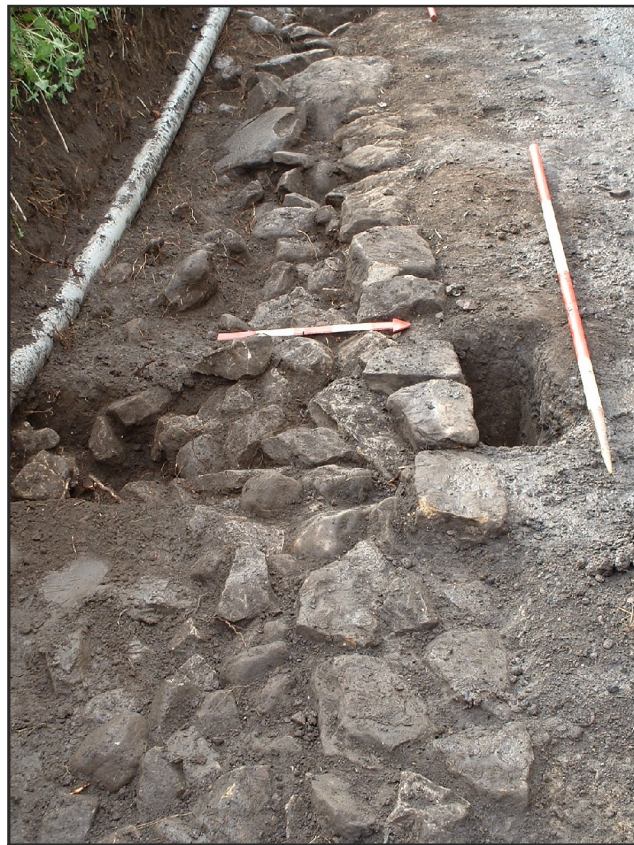
Plate 6: View westwards of Wall [108] incorporating a re-used Roman masonry block, showing location of archaeological evaluation slot

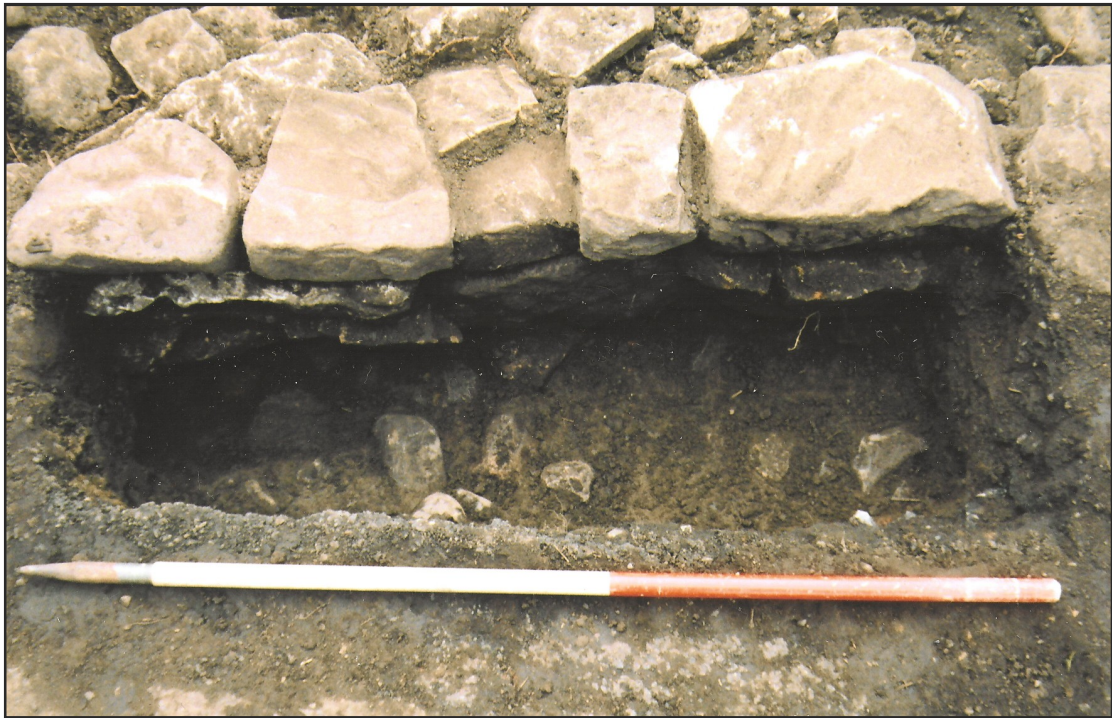
Plate 7: View from North of evaluation slot across wall [108], showing underlying cobbled surface

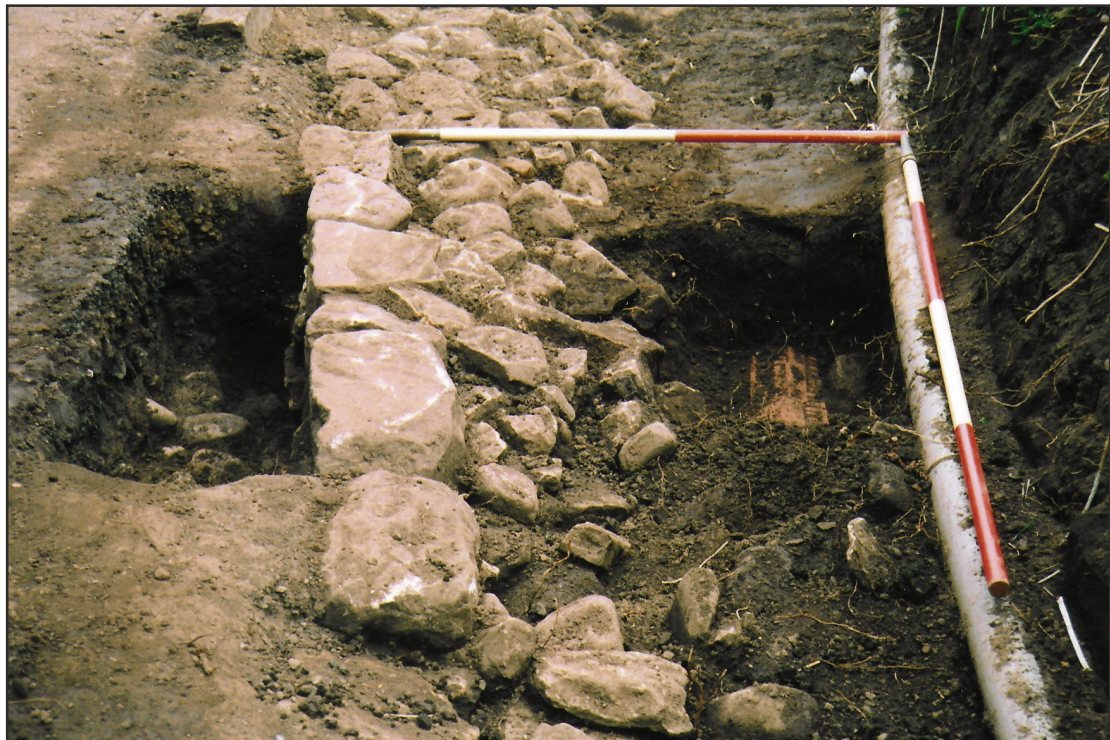
Plate 8: View from West of section cut across wall [108], showing facing stones to left and guarded electric cable to right
