HARBOTTLE
CHURCH OF ENGLAND FIRST SCHOOL,
NORTHUMBERLAND

ARCHAEOLOGICAL EVALUATION

February 2004

<i>Project code:</i> AP04/02	<i>Stage:</i> Final	<i>Compiled by:</i> RJC	<i>Control:</i> AR	<i>Completion date:</i> 8/03/04
---------------------------------	------------------------	----------------------------	-----------------------	------------------------------------

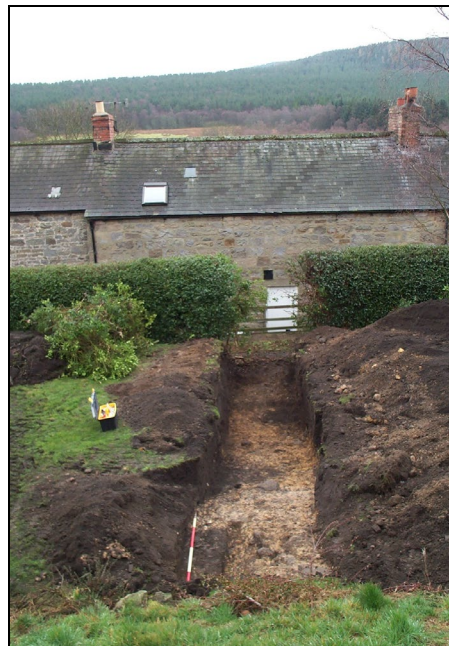
Cover: *View of evaluation trench from the North*

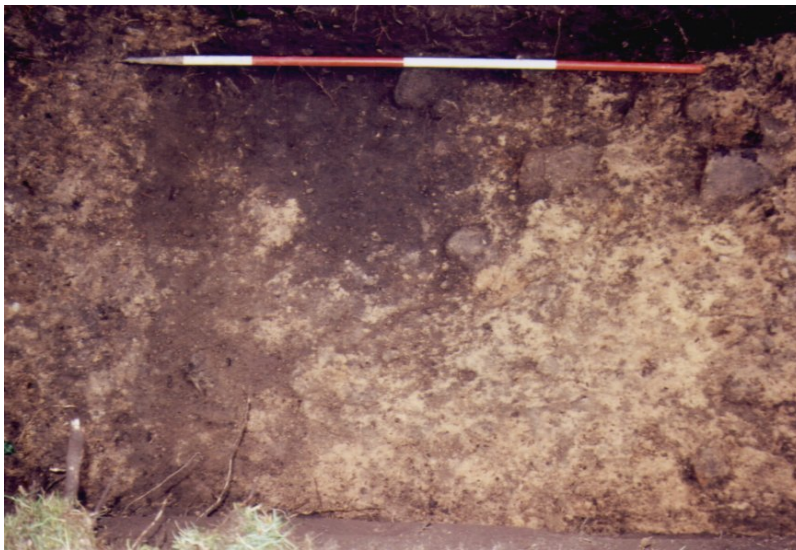
Frontispiece: South end of trench during excavation, showing partially-revealed shallow ditch feature and shallow pit interpreted as a root bowl

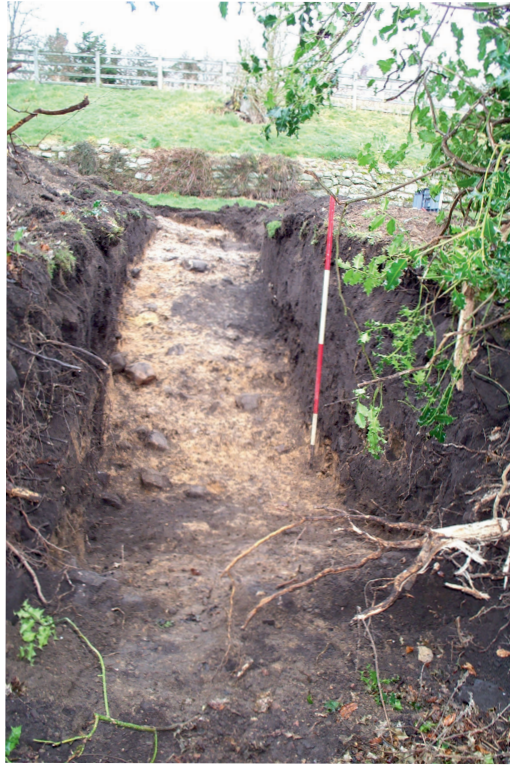
Plate 2: View from the south, with upper course of lower revetment wall in foreground

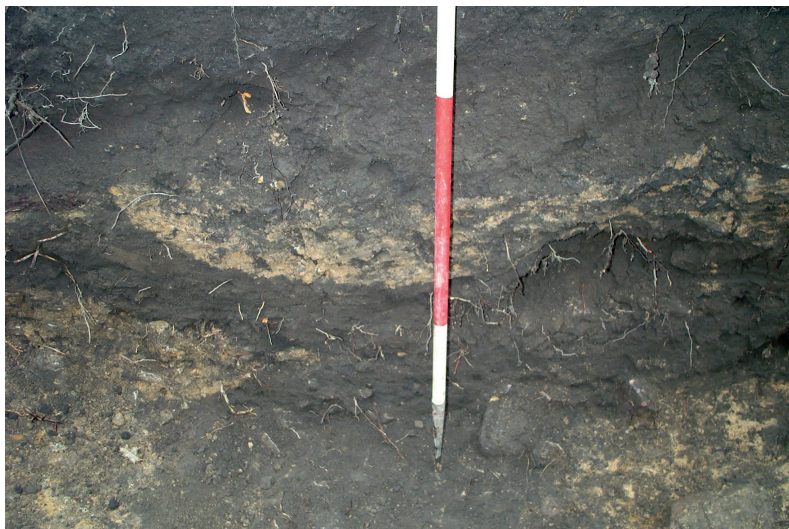
Plate 3: East-facing section showing boulder clay lense in topsoil

- 104 Lenses of orange boulder clay, clearly redeposited, perhaps following work associated with the road.
- 105 Stone wall of two or three courses set upon sub-soil; probably originally constructed as a revetment, but since submerged by soil creep. Sits immediately adjacent to, or bordering, the north side of the castle access trackway.
