10 YORK ROAD, WHITLEY BAY

ARCHAEOLOGICAL WATCHING BRIEF

MARCH 2004

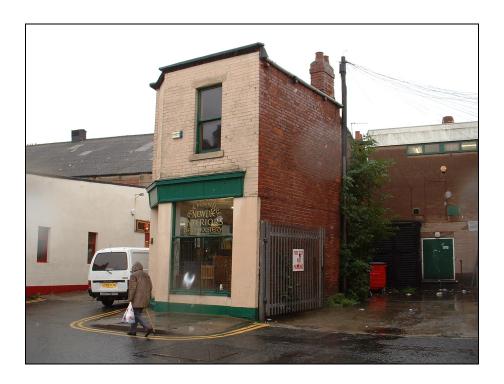
Front Cover: View from the North, in September 2003, of the building at 10 York Road, latterly a furniture and upholstery business, recently demolished to make way for the present development.

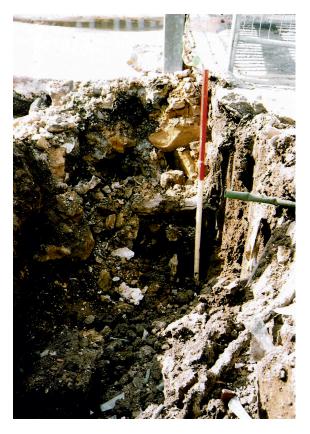
- The first feature was a wall foundation running east-west across the northern edge of the site (*Plate 1*). This was comprised of irregular masonry blocks and appears to have been a foundation layer for the recently demolished building, although alternative interpretations are possible (e.g. field wall/roadside wall). No artefacts were found in association with this feature and no date can be ascribed to it, althoughits context, as discussed, suggests it is late 19th century or early 20th century in origin.

Plate 1: North-West corner of site, viewed from the east note remains of wall (in section) on roadside.

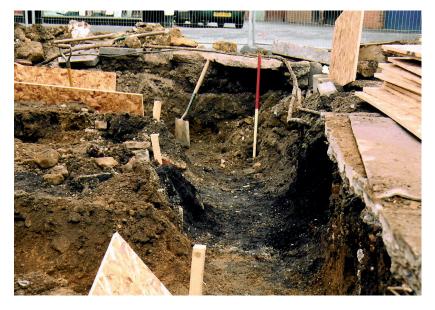
- The third was a coal bunker that had bee built into the north end of the eastern edge of the recently demolished building at foundation level. This appeared as a spread of coal finings/dust in the foundation trench floor and sections, and as the remains of a brick-built structure in the west-facing section (*Plate 2*).

Plate 2: View from South towards the North-East corner of the site, showing coal dust from former coal bunker

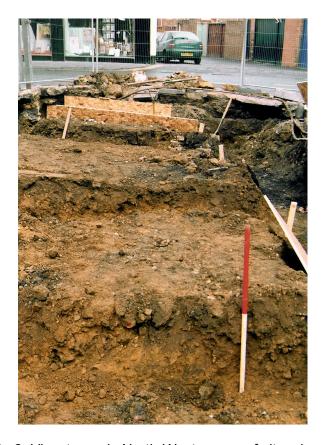
Machine stripping of the overburden (mainly concrete surfaces) revealed a very thin top-soil layer which quickly gave way to an orange boulder clay (*Plate 3*). Three features were noted within the site, all probably associated with the recently destroyed building (lattely a furniture and upholstery business).

Plate 3: View towards North-West corner of site, viewed from the South-East, showing boulder clay sub-soil (disturbed in upper levels) at a shallow depth across the site

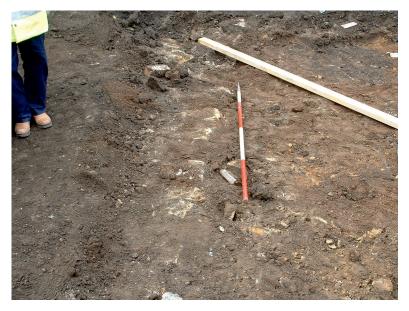
- The second feture note on the site was a wall running east-west across the middle of the site (*Plate 4*). Only the upper most part of the surviving part of this wall was exposed, but since it did not appear in section to the east or west, it may be assumed that the exposed course was the lower foundation layer. The wall appeared to be on the line of a former partition between shop front and office/workshop in the recently demolished building. No alternative interpretation of this evidence is warranted.

Plate 4: Remains of a wall running east-west across the middle of the site - probably the foundations of an internal partition wall within the recently demolished building
