# TIME CENTRAL DEVELOPMENT SITE GALLOWGATE NEWCASTLE UPON TYNE

## WATCHING BRIEF

JULY 2006

<i>Project code:</i> AP 06/49	<i>Stage:</i> Final	<i>Compiled by:</i> AR	<i>Control:</i> RC	<i>Completion date:</i> 18/07/06
----------------------------------	------------------------	---------------------------	-----------------------	-------------------------------------

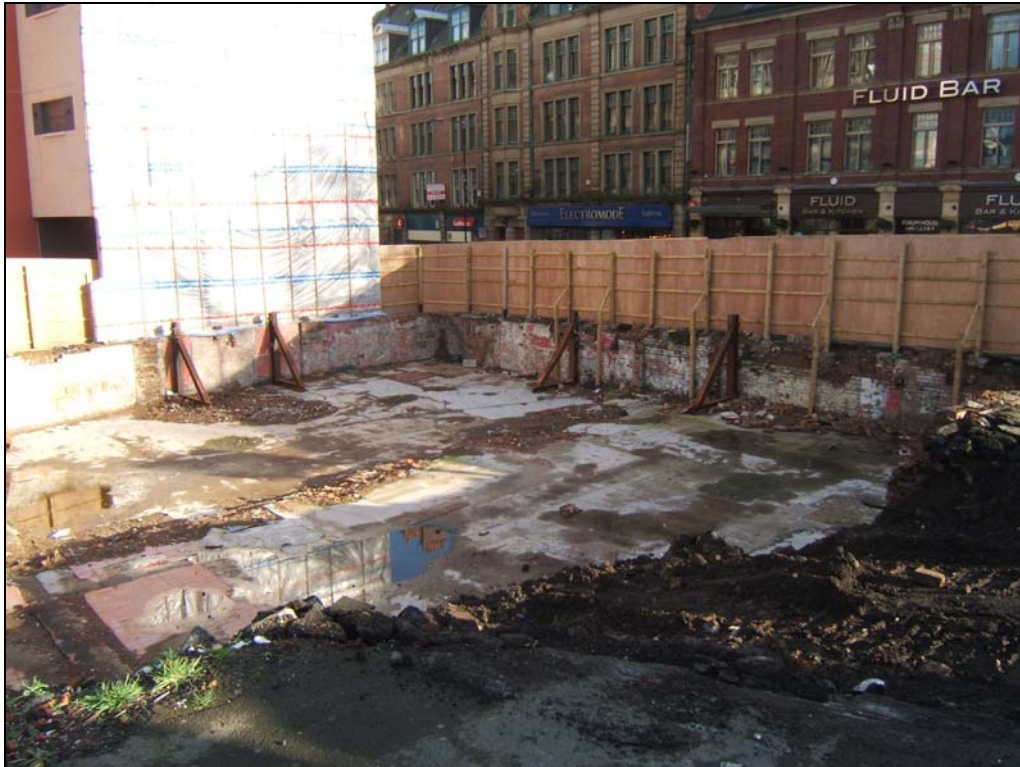
*Front Cover: The eastern half of the development site viewed from the NW, showing the depth of cellaring for 30-34 Gallowgate*

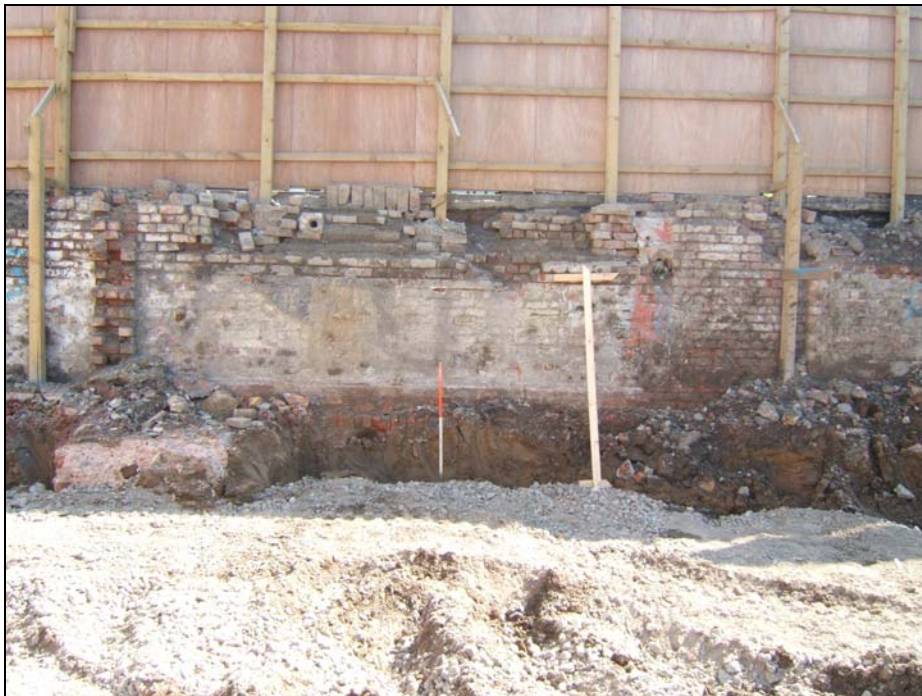
**Frontispiece:** *Front wall of the cellaring for 30-34 Gallowgate and underlying clay deposits*

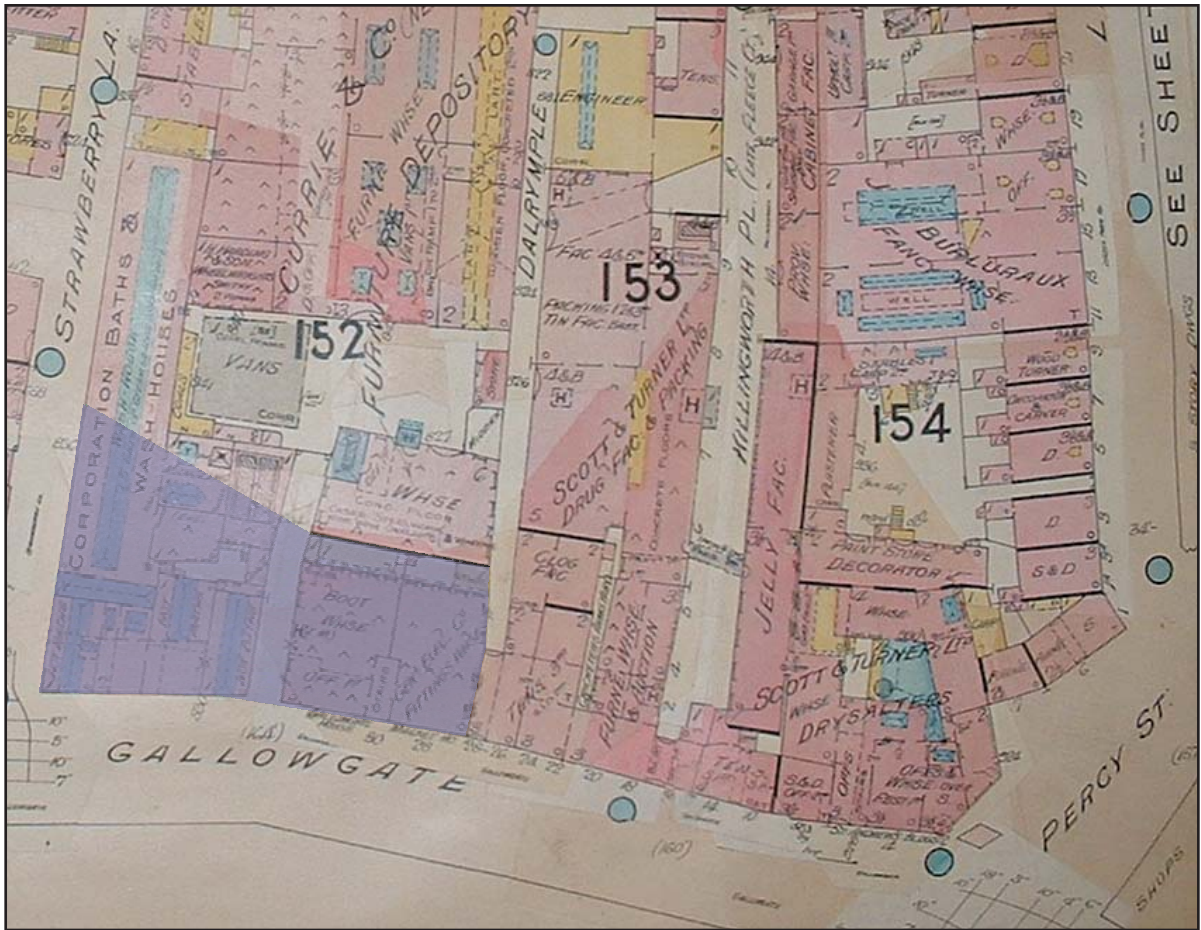
*Illus. 3: Assessment area (marked in blue) shown on the Goad plan of 1930.*

The brick and concrete construction of the majority of the structures recorded in the SE part of the site demonstrates they are of no great antiquity. They are probably to be associated with the public baths and wash houses known to have existed in this part of the site at the end of the 19<sup>th</sup> century and early 20<sup>th</sup> century (see Illus. 3: Goad plan of 1930).

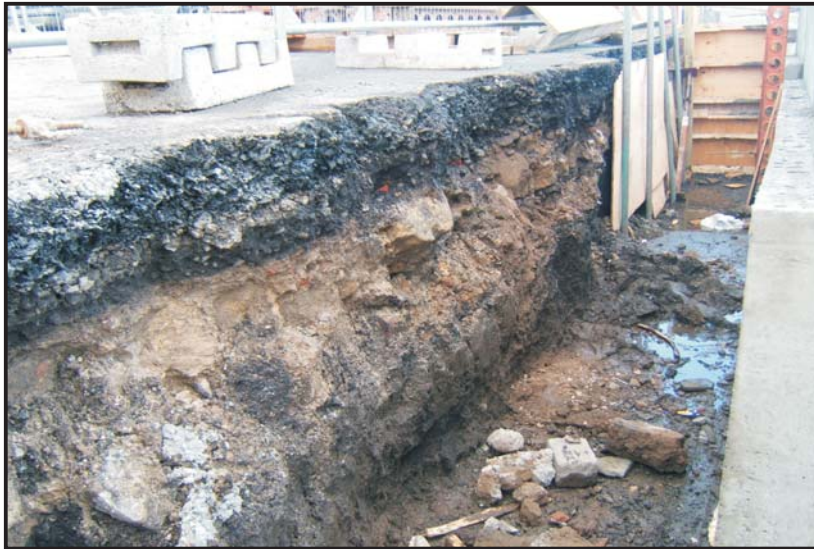
1. The trench for the revetment wall of the access ramp viewed from the west. The section shows layers of demolition rubble and redeposited material

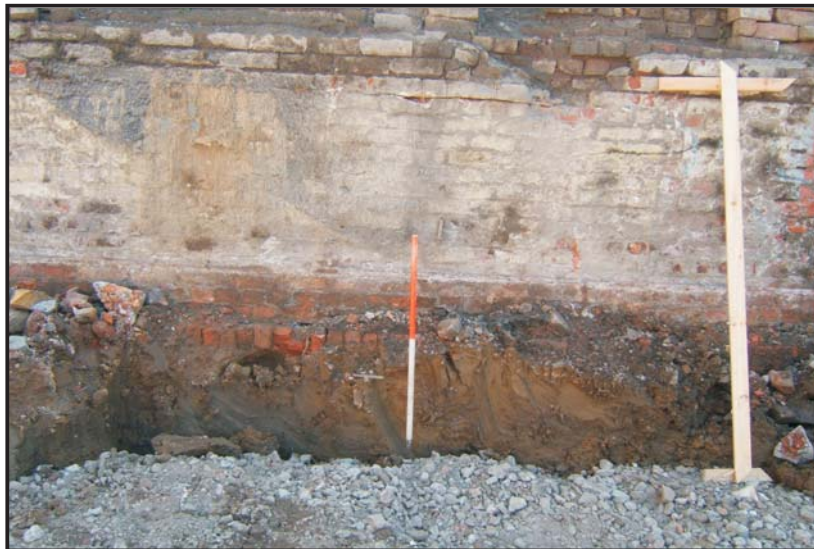
2. Section at the front of the western part of the site (the wall is the front wall of the cellaring for 30-34 Gallowgate)

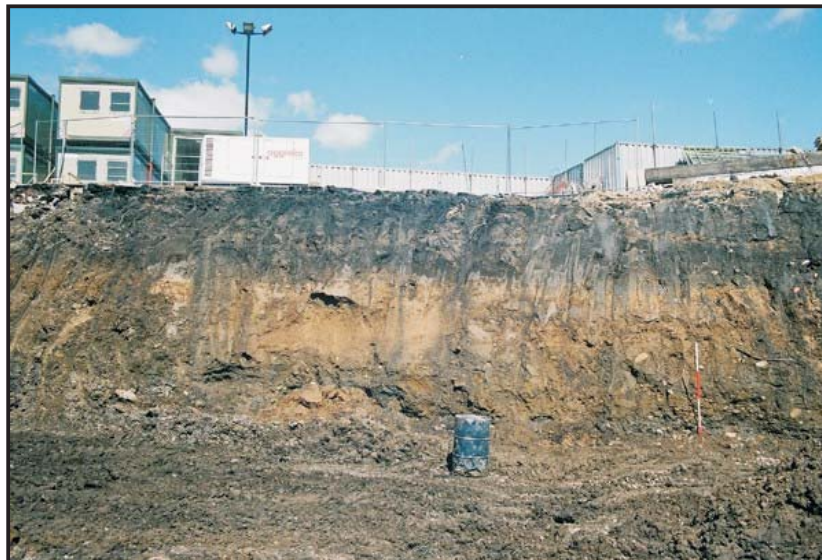
3. Deep section on the N edge of the development site showing the deep cut into natural subsoil and the thick overlying layer of redeposited clay

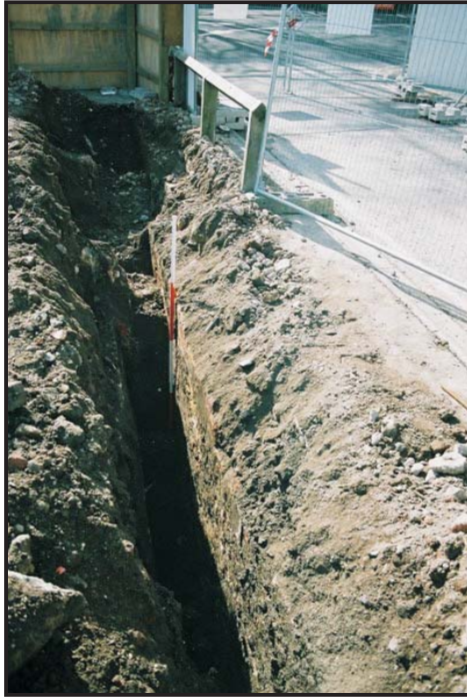
4. Construction trench beside Strawberry Lane looking S towards Gallowgate

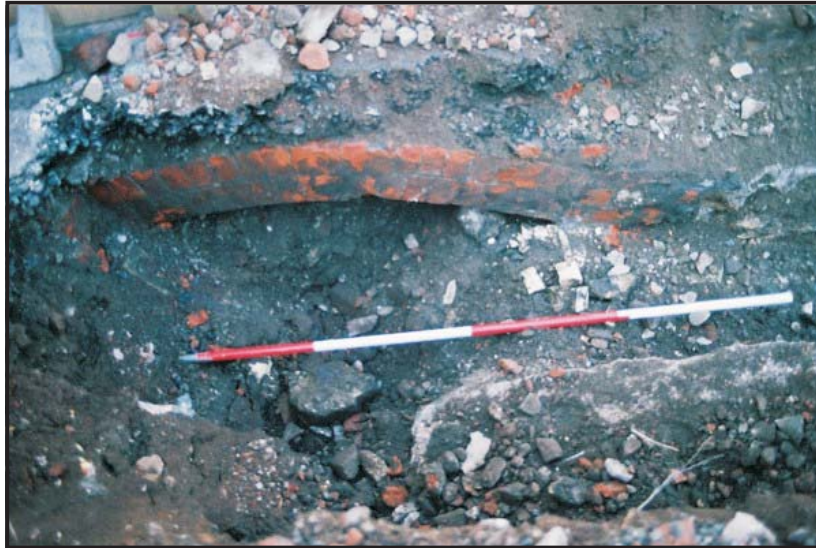
5. Brick vault associated with Corporation Baths in the S end of the Strawberry Lane construction trench

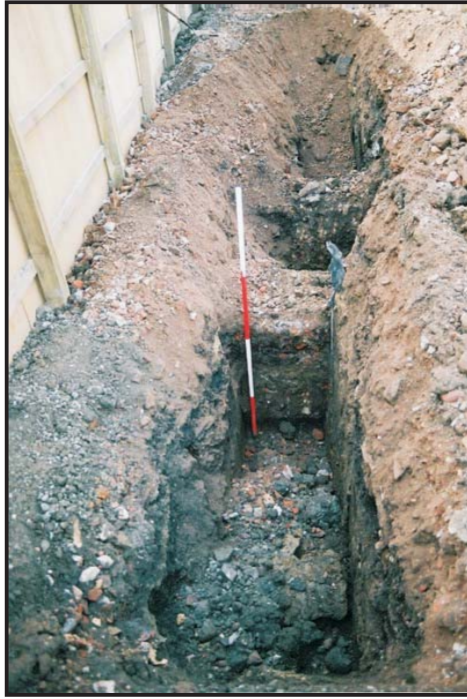
7. Piling trench along the S edge of the development site showing brick walls probably associated with Corporation Baths (looking W)

Most of the structures identified in the works trenches along the south and west edges of the site were of brick and concrete indicating a relatively recent date of construction. They are probably to be associated with the Corporation Baths and Wash Houses which are known to have occupied the western half of the Gallowgate frontage of the development site. The wash houses also extended back up the slope alongside Strawberry Lane (see Illus. 3). The underlying stone wall may be tentatively attributed to an earlier post-medieval building. It is likely that survival was better along the edge of the site because structures were left standing here as they served to revet the substructure of the road carriageways and pavements along Gallowgate and Strawberry Lane.

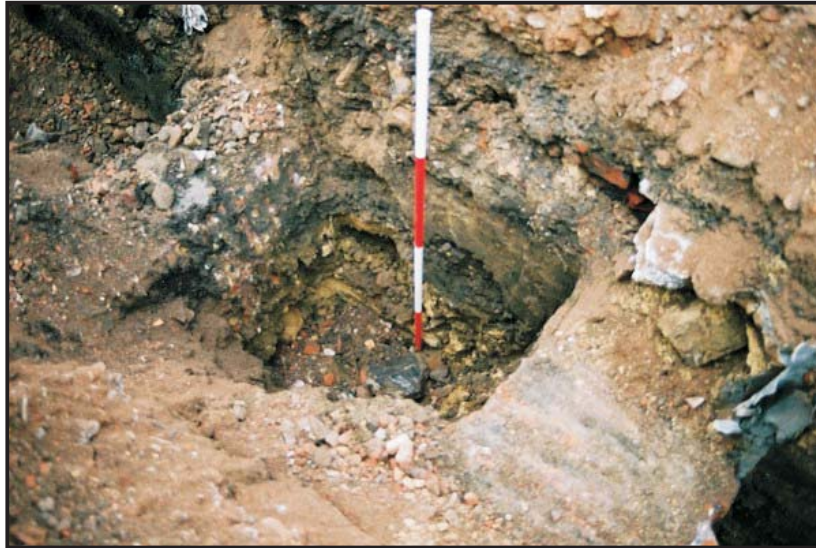
8. Slot between the two brick walls in the piling trench showing the courses of stone walling at the bottom (looking N)

The stone wall was roughly coursed, its characteristics suggesting it may have formed part of foundation walling. No material was recovered which could assist in the dating of this structure. However some elements provide relative dating. Its longest recorded face lay parallel to the line of Gallowgate implying it was constructed after that street had been laid out. Although it turned and ran under the line of one of the brick walls apparently on the same alignment as that structure the stone wall was not necessarily associated with the brick one. None of the other brick walls were observed to be associated with stone foundations in this way. An early modern date (17<sup>th</sup>-early 19<sup>th</sup>-century) is most plausible.

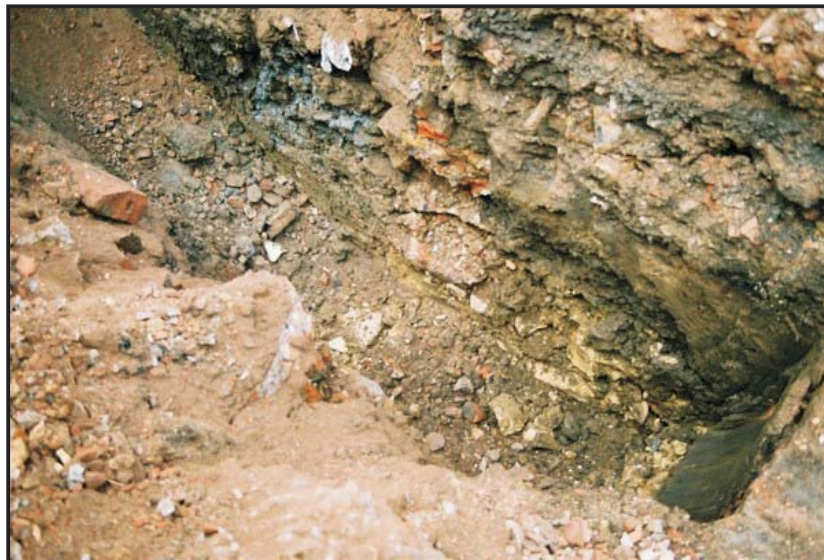
9. The stone wall at the bottom of the same section viewed in Pl. 8 with the W brick wall removed
