CASTLE FARM
BISHOP MIDDLEHAM
CO. DURHAM

HISTORIC BUILDING RECORD

MAY 2022

Historic Buildings Record

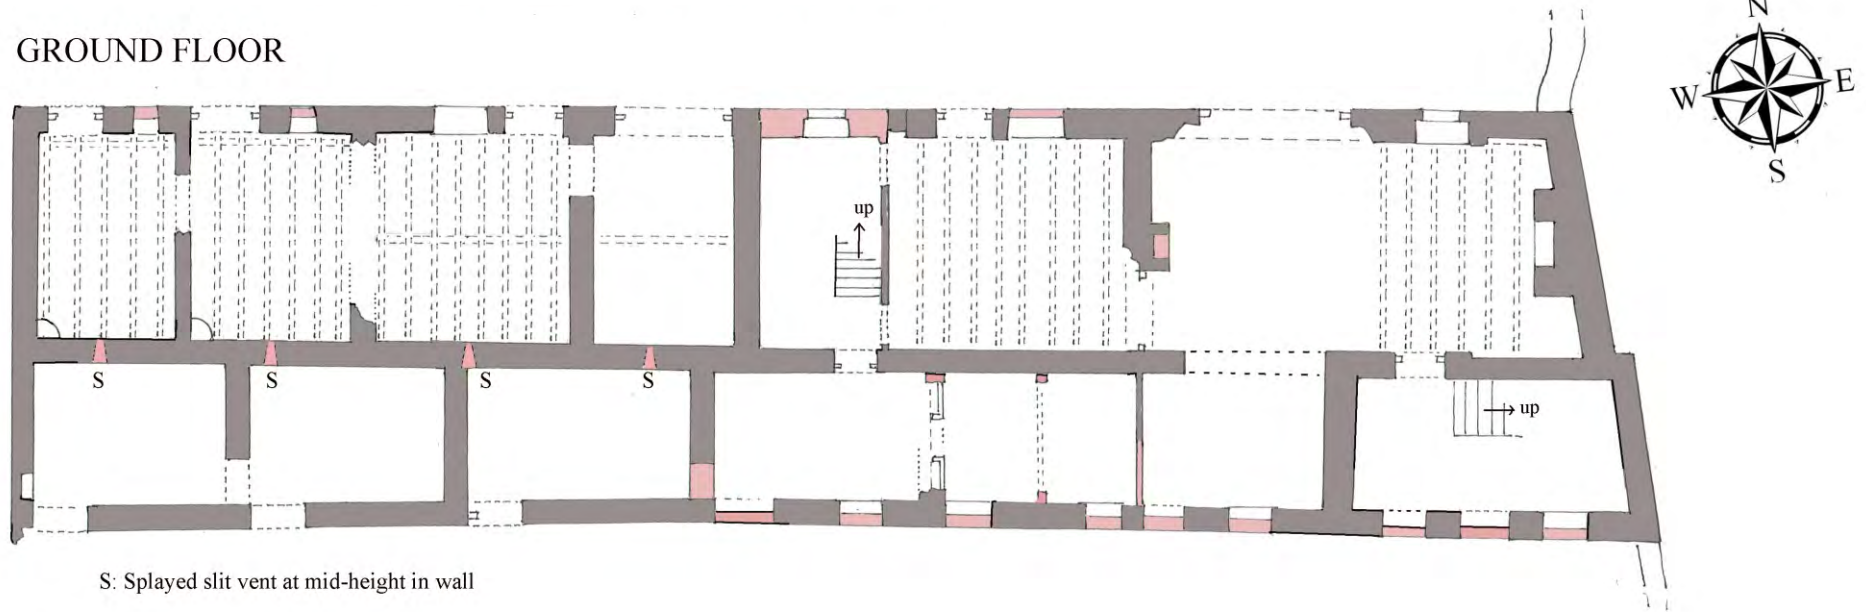
Illus. 11: Farm Plan surveyed by Peter Ryder October, 2020 with additions and alterations made up to April, 2022.

S: Splayed slit vent at mid-height in wall

Obvious secondary fabric (largely brick)

The photographic recording of this almost-entirely redundant farmstead was undertaken to accompany a drawn survey (*Illus. 10, 11 & 13*) and written description in December 2020, using digital photography (see *Appendix 1*). All elevations were photographed as far as possible face-on and from a consistent height and perspective. Where possible, all record photographs included a scaled ranging pole. Where it was not possible to capture an entire elevation in a single photograph because of the constricted nature of the site, a series of partial elevations were recorded along with an oblique overall view of the full elevation.

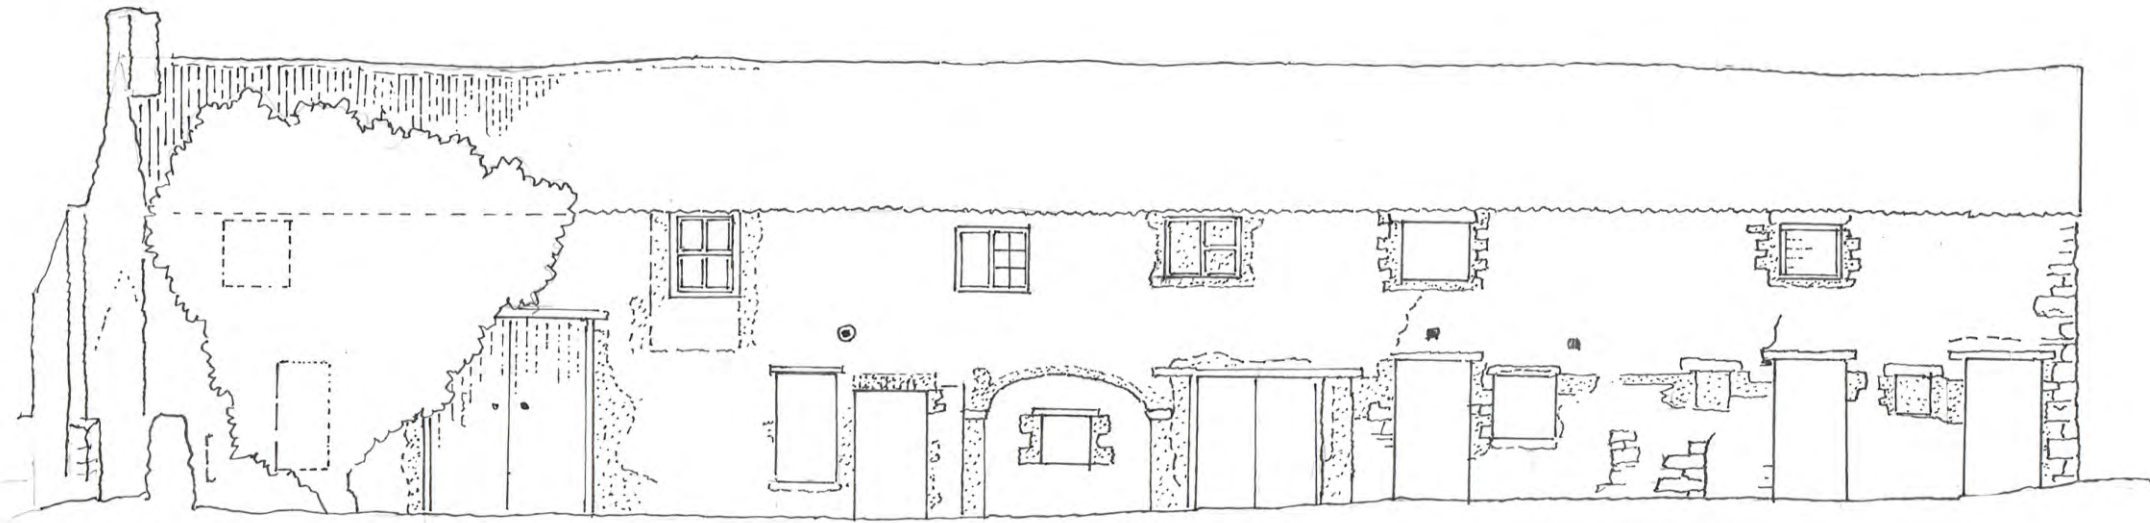
Illus. 13 (below): Elevation surveyed by Peter Ryder & Richard Carlton, October, 2020 with additions and alterations made using digital scan in April, 2022.

brickwork (several different phases)

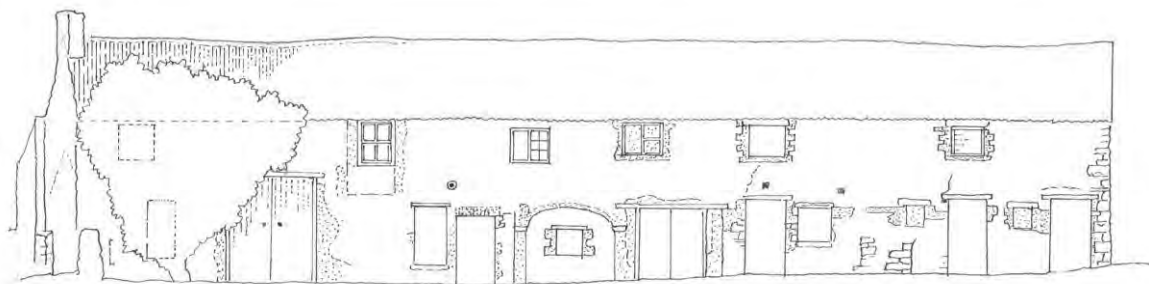
BISHOP MIDDLEHAM, CASTLE FARM
MAIN RANGE, NORTH ELEVATION

0 5 10 metres
brickwork (several different phases)

The front elevation demonstrates that this is a much-altered and complex fabric. At the west end, the angle quoins change from large and well squared to much smaller at around two-third height, perhaps pointing to a heightening. About 6 m to the east there are some large well-squared quoins low in the wall, perhaps an in-situ remnant of an earlier building. Near the centre is a blocked three-centred arch, turned in brick but springing from cut stone impostes, with a later window inserted in its blocking. East again are a pair of large boarded doors in a

section of wall that seems to be a recent rebuild; just to the west of these a first-floor window is set in an earlier doorway; old OS maps show an external staircase here. There is now only a chimney on the east gable end, but there was formerly at least one more, on a line between the big boarded doors and the upper-floor doorway.

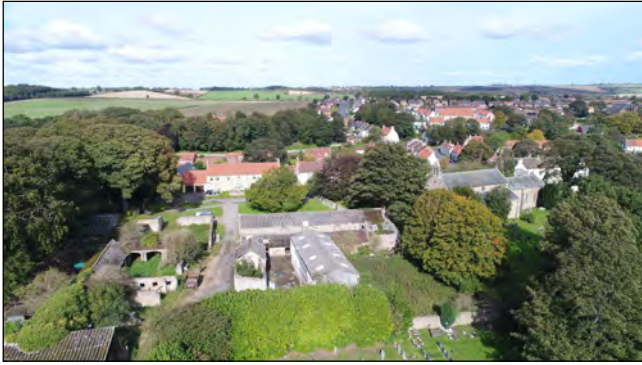
Photo 01.

01	Oblique aerial view of the farm from the south.
02	Detailed oblique aerial view of the farm from the south.
03	Vertical aerial view of the farm.
04	Oblique aerial view of the Main North Range from the north
05	North Range, north elevation
06	East end of north elevation of North Range, showing connection with cemetery wall
07	East end of north elevation of North Range
08	Detail from east part of north elevation of North Range (see Photo. 07)
09	Central part of north elevation of North Range
10	Detail of blocked opening in central part of north elevation of North Range (see Photo. 08)
11	West part of north elevation of North Range
12	Detail of blocked openings in the west part of north elevation of North Range (see Photo. 11)
13	View of the north and west elevations of the North Range from the north-west.
14	West elevation of North Range
15	View of the south and west elevations of the North Range from the south-west.

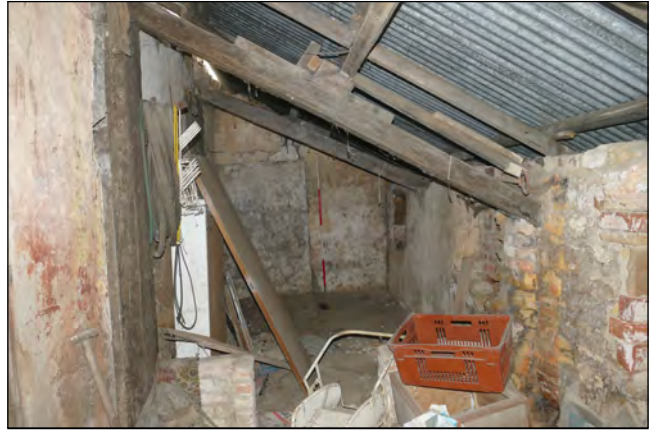
Photo 49.

49	View SE from western stair passage addition to GF compartment second from east in the main range, towards openings to the east and (right of view) the southern lean-to extension.
50	View to east end of eastern GF lean-to extension.
51	Blocked opening in the east end of the south wall of the eastern GF lean-to extension.
52	Blocked openings in the east part of the south wall of the eastern GF lean-to extension (see Photo. 50).
53	View to west end of eastern GF lean-to extension.
54	View to door into the eastern GF lean-to extension from Main Range compartment.
55	View northwards up stairs from stair passage addition to GF compartment in the main range
56	View east from top of stairs into second (from east) first floor compartment
57	Internal south wall in second (from east) first floor (F1) compartment
58	View from west end of second compartment (from east) looking west to window and passage entrance along the north side of the Main Range at first floor level

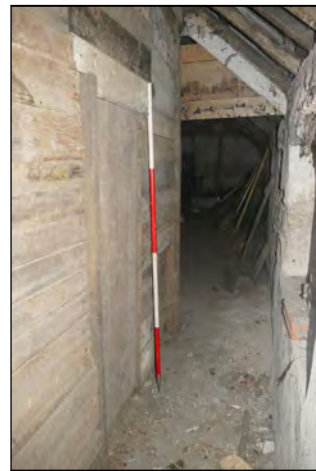
Photo 59.

59	View west past stair landing along northern passage at F1 level
60	View west along northern passage at F1 level.
61	View south from N passage to south wall of 3 rd compartment at F1 level
62	View north to doorway from N passage in 3 rd compartment at F1 level
63	View ENE to blocked opening in N passage adjacent to doorway to 3 rd compartment at F1 level
64	Blocked opening in N passage adjacent to doorway to 3 rd compartment (see Photo. 63) of the Main Range
65	View west to west end first floor (F1) compartment of the Main Range
66	West end window in the south wall of the western first floor (F1) compartment
67	Doorway at south end of west wall of the western first floor (F1) compartment
68	West end window in the north wall of the western first floor (F1) compartment
69	View east to east end first floor (F1) compartment, showing entrance to northern passage.
70	Entrance to northern passage in east end of first floor (F1) compartment of the Main Range

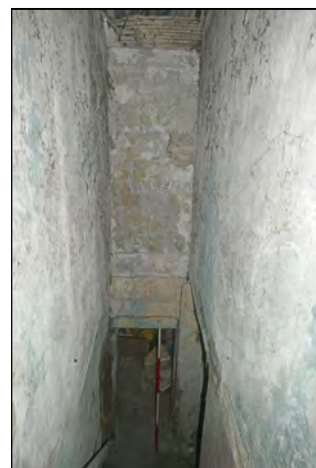
Photo 71.

71	East end of the south wall in the first floor (F1) compartment of the Main Range
72	View southwards down central stairs (see Photo. 55) from the first floor (F1) of the Main Range
73	View southwards in central stair-well (see Photos. 55 & 72) showing roof structure.
74	View SE of roof structure in the central compartment of the Main Range at F1 level.
75	Blocked window in the east end of the north wall of the western group of four GF compartments, incl. a small central compartment to the east of this opening.
76	View to north entrance doorway to small central GF compartment.
77	View to west wall and NW corner of small central GF compartment.
78	View westwards to door at N end of west wall of small central GF compartment.

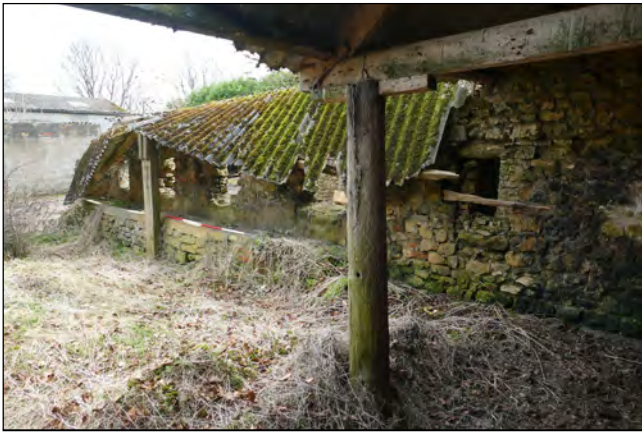
Photo 144.

144	Looking south to troughs on the south side of the Central Yard.
145	View from NW to SE of the south side of the Central Yard.
146	View south along back passage of the west range of the Central Yard, behind brick feeder-trough partition, into north range of the South Yard
147	View north along back passage of the west range of the Central Yard, towards the north side of the Central Yard
148	View from SE of the rear of troughs shelter on the south side of the Central Yard.
149	South face of the east end of the rear of troughs shelter on the south side of the Central Yard.
150	View west between Central and South Yards, into north range of South Yard (rear of troughs seen in Pic. 148, to right of view).
151	View west to shredder and rear west wall of north range of South Yard (between Central and South Yards)
152	View north-west to rear wall of north range of South Yard (between Central and South Yards)

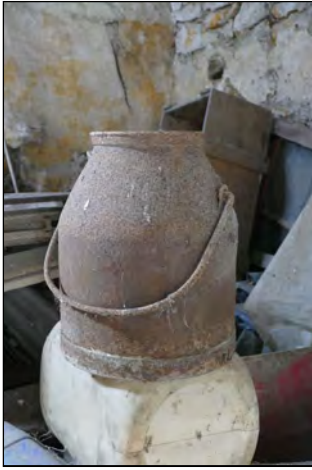
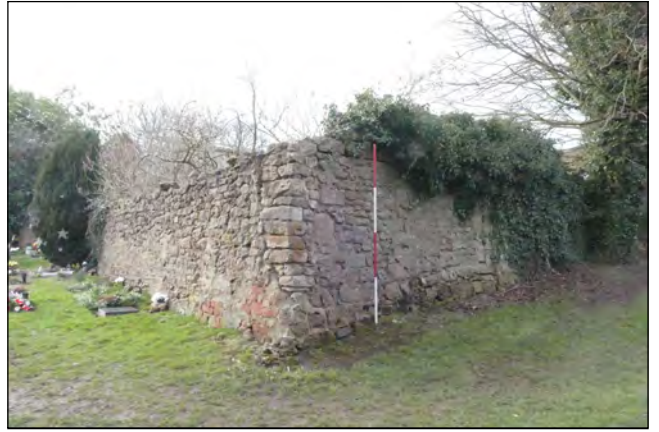
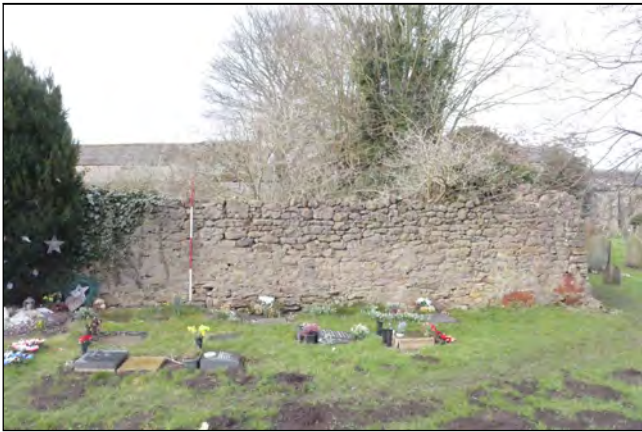
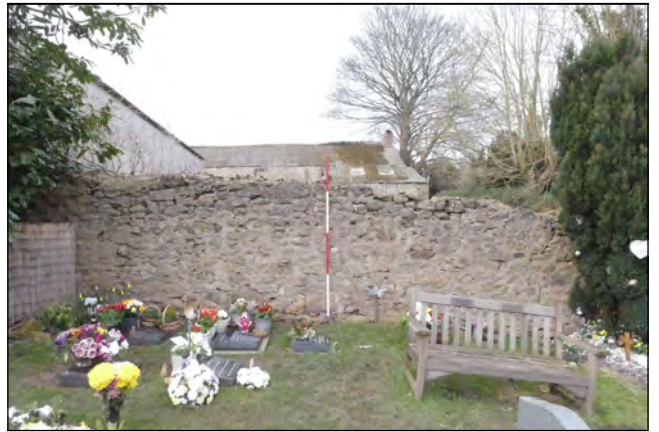
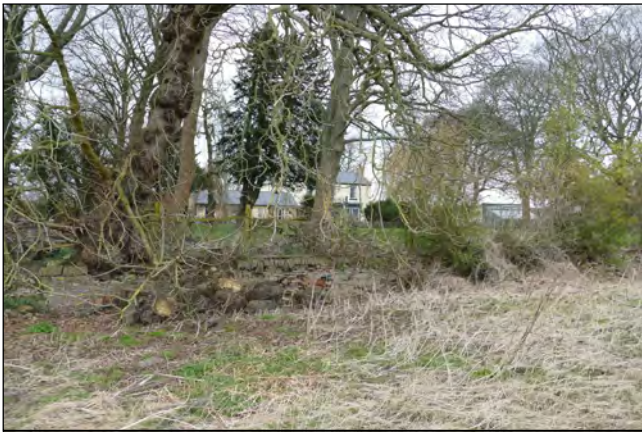
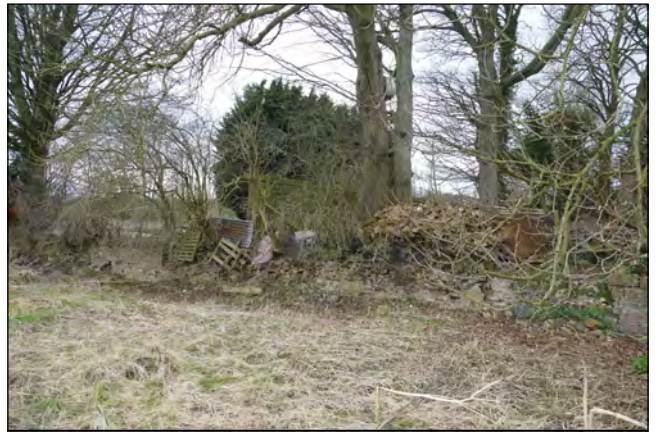
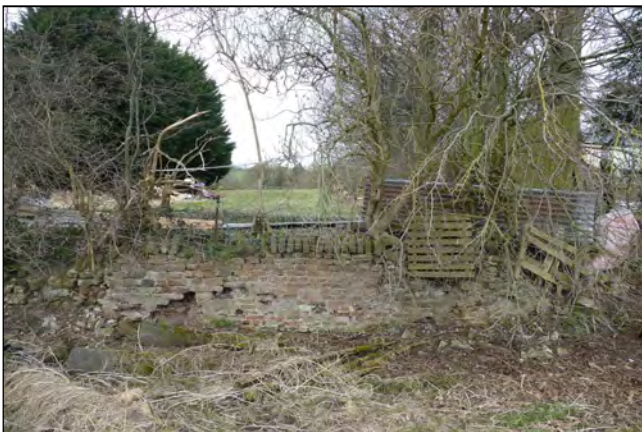
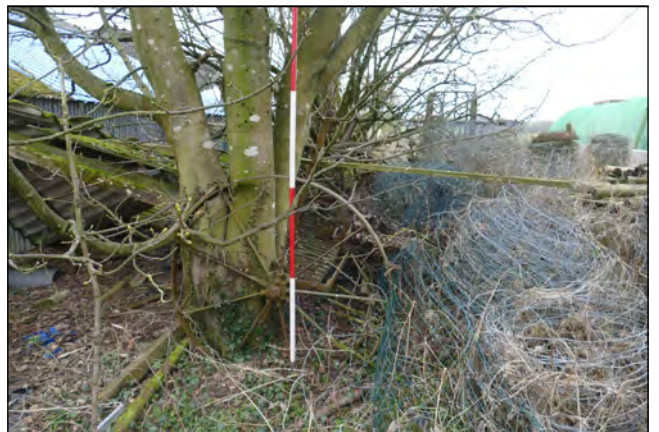
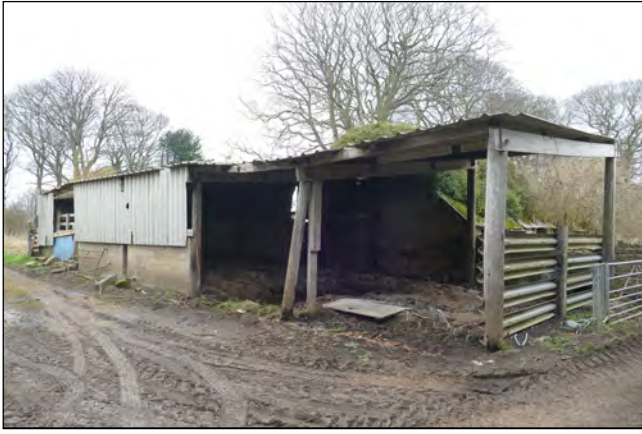
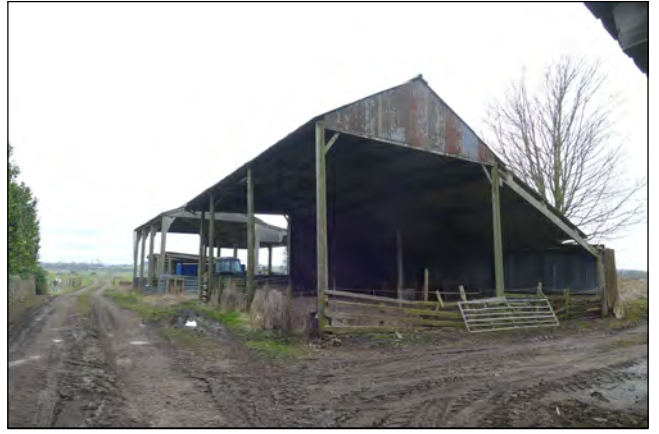
209	Abandoned milk churn within the dairy.
210	View north-west to the south-east corner of the farmstead boundary wall from within the churchyard extension.
211	View north from within the churchyard extension of the east part of the southern farmstead boundary wall.
212	View north from within the churchyard extension of the central-east part of the southern farmstead boundary wall.
213	View north-east to remains of a boundary wall south of House, on the same line as the southern farmstead boundary wall.
214	View north-west to remains of a boundary wall south of House, on the same line as the southern farmstead boundary wall.
215	Detail of remains of a boundary wall south of House (see Photos. 213 & 214, above)
216	Farm machinery embedded in vegetation west of the South Yard.
217	View from the south-east of an E-W modern shed range bordering the South Yards.
218	View from NNE of modern sheds south of the South Yards.
