*GREAT ISLE FARM  
NEWTON AYECLIFFE  
COUNTY DURHAM*

HISTORIC BUILDINGS RECORD

<b>Report title:</b>	<i>Great Isle Farm, Newton Ayecliffe, County Durham. Historic Buildings Record.</i>
<b>Stage:</b>	<i>Final</i>
<b>Project code:</b>	<i>AP 22/18</i>
<b>Compiled by:</b>	<i>Richard Carlton &amp; Peter Ryder</i>
<b>Control:</b>	<i>Marc Johnstone</i>
<b>OASIS ID:</b>	<i>thearcha2-510214</i>
<b>ADS Project ID:</b>	<i>20016663</i>
<b>Date issued:</b>	<i>23/06/2022</i>
<b>Planning reference:</b>	<i>N/A</i>
<b>Grid reference:</b>	<i>NZ 30311 26975 (centre)</i>
<b>Client:</b>	<i>Bright Water Landscape Partnership, with thanks to the National Lottery Heritage Fund</i>

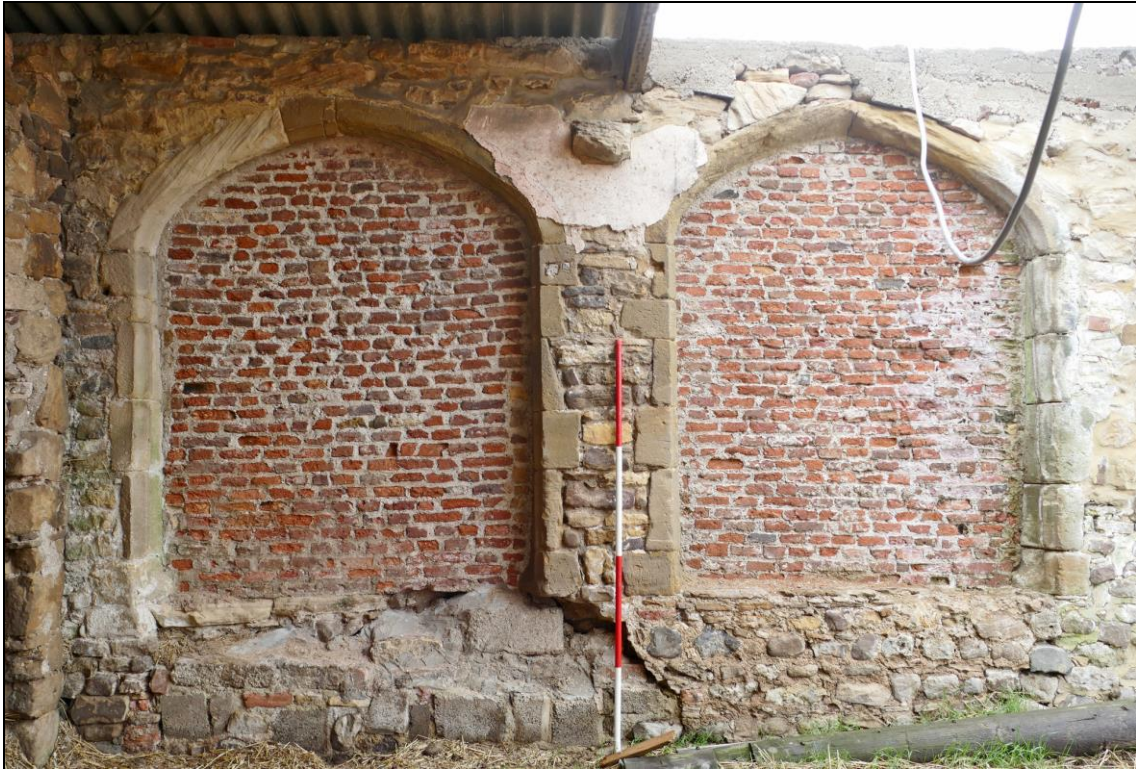
*Frontispiece: View of blocked late-medieval four-pointed windows, with moulded surrounds and indications of tracery, located in the internal, north-facing elevation of the 'Chapel' Range.*

The internal face of the wall is described from the pair of large arched windows, as immediately east of these is a secondary cross wall. Internally the arched windows have surrounds moulded with a pair of rolls between two hollows; presumably they had some form of tracery, but any evidence of this is concealed by their brick blocking. Further west the internal face of the wall shows the same complex of blocked openings and patching as the exterior; the small window near the far end has an internal splay and jambs in old brick.

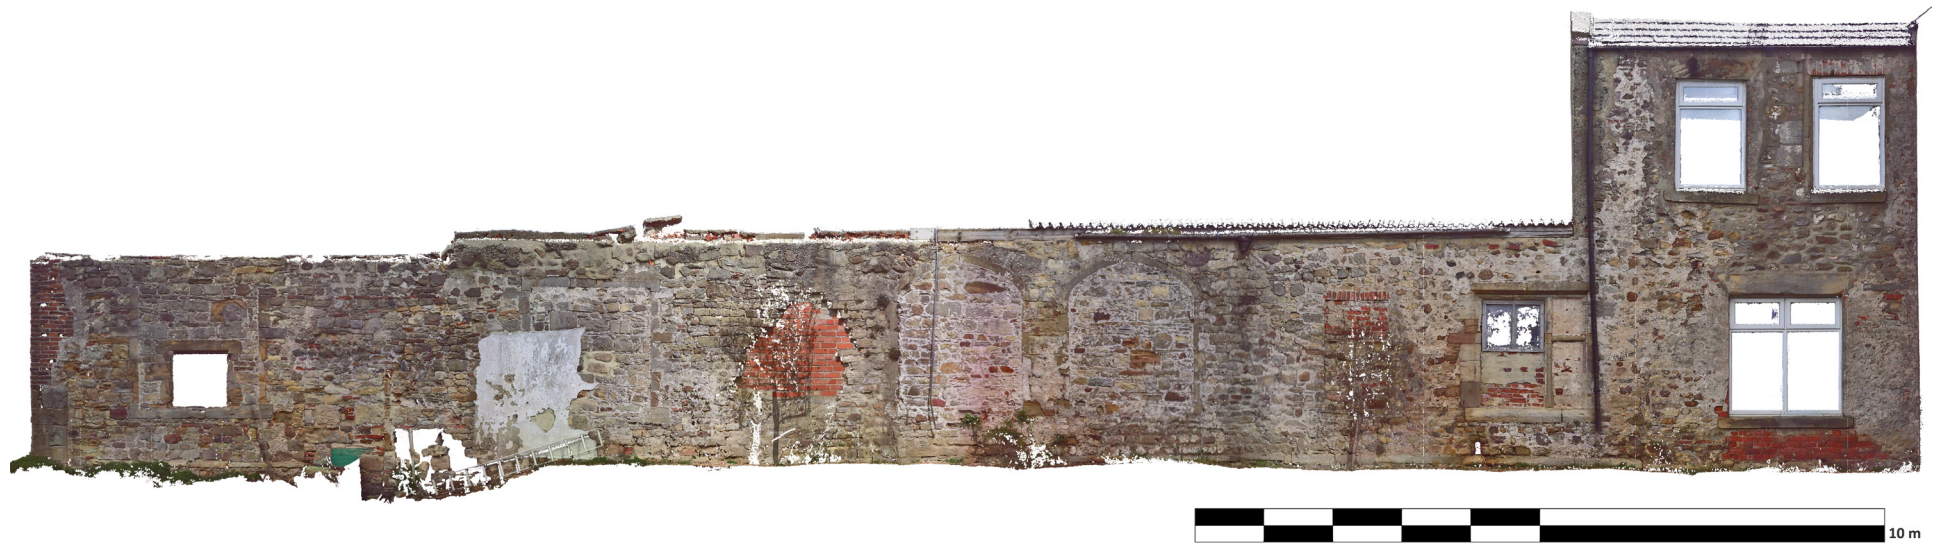
*Illus. 14: Digital scan showing south facing elevation of south wall, The Chapel, Great Isle.*

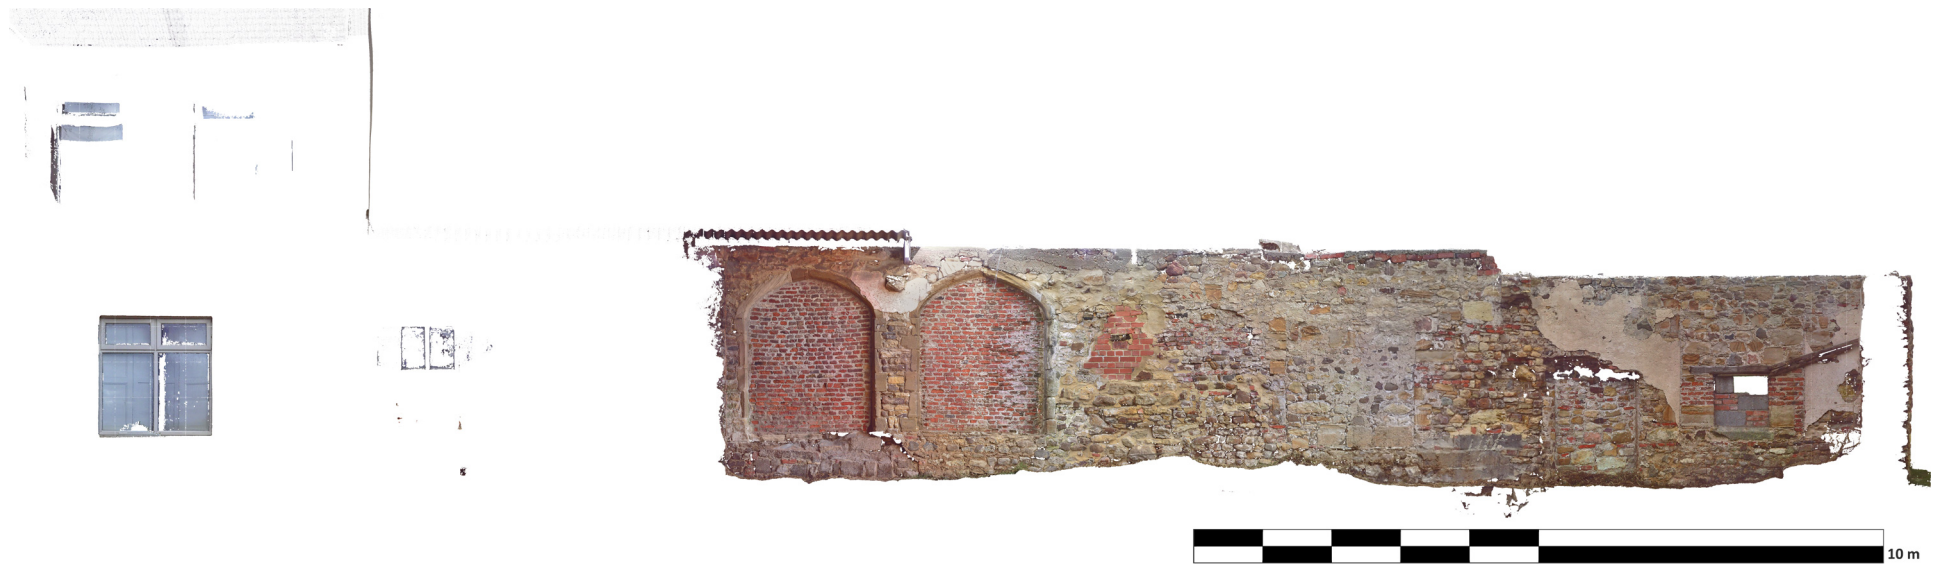
*Illus. 15: Digital scan showing north facing elevation of south wall, The Chapel, Great Isle.*

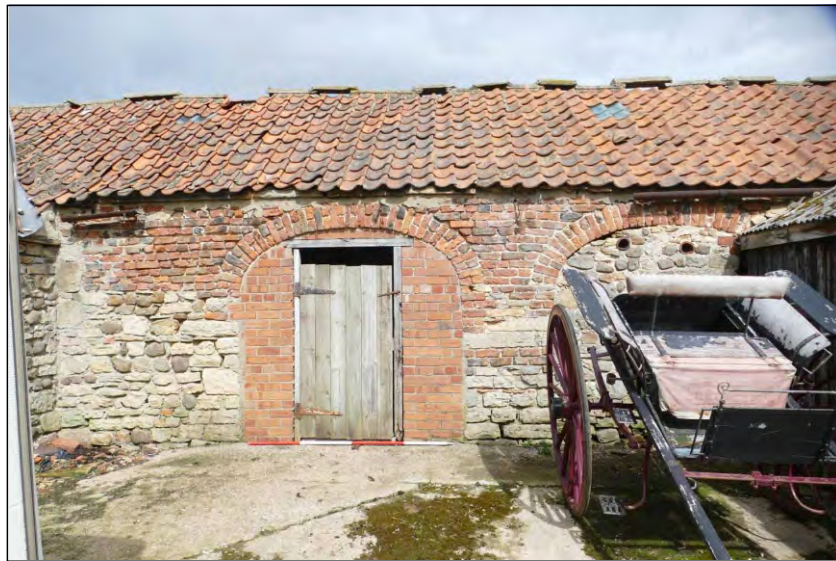
Photo 62

62	View north within the lean-to wooden shed built against the west side of a relatively modern barn south of the north range, showing the western cart-shed opening in the south elevation of the 19 <sup>th</sup> -century west part of the north range.
63	View within the western fold yard to the central part of the south frontage of the eastern section of the North range.
64	View westwards from the east end of the western part of the north range of farm-buildings, showing modern stalls and partially-blocked cart-shed openings to the south (left of view).
65	View south-east from west-central doorway in the south side of the east part of the north range into the narrow foldyard seen on Photos. 58 & 63 (above).
66	The north part of the east elevation of the west range, within the fold yard seen on Photos. 58 & 63 (above).
67	The south part of the east elevation of the west range seen within the fold yard seen on Photos. 58 & 63 (above).
