*HALL FARM
ARCHDEACON NEWTON
DARLINGTON
COUNTY DURHAM*

HISTORIC BUILDING RECORD

HALL FARM
ARCHDEACON NEWTON
HISTORIC BUILDINGS RECORD

Report title:	<i>Hall Farm, Archdeacon Newton, Darlington, County Durham. Historic Building Record.</i>
Stage:	<i>Final</i>
Project code:	<i>AP 22/17</i>
Compiled by:	<i>Richard Carlton & Peter Ryder</i>
Control:	<i>Marc Johnstone</i>
OASIS ID:	<i>thearcha2-510223</i>
ADS Project ID:	<i>20016663</i>
Date issued:	<i>29/06/2022</i>
Planning reference:	<i>N/A</i>
Grid reference:	<i>NZ 25473 17137 (centre)</i>
Client:	<i>Bright Water Landscape Partnership, with thanks to the National Lottery Heritage Fund</i>

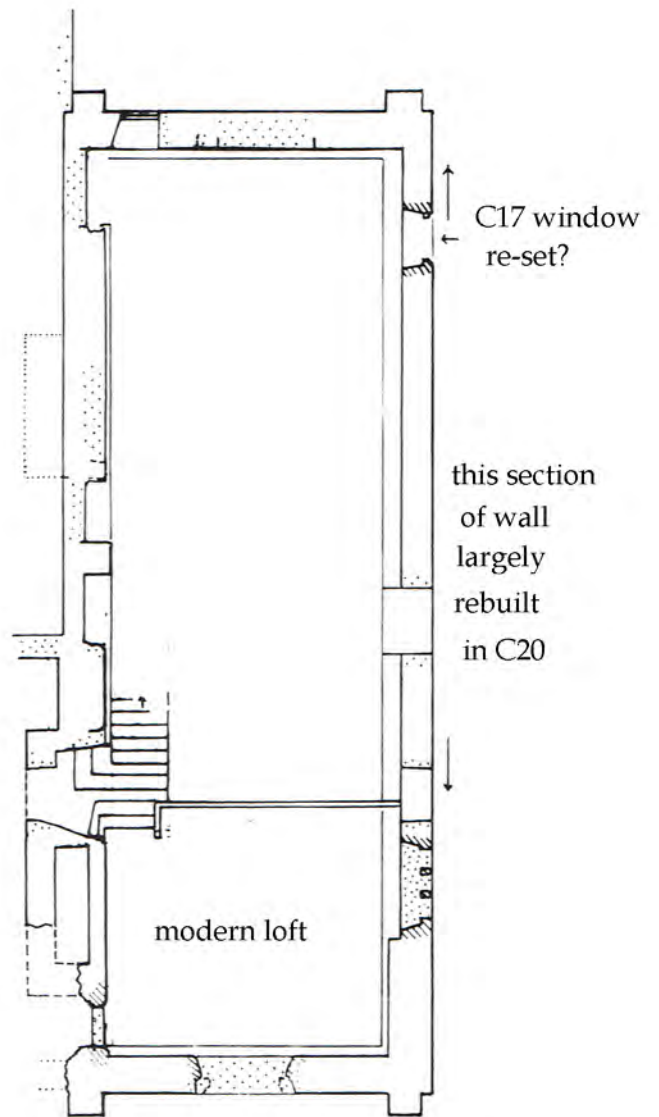
Illus. 10: Measured ground and first floor plans of 'The Old Hall', Archdeacon Newton. Surveyed by Peter Ryder 1989/1990.

GROUND PLAN

PLAN AT FIRST FLOOR LEVEL

The 'Old Hall' is a rectangular building of two storeys, with an attic at its south end; its external measurements are 19.4 m by 7.3 m. The walls are generally around 1.0 m thick, thinned back at first-floor level by internal set-backs; the original fabric is of roughly-squared and roughly-coursed Magnesian Limestone, with cut sandstone dressings; later rebuilding and patching introduces rubble and river cobbles.

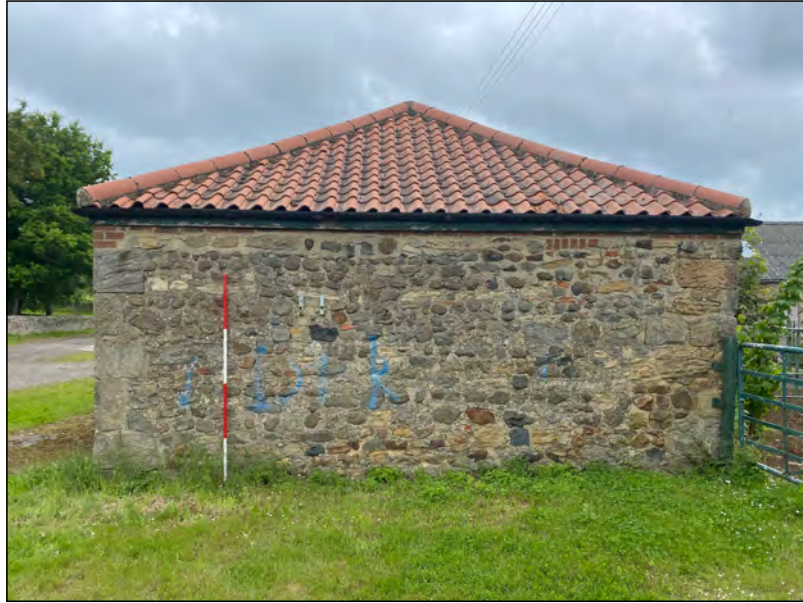
Photo 05. South gable elevation of the single-storey west range of farm-buildings

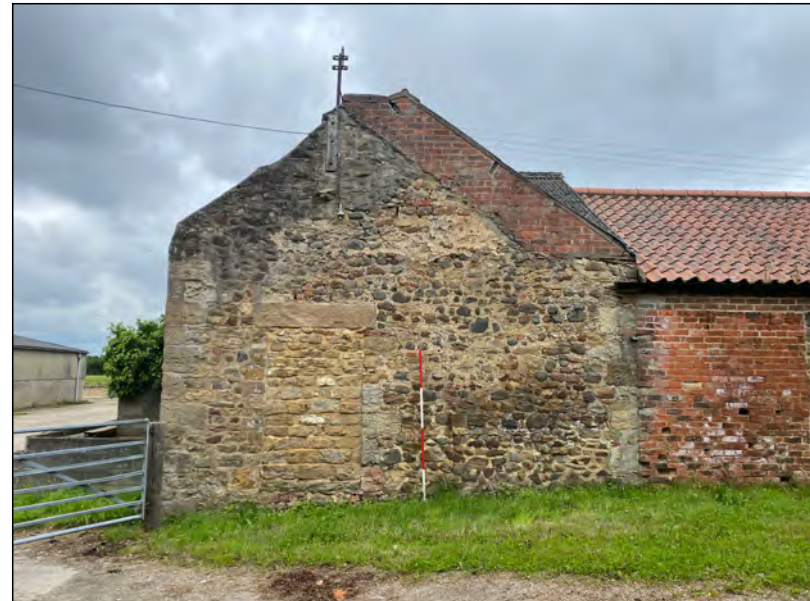
Photo 08. West gable elevation of the single-storey north range of farm-buildings, showing blocked doorway and alterations to the roof structure.

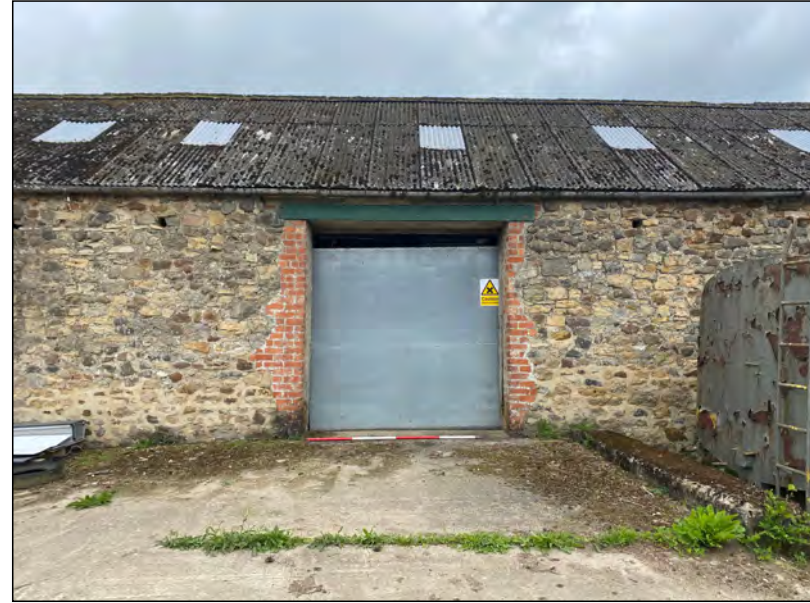
Photo 10. Doorway in the middle part of the north elevation to the north range

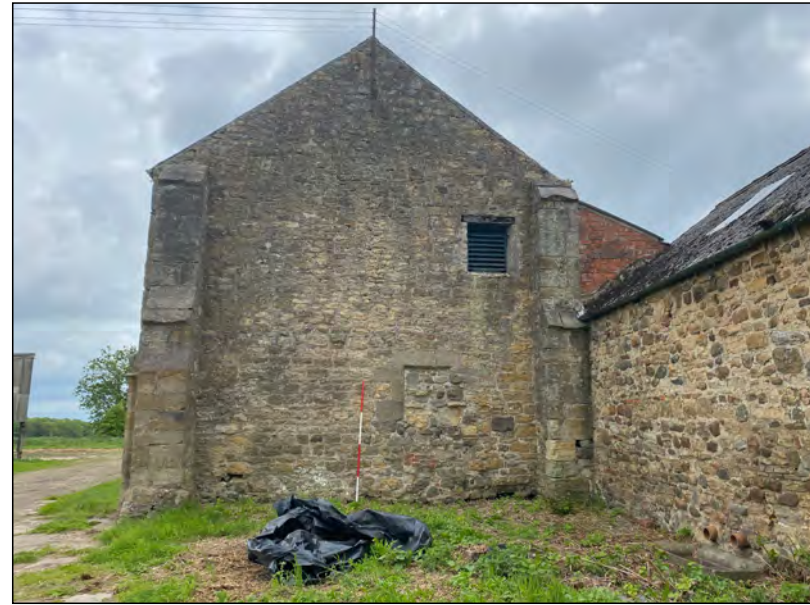
Photo 14. The north elevation of the 'old hall' attached to the east side of the east range.

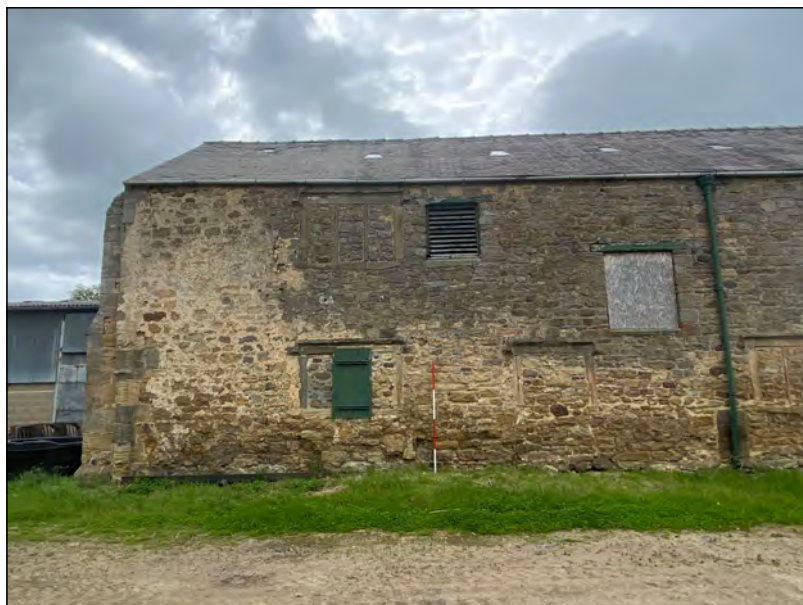
Photo 19. The south part of the east elevation of the 'Old Hall', with remains of the respond of an arch at the south end, two blocked ground-floor windows of medieval origin with another at first floor level.

Midway along the east wall, below a 16th or 17th-century two-light window, the lower parts of the chamfered sill and jambs of a medieval doorway are visible; the south jamb is in fact a pier, as there has been a second doorway immediately adjacent; no other part of this is visible. Further south, beneath the north jamb of a three-light window, a large upright block may be a remnant of the jamb of another medieval opening.

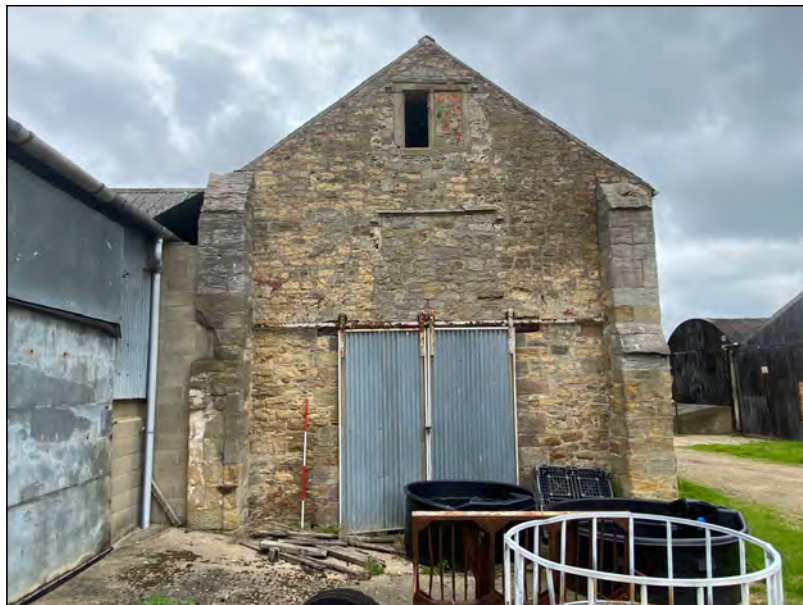
Photo 23. The south elevation of the 'Old Hall'.

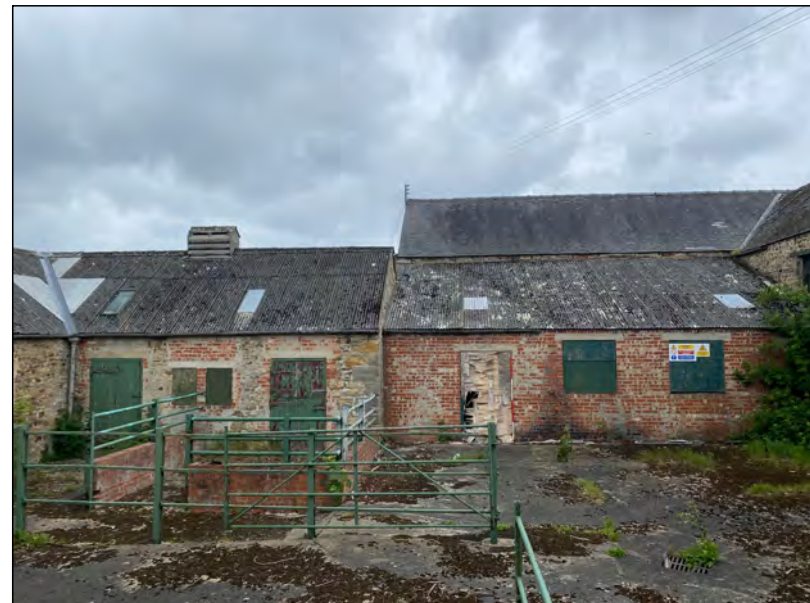
Photo 28. The west elevation of the east range of farm-buildings, comprising an original north part (left of view) and a later, lean-to addition to the north part of the west side of the 'Old Hall'.

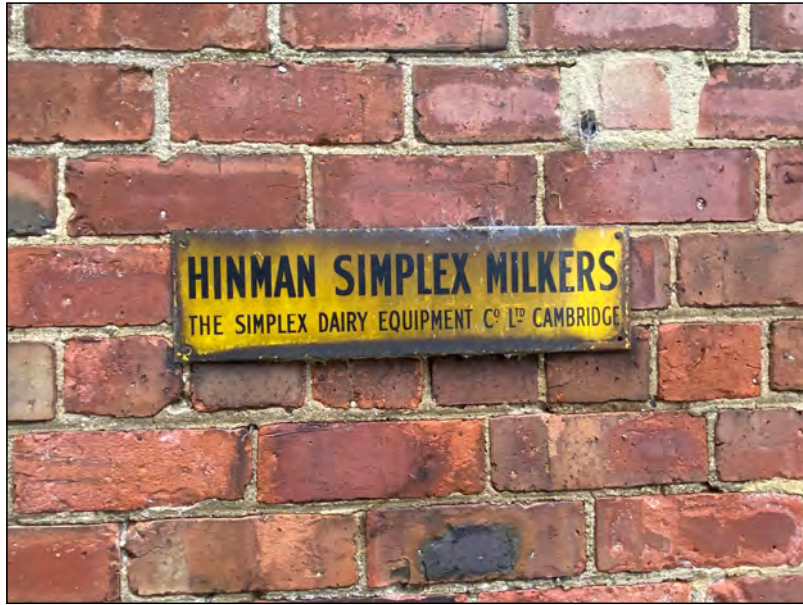
Photo 37. Old 'Hinman Simplex Milkers' (c 1930s) sign attached to the west elevation of the detached NW range.

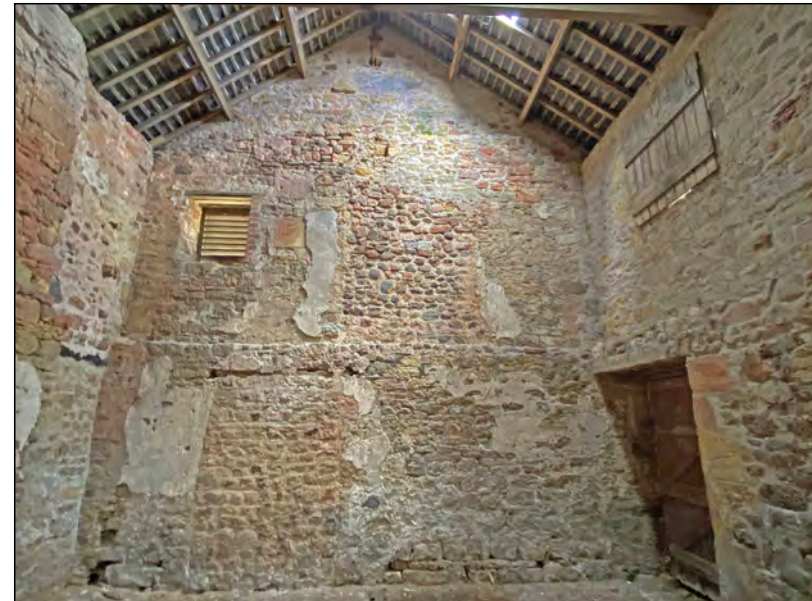
Photo 52. The south face of the north wall of the 'Old Hall'.

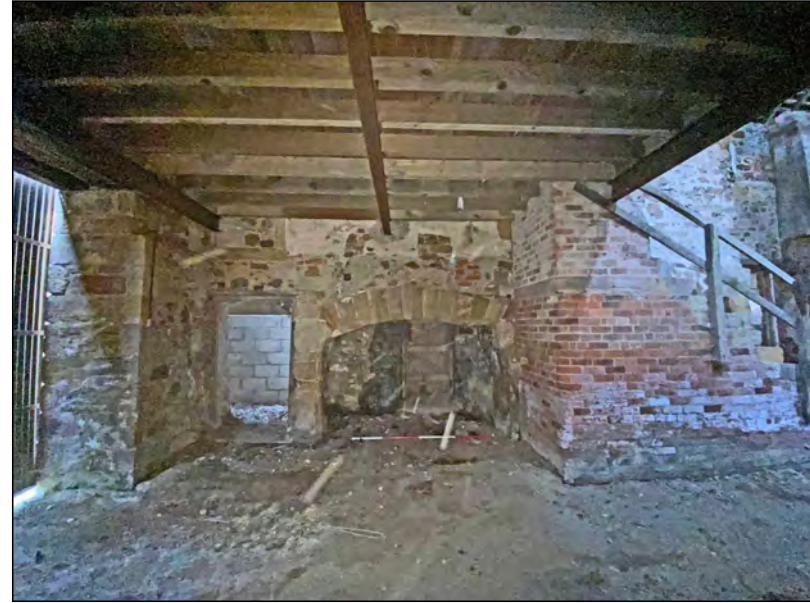
Photo 58. The south part of the internal face of the west wall of the 'Old Hall', with fireplace and modern brick-built stairs to first-floor level.

Towards the south end of the wall is a large segmental-arched fireplace with a chamfer of head and jambs broken by a single diamond-shaped stop at the centre of the arch; the chamfer has been partly cut away when the fireplace was adapted for a later range, now removed. A large projecting stack behind the fireplace survives in part, and also served a first-floor fireplace a little to the north, which has also been broken through by a doorway into the adjacent range. The surround (best seen on the south jamb which preserves the springing of an apparently segmental arch) is moulded with a sunk quarter-round inside a plain chamfer.

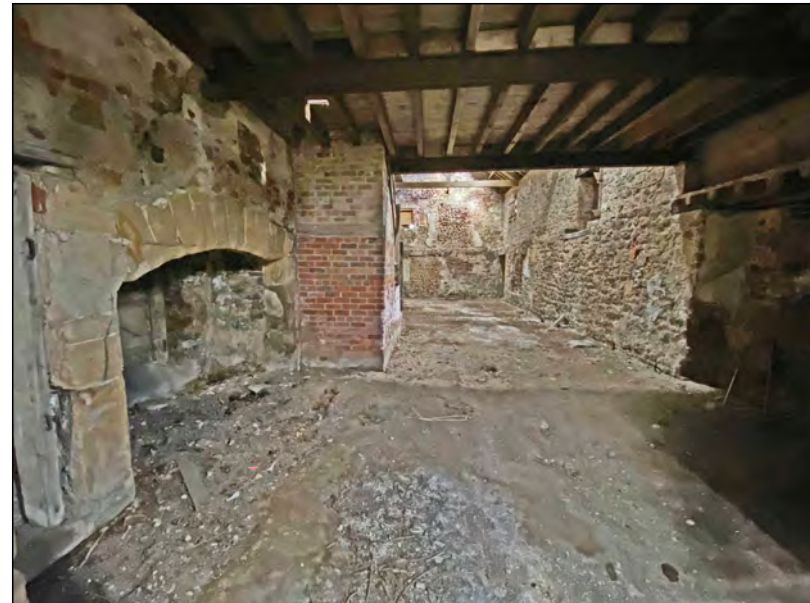
Photo 60. View NNE from the SW corner of the 'Old Hall' at GF level, showing fireplace in the S part of the internal W wall and modern brick-built stair beyond.

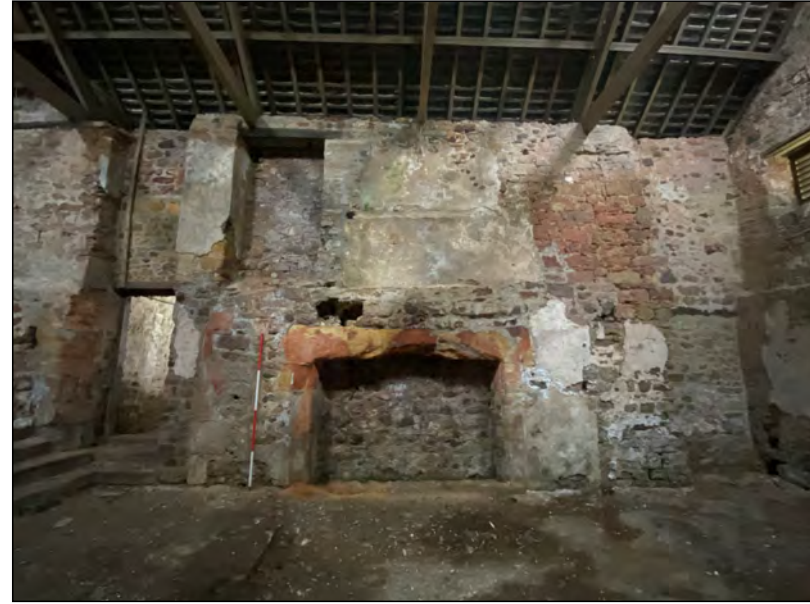
Photo 62. The north part of the internal (E-facing) west wall of the 'Old Hall', with fireplace prominent.

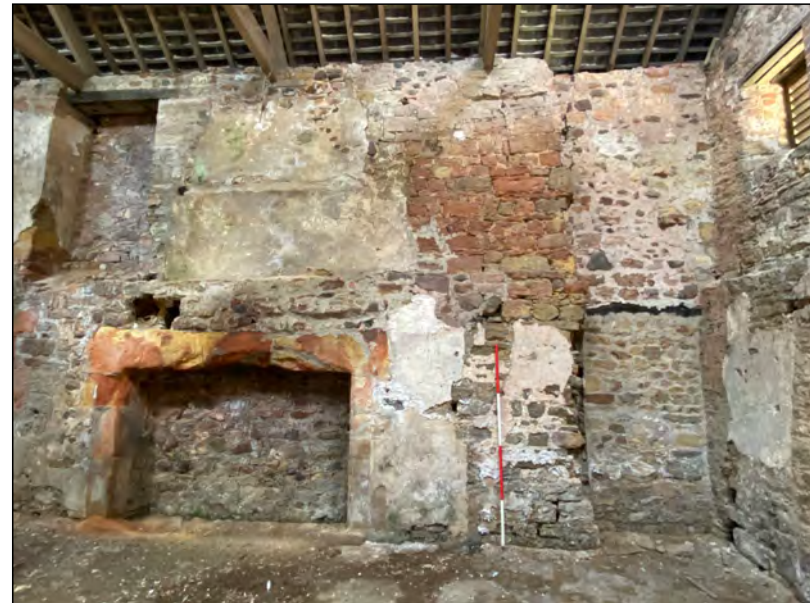
Photo 64. The N end of the internal (E-facing) W wall of the 'Old Hall', with fireplace to left and blocked opening with timber lintel at extreme right.

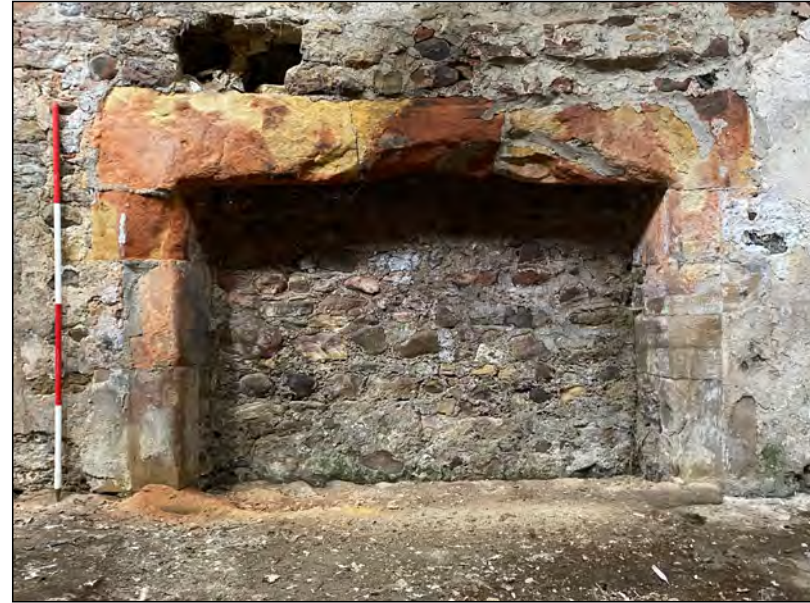
Photo 66. Fireplace in the N part of the internal (E-facing) W wall of the 'Old Hall', with signs of decay clearly visible in the mound of sand from the decayed lintel, particularly against the south jamb.

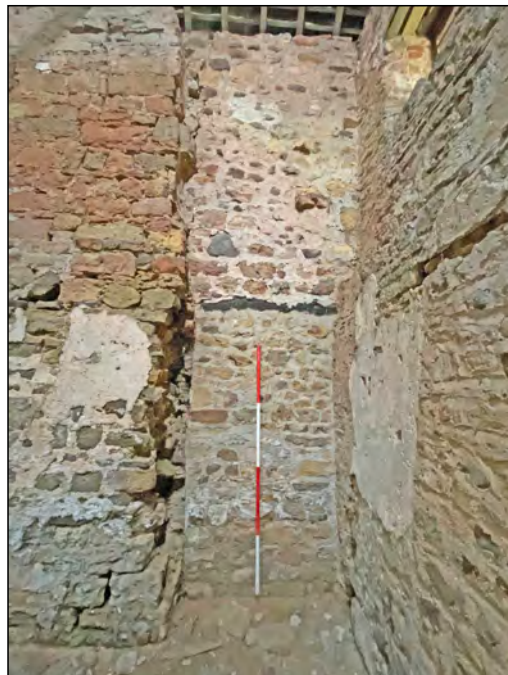
Photo 67. Blocked opening with remains of timber lintel at north end of the internal (E-facing) west wall of the 'Old Hall'.

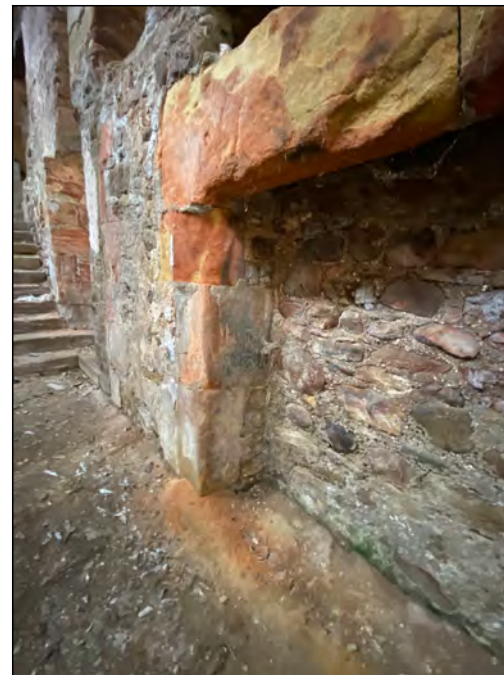
Photo 68. View from NE of fireplace in the north part of the internal (E-facing) west wall of the 'Old Hall', with signs of decay to its stonework clearly visible in the mound of sand below the decayed lintel, particularly against the south jamb. ⁴⁶

68	View from NE of fireplace in the north part of the internal (E-facing) west wall of the 'Old Hall', with signs of decay to its stonework clearly visible in the mound of sand below the decayed lintel, particularly against the south jamb.
69	View to the north-west corner of the 'Old Hall' interior.
70	A section of cobbled flooring in the north part of the 'Old Hall'.
71	View from the north of the stair to first-floor level.
72	View from the north of top of stairs at first-floor level, showing the surviving, decorated south jamb of former first-floor fireplace
73	View SW to north-facing wall forming passage to first-floor entrance door (to adjoining the first-floor granary of the south range of farm-buildings), formerly a fireplace marked by surviving south jamb.
74	Detail of former fireplace jamb in the west wall, first-floor level.
75	Possible column base now forming part of doorway surround to a passage into a first-floor entrance door at the top of stairs against the west wall.

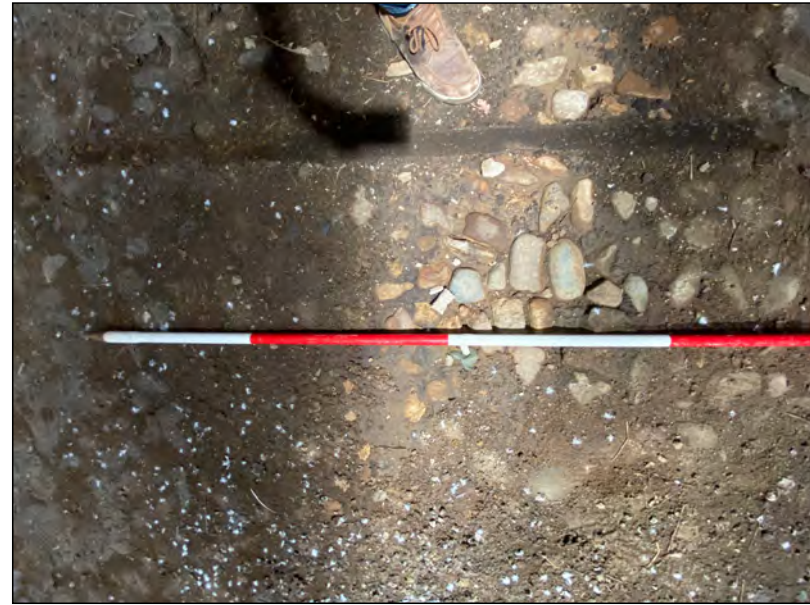
Photo 70. A section of cobbled flooring in the north part of the 'Old Hall'.

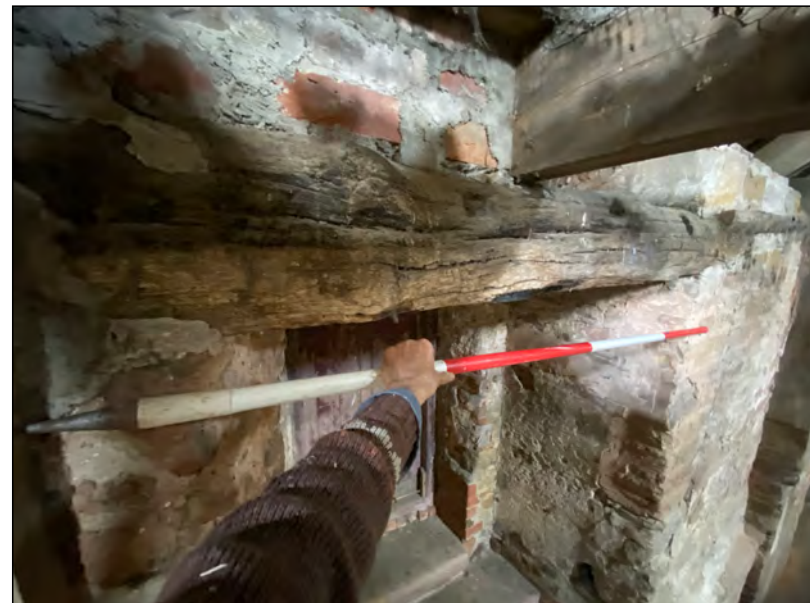
Photo 76. View from SE of worked timber reused as a window lintel in the south part of the west wall at first floor level.

76	View from SE of worked timber reused as a window lintel in the south part of the west wall at first floor level
77	View north to the north end of the first-floor space.
78	View north into the 'Old Hall' interior from the north end of the first-floor space.
79	The west-facing internal face of the south end of the east wall at first-floor level.
80	The north-facing internal face of the south wall at first-floor level.
81	The east-facing internal face of the south end of the west wall at first-floor level.
82	Blocked fireplace in the east-facing internal face of the south end of the west wall at first-floor level.
83	View NNE from the internal south-west corner of the internal first-floor space.

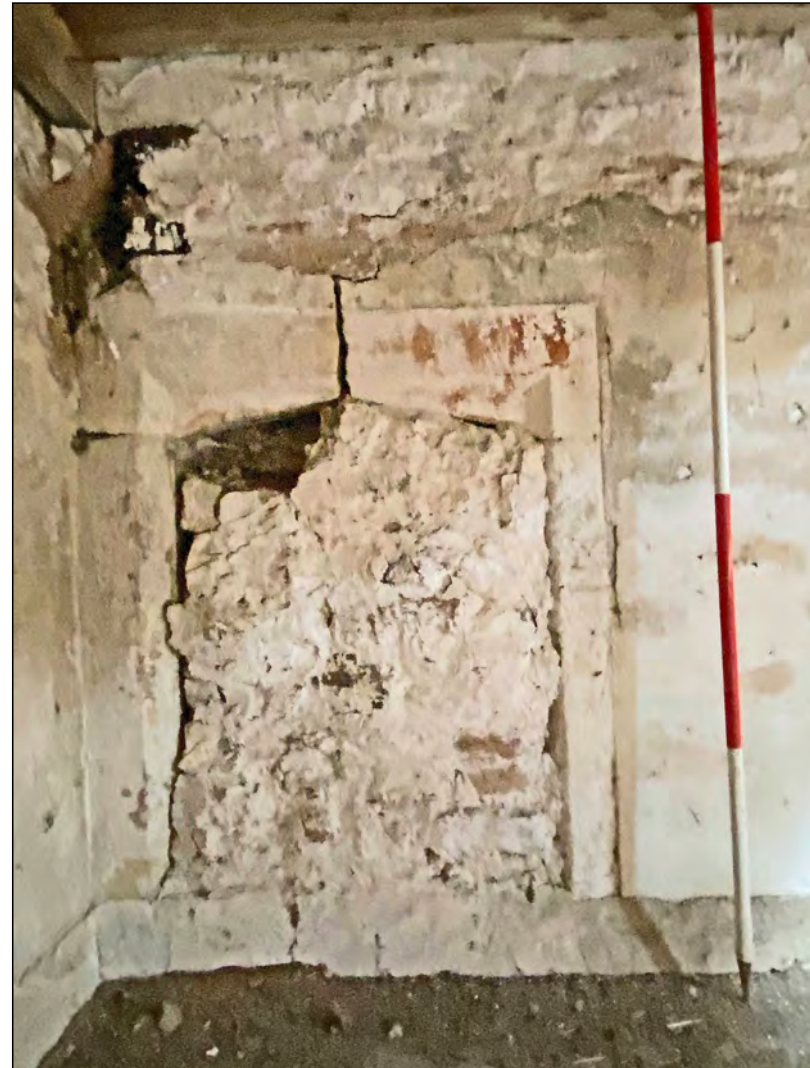
Photo 82. Blocked fireplace in the east-facing internal face of the south end of the west wall at first-floor level.
