EXCAVATIONS ON THE SITE OF WALWORTH
DESERTED MEDIEVAL VILLAGE
AT NORTH FARM, WALWORTH, COUNTY DURHAM
FOR THE BRIGHT WATER LANDSCAPE
PARTNERSHIP PROJECT

~ ARCHAEOLOGICAL EXCAVATION ~

JUNE 2022

REPORT ON AN ARCHAEOLOGICAL EXCAVATION

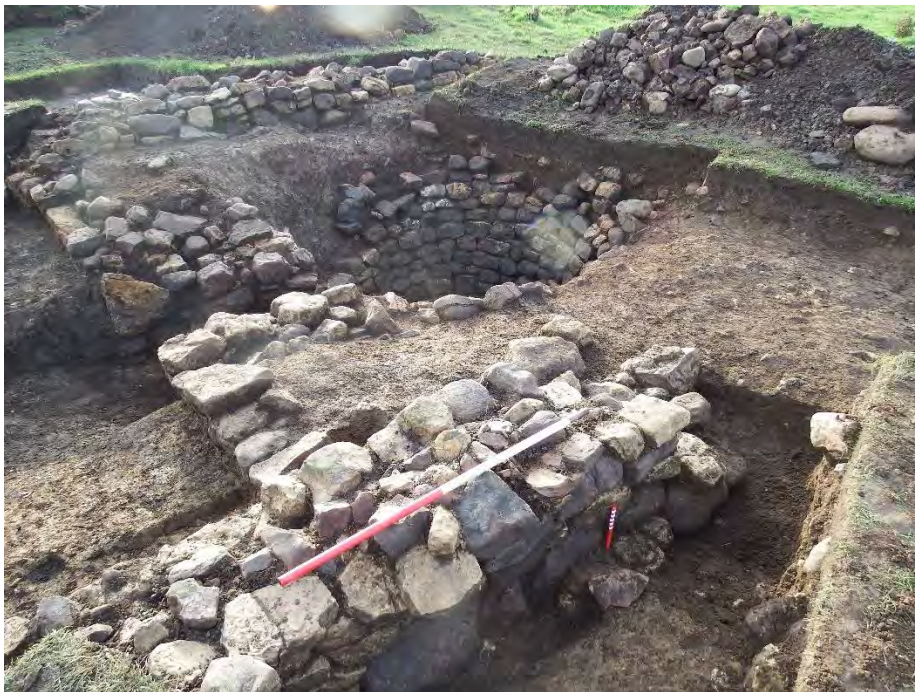
Frontispiece: *Building remains and a kiln at the west end of Trench1, seen from the north-east.*

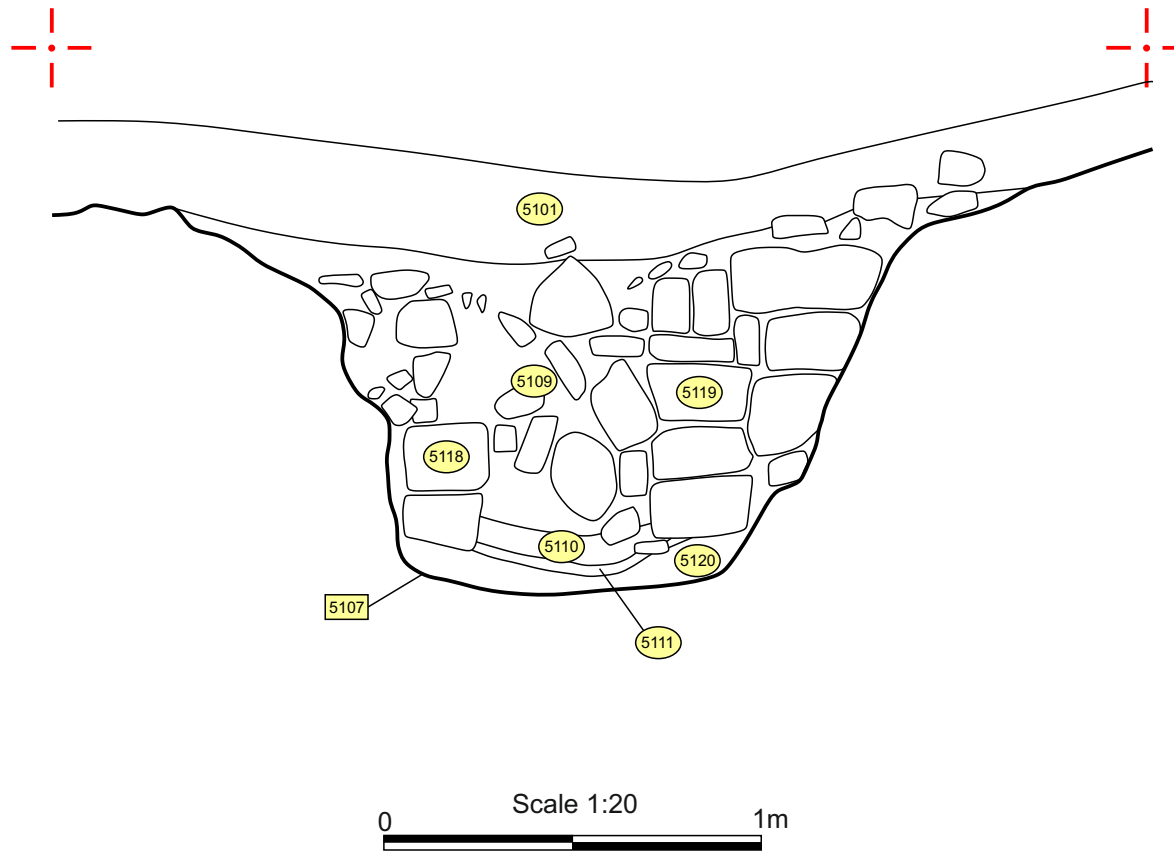
Illus. 33: West facing profile through Malting Kiln [5129].

In its original phase the kiln does not appear to have been lined with stones, as the natural clay around the outside of the feature showed a distinct reddening due to burning. Whether this original phase of use was also as a malting kiln is uncertain, but some re-cutting and deepening of the feature is implied in the subsequent phase (see below).

Following this initial phase of burning and use, a sandstone base [5138] was laid within the central part of the kiln floor, set into the natural clay [5120]. This stone base may have dated to the primary phase of the feature, but given that burning [5148] around the stone was localised and did not generally spread to the sides of the kiln, whereas the primary phase saw universal burning of the surrounding natural all around the upper part of the feature, it seems likely that this secondary phase involved some re-modelling and deepening [5107] of the original feature in also to convert it into a malting kiln (where it would be most undesirable for high heat and flames to reach the upper part of the firing pit). As a result of this deepening, fresh, unburnt clay [5120] was exposed at the base of the new kiln.

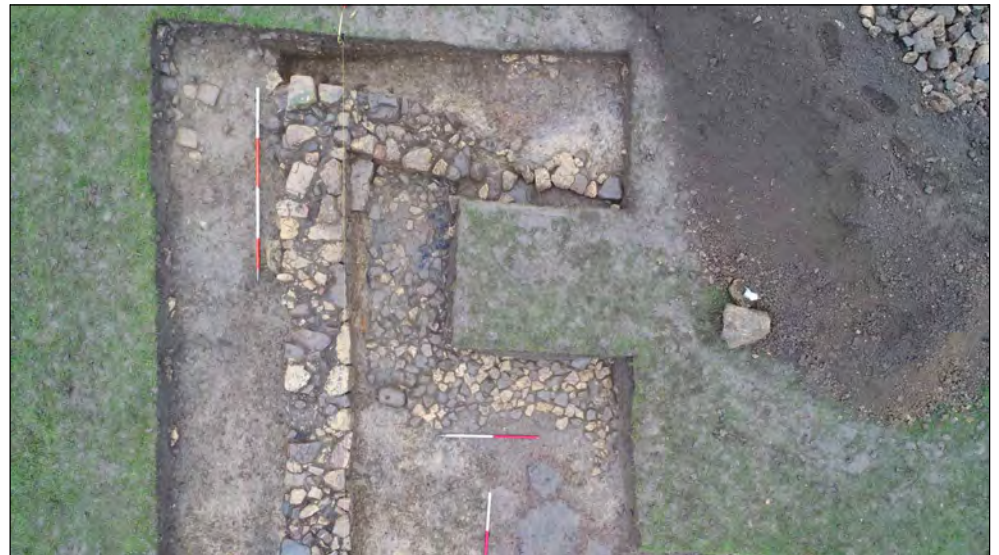
Photo 06. Trench 1 (East), aerial view looking east at walls [5209] [5219] and cobbled surface [5227].

The northern wall [5219] of this structure cut through an earlier feature marked by an area of closely packed cobbles [5227] that had been set into the natural clay to make up an area of hard-standing or a working surface. To the immediate west of this surface was a broadly linear area of heavy burning [5216] across the upper part of the natural clay. This was interpreted as the base of an industrial feature such as a kiln or oven, which would have generated enough heat to bake the underlying clay. Remnants of charcoal [5226] pressed between the upper part of the cobble surface may indicate firing waste from this process. Only these lower levels of this feature survived, with the upper parts presumably having been removed prior to the building of the northern and western wall lines of Structure 03). These walls presumably replaced earlier walls associated with a structure around this industrial feature.

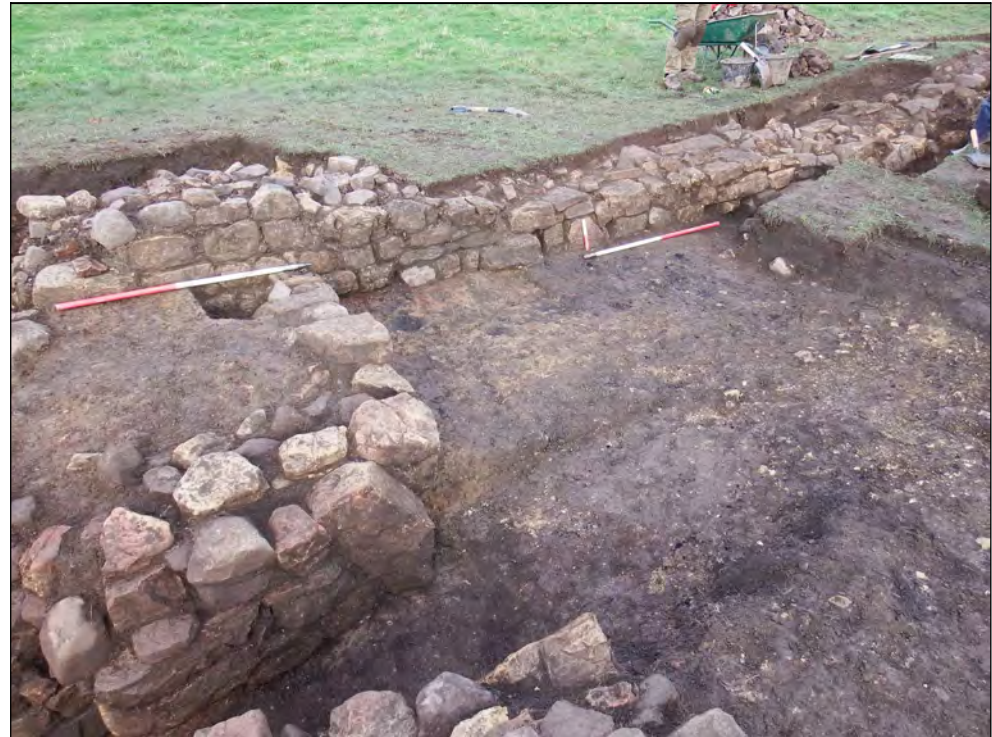
Photo 12. Trench 1 (West), view from the south-west across Building 1 Wall [5113], with kiln flue in the foreground.

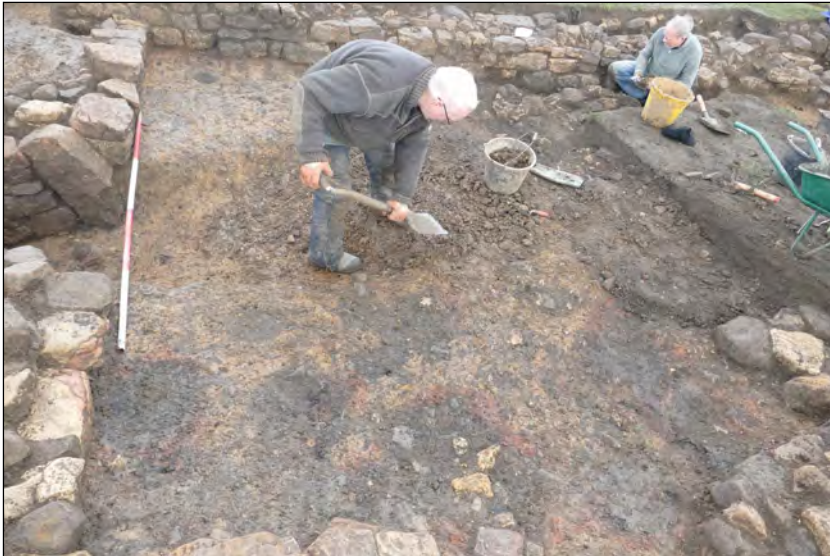
Photo 13. Trench 1 (West), showing the dark fills of sub-circular features with burnt rims, possibly postholes or small fire pits east of the kiln.

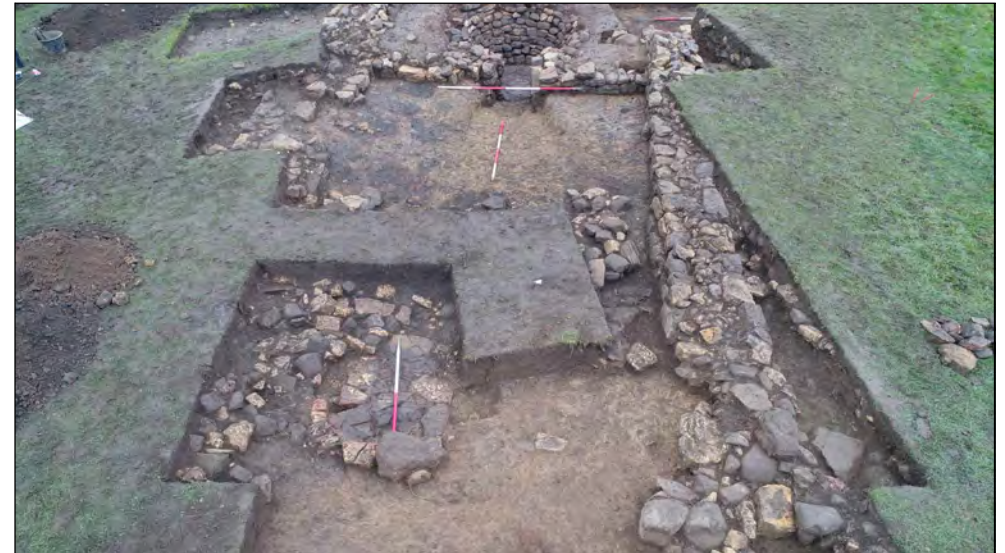
Photo 15. Trench 1 (West), final oblique view from the East, showing kiln to rear and possible (bread-)oven base in the foreground.

The second feature [5141] has been interpreted as the base of an oven, perhaps a bread oven and was formed by a layer of closely packed stones with the remnants of an outer structure rising from its circumference. Areas of burning upon several of these stones indicated localised high temperatures within this feature.

Further east, a partially-excavated, apparently oval-shaped feature formed by a layer of closely packed stones, with the remnants of an outer structure rising from its circumference, was interpreted as the base of a bread oven. Areas of burning upon several of these stones indicated localised high temperatures within this feature. Removal of a baulk of unexcavated ground between the oval feature [5142] and possible bread-oven base [5141] would have elucidated the interpretation of both as separate features or a single larger feature, but time constraints prevented this.

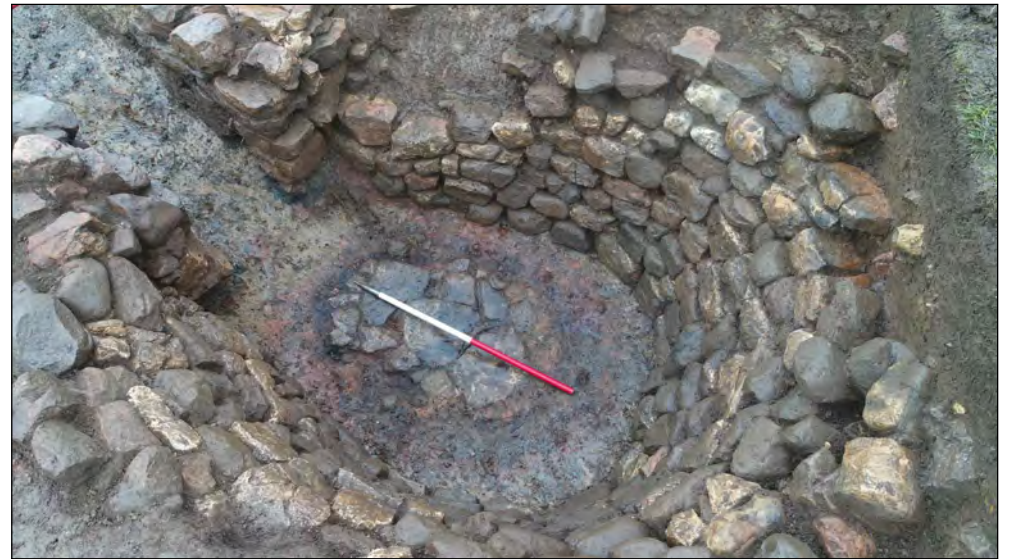
Photo 22. Trench 1 (Kiln), oblique working view showing rings of burning around the central stone component of the floor.

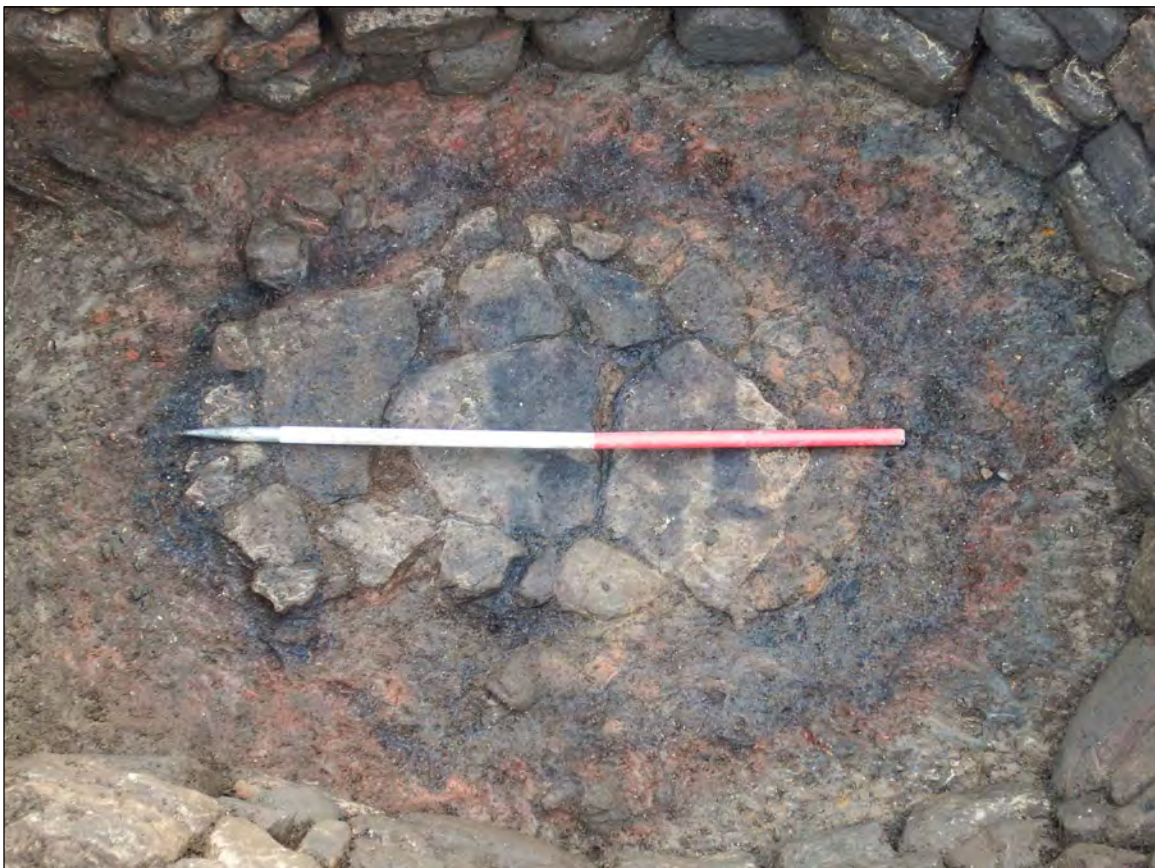
Photo 24. Trench 1 (Kiln), vertical view of the kiln floor, showing patterns of burning.

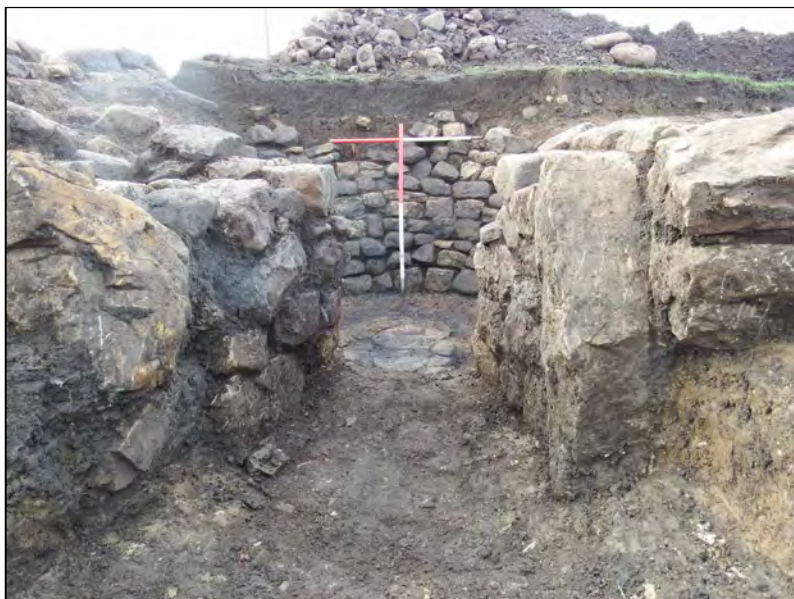
Photo 27. Trench 1 (Kiln), external view of kiln east opening before cleaning the floor deposits.

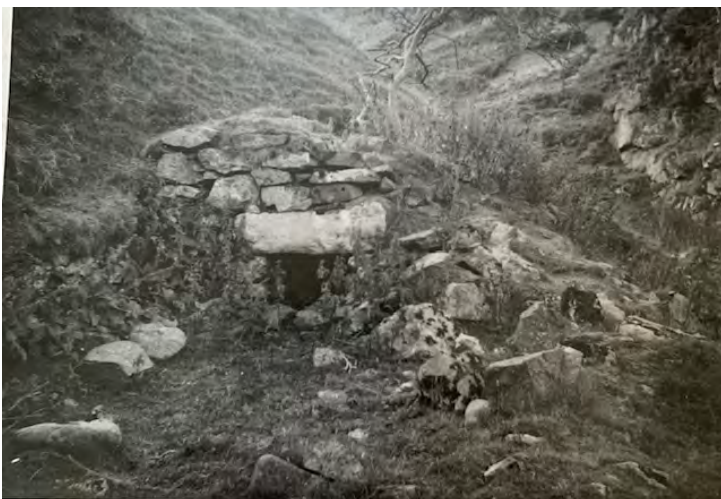
Illus. A5_03 A malting kiln used in the production of whiskey at Rory's Still, Upper Coquetdale (unpublished photo. Taken in 1956 by Captn. Walton, used courtesy of BrightWater volunteer, Barbara McCabe)

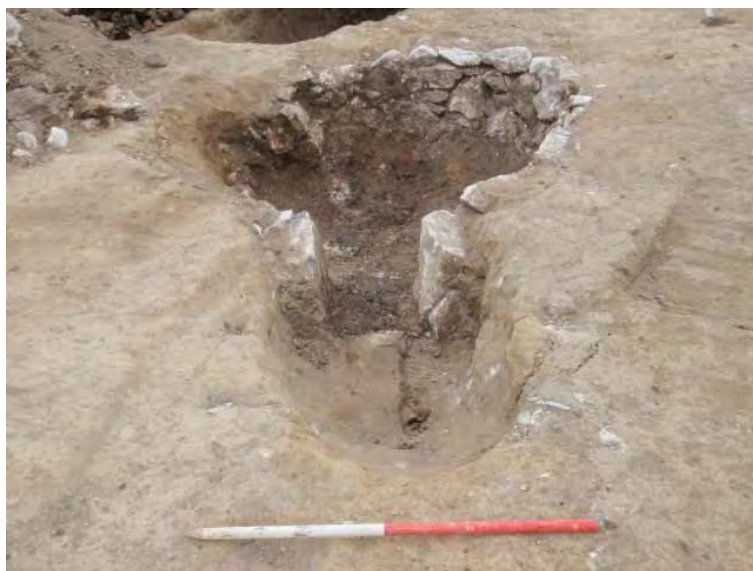
Illus. A5_05: Medieval lime-kiln excavated at Caherduggan castle, Cork

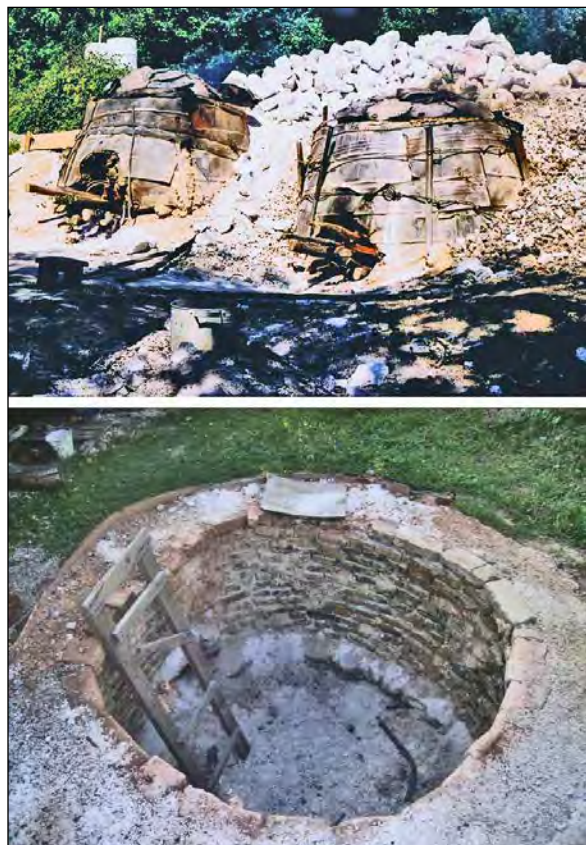
Illus. 05_06 a&b: Traditional European flare kilns. Although superseded in Northern & Western Europe, traditional flare kilns of the form once used in Northumberland are still used by small-scale producers in Southern and Eastern Europe, where they are used to produce pure forms of lime, often from superior forms of limestone, untainted by the by-products of burnt fuel. The pure lime products are often sold in small quantities directly to consumers, or in larger quantities to middlemen or professional builders, the majority of whom use it as lime wash. The upper photograph shows two kilns built into a road embankment with a supply of limestone dumped by the roadside. The kilns, of 1-2 tonnes capacity, are being fired with beachwood stoked through an opening into the firing chamber, over which the limestone blocks are stacked to form a temporary vaulted floor. The top of the kiln is loosely covered with tiles and metal sheeting during firing, which takes approximately a day and night of continuous stoking, towards the end of which flames shoot out of the top of the kiln. The lower photograph shows an empty kiln with brick lining and ledge from which the temporary limestone vault is sprung.
