**NATIONAL TRUST  
LINDISFARNE CASTLE  
BUTLER'S PANTRY**

ARCHAEOLOGICAL WATCHING BRIEF

<b>Report title:</b>	<i>National Trust, Lindisfarne Castle, Butler's Pantry. Archaeological Watching Brief.</i>
<b>Stage:</b>	<i>Final</i>
<b>Project code:</b>	<i>AP 22/29</i>
<b>Compiled by:</b>	<i>Marc Johnstone</i>
<b>Control:</b>	<i>Richard Carlton</i>
<b>OASIS ID:</b>	<i>thearcha2-512322</i>
<b>Date of fieldwork:</b>	<i>14/11/2022</i>
<b>Date Issued:</b>	<i>13/12/2022</i>
<b>Listed Building Consent:</b>	<i>18/04503/LBC; 16/02378/LBC; 21/04315/LBC</i>
<b>Grid reference (NGR):</b>	<i>NU 13638 41751</i>
<b>Client:</b>	<i>National Trust</i>

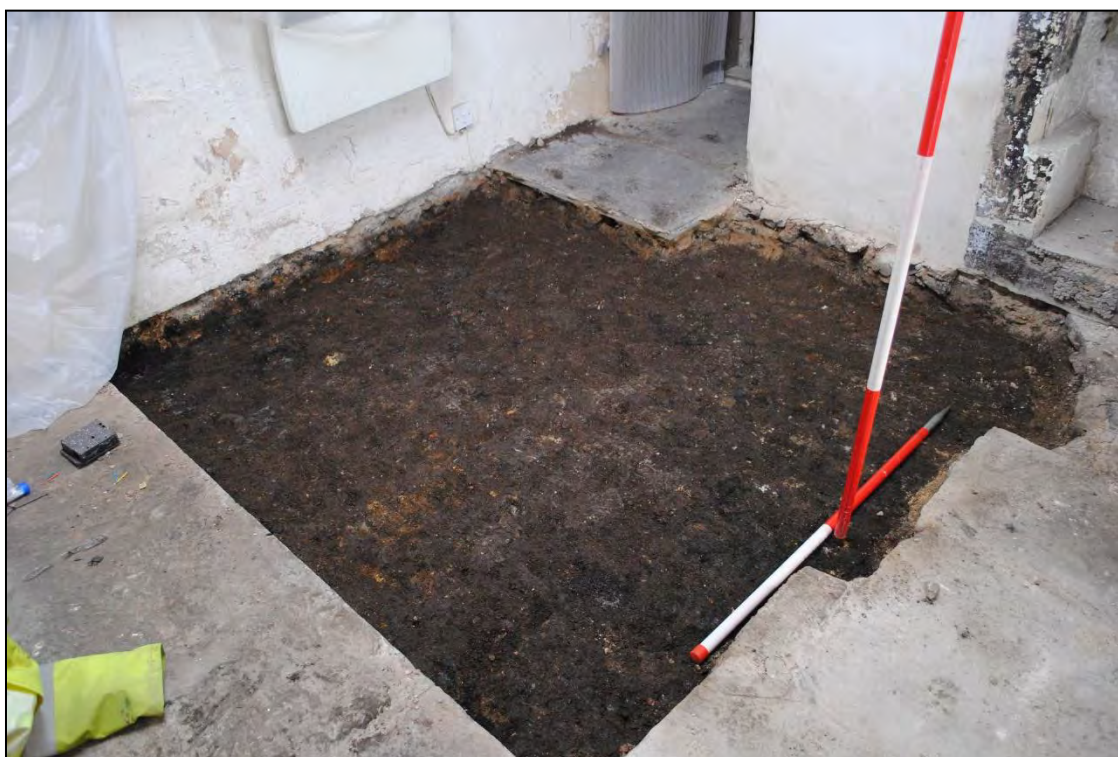
*Frontispiece: View looking north-east across the floor of the Butler's Pantry, following excavation of concrete debris and rubble layers.*

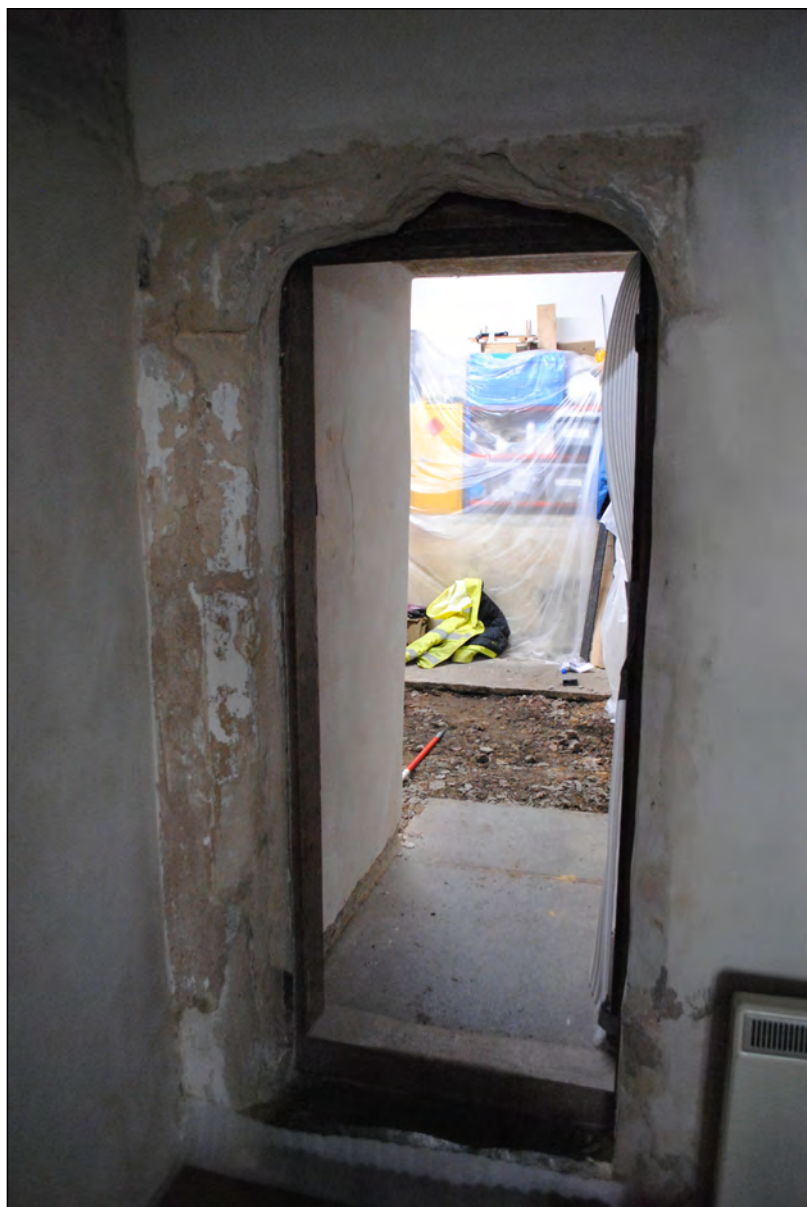
3.2.1.1 Upon arrival it was observed that the floor of the Butler's Pantry slopes, declining to the east. The current floor level across much of the Butler's Pantry, which comprised of modern concrete, had just been broken up and largely removed to a depth of approximately 0.04 m. This removed concrete floor extended from the step of the entranceway in the north-east corner of the room for 1.71 m westwards and approx. 1.91 m southwards, but with an uneven, somewhat crenelated southern edge reflecting the position of remaining sandstone flags to the south.

*Photo 1. View looking west through the entrance passage to the Butler's Pantry, following the removal of concrete but prior to archaeological excavation.*

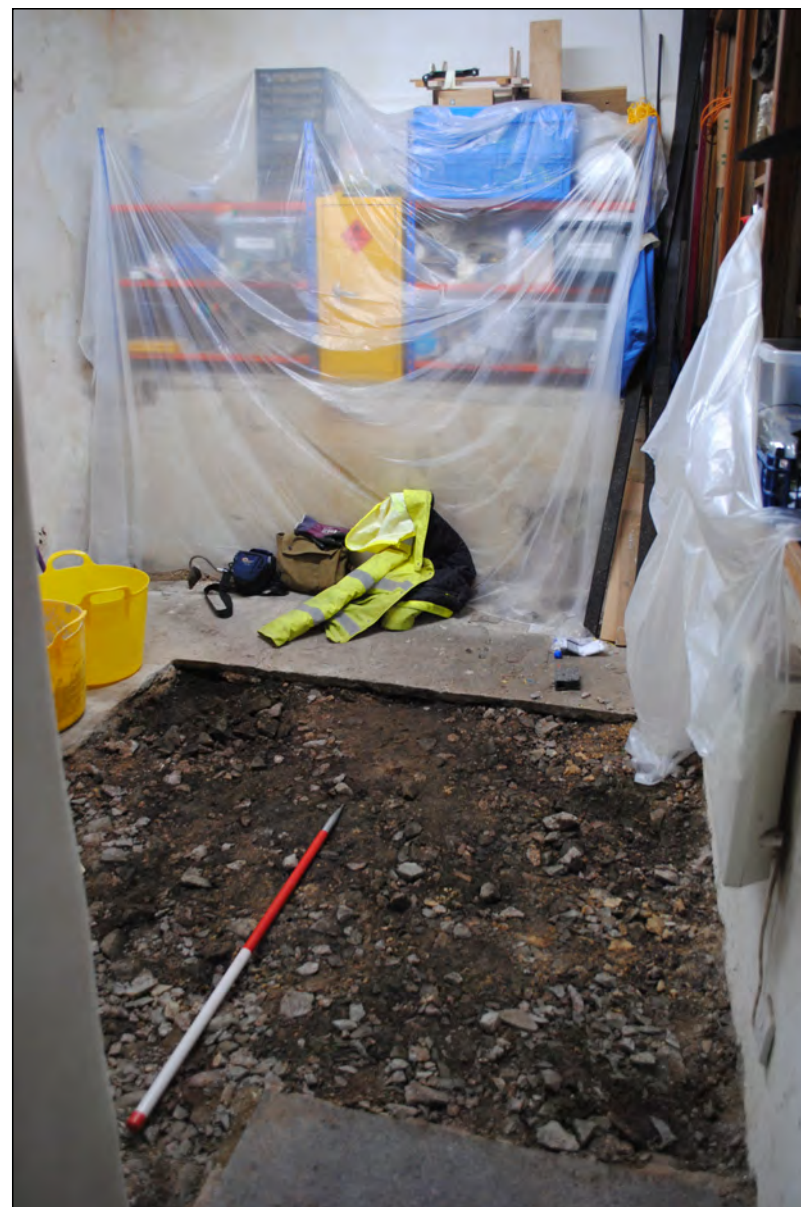
*Photo 2. View looking WSW following the removal of concrete on the floor of the Butler's Pantry.*

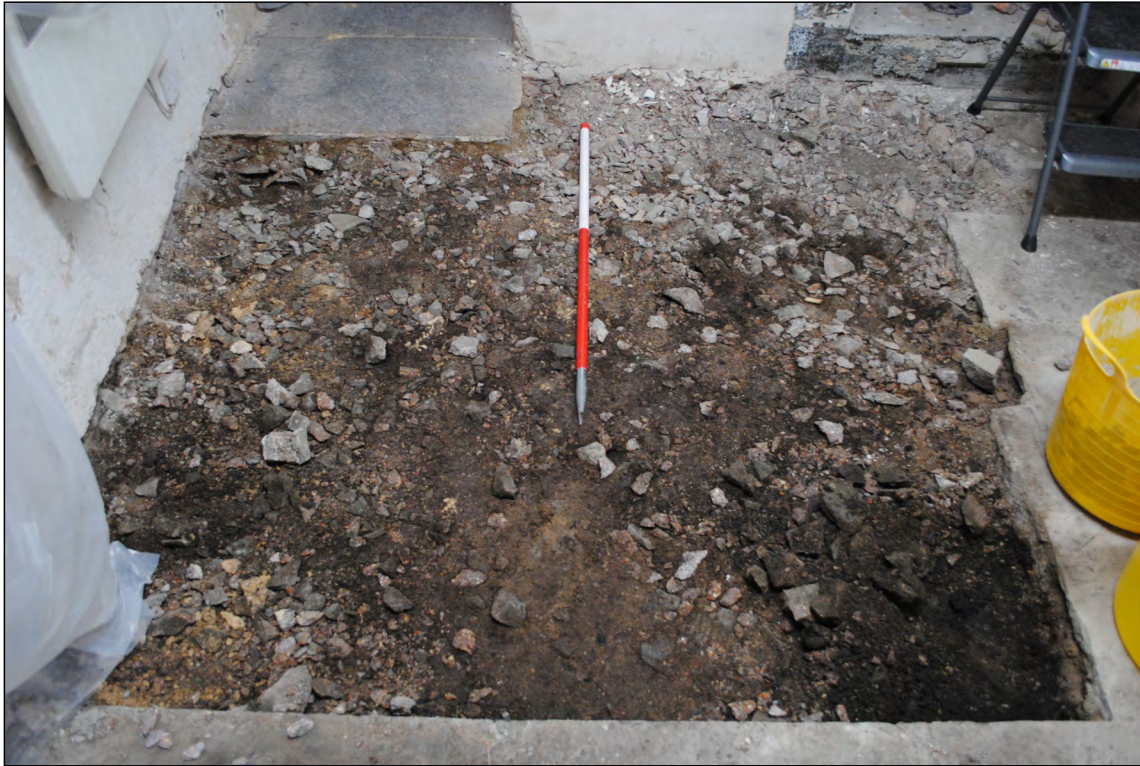
*Photo 3. View looking east across the floor of the Butler's Pantry, following removal of concrete.*

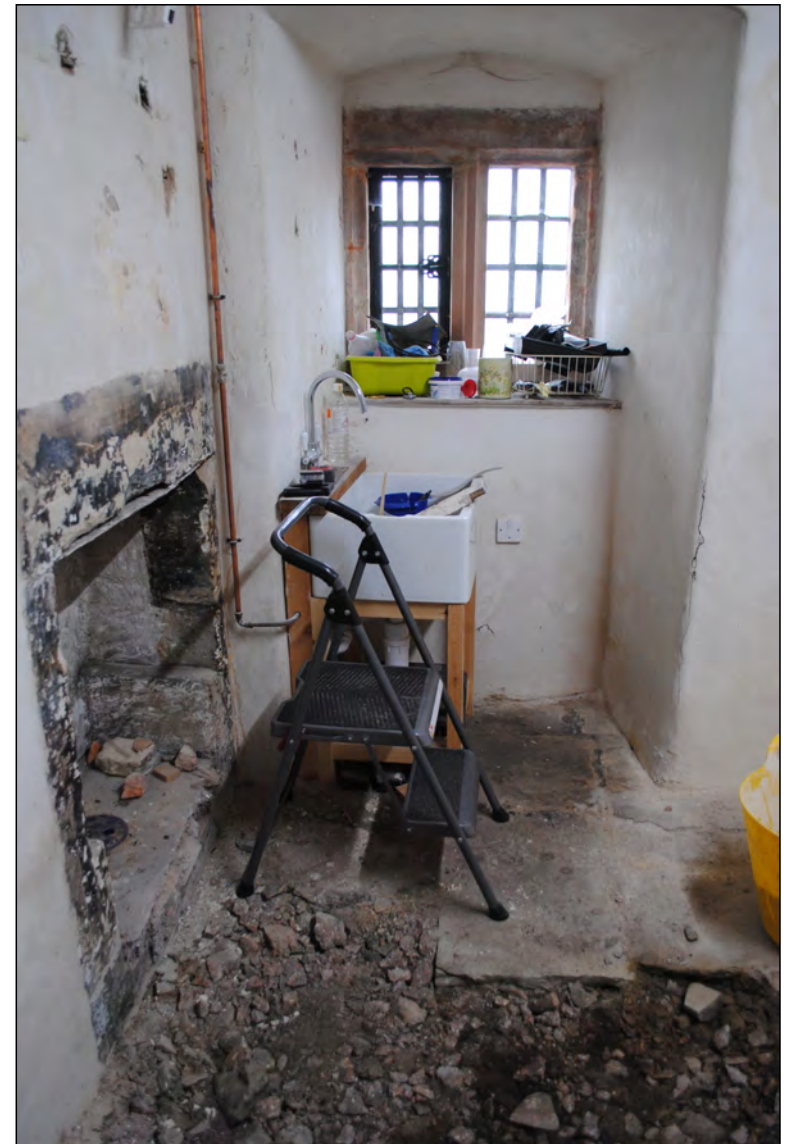
*Photo 4. View looking south across the floor of the Butler's Pantry, following removal of concrete.*

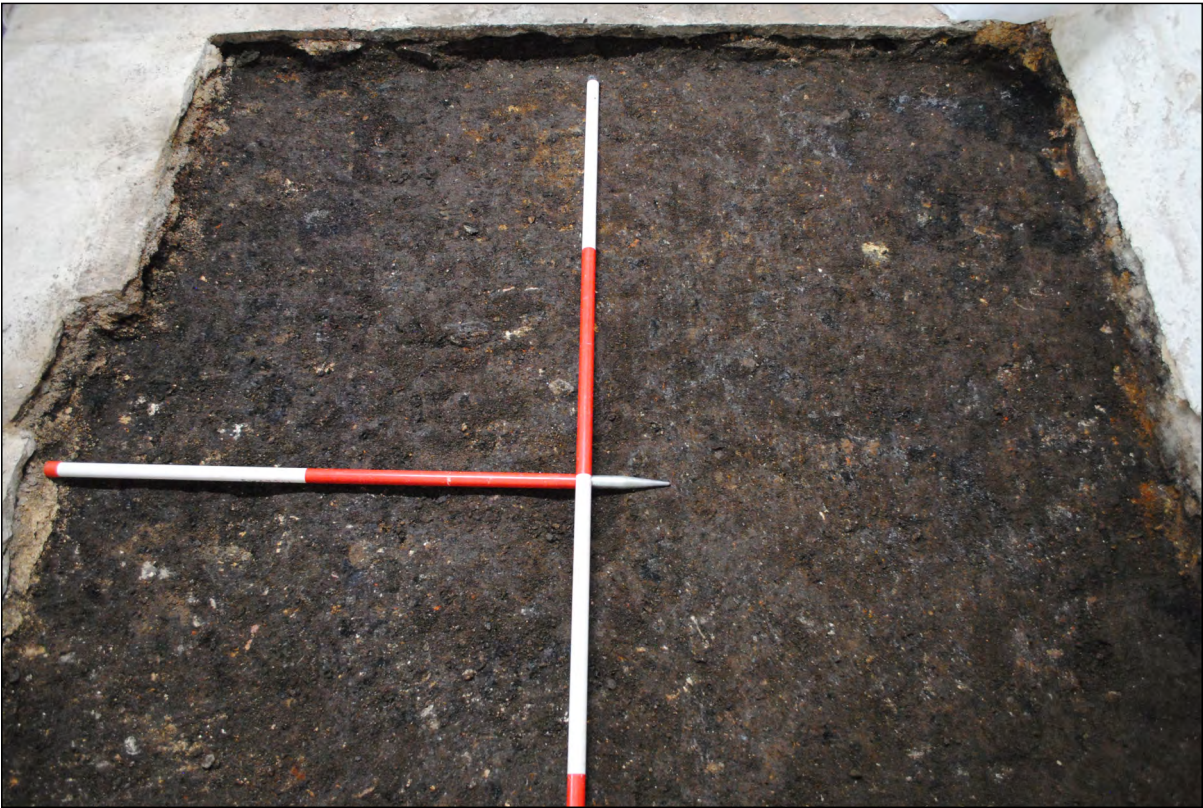
3.2.2.1 Below the modern concrete floor [01], sandstone flags [02] and associated cement mortar bedding [03], was a coal-rich silty-ash layer [04] observed throughout the entire excavation area, from 0.08 – 0.12 m from the top of the flags on west side and 0.09 – 0.13 m on east side.

*Photo 5. View looking west across the floor of the Butler's Pantry, following excavation of concrete debris and rubble layers.*

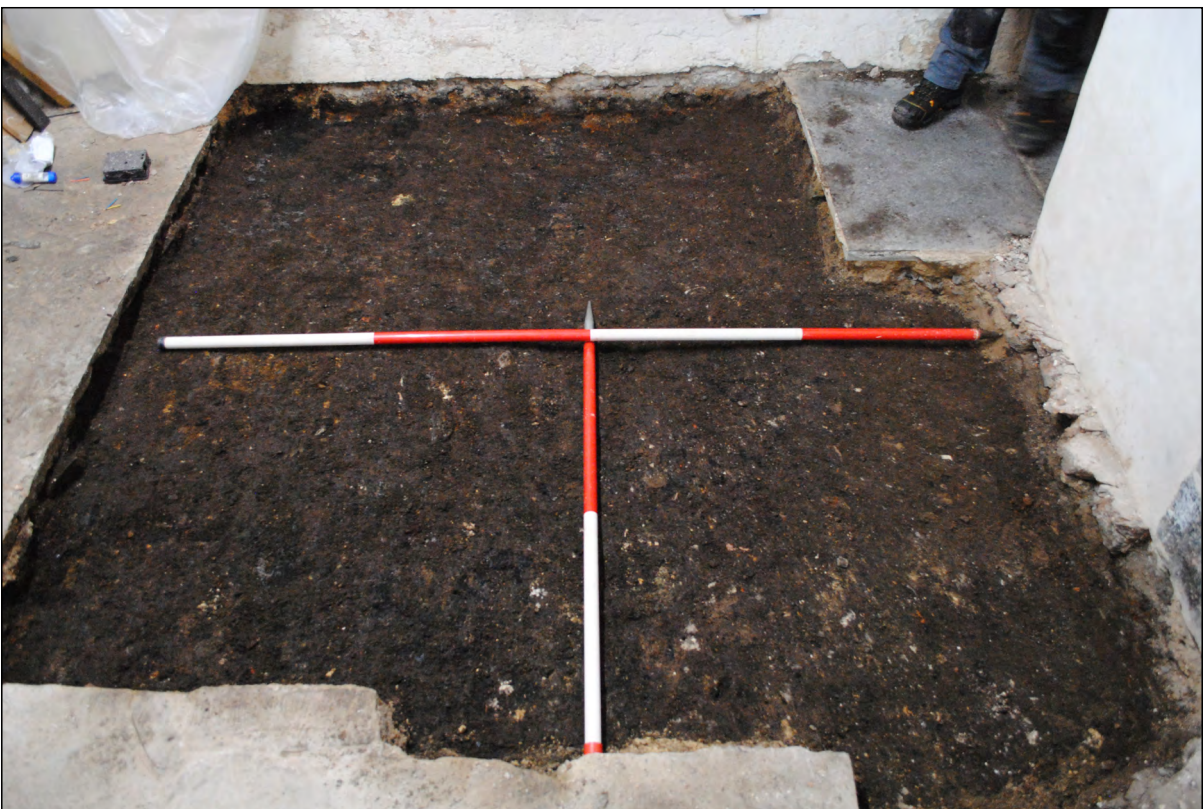
3.2.2.2 Noticeably more coal inclusions were observed along the north side of the excavation area, extending from the entrance and culminating in a particularly coal-rich patch, revealed in the north-west corner. This is entirely consistent with what room was used for, a coal store, for the last 300 years or so. The layer has therefore been interpreted as cumulative, residual waste from historic coal-storage dating from the late post-medieval – early modern period.

*Photo 6. View looking north across the floor of the Butler's Pantry, following excavation of concrete debris and rubble layers.*

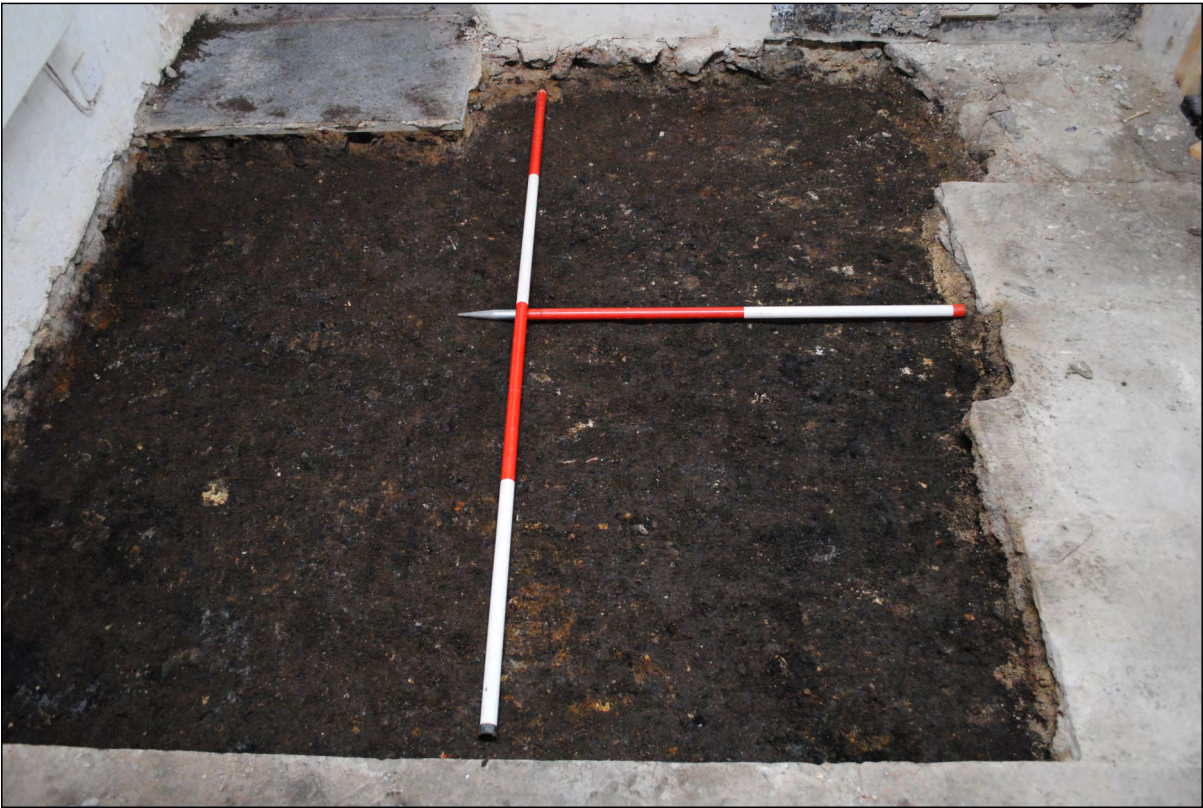
*Photo 7. View looking east across the floor of the Butler's Pantry, following excavation of concrete debris and rubble layers.*

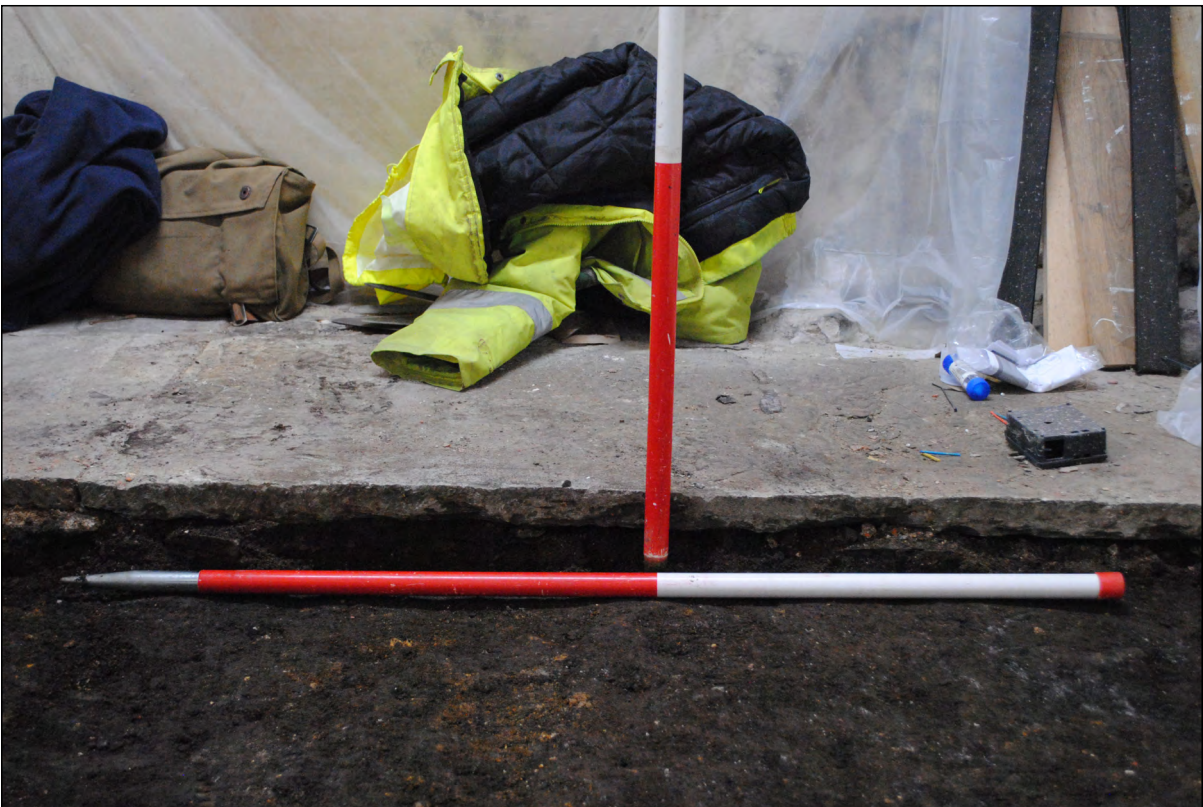
- [01] Concrete floor, removed by building contractors prior to arrival. Modern concrete observed to depth of 0.04 -0.05 m.
- [02] Sandstone flags, seen in section around the perimeter of the excavation area to a depth of approx. 0.04 – 0.05 m.
- [03] Cement/mortar bedding for upper flags, observed to be 0.03 – 0.04 m in depth.
- [04] Coal-rich silty ash layer observed below the concrete floor and bedding layer, throughout the entire excavation area. Firm and compact, gritty, dark reddish-brown with frequent rubble waste and clinker. Observed from 0.08 – 0.12 m from top of flags on west side and 0.09 – 0.13 m on east side. A particularly coal-rich patch was revealed in the north-west corner of the excavation area, measuring approx. 0.50 x 0.50 m. Noticeably more coal inclusions were observed along the north side of the excavation area, extending from the entrance.

*Photo 8. East facing section of the Butler's Pantry floor, following excavation of concrete debris and rubble layers.*

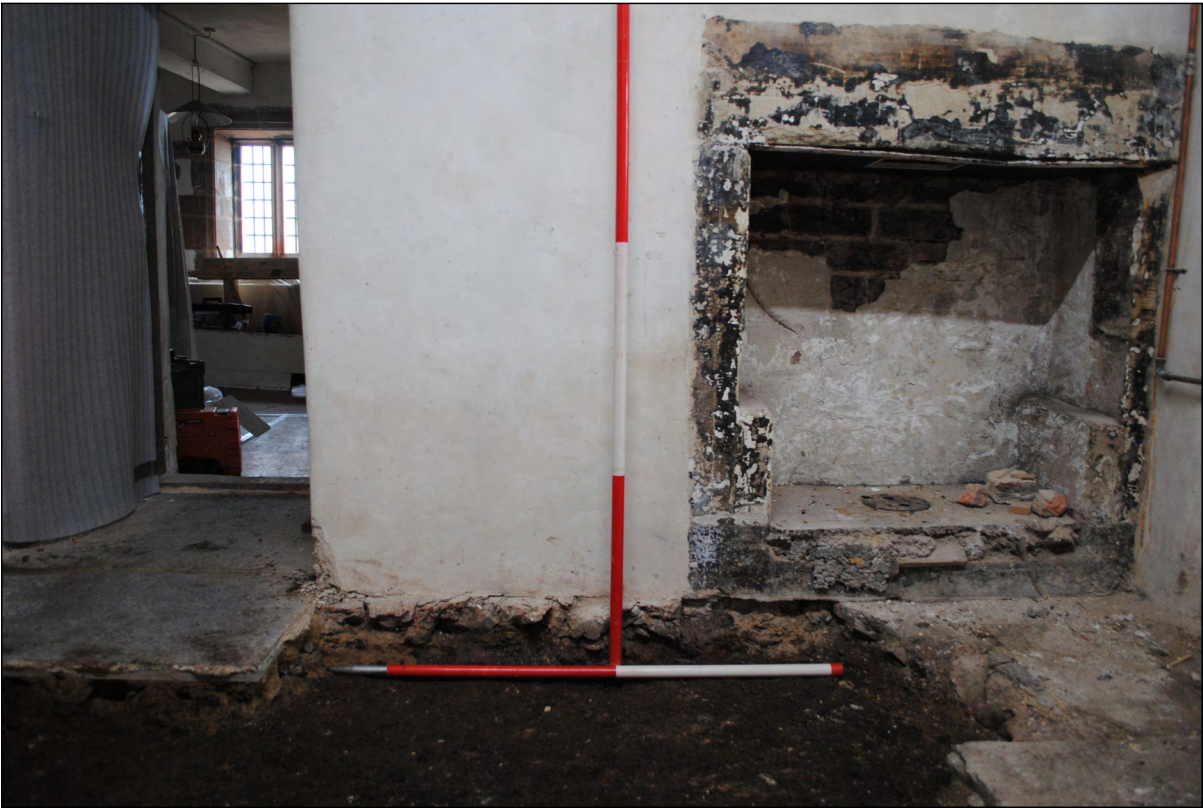
*Photo 9. West facing section of the Butler's Pantry floor, following excavation of concrete debris and rubble layers.*

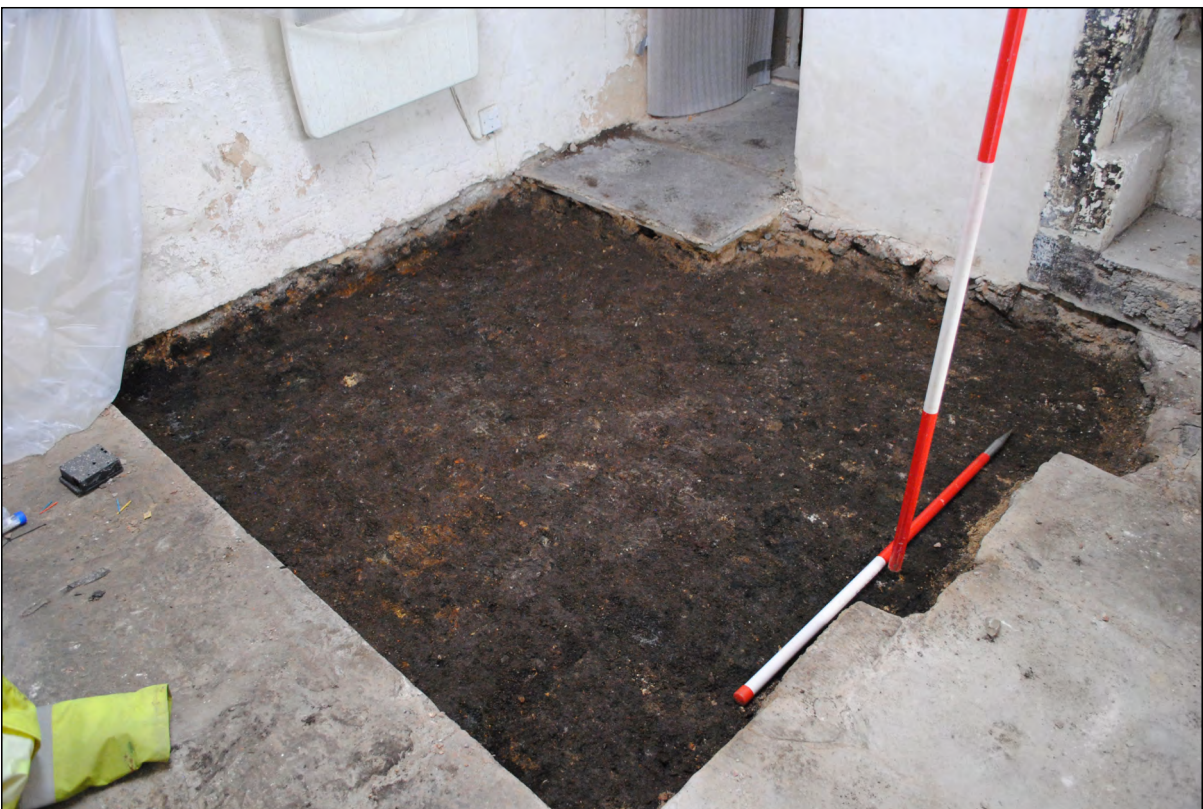
*Photo 10. View looking north-east across the floor of the Butler's Pantry, following excavation of concrete debris and rubble layers.*

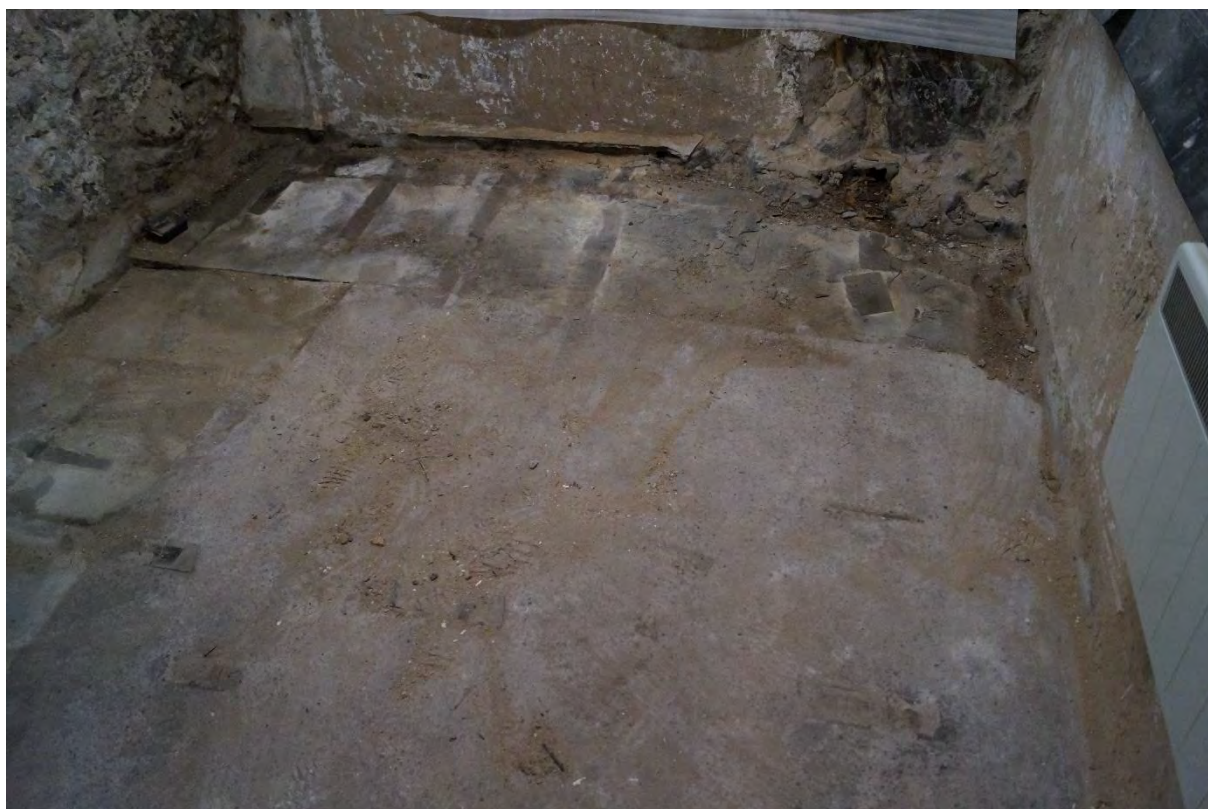
The area in question is identified in the following photograph;

Concrete floor, Butler's Pantry, looking west

The proposal seeks consent remove the concrete floor and replace with Caithness flagstones, with which the floor of the doorway and adjacent Kitchen is covered.

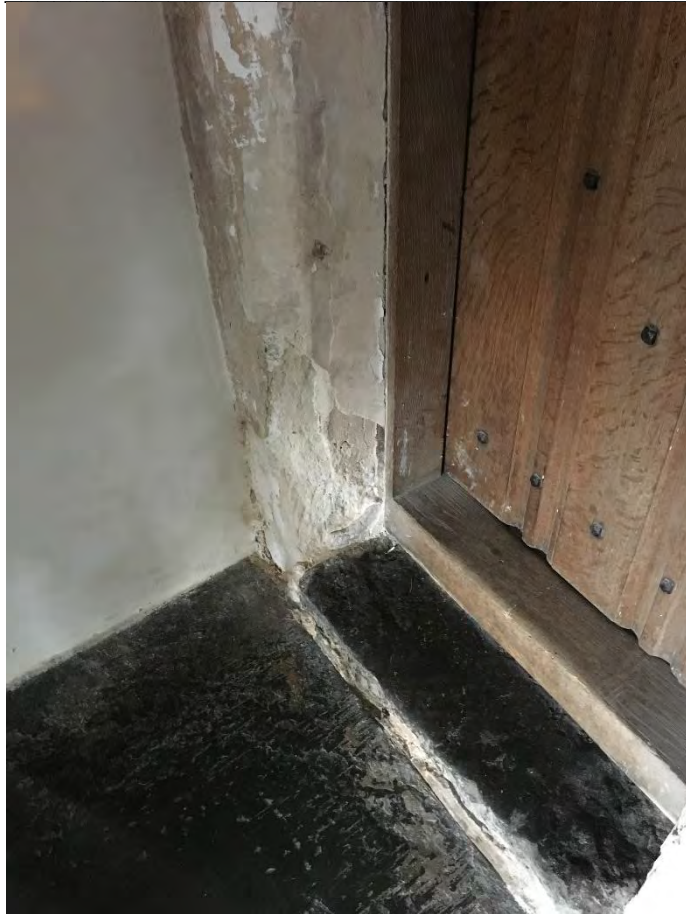
South-East corner: damage to the door jamb leading into the Pantry

The planned works will involve removing all remaining concrete floor in its entirety. The extent of the work is considered necessary to control deterioration to the historic features of the room, most especially to the oak of the Lutyens door surround.
