SINDERHOPE SHIELD ALLENDALE NORTHUMBERLAND

An Historic Buildings Assessment and Record
of a Bastle and Bastle-Derivative House

JANUARY 2023

Historic Buildings Assessment and Record

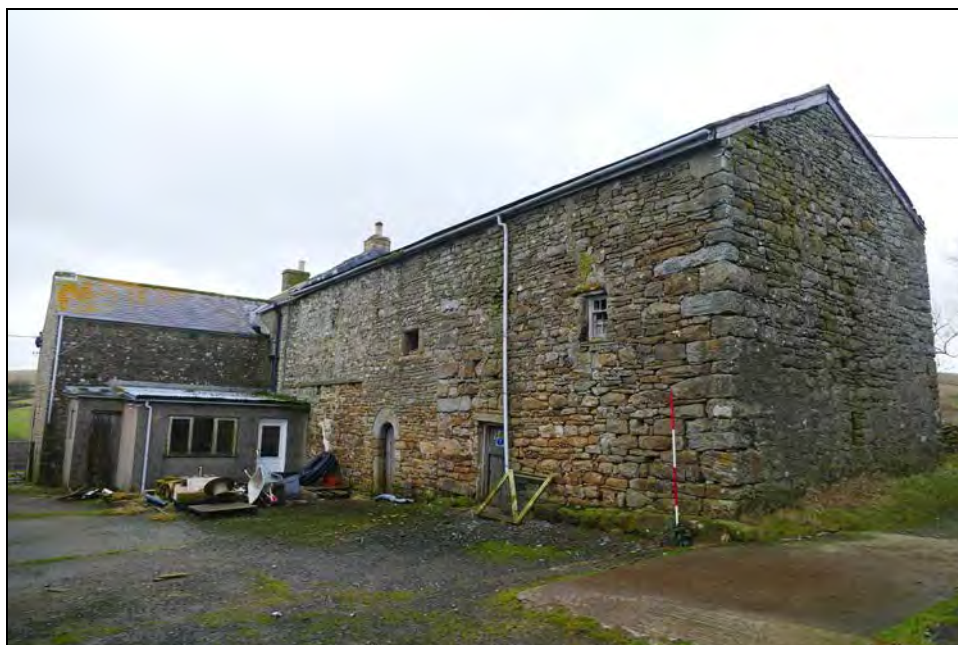
Frontispiece: *The stone-buildings complex containing the bastle (right of view), bastle-derivative house (centre), 19th century house and barn conversion (left), viewed from the west.*

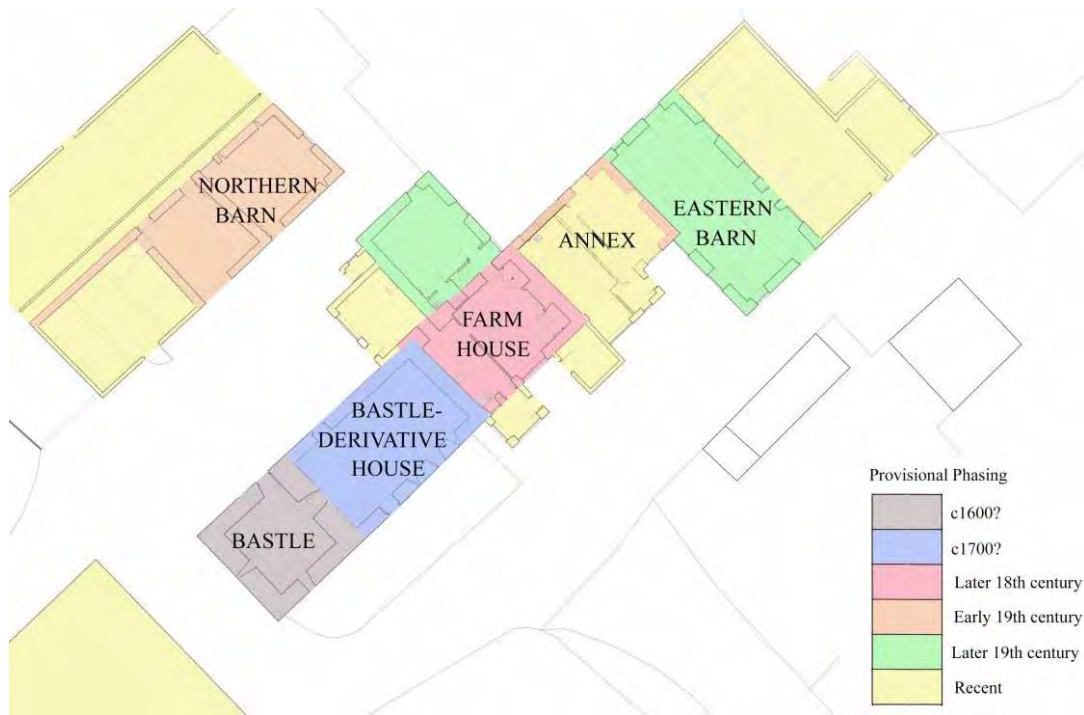
Illus. 09: Phased plan of the Low Sinderhope farmstead complex.

The bastle is clearly the earliest building on the site, and the bastle-derivative house the second; as discussed below, they may date to c. 1600 and c. 1700 respectively. Then comes the farmhouse, possibly originally an upper-floor house but heavily altered; it could be of later 18th-century date.

The upper parts of the bastle have been so much altered that it is difficult to ascertain its original form; it was probably of two storeys, as can be seen from the manner in which the wall of the added bastle-derivative house overlaps its thick east wall, before at some uncertain later date the bastle was raised to the same height.

The bastle-derivative house was always of three storeys high, and was not seriously defensible. The stone platform with its stair provided access to the first-floor doorway. The similarity between the lintels of the first-floor windows in the house and bastle suggest that the bastle was remodelled when the house was added, and both formed part of the same residence. The top floor of the building may have been lit by half dormers - a type of fenestration favoured by a number of later 17th century houses in the area, often with upper cruck roofs such as this one had. Later on, they may have formed separate residences, and the door in the wall between them was sealed; the fact that the entrance platform once had two stairs, and a wall between them, implies that they were in separate hands.

The buildings may have been abandoned when the present farmhouse was built, in the late 18th or early 19th century. More recently the roof of the whole range was renewed, leaving just remnants of the old upper-cruck trusses, and areas of the upper walls were probably rebuilt at the same time.

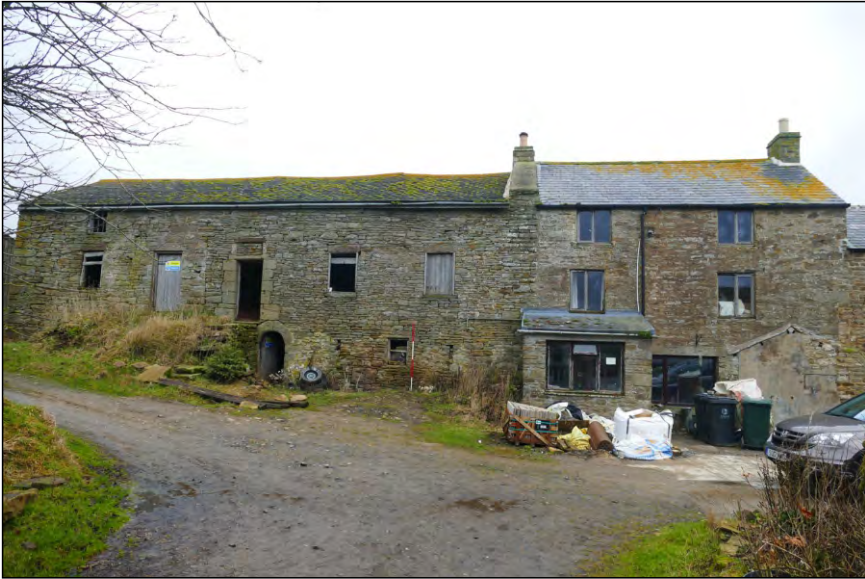
Photo 01.

| <i>Photo number</i> | <i>Internal/ External</i> | <i>Description</i> |
|---|---|--|
| 01 | External | Front, SE elevation of the bastle (left of view), bastle derivative house (BDH - centre of view) and 19 th century house (right). |

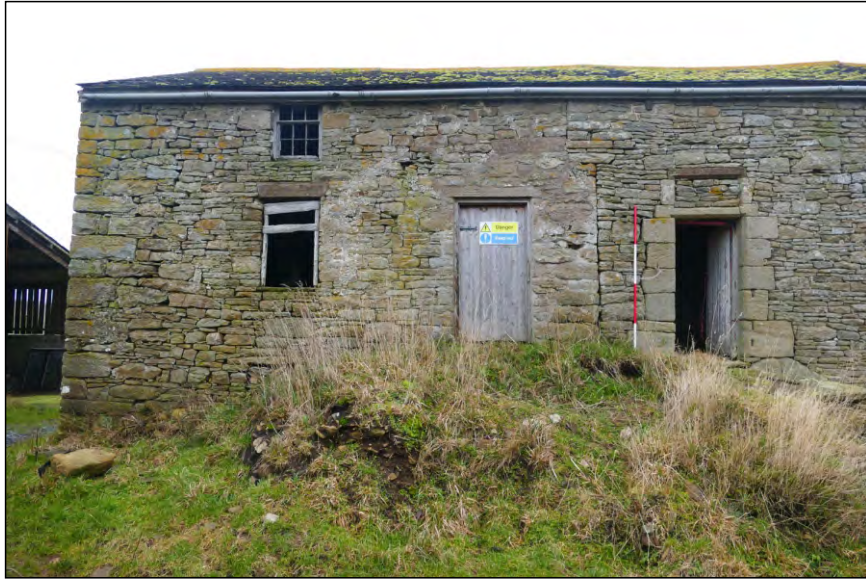
Photo 05.

| 05 | Front, SE elevation of the bastle |

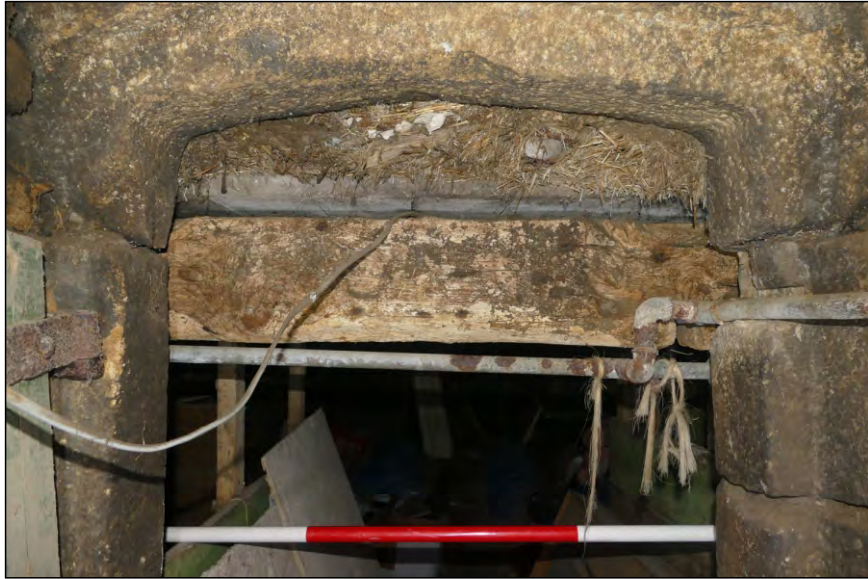
Photo 21.

The basement of the bastle was originally only entered by a doorway (18) in the centre of the east wall, now within the basement of the adjacent bastle-derivative house. This doorway has a chamfered surround with a shallow monolithic triangular head and massive blocks in the jambs, rebated internally for a door. In an odd manner the springing of the arch is well above the base of the stone, perhaps suggesting that its form has been modified from a steeped triangle or pointed shape. The drawbar tunnel and its socket have been infilled; internally the opening has a series of decayed timber lintels.

| 21 | SW view of the shallow triangular head of the original GF bastle doorway, with internal decayed timber lintels. |

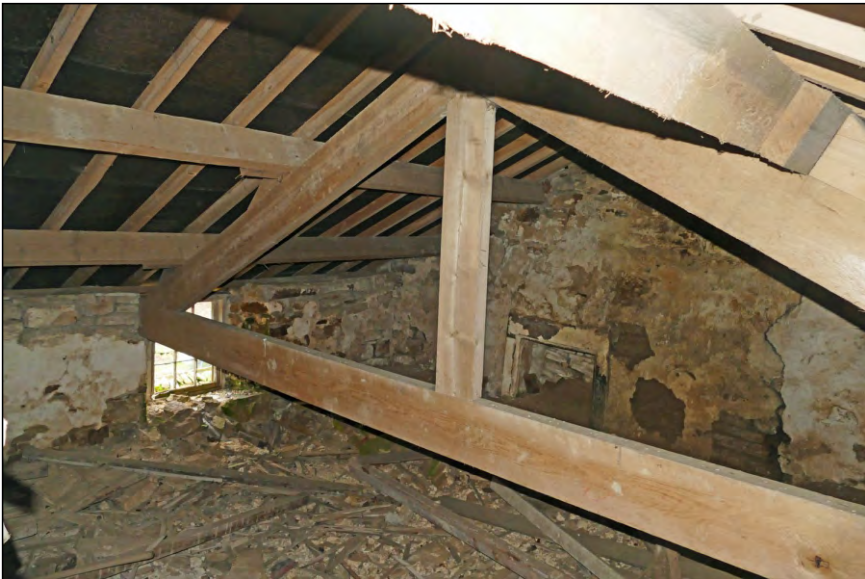
Photo 39.

| 39 | Oblique view taken at ceiling level SSW from the north corner of the 2 nd floor/loft space of the bastle (as above, see caption to Photo. 38). |

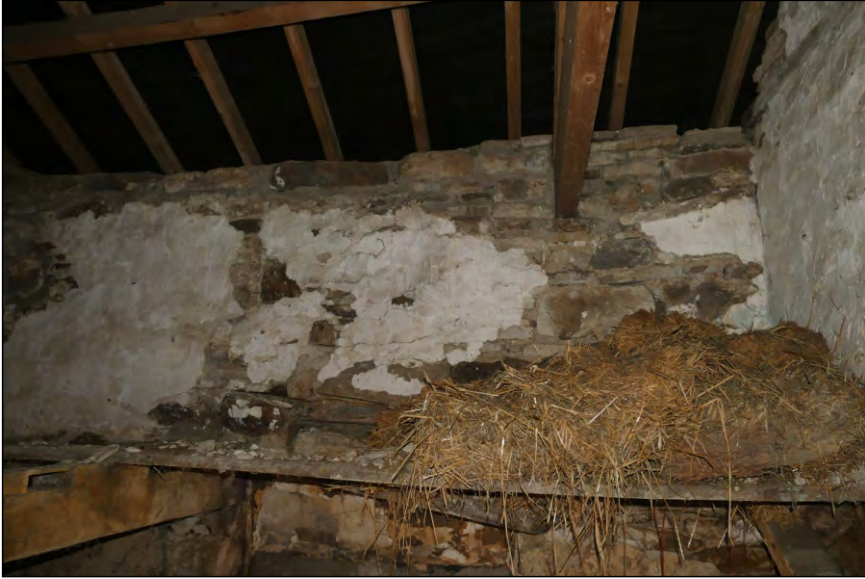
Photo 53.

| 53 | The SW end of the SE elevation of the BDH at 2 nd floor level. |

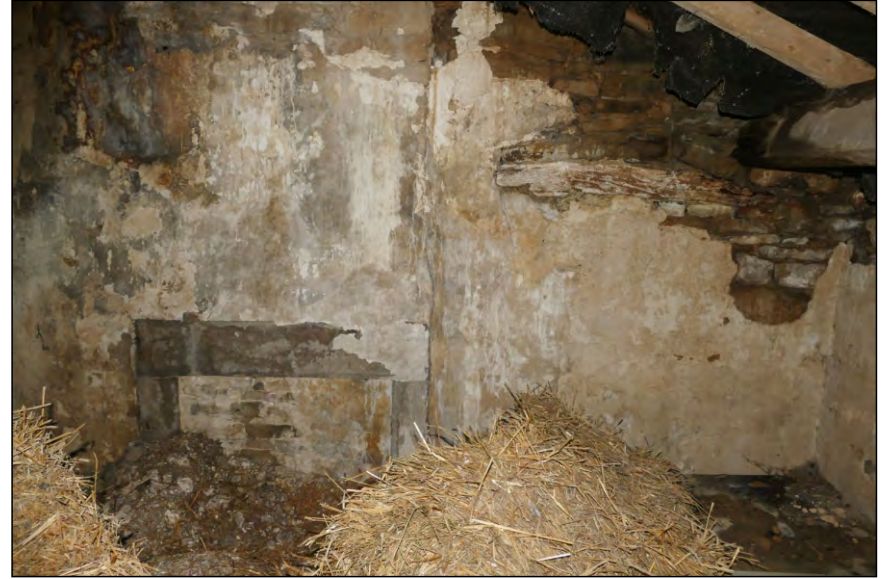
Photo 54.

| 54 | Small fireplace and wooden lintel in the internal NE elevation of the BDH at 2 nd floor 'loft' level. |
