**CARVILLE ROAD
WALLSEND
TYNE AND WEAR**

ARCHAEOLOGICAL EVALUATION

MARCH 2023

**The Archaeological
Practice Ltd.**

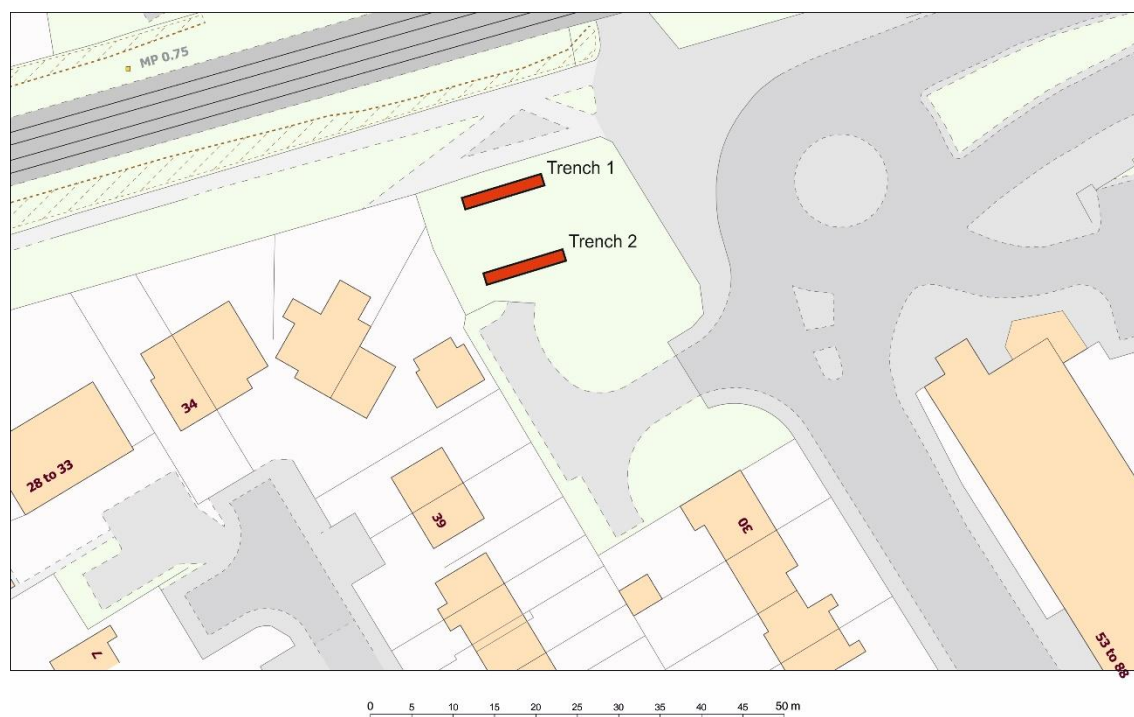
Figure 05. Evaluation Trench Location

The evaluation took the form of two Trenches (*Figure 05*). These trenches were positioned in the western part of the site, largely beyond the footprint of the former Carville Hotel, which was assumed to have had a significant impact on any surviving remains. Trench 1 was to the north of Trench 2 and both trenches measured 10m long by 1.5m wide.

The evaluation took the form of two trenches (Fig. 03). These trenches were positioned in the western part of the site, largely beyond the footprint of the former Carville Hotel, which was assumed to have had a significant impact on any surviving remains. Trench 1 was to the north of Trench 2 and both trenches measured 10m long by 1.5m wide.

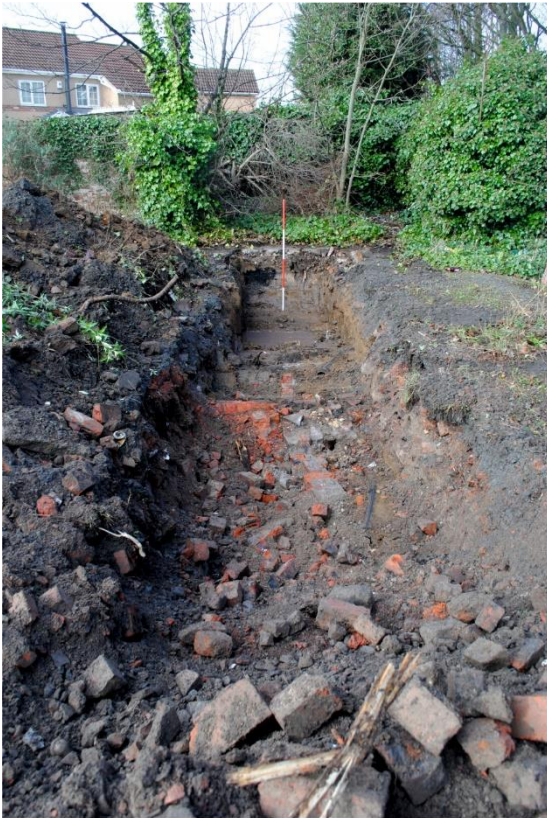
Photo 01. Trench 1 looking west

Trench 1 was located in the north-western part of the site, a short distance from the northern site boundary. Orientated in an approximately east-west direction, the trench measured 10m long by 1.50m wide, with an approximate depth of 1m.

The uppermost layer within the western 3.50m of the trench was the 0.07m thick concrete surface [101] associated with the former carpark to the rear of the Carville Hotel. This lay above a 0.34m thick levelling layer of modern rubble [102]. To the east of this was a 0.30m thick hard stand layer [105] of mixed grey dolomite and brick contemporary with concrete surface [101]. Beneath these layers was a redeposited mixed yellow sand [103] containing lenses of grey clay and occasional brick fragments. This lay directly above the firm pinkish grey boulder clay [104] which rose from a depth of 0.94m below the modern surface at the western edge of the trench to 0.65m below the modern surface at a point approximately 4m from the western end of the trench, where the foundations, walls [106], and east-west services [107] of the brick-built Carville Hotel cut down through the trench from the modern surface to beyond the excavated depth (0.95m) of the trench. The truncated natural clay [104] was occasionally visible between these foundations and services. Any archaeologically significant layers or features within the eastern 6m of the trench had been truncated by the construction of this building.

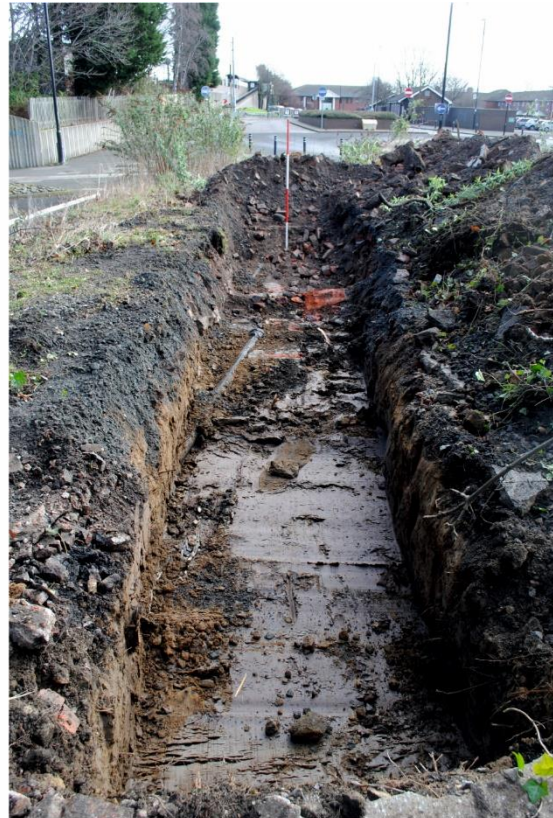
Photo 02. Trench 1 looking east

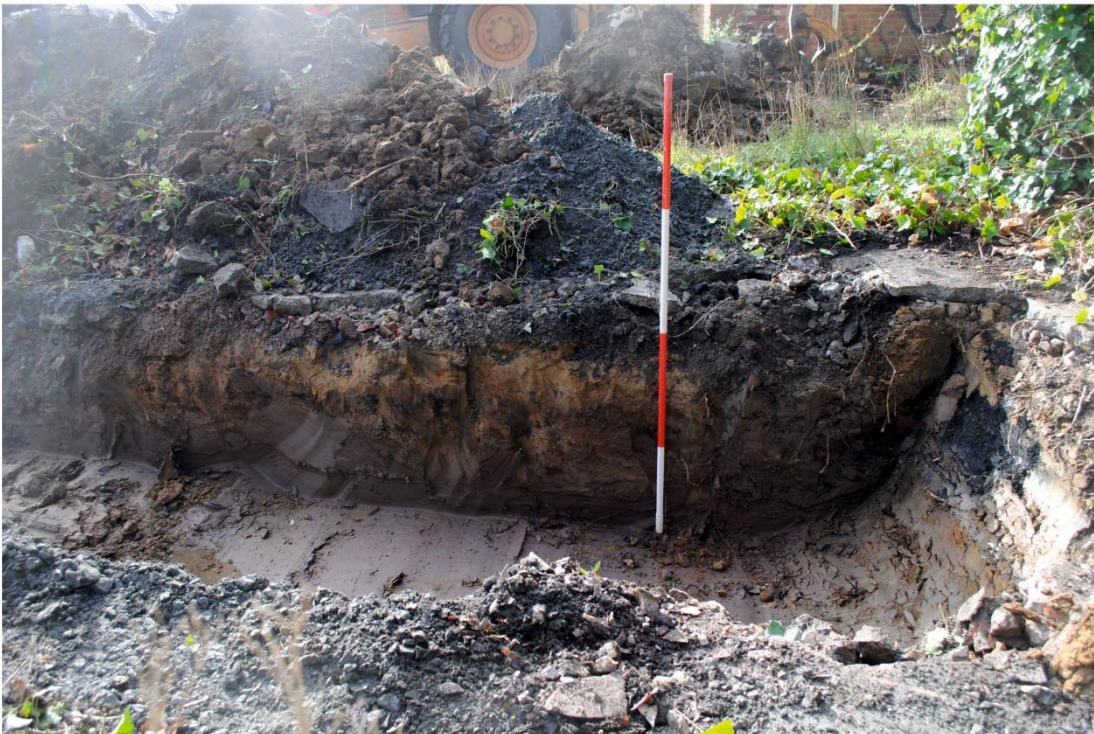
It is significant that there was no trace of a buried soil horizon or earlier ground level within this trench as might have been expected had the redeposited and levelling material been placed upon an existing ground level. Instead, it would appear that any such horizons had been cleared away prior to the construction of the Carville Hotel – an act which would also have removed any archaeological material present on the site.

Photo 03. Trench 1 north-facing section, showing redeposited yellow sand directly over brown natural clay

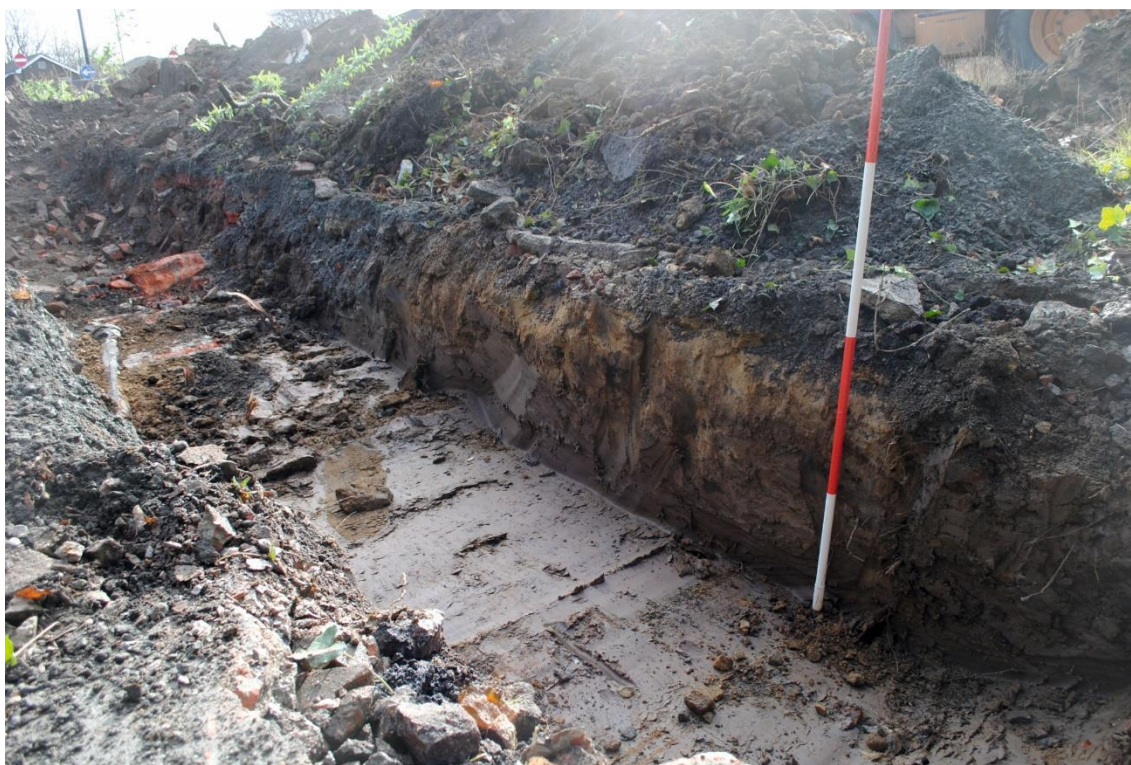
Photo 04. Trench 1 north-facing section, looking south-west, showing disturbance caused by Carville Hotel building and services towards eastern end of trench

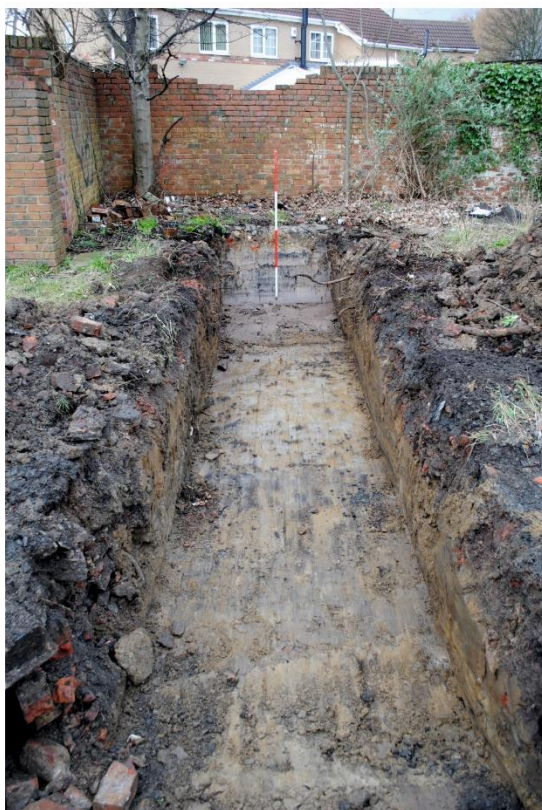
Photo 05. Trench 2 looking west

Trench 2 was located approximately 6.5m to the south of Trench 1 and was also orientated in a roughly east-west direction. This trench measured 10m long, 1.50m wide, with an approximate depth of 1m.

The uppermost layer within the westernmost 6m of the trench was the 0.07m thick concrete surface [201] associated with the yard/carpark of the Carville Hotel, along with the approximately 0.10m thick associated mixed brick rubble makeup layer [202]. This abutted a 0.30m thick area of concrete and brick hard-standing [203] between the yard and the north-south running brick walls of the Carville Hotel [205] which lay within the eastern 2m of the trench (including a brick-built manhole [2060 within the south-eastern corner of the trench). Immediately beneath the modern layers of the yard and hard-stand were natural levels [204]. These were a mix of clean pink-brown clay and tan sand containing manganese staining and were present at a depth of 0.17-0.30m below the modern surface.

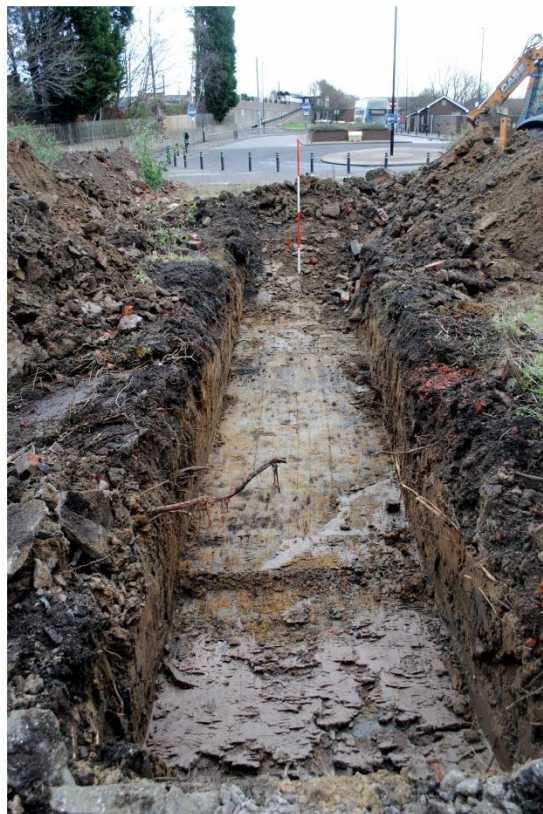
Photo 06. Trench 2 looking east

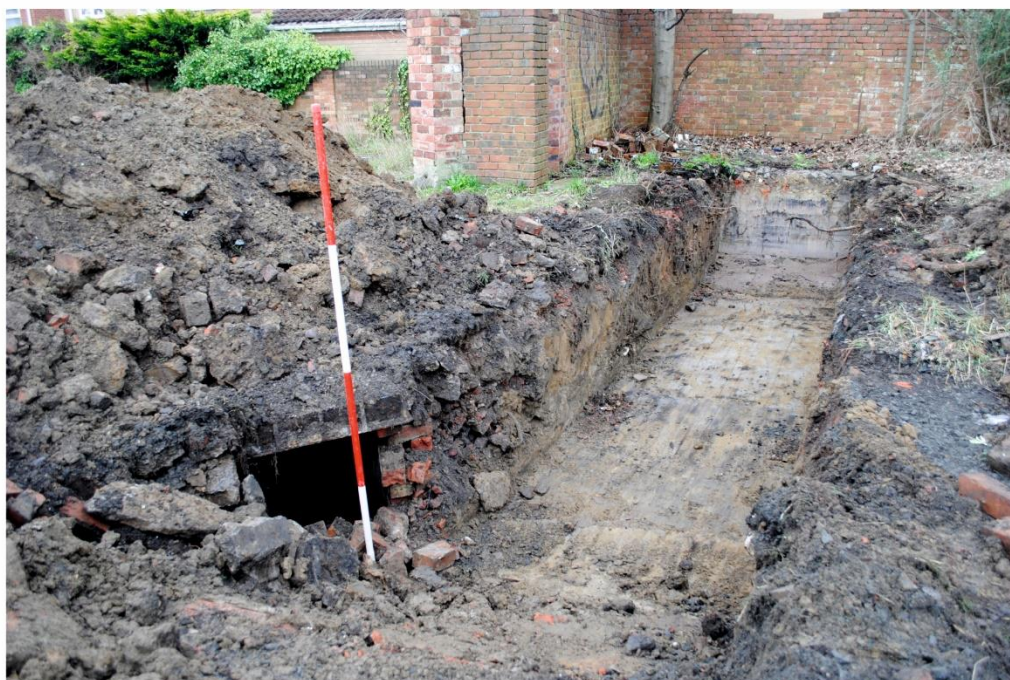
As with Trench 1, there was no evidence of any surviving buried soil horizons or occupation layers as might have been expected had the ground here been unaltered during the construction of the Carville buildings. It therefore appears that this part of the site had also been truncated down to natural levels prior to or during the construction of the Carville Hotel.

Photo 07. Trench 2 looking south-west, showing disturbed manhole adjacent to Carville Hotel (foreground) and trench cut through natural deposits (rear)
