HEPBURN BASTLE, CHILLINGHAM,  
NORTHUMBERLAND

~ ARCHAEOLOGICAL EVALUATION ~

OCTOBER 2022

## REPORT ON AN ARCHAEOLOGICAL EVALUATION

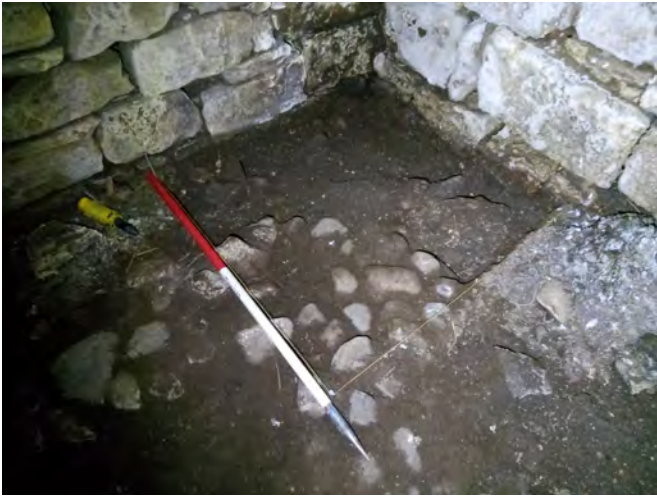
Illus 9a: Trench A looking NW

Beneath a 0.05m layer of modern accumulated dark grey silty loam and bird waste (100-A) was a surface made up of rounded and worn cobbles averaging 0.15m in size (101-A). This surface was slightly uneven in its survival, and did not survive well within the area of the trench closest to the walls of the bastle. Here, a dark grey silty loam (102-A) continued beneath the excavated depth of the trench.

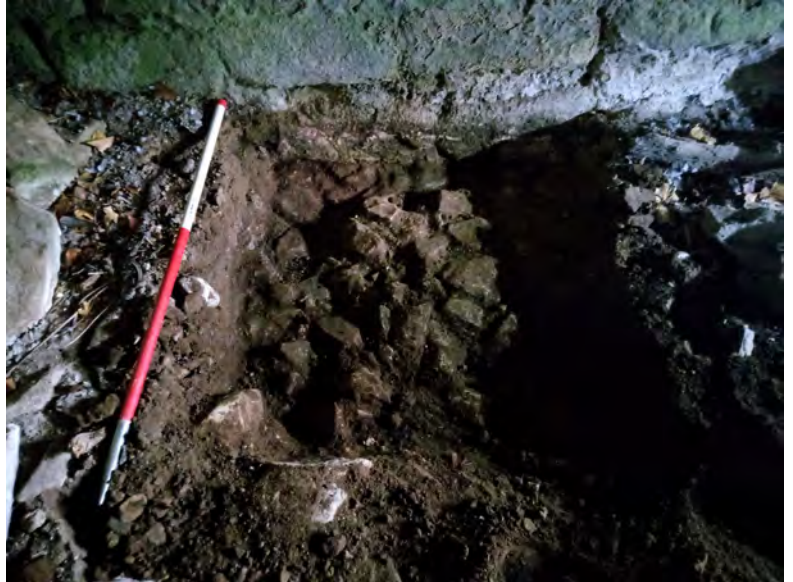
Illus 9b: Trench B looking E

Beneath a 0.10m layer of modern accumulated dark grey silty loam and bird waste (100-B) was a surface made up of rounded and worn cobbles averaging 0.15m in size (101-B). This surface survived reasonably well across the whole of the investigation trench. A small area of coal-dust rich silting (103-B) survived across the northern part of these cobbles, and measured up to 0.10m deep

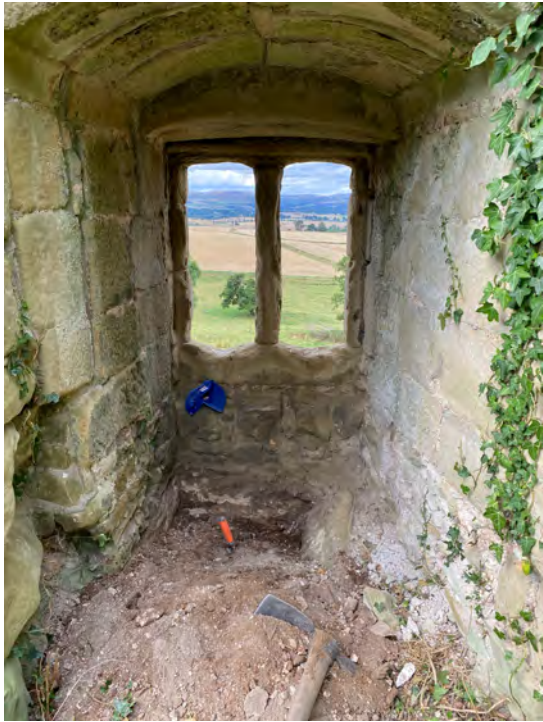
Illus. 10a: Trench F1 looking W

This trench was located within the north-western part of the first floor of the bastle and measured approximately 1x1.7 m

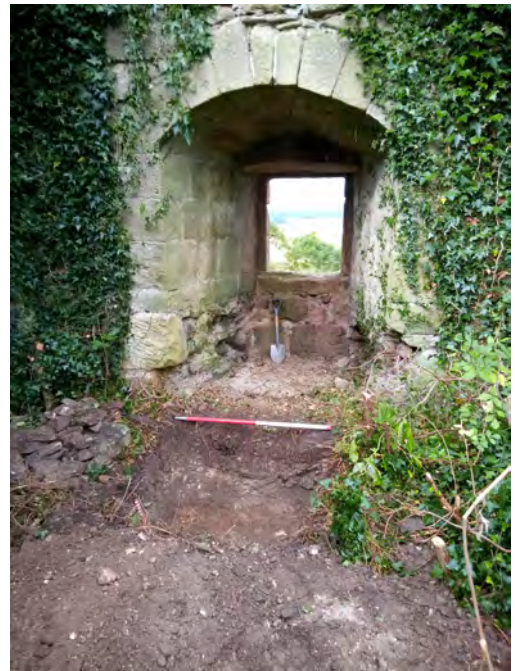
Illus. 10b Trench F2 looking W

No floor surface was found in this trench and it is assumed that such flooring had been robbed after the building went out of use.

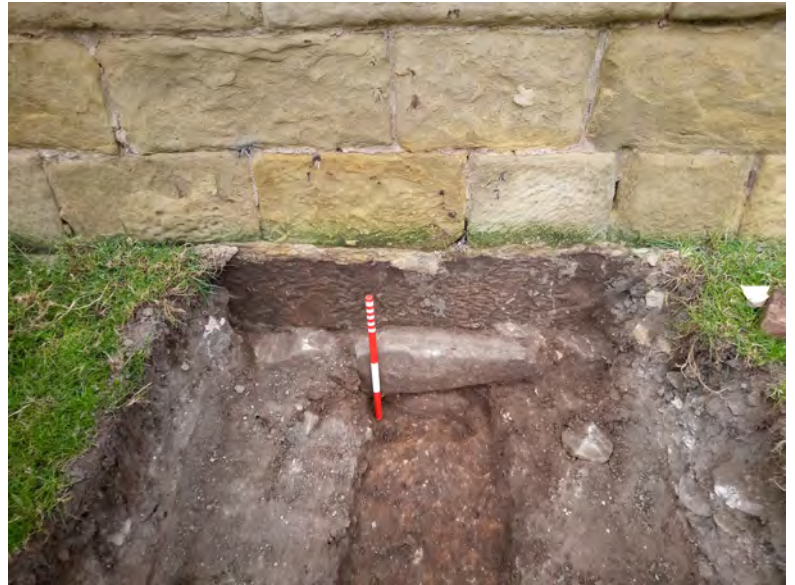
Illus. 12b: Trench K looking W, showing foundation step

Beneath the 0.15m thick turf and topsoil (108-K) was a layer of mixed loam (115-K) containing numerous inclusions of mortar and sandstone pieces, as well as post-medieval pottery. This lay at a maximum thickness of 0.15m against the wall of the building, and became thinner towards the west. This material lay directly above the natural tan clay (109-K) to the west, and above a slightly offset foundation course (116-K) for the wall. This foundation course consisted of roughly laid flat sandstones here offset 0.11m from overlying wall.

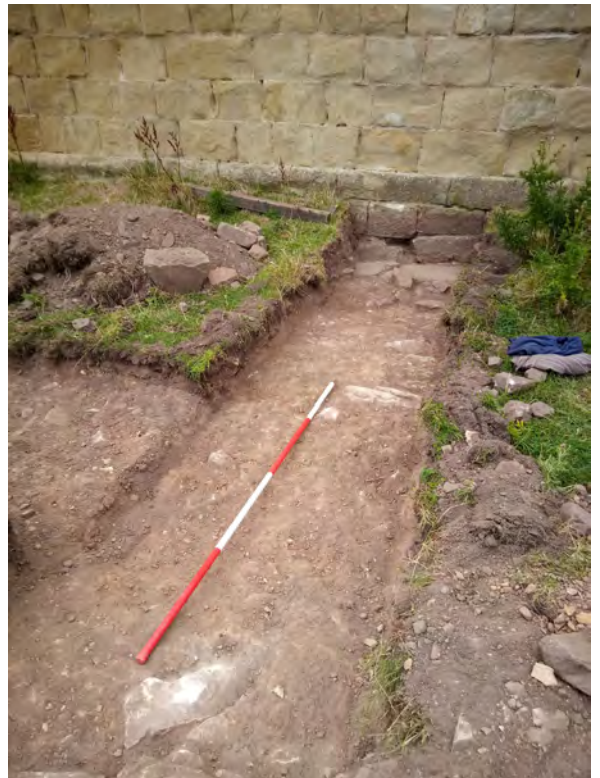
Illus. 12d: Trench I,J,O looking N showing lower courses and building wall foundation

No trace of a building was found in any of these trenches. The 0.15-0.20m thick turf and topsoil (108-I,J,P) generally lay directly upon the natural tan clay (109-I,J,P), which here contained several fragments of the underlying sandstone.

Towards the northern end of the trench was the construction cut (110-I) for the southern bastle wall, which here contained a rubble and clay packing (111-I), in front of which was a flat course of sandstone blocks forming a foundation layer for the overlying wall. The lower part of this wall (113-I), up to the level of the plinth, consisted of three courses of squared blocks, with the lowermost one being very much more fragmentary in nature.

Investigations into a structure against the south wall of the building (Trenches I, J, O) failed to recover any surviving evidence to accompany the roof scar visible on the south wall of the building here. This structure has therefore been entirely removed, and it has been speculated that it may originally have been a fairly ephemeral construction, perhaps of wood. Given the care taken to cut a groove along the wall for an associated roof however, the latter option seems unlikely.

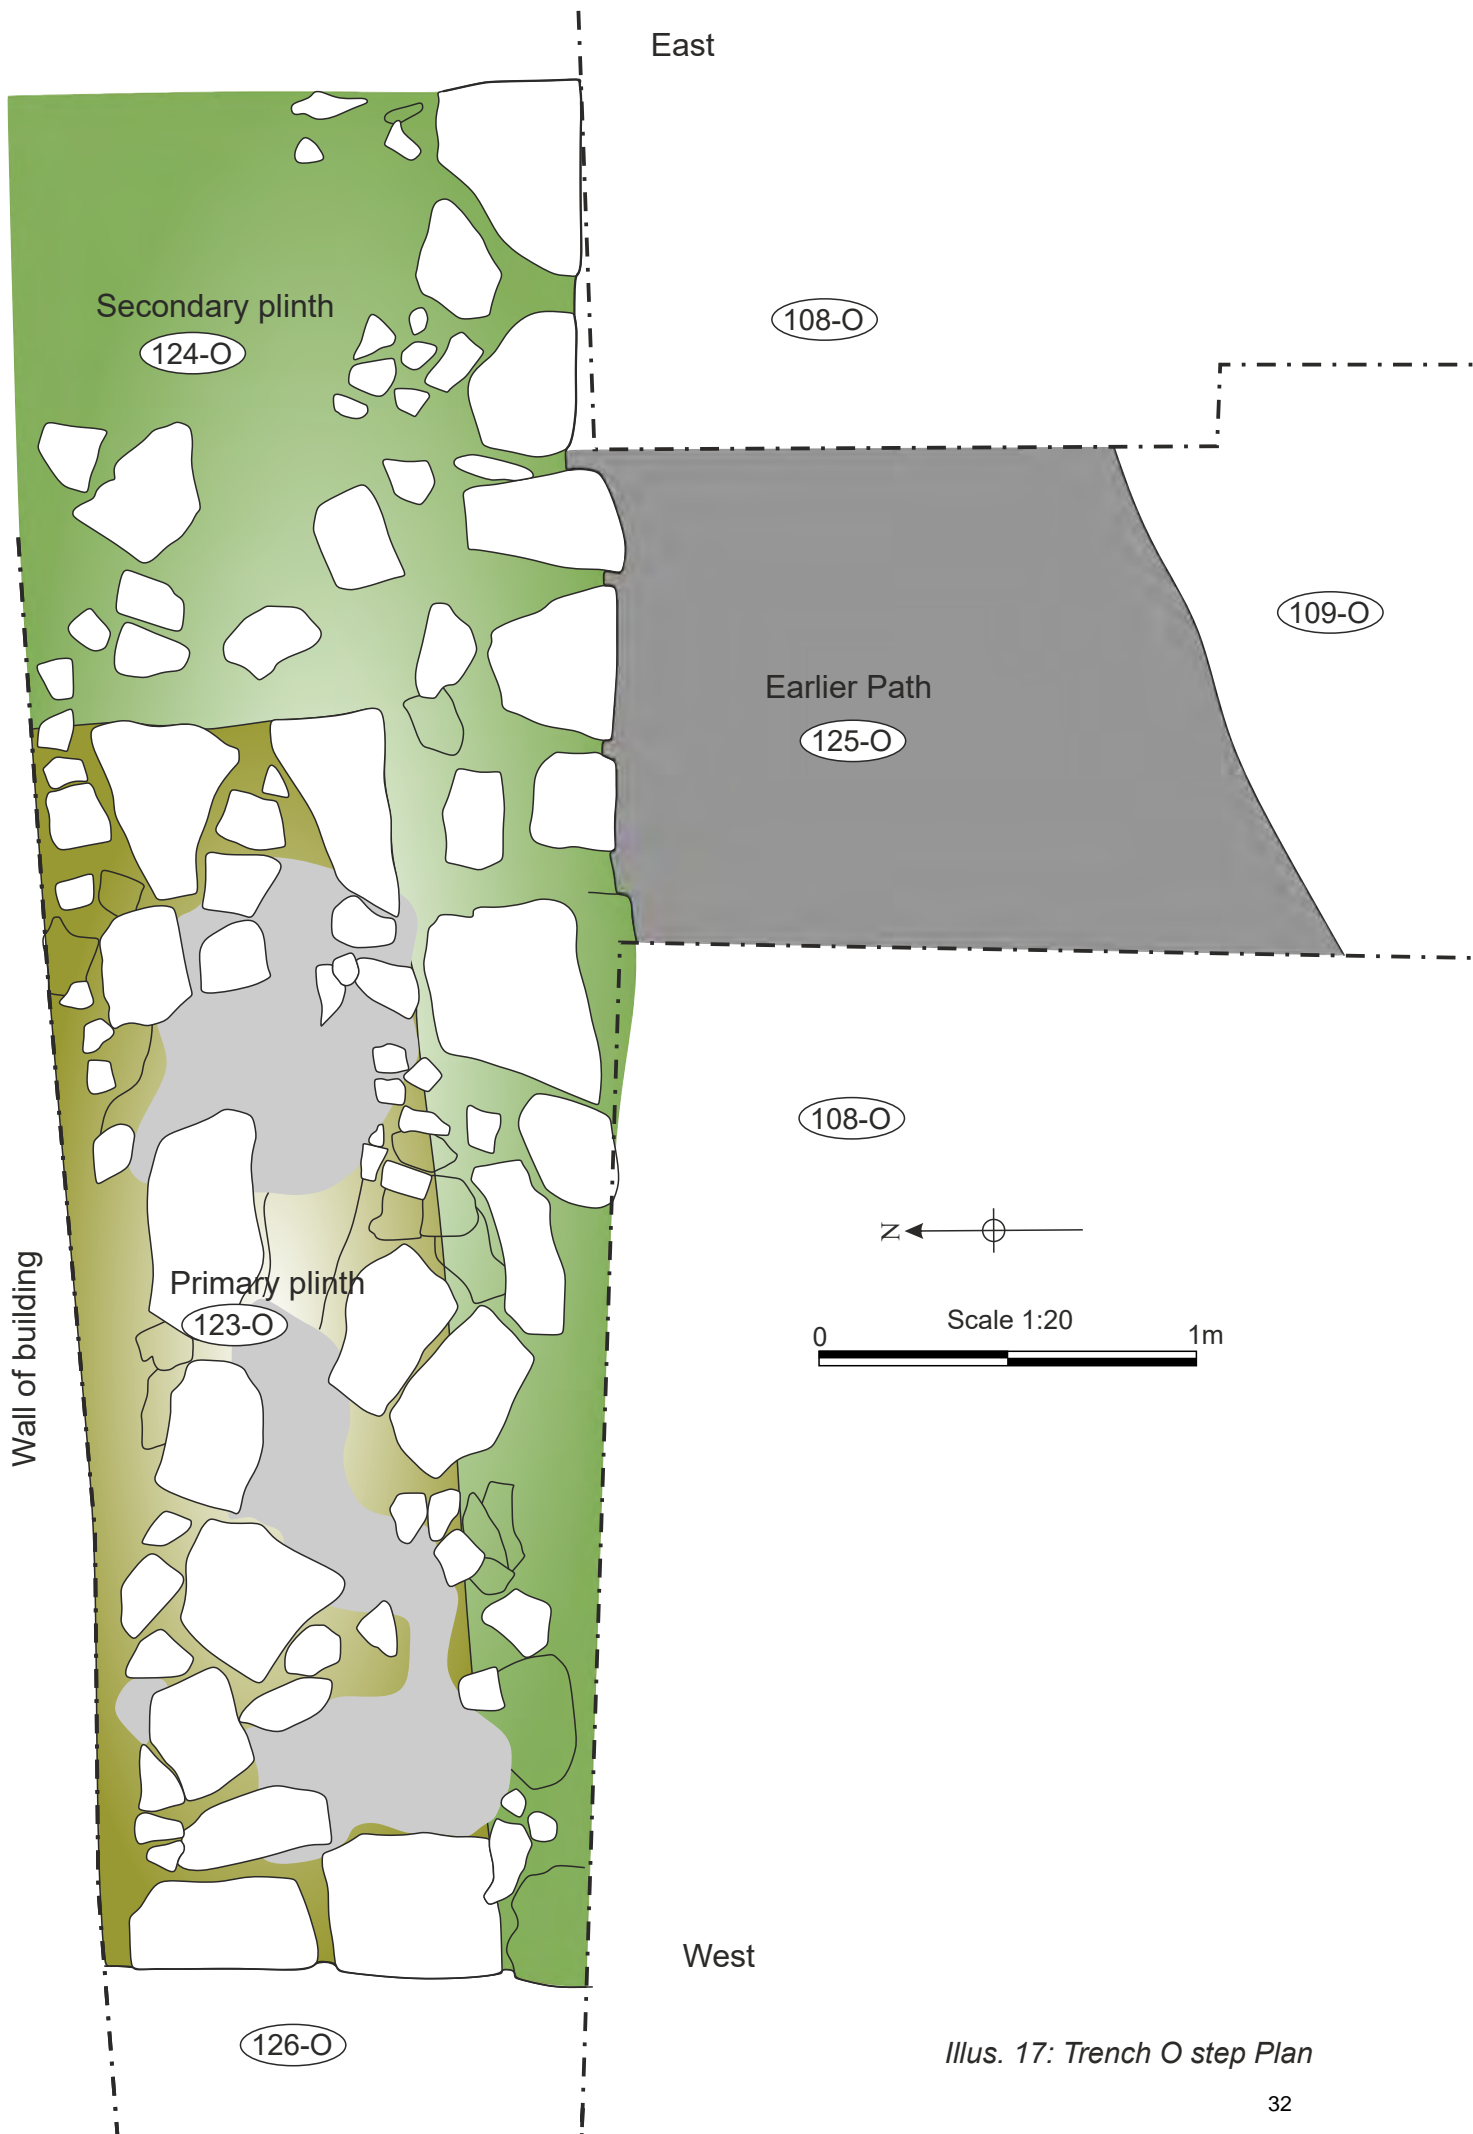
Illus. 17: Trench O step Plan

Beneath the 0.15m thick turf and topsoil (108-O) was a large rectangular step or plinth set up against the southern wall of the bastle in the area of the newel stair. This step was solidly made up of sandstone blocks, faced on the outer sides, and was evidently of two phases. The earliest phase (123-O) measured 4.3m by 0.85m and was positioned directly outside the area of the staircase. The blocks were bonded with a hard white mortar, and evidently represent an entrance point into the adjacent stairwell – or the projecting base of a stairway into this area. This step was subsequently enlarged (124-O), with the original stonework becoming incorporated within a larger rectangular plinth/step which projected slightly beyond the eastern edge of the bastle. This later phase measured 5m long and 1.7m wide. It is unknown whether it continued around the corner and along the eastern wall of the building, though it is perhaps more likely that it merely provided a stable foundation for a north-south staircase up the outside of the building to the first floor. Notably, the approach to the building appears to have been from this direction, which would have avoided circumnavigating the adjacent quarry and spoil heap between the modern field gate and the bastle.

Projecting for a distance of 1.6m from beneath the southern edge of this step/plinth was an area of cobbling (125-O), roughly bounded on its southern edge by larger stones. This may either

have represented a foundation layer for the stepped area, or more likely an earlier path which was subsequently built over. Beneath this area of cobbling was the natural tan clay (109-O)

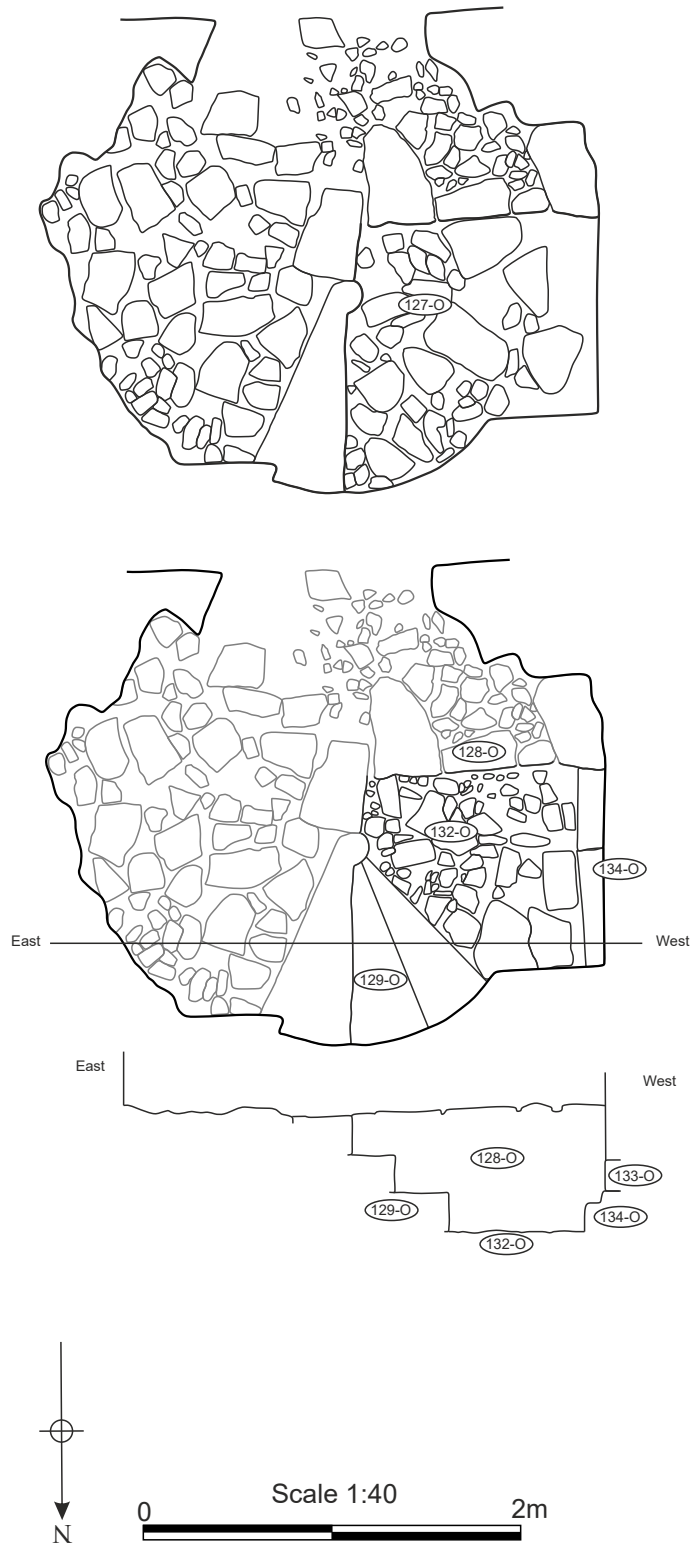
*Illus. 18: Trench O newel stair plans and section*

Following the initial clean of this area, it was apparent that the lower part of the stairwell had been filled in with loose rubble and tooled blocks (127-O), evidently from dismantled/collapsed areas of the initial phase of the building. Three faced sandstone blocks (128-O) forming the southern wall of the entrance to the stairs were visible, along with the upper tread and newel of one stair (129-O), climbing in an anti-clockwise direction. Behind these was a mixed packing of sandstone blocks, fragments, mortar, and soil (130-O).

Within the doorway between the staircase and the ground floor corridor into the bastle was a carved stone threshold step (134-O), which was set directly onto the natural bedrock (109\_O). This step was made up of two blocks, the faces of which were carved with a curved scrollwork decoration and measured 0.23m high. The southernmost stone measured 0.43m long (as visible) and the northernmost 0.66m long (as visible). Above this threshold was a 0.17m deep accumulation (133-O) of modern silty loam, as was found within those trenches excavated within the ground floor of the building.
