HEXHAM SWIMMING POOL SITE,
GILESGATE, HEXHAM,
NORTHUMBERLAND

~ ARCHAEOLOGICAL MITIGATION by
STRIP, MAP & RECORD ~

AUGUST 2020 – FEBRUARY 2021

ARCHAEOLOGICAL MITIGATION REPORT

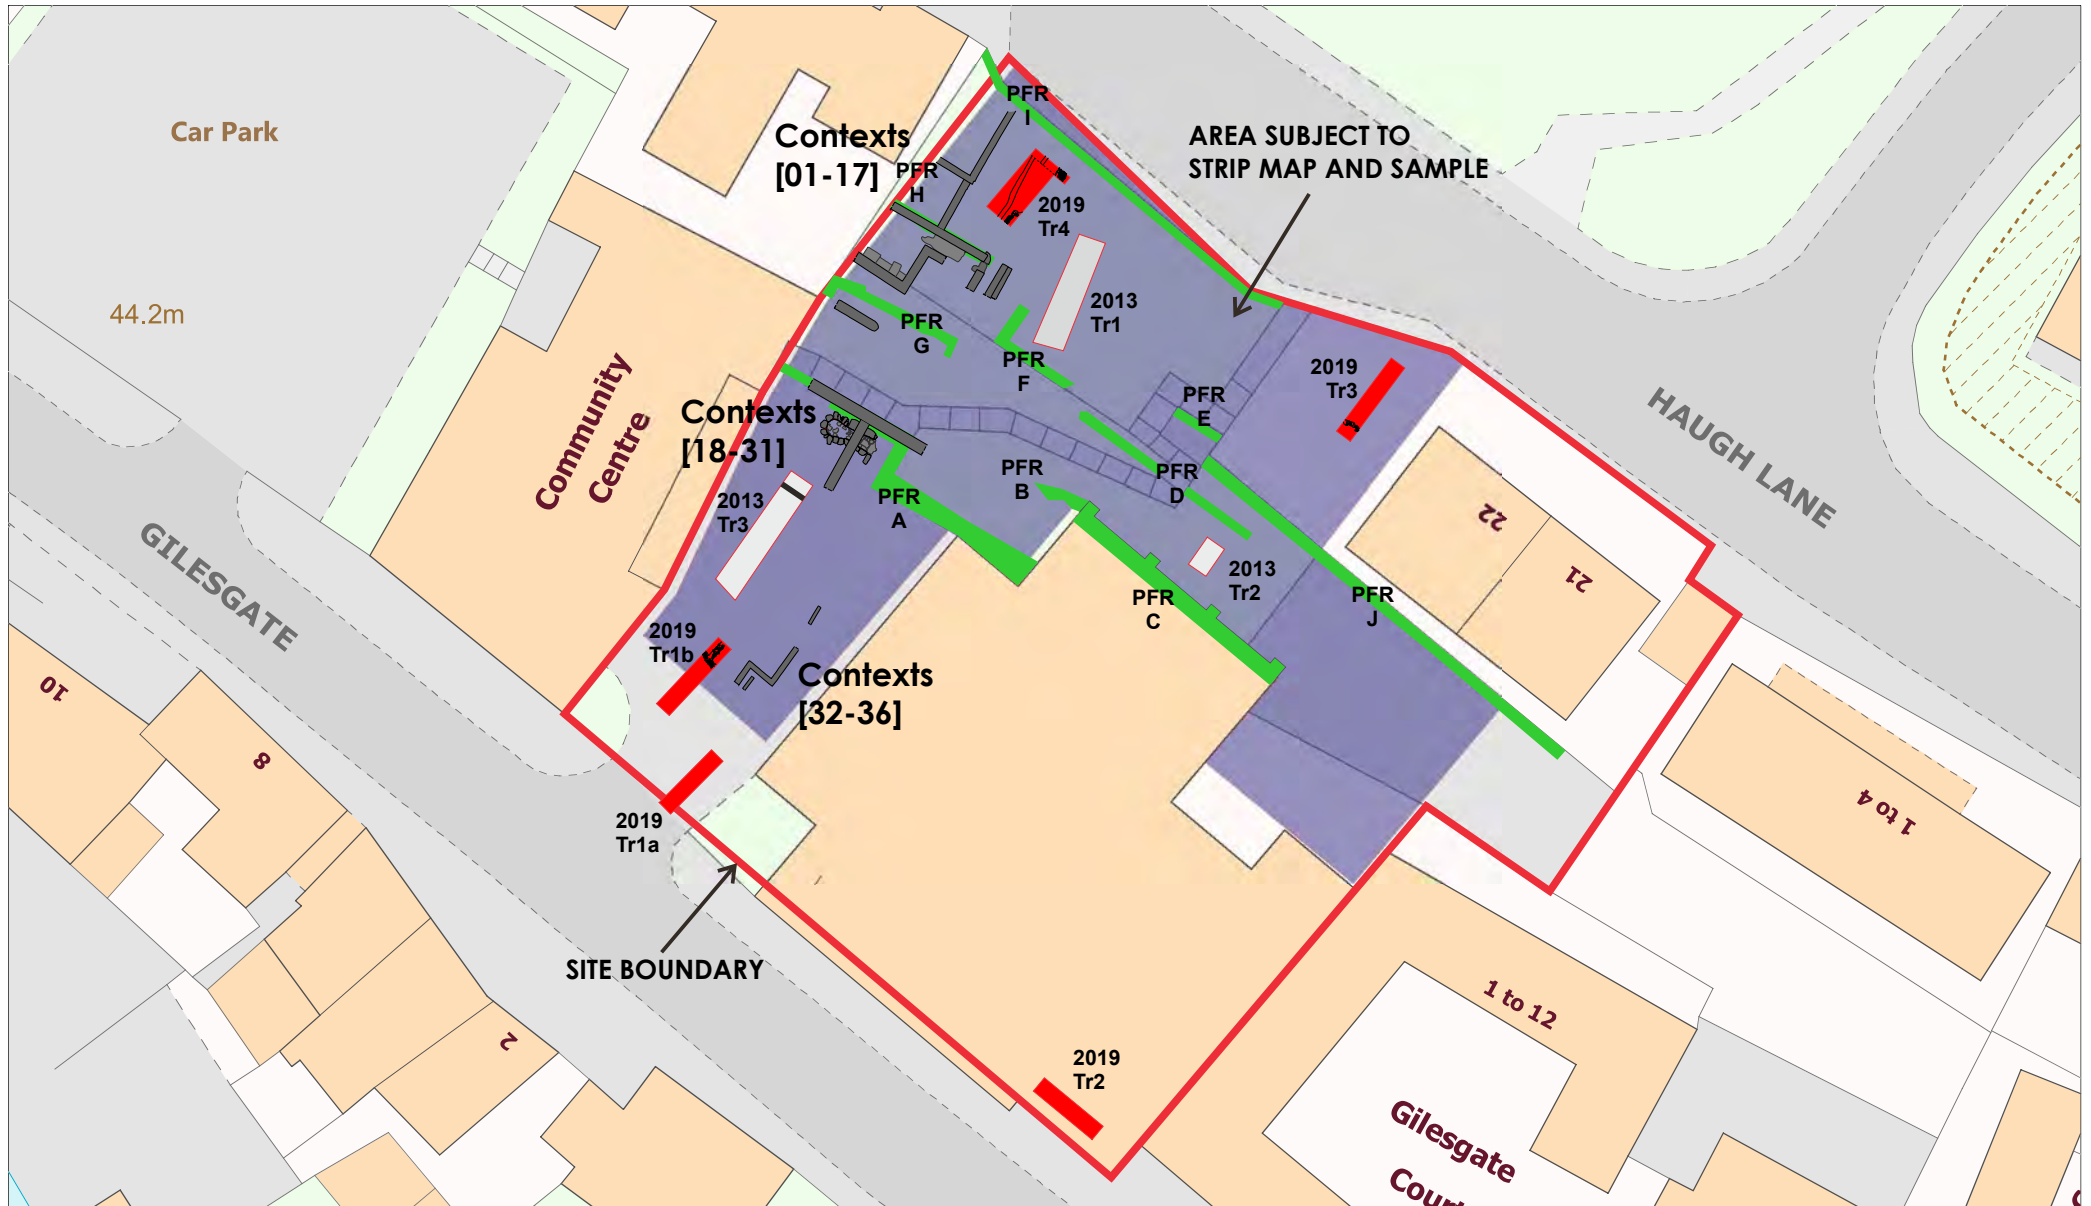
Illus. 03: Plan of archaeological features recorded within the boundary of the former Hexham Swimming Pool site.

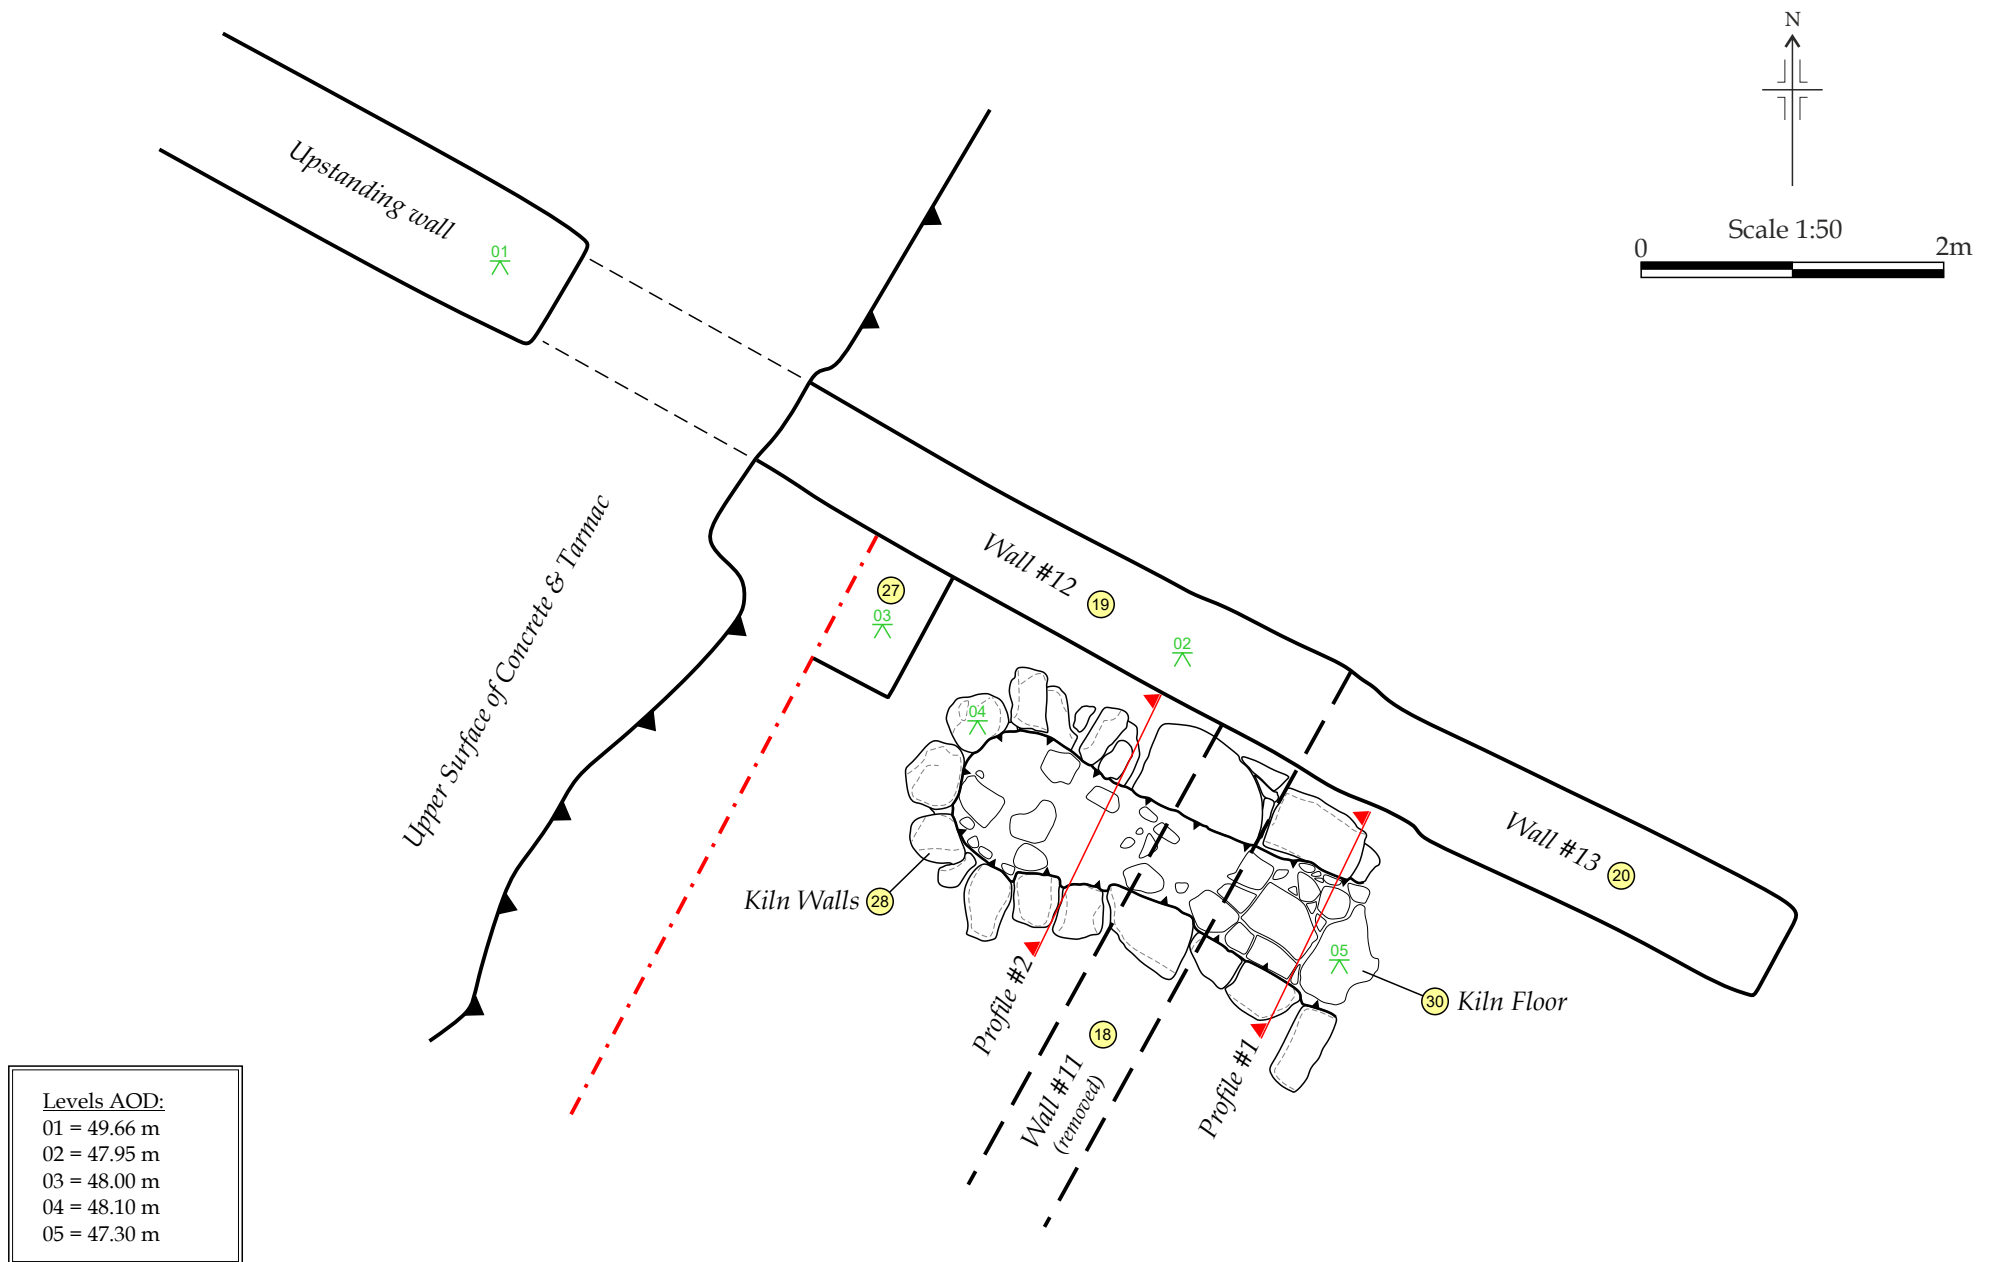
Illus. 14: Plan of Kiln Structure [28], later walls and associated features [18-31], located in the south-west area of Hexham Swimming Pool Site, January 2021.

Kiln structure [11] and removed subsequent to recording the latter (see below), was a NE-SW aligned sandstone wall of random courses bonded with an off-white lime mortar, also interpreted as part of a 19th century industrial structure visible on OS 1st Ed c.1862 (see *Illus. 08*). Abutting its east face was a layer [21] of loose, mortar-rich rubble, interpreted as the building demolition associated with Walls #11 and 12, sitting upon a layer of redeposited natural material [22] comprising reddish-brown glacial sand and gravels.

The function of the kiln is with reasonable confidence identified as a corn-drying kiln or malting kiln on the basis of palaeo-environmental evidence for a typically late-medieval assemblage of crop remains and weeds in its lower fill. More heterogenous remains from the upper fills of the kiln bowl have a composition possibly reflecting use of the kiln for drying other crops and the presence of domestic waste from other sources, including a mixture of fuel waste and crops accidentally charred during drying. The presence of coal and clinker/cinder supports a later-medieval date for the kiln when coal became more widely used as a fuel source.

- [18] Wall #11. Observed above Kiln structure [11] and removed subsequent to recording. NE-SW aligned sandstone wall, random courses with an off-white lime mortar, contemporary with and perpendicular to Wall #12. Interpreted as part of a 19th century industrial structure visible on OS 1st Ed c.1862 (see *Illus. 08*). Dimensions: 0.57 m (width) x 4.20 m (length, but extending to the SW for an unknown distance).

- [23] Infilling of kiln structure [28]. Dark grey sandy-loam, loose, common well-sorted small sandstone pieces, rare riverine pebbles. Observed to a maximum depth 0.90m. Truncated flat by the construction of 19th century walls. Interpreted as the complete backfilling of Kiln [28] subsequent to its expiration, certainly before the mid-19th century.

- [28] Kiln structure of pre-19th century date, observed beneath Wall #11 [18]. Internally the kiln measures 2.73 m from internal east face of the bowl to the east end of the south wall, but the floor continues to 2.84 m before being cut by a modern service pipe. The bowl wall survives to 1.14 m high (1.04 m above the floor surface) comprising six irregular courses of mainly boulder-stones with some pieces of reused cut stone. The remains of the flat flagged floor are set into natural deposits. The internal dimensions at the base are 0.90 m, but a slight batter (perhaps due to sagging) means that the bowl opening is 0.10 m narrower than the base. In plan, the bowl narrows to 0.77 m at the neck of the flue which then varies in width between 0.77 m (at the east and west ends) and 0.82 m in the middle. The surviving length of the flue is 1.55 m and its side walls survive up to five courses and 0.75 m high, its constituent stones being up to 0.80 x 0.55 m in size. A modern drain has destroyed the east end of the flue where it survives to 0.70 m above the flagged floor surface.

- [29] Layer within interior of Kiln [28] and beneath backfilling layer [23], comprising of loose sandstone pieces and riverine cobbles in a loose, black sandy-loam matrix. Dimensions: approx. 0.30 m. in depth. Interpreted as the primary demolition/robbing layer of the kiln.

- [31] A modern soakaway drain running along the west face of Wall #11. The drain was observed to discharge through a brick and cement lined opening through the wall. Dimensions: 0.48 m (depth) x 0.30 m (width).

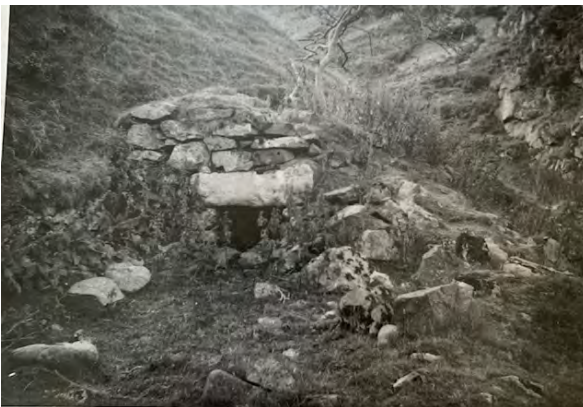
A malting kiln used in the production of whiskey at Rory's Still, Upper Coquetdale (unpublished photo. Taken in 1956 by Captn. Walton, used courtesy of BrightWater volunteer, Barbara McCabe)

Since the purpose of malting kilns is not to kill or dry the seed corn, but to induce sprouting, the temperatures attained are lower and more carefully controlled than in corn-driers, although neither should achieve very high temperatures, the purpose being to heat rather than burn. However, this subtle difference between the two functions makes it more likely that corn driers would have been detached from settlement to minimise the risk of spreading fire, while malting kilns were more likely to have formed part of built ensembles, often attached to, or part of breweries and bakeries. Historical records show that only limited numbers of medieval households had their own bread oven and brewhouse, often the manor house in rural areas, and the lord would charge for others to bake their bread or brew beer on his premises (Brown and Hardy 2011, 287).

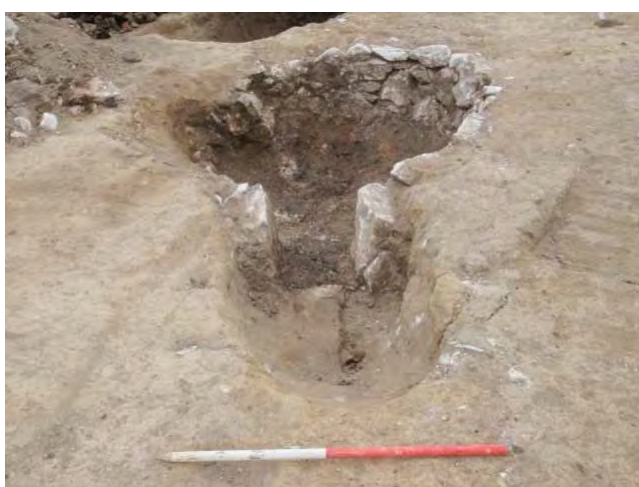
A medieval lime-kiln excavated at Caherduggan Castle, Cork.
[<https://headlandarchaeology.wordpress.com/2011/10/28/the-big-dig-at-caherduggan-castle/>]

Recent research in the Yorkshire Dales National Park [<http://www.outofoblivion.org.uk/lime.asp>] has identified a number of such early kiln sites which are mostly built into slopes and are identifiable as low circular earthworks about 1 m deep and of about 2 m diameter, with a narrow neck or funnel leading into the central bowl. None of these kilns have been excavated in the Dales so understanding of them is based on work carried out elsewhere, including places where they are still used, such as the Western Balkans, where stone is stacked in such a way as to leave a space for burning in the temporary firing chamber underneath, allowing separation of the fuel and limestone, unlike in the later, 'continuous' kilns where layers of stone and coal are interleaved. Such a kiln, of 17th century origin, was excavated near Ingleton in 2003 and found to consist of a bowl c 1 m deep and 2 m in diameter with a horizontal stoking hole on one side.

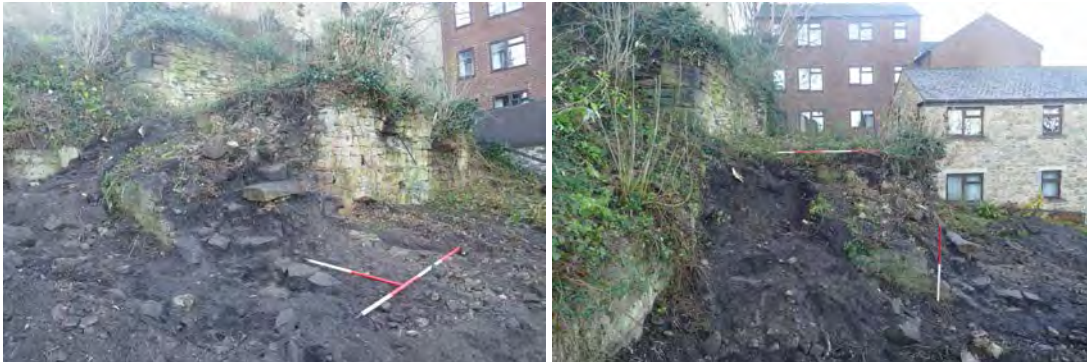
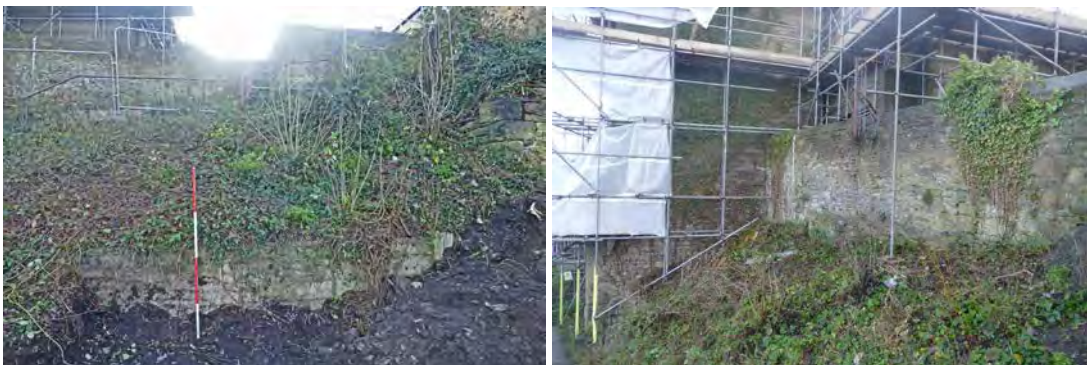
Illus. 02-05: Views of the lower part of the site (clockwise from top left):

Remains of two buildings (front walls represented by Walls G & H) and remains of N-S stairway running alongside to the east; view of the terraced remains of the same structures; view from the south showing embankment up to the upper part of the site; view from SW showing embankment against the E-W car park wall where it abuts the west wall of the former swimming pool building.
