***SITE OF FORMER POLE BARN AT  
SHORTFLATT TOWER  
BELSAY  
NORTHUMBERLAND***

**ARCHAEOLOGICAL WATCHING BRIEF**

REPORT ON AN ARCHAEOLOGICAL WATCHING BRIEF  
FOR A RESIDENTIAL PROPERTY ON THE SITE OF  
THE FORMER POLE BARN

SHORTFLATT TOWER  
BELSAY

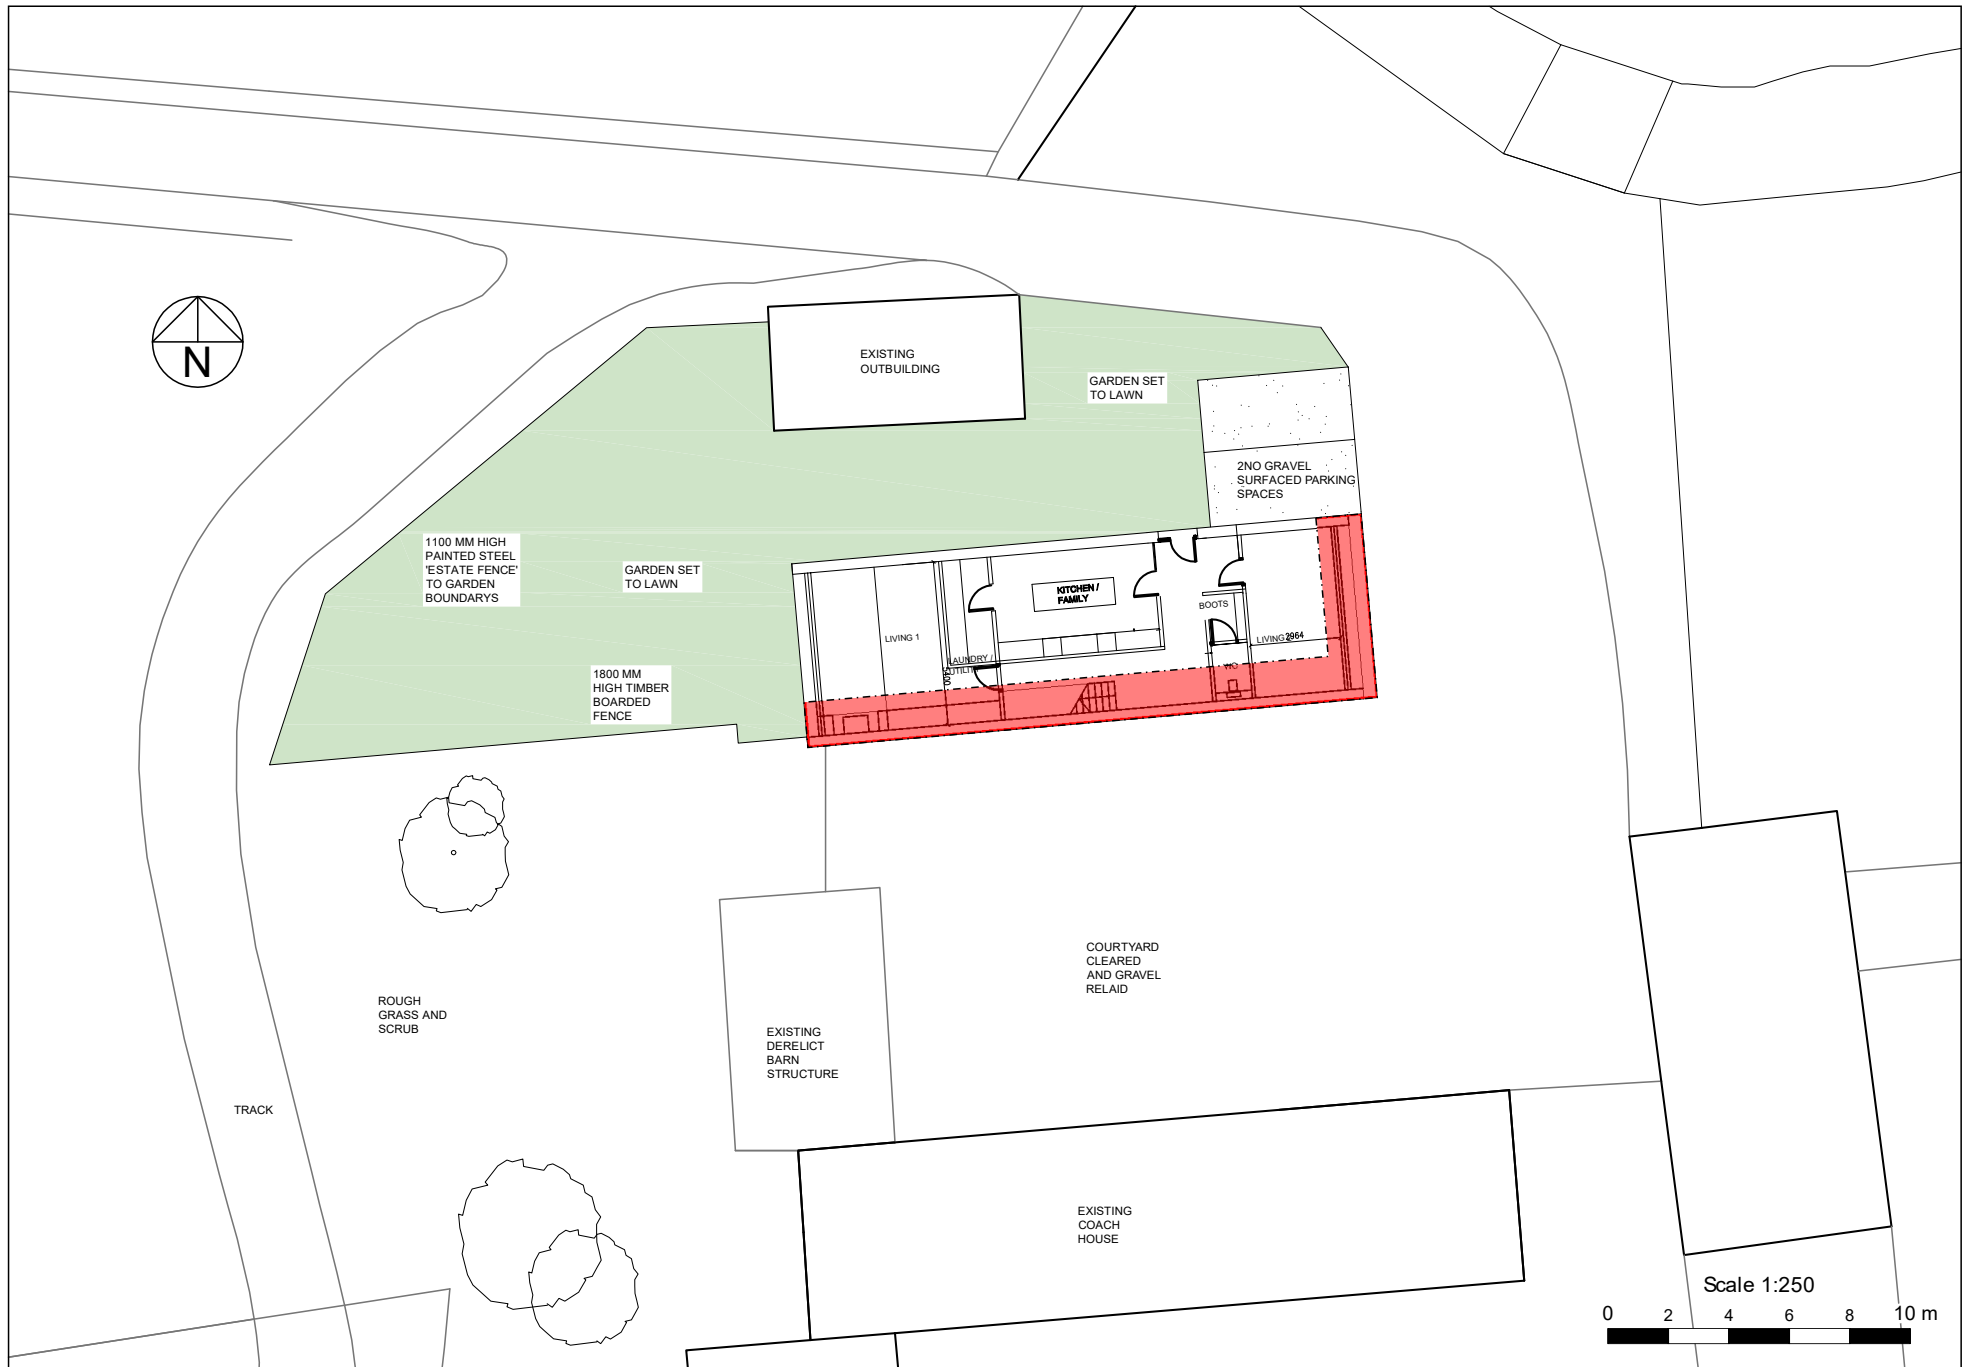
The footprint of the proposed new build is specifically located over the northern half of the former Pole Barn site, which had been demolished prior to arrival. The new residential build is to be of identical length to the previous build and sits upon the same east-west alignment. Its western foundation is to utilize/build off the existing footing of the former Pole Barn, and its northern foundation is to utilize/build off the existing footing of the former 19<sup>th</sup> century site boundary wall, still evident on the ground and visible on the 1<sup>st</sup> Edition Ordnance Survey Plan c.1866 (see *Illus. 05*).

*Illus. 04: Architect supplied plan showing the location of the new development (bound in red) on the site of the former Pole Barn, to the north-west of Shortflatt Tower.*

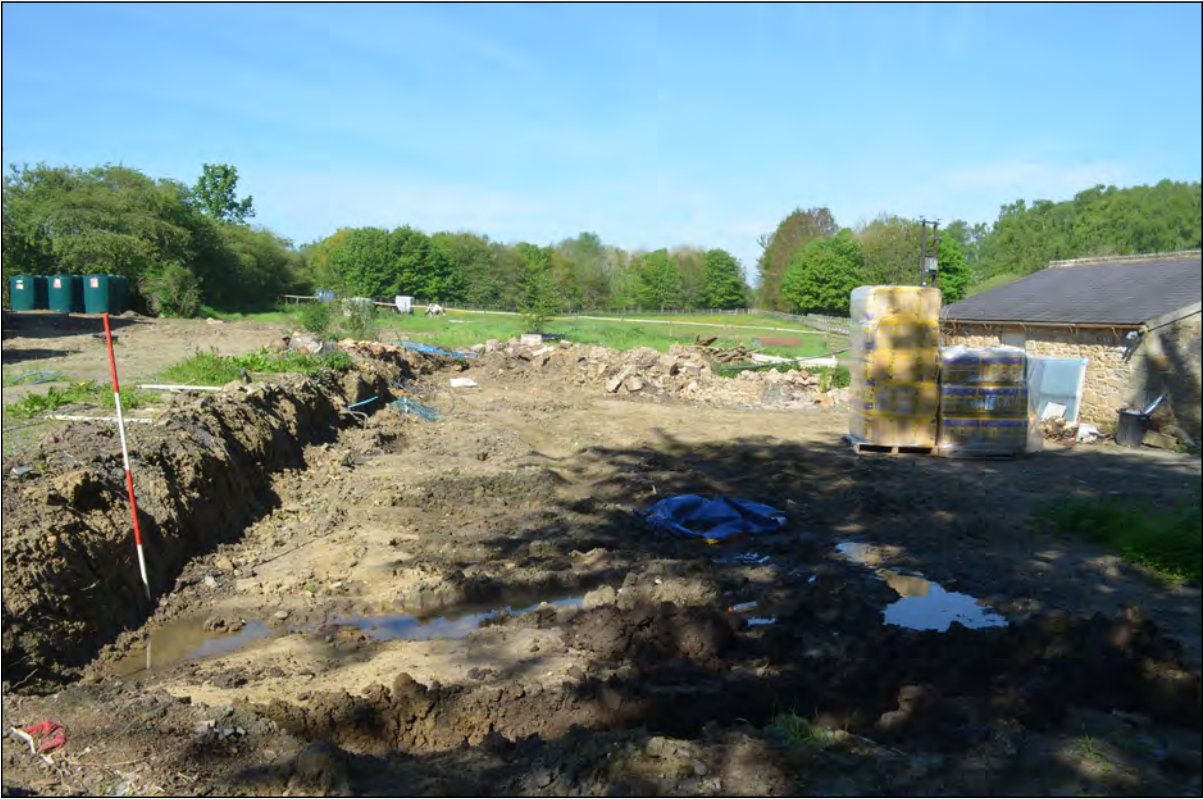
*Photo 01. Pre-excitation shot. View looking west following demolition of the Pole Barn.*

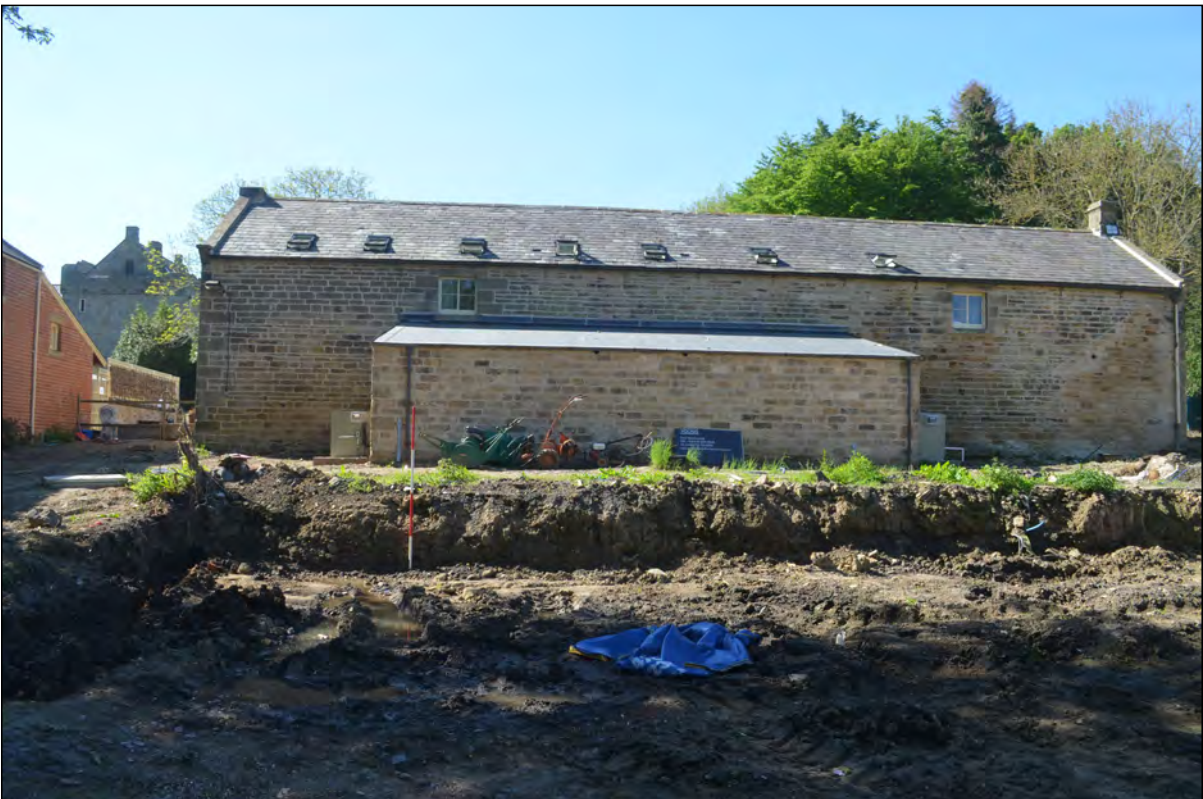
*Photo 02. Pre-excitation shot. View looking south towards the Coach House, following demolition of the Pole Barn.*

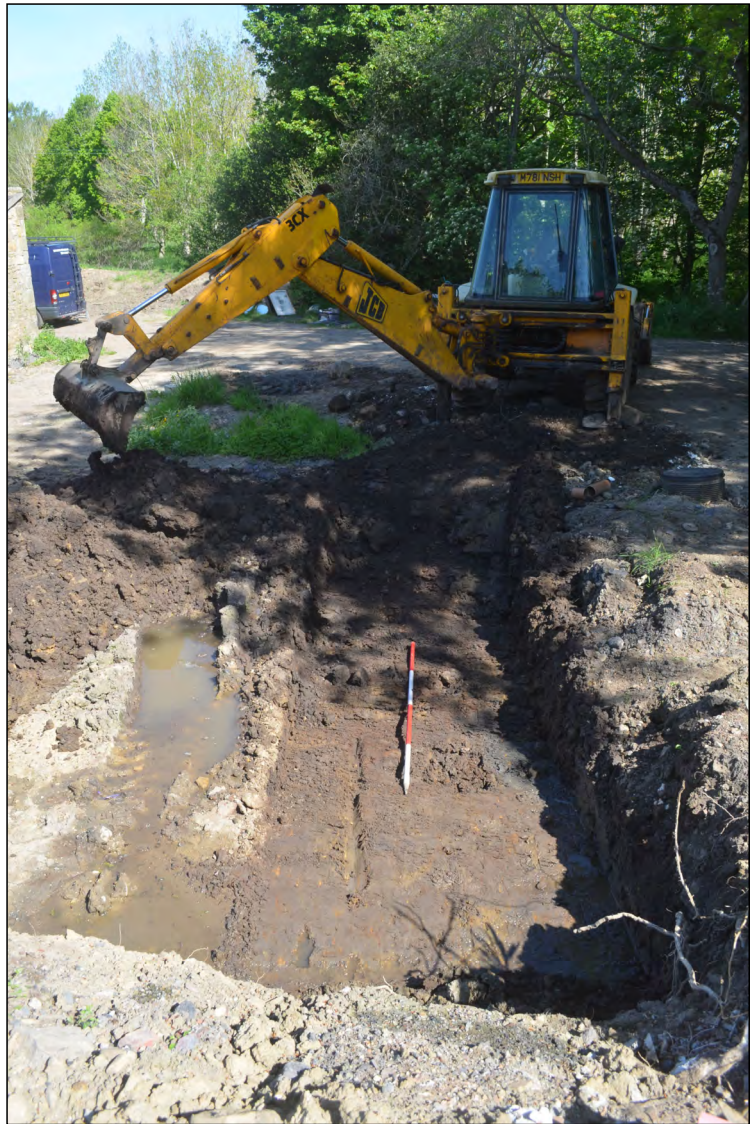
Dimensions: the south trench measured 19 m (length) x 1.20 m (width) x 0.90 m (depth at the north end) – 1.40 m (depth at south end where construction trench for Pole Barn forms a cut-in terrace); the east trench measured 6 m (length) x 1.20 m (width) x 0.90 m (depth).

Elsewhere, both trenches excavated through modern overburden/topsoil, into firm, natural reddish-brown boulder clay [04] with common inclusions of sandstone chippings throughout.

*Photo 03. View looking north along the east trench, following excavation.*

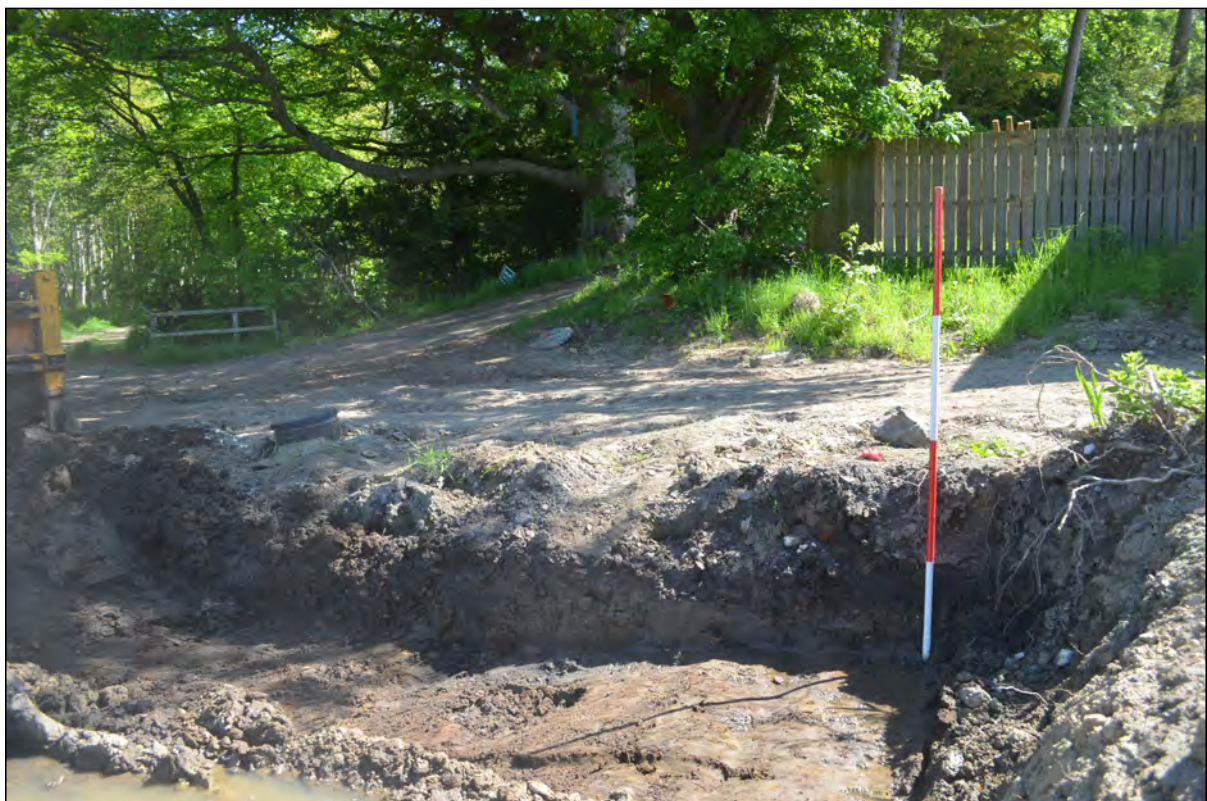
*Photo 04. West facing section of east trench, following excavation.*

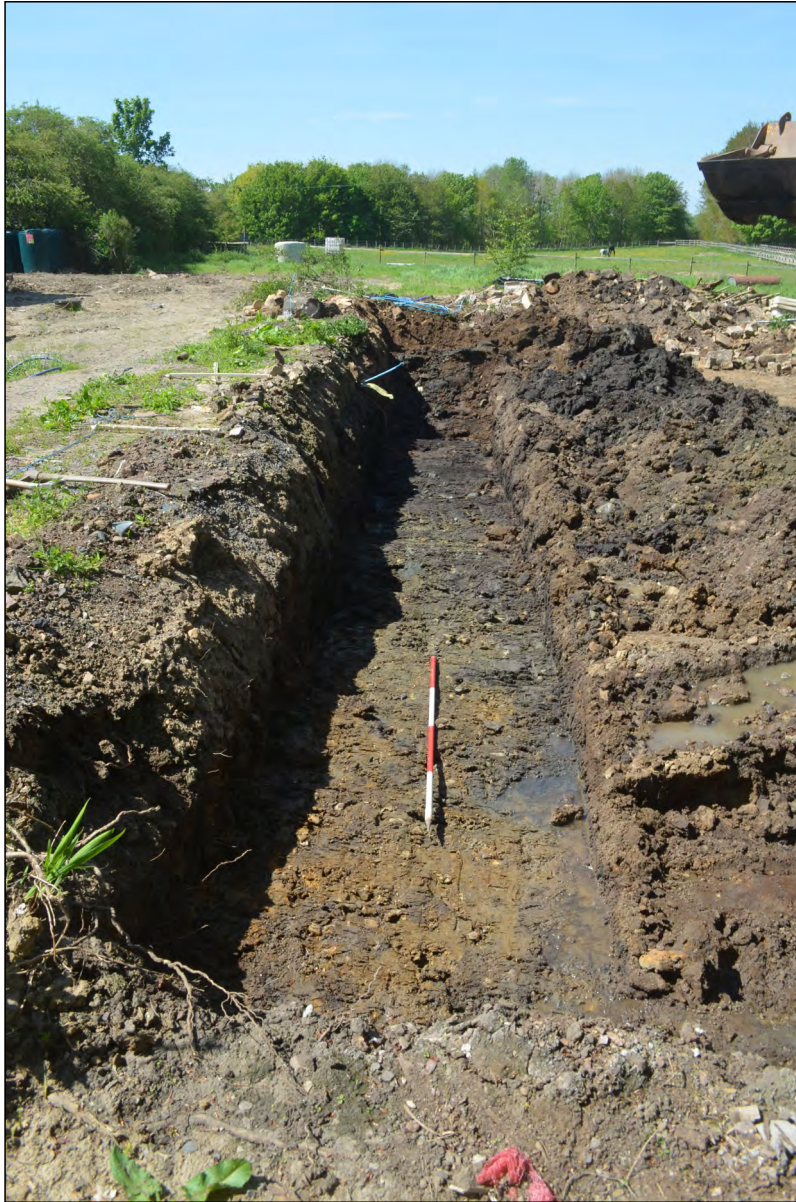
Areas along the former south wall of the Pole Barn indicate that its footing was sitting directly upon natural clay. Indeed, the entire southern portion of the site, occupying the southern half of the former Pole Barn, has been terraced in to the bank to a depth of approx. 1 metre below ground level probably during the construction of the Pole Barn in the mid-19<sup>th</sup> century. It was noted that the gradient of the bank declines to the north by a depth of 1 metre or more by the time the east-west track is reached (see *Illus. 03-04*).

*Photo 05. View looking west along south trench, following excavation to finished depth.*

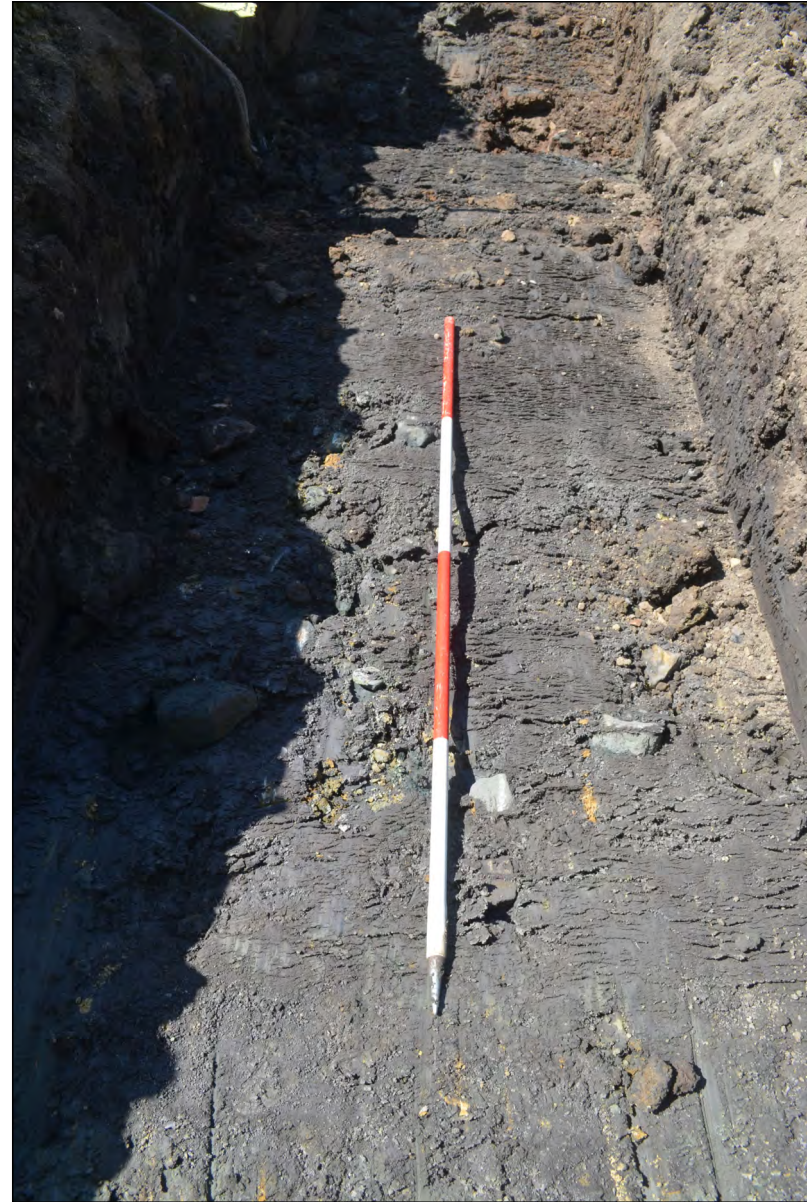
Beneath the mix of 19<sup>th</sup> century demolition material from the former Pole Barn and silt-loam topsoil [01], a fairly soft, dark brown-black dirty silt-clay deposit [02] was observed in the central portion of the southern trench, extending beyond the maximum depth of excavation. It was located 4 m from the east end of the trench and extended in length for the remaining 15 m of the trench – occupying the entirety of the Pole Barn footprint. This material contained 19<sup>th</sup> and 20<sup>th</sup> century pottery exclusively and has been interpreted as an occupation layer associated and contemporary with the former Pole Barn. Crude soak away drains [03], located at the east and west extent of this occupation layer, were observed upon a north-south alignment and interpreted as contemporary 19<sup>th</sup> century drains associated with the former Pole Barn.

- [02] Occupation level from former Pole Barn. Comprising of fairly soft, dark brown-black dirty silt-clay, observed in the central portion of the southern trench, extending beyond the maximum depth of excavation. Located 4 m from the east end of the trench and extended in length for the remaining 15 m of the trench – occupying the entirety of the Pole Barn footprint. Contained 19<sup>th</sup>-20<sup>th</sup> century pottery exclusively and has been interpreted as an occupation layer associated and contemporary with the former Pole Barn.

- [03] Crude soak away drains comprising of irregular sandstone pieces within a linear slot of N-S alignment, located at the east and west extent of the Pole Barn occupation layer [02]. Interpreted as contemporary 19<sup>th</sup> century drains associated with the former Pole Barn.

*Photo 06. View looking west at detail of 19th century deposit within the south trench, following excavation to finished depth.*

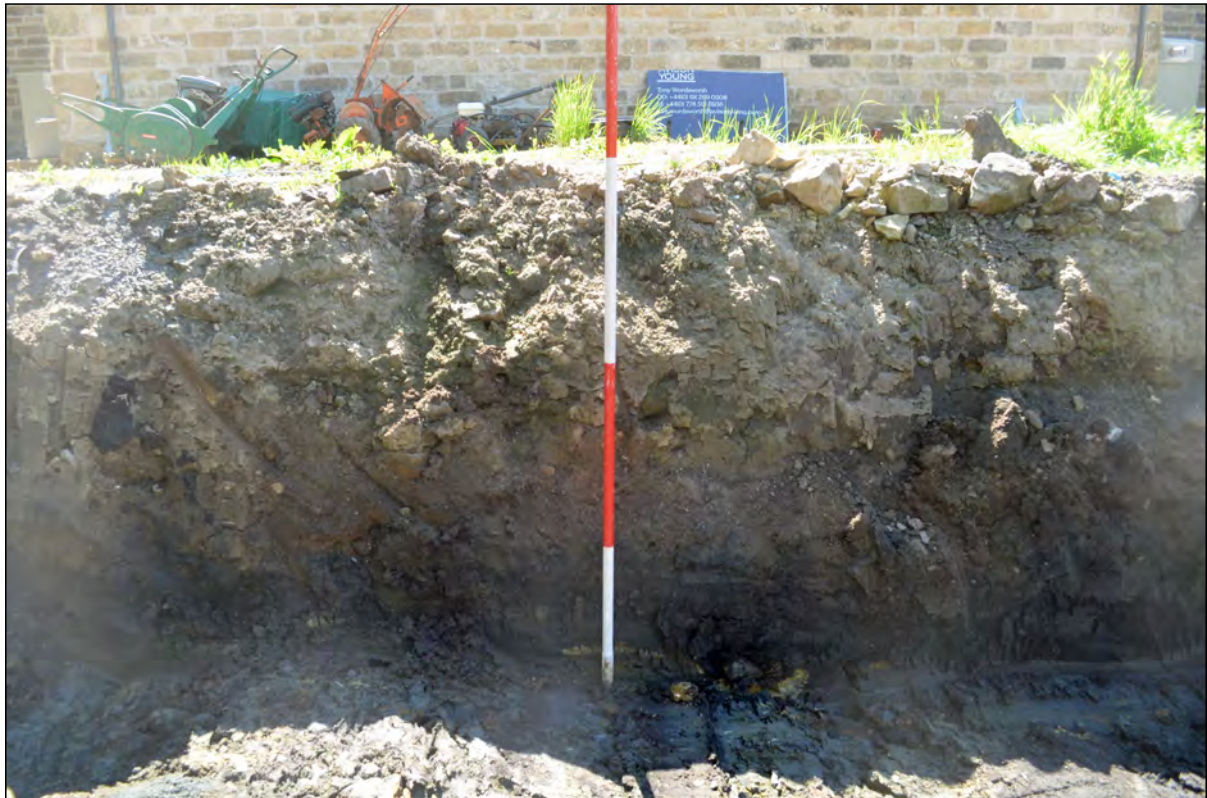
- [01] Mixed demolition material and topsoil. Comprising of mixed sandstone rubble from the demolition of the 19<sup>th</sup> century Pole Barn, together with topsoil comprising mid grey-brown rich silt-loam, fairly soft. Observed to average depths of 0.40 m below ground level.

- [04] Natural. Mid reddish-brown boulder clay, firm, with frequent glacial sandstone fragments and mixed alluvium. Observed from depths of 0.40 m (average) below ground level.

*Photo 07. North facing section of south trench, following excavation.*

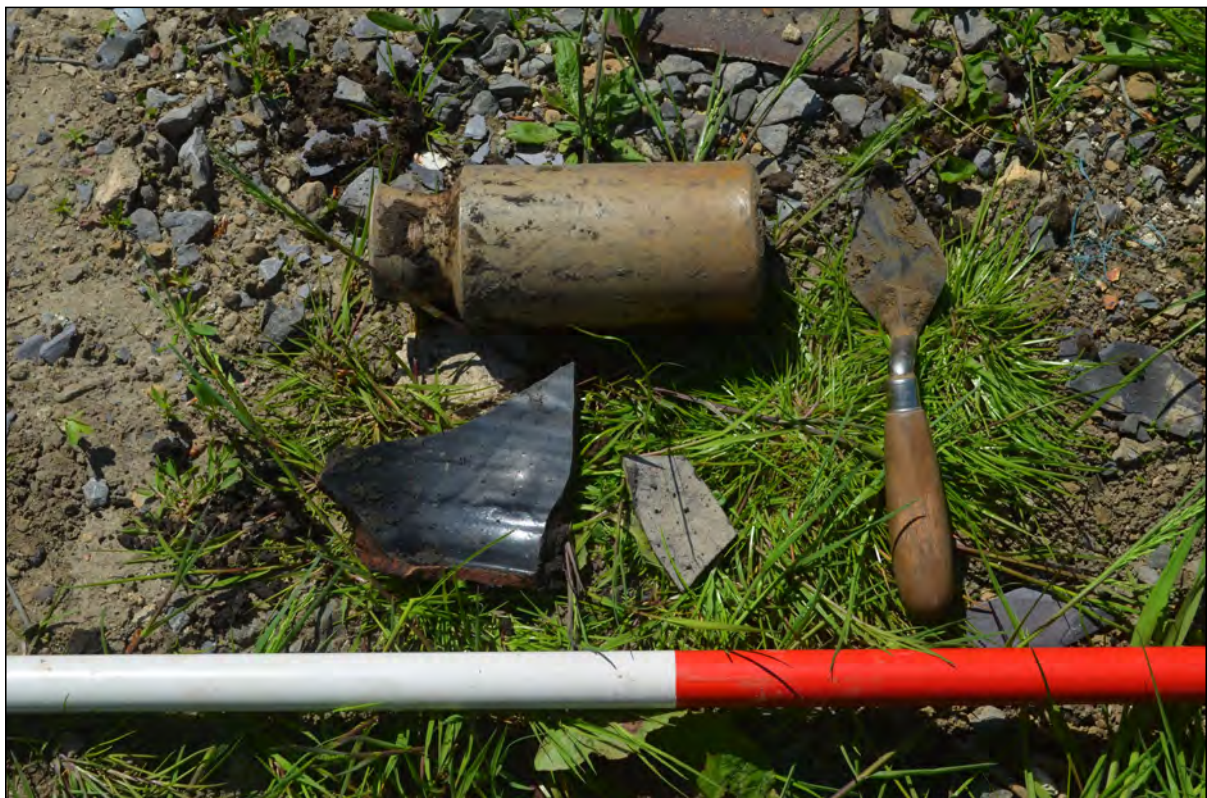
*Photo 08. Selection of late-19th century pottery found within a deposit in the south trench, associated with the recently demolished (late-19th century) Pole Barn.*
