SHIELD HALL
SLALEY
NORTHUMBERLAND

~ HISTORIC BUILDING RECORDING
AND WATCHING BRIEF ~

APRIL 2022 – FEBRUARY 2023

REPORT ON ARCHAEOLOGICAL INVESTIGATIONS 2022-23

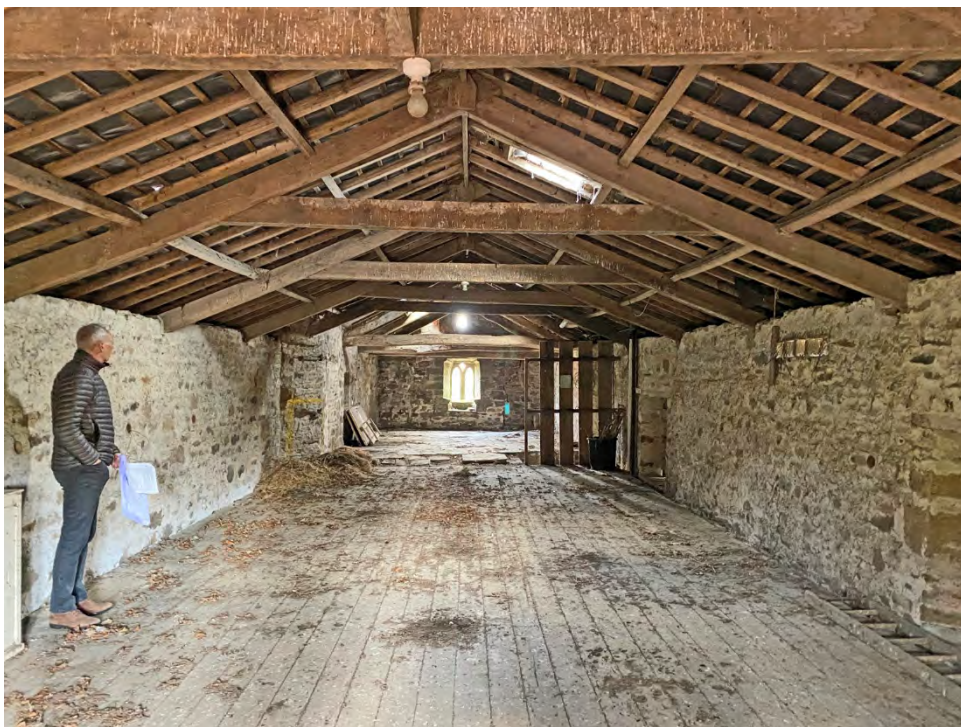
Frontispiece: View south into the southern 19th-century component of the West Range.

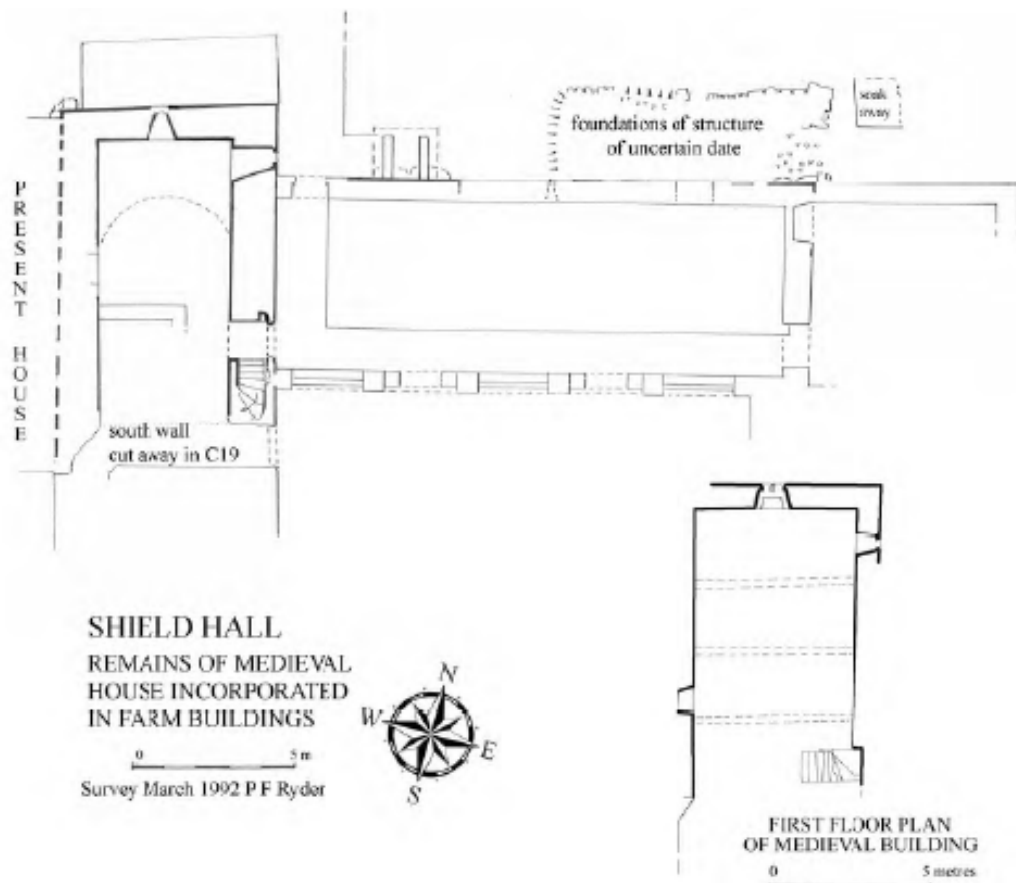
Illus. 10: Survey plan of Shield Hall, c.1992 by Peter Ryder.

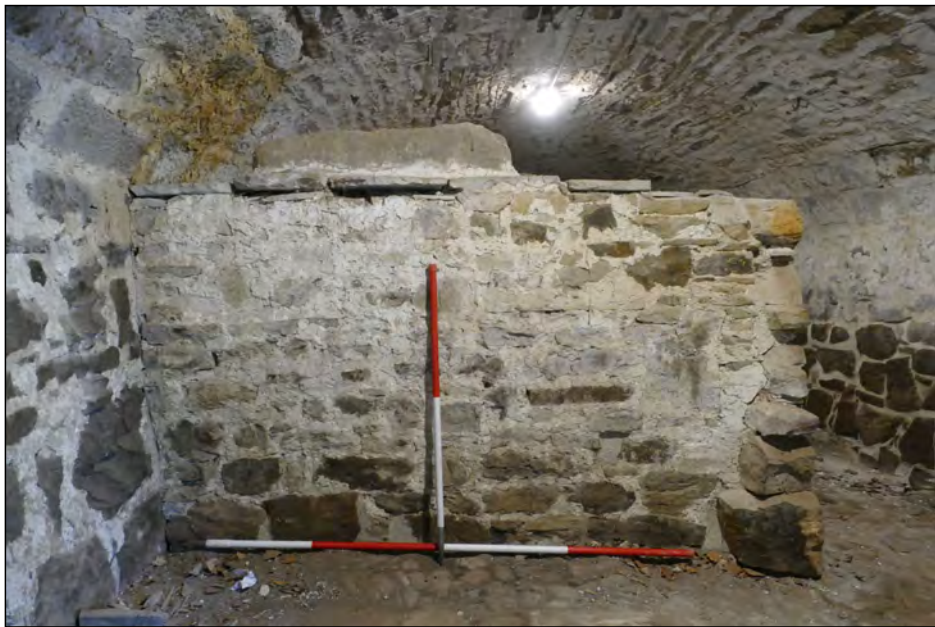
Photo 31.

Test-pit 1 was excavated below a floor layer of disturbed cobbles and revealed, immediately below the floor, decaying sandstone bedrock with cavities containing a silty fill (see Phase 2 Record Photos. 31-33).

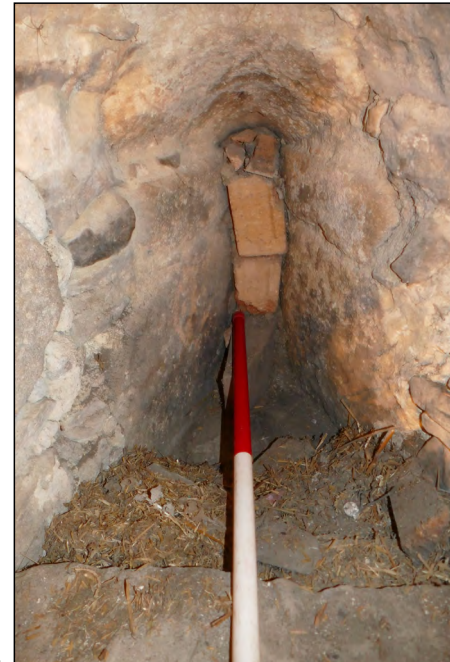
Photo 36.

Test-pit 3 revealed sandstone bedrock or, potentially, a foundation course below the medieval west wall with a deposit of fill against it, below the disturbed cobbled floor to the east (see Phase 2 Record Photos. 36-39). Within the silty fill some 0.20 m below the floor level was a small squared stone c 0.12 m square set into the silty deposit next to the remains of squared timber post c 0.10 m square driven into the same deposit. These features, of unknown age, probably both served - as post-pad and post – as part of a dividing fence or gate within the cross-wing space.

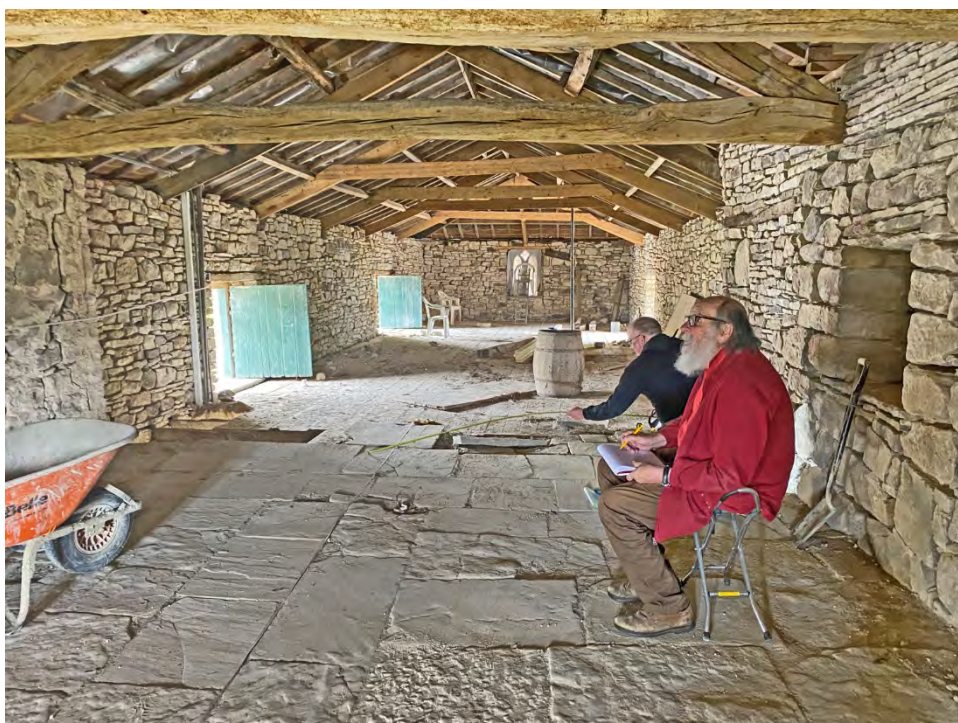
Illus. 11: Recording the upper floor and internal walls of the cross-wing prior to consolidation works.

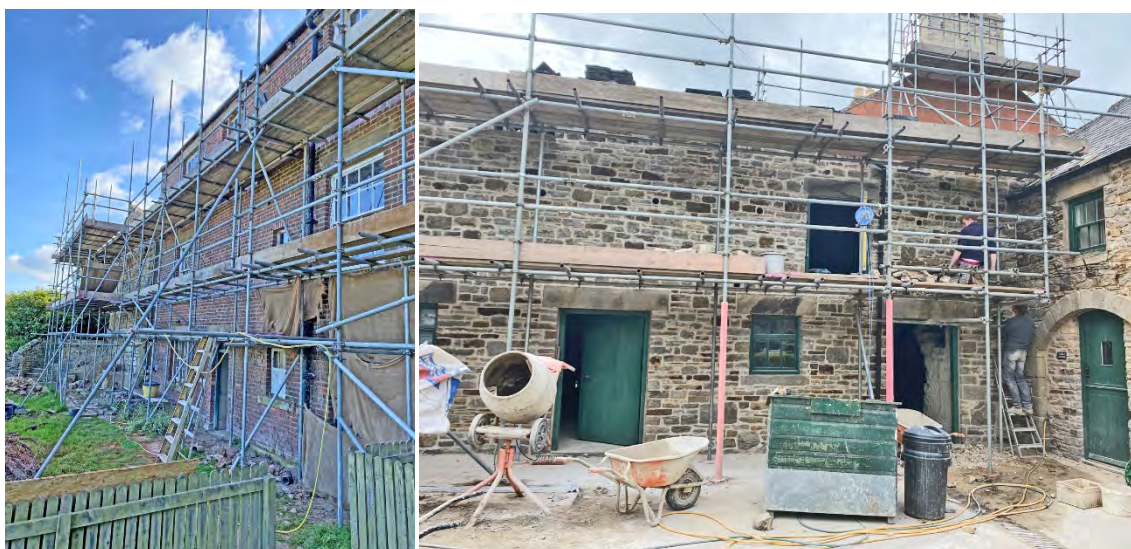
Illus. 12 & 13 (above left): The north-facing rear façade of the cross-wing of a 13th-century house (rear) and main house (foreground) during consolidation works.

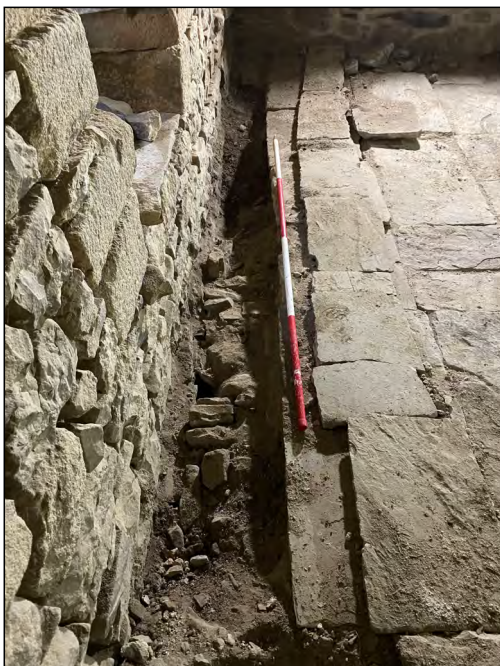
Photo 28.

A watching brief on the removal of the first-floor flagging within the medieval cross-wing (see Phase 2 Record Photos. 27-29) was preceded by test-excavation of a strip of flags along the north wall. This showed the flags to be laid upon a base of loose stone chippings with finer silty material below the joints (i.e., material swept in from the floor through the joints). Although this material was not explored in detail, its depth was greater towards the sides than in the centre where the top of the vault rises to its apex. The floor base exposed against the north wall contained no architectural fragments or other finds of note. Upon removal of the rest of the floor prior to its replacement the same sub-base was noted with no significant finds.

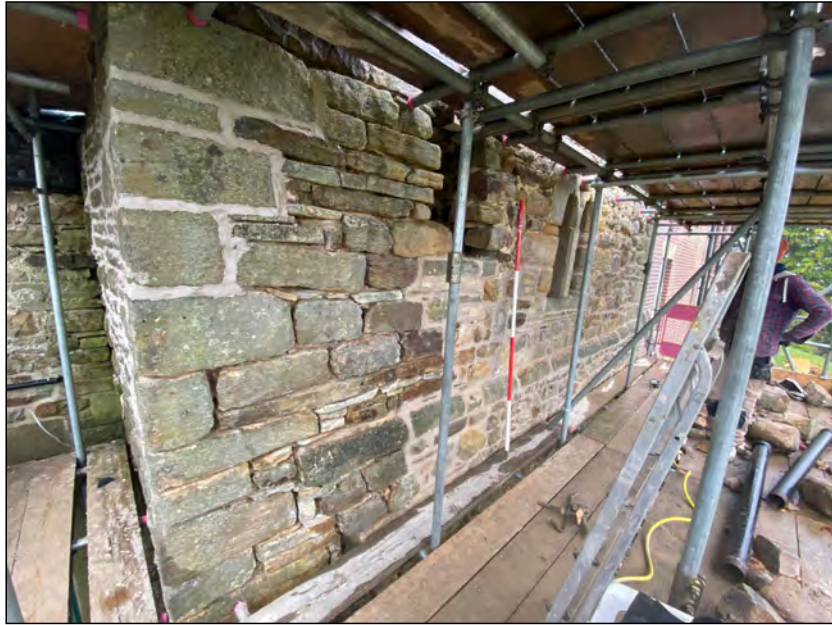
Photo 41.

Two small sections of masonry were removed from the north wall at first-floor level in order to repair areas of displaced or cracked masonry. The areas chosen, one to the east of the window (see Phase 2 Record Photos. 41-47) and one to the west (see Phase 2 Record Photos. 48-54) were featureless and did not include the central window or quoins. No significant features or worked stones were revealed during this intervention (see Phase 2 Record Photos. 55-57) which was followed by the infilling of the removed sections of masonry (see Phase 2 Record Photo. 58).

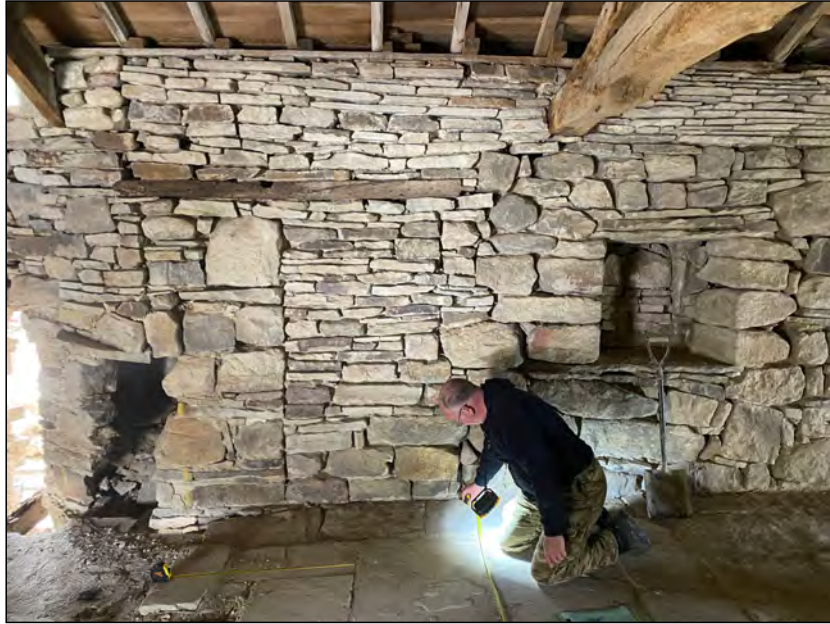
West Wall, Blocked Door

The site chosen for the new door was within an area of blocking below an inserted timber lintel (see Phase 2 Record Photo. 74). Removal of this section of masonry (see Phase 2 Record Photos. 75-77) revealed no significant features or worked stone with markings other than basic tooling, (see Phase 2 Record Photos. 78-82).

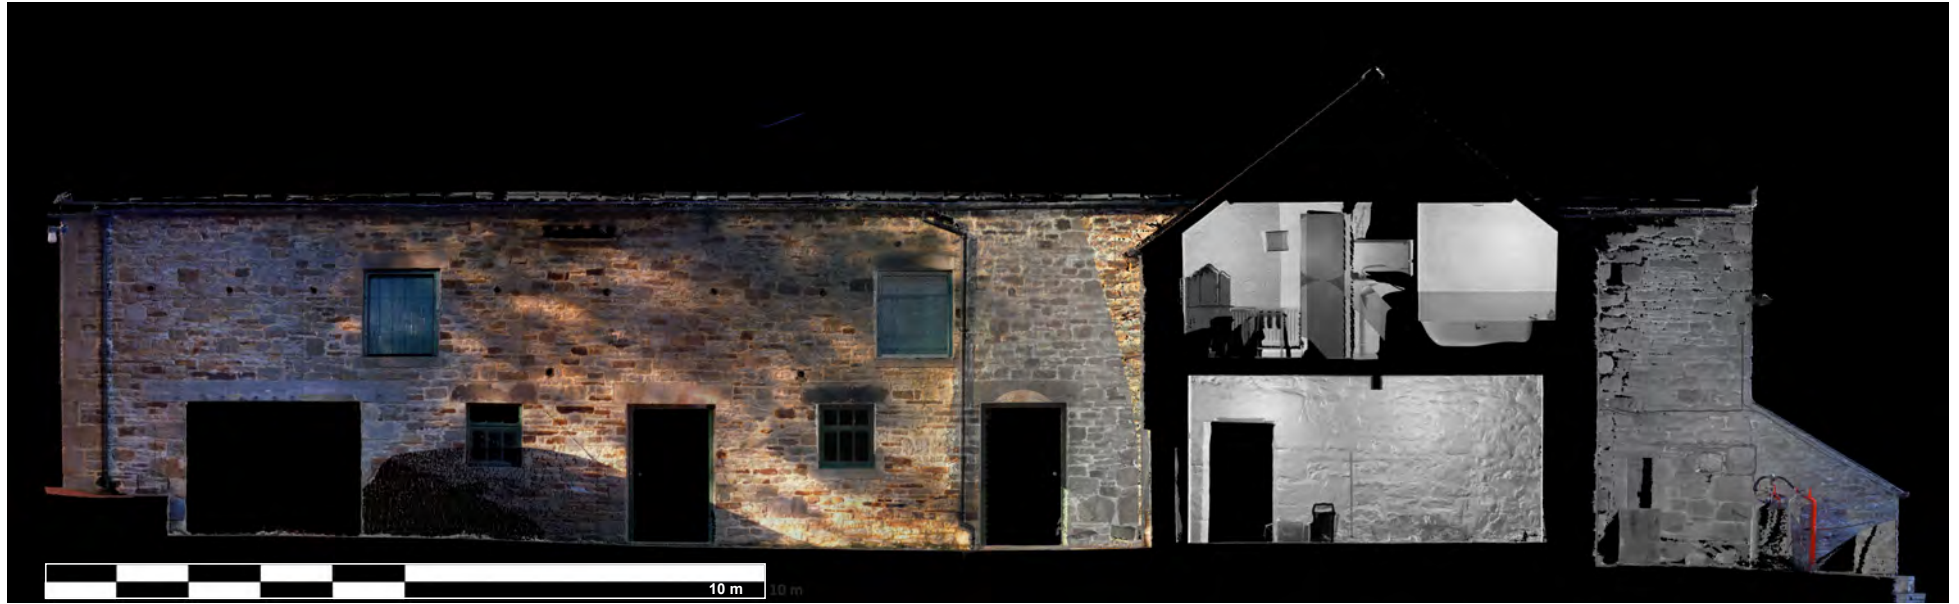
Illus. 14: Digital Scan of the east elevation of the east wall of the West Range, processed by Gianluca Foschi, April 2022.

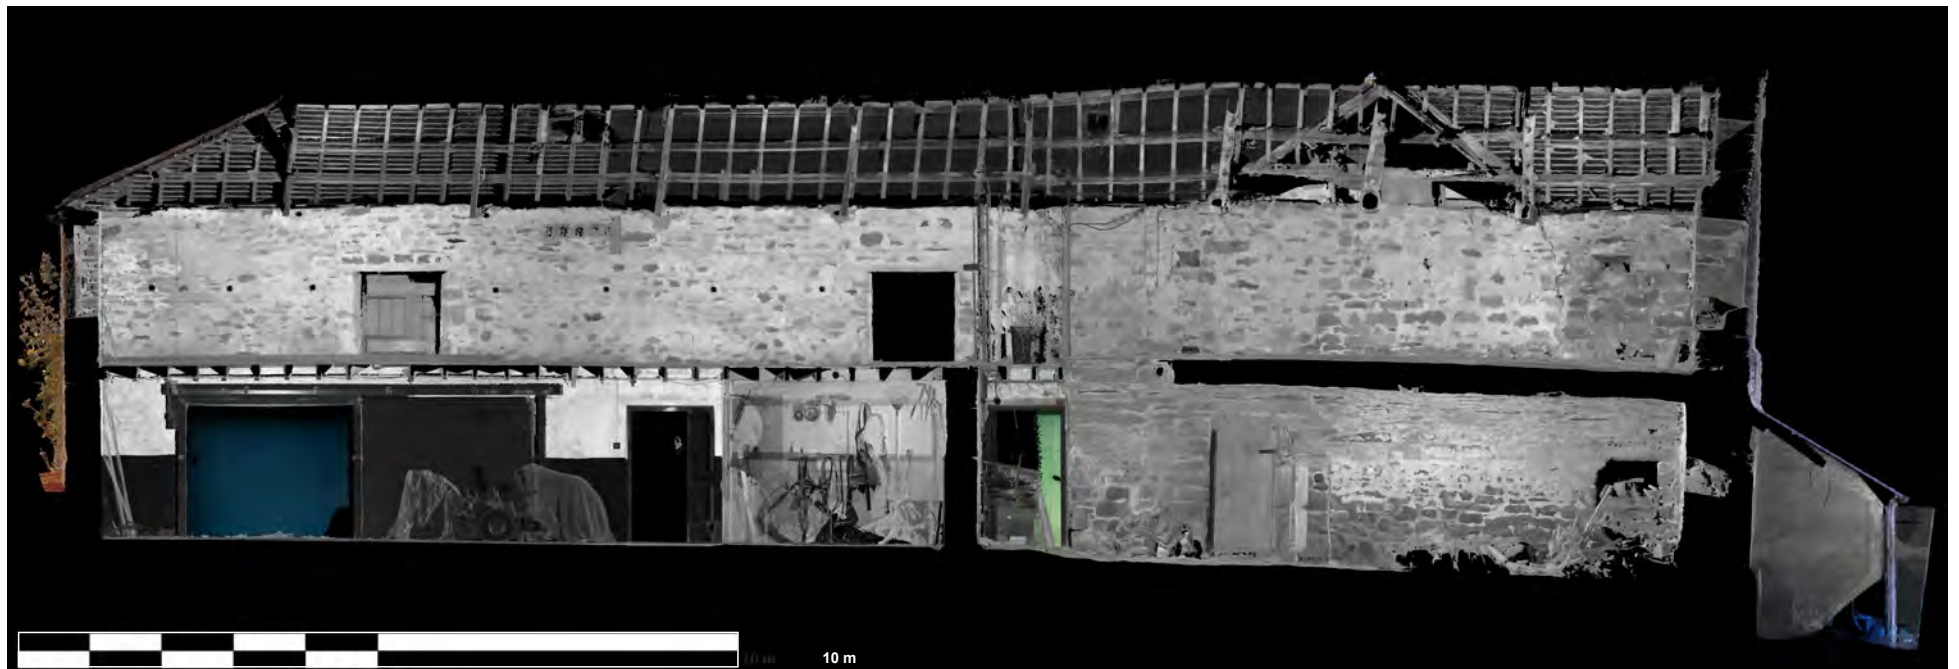
Illus. 15: Digital Scan of the internal west-facing elevation of the east wall of the West Range, processed by Gianluca Foschi, April 2022.

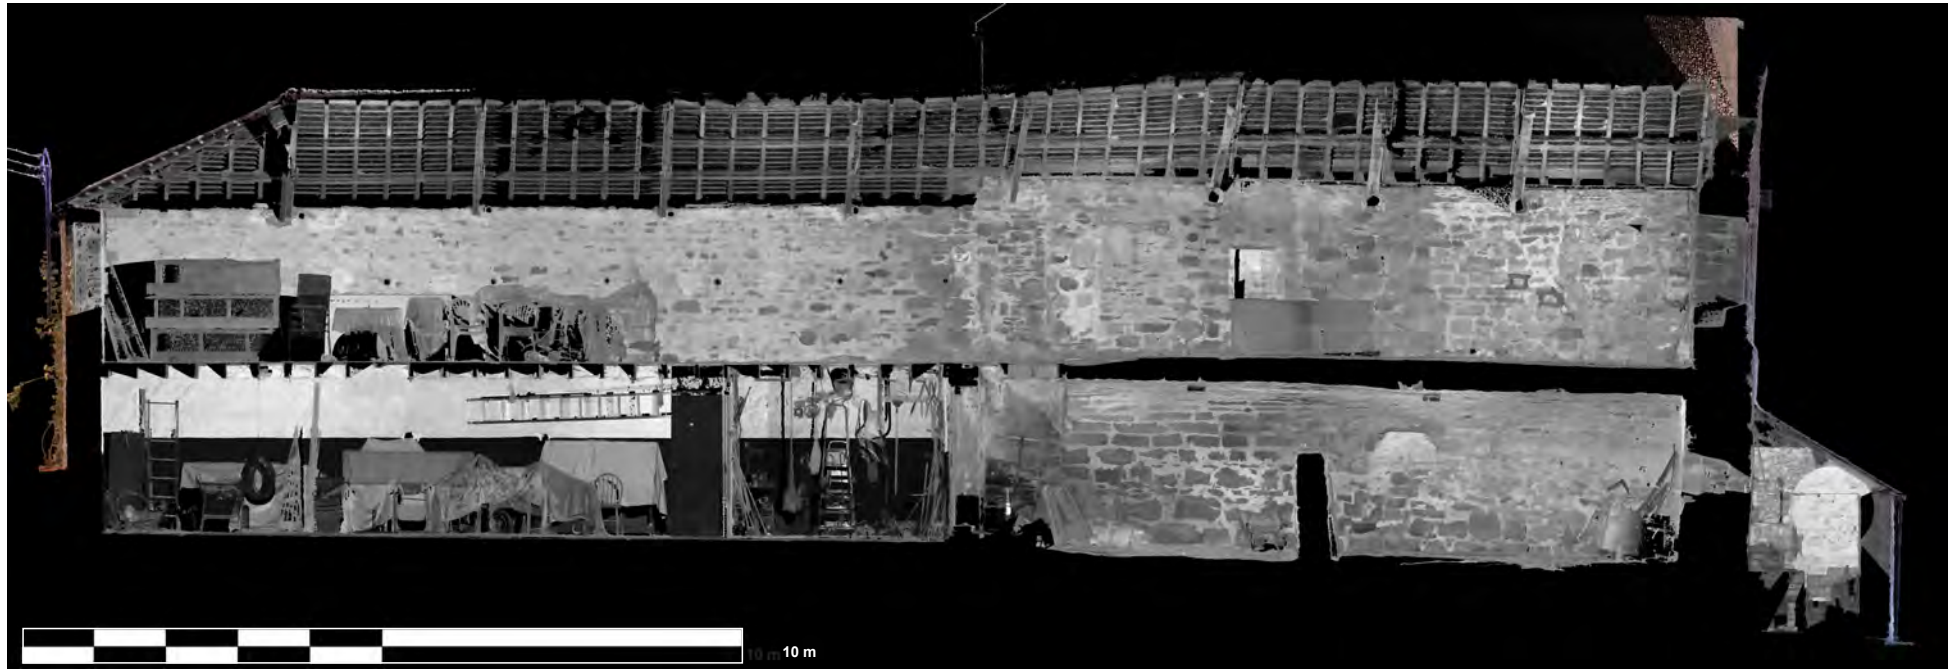
Illus. 16: Digital Scan of the internal east elevation of the west wall of the West Range, processed by Gianluca Foschi, April 2022.

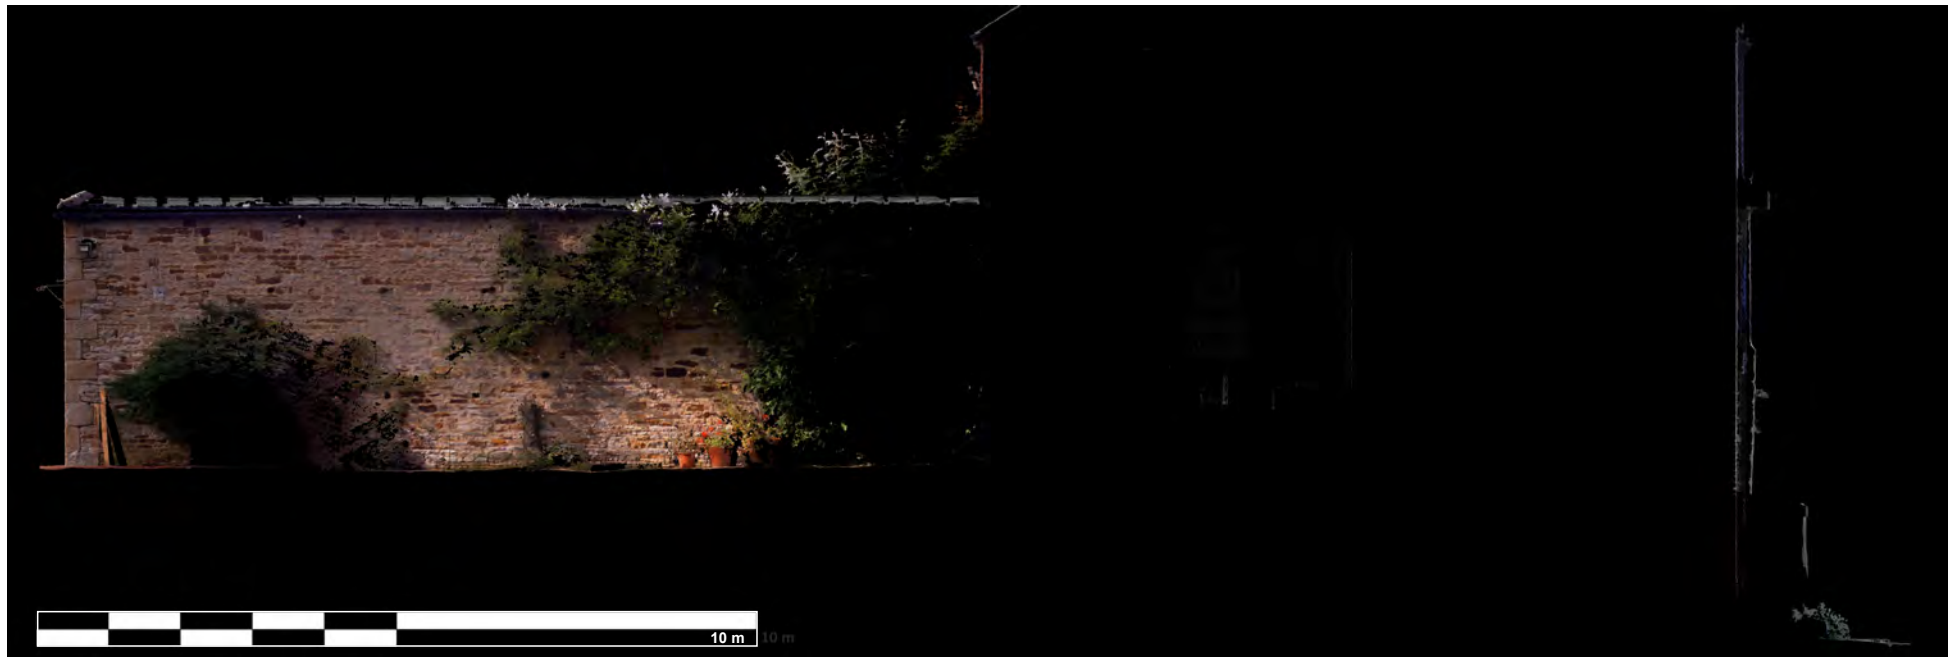
Illus. 17: Digital Scan of the west elevation of the west wall of the West Range, processed by Gianluca Foschi, April 2022.

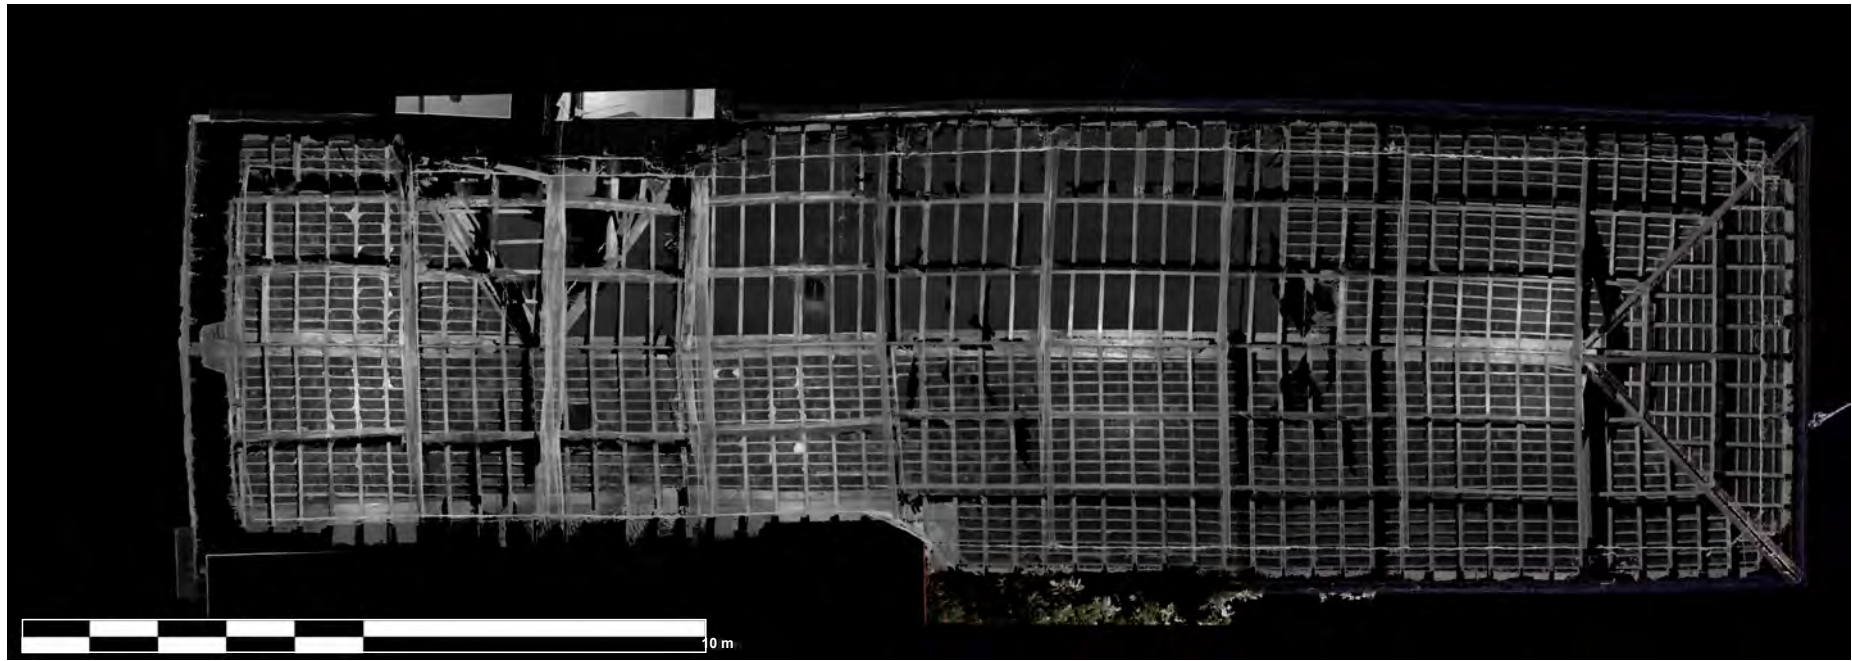
Illus. 18: Digital Scan of the roof structure of the West Range, Shield Hall, processed by Gianluca Foschi, April 2022.

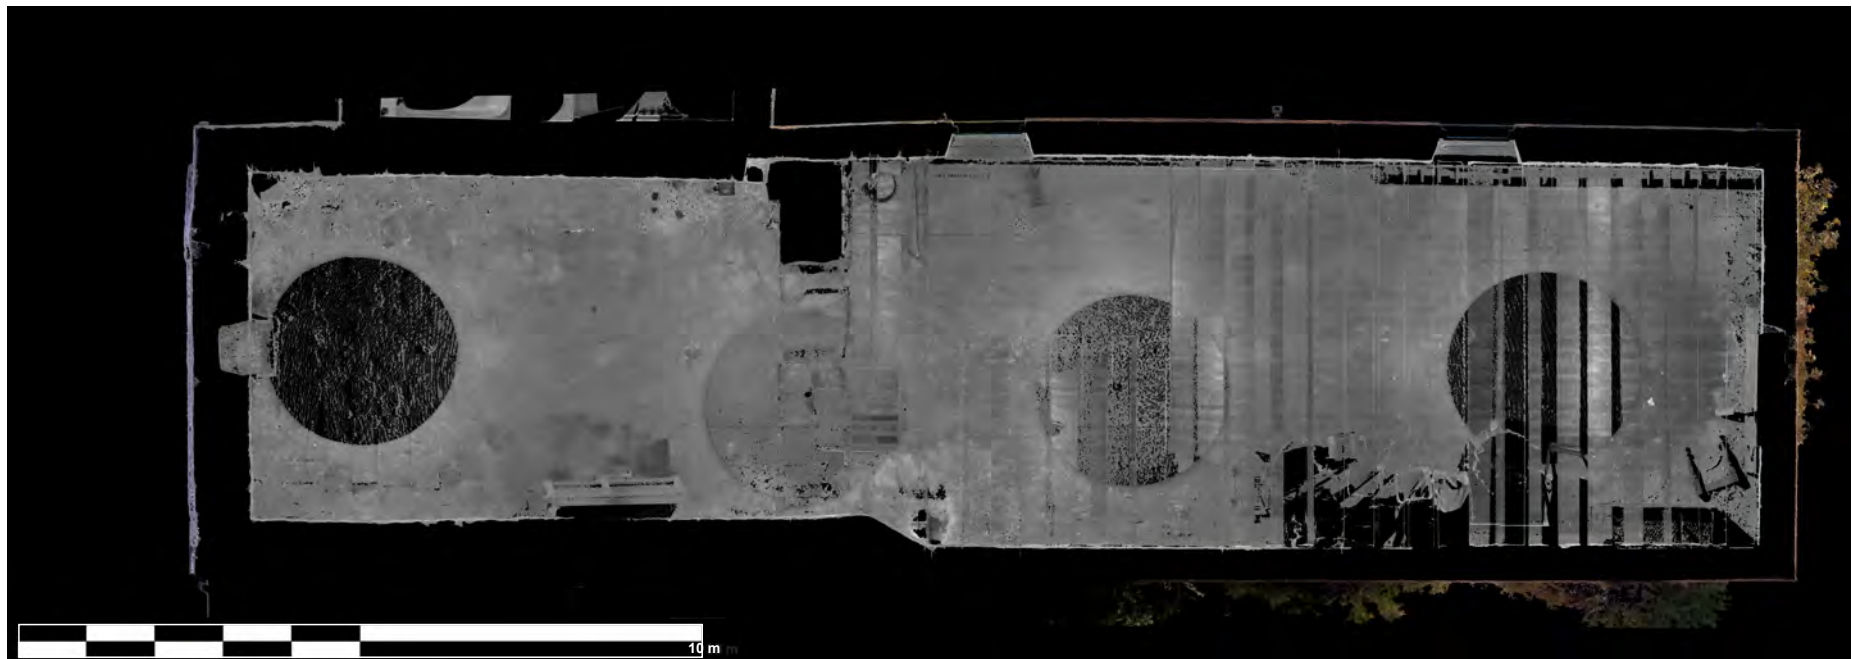
Illus. 19: Digital Scan of the first floor plan of the West Range, Shield Hall, processed by Gianluca Foschi, April 2022.

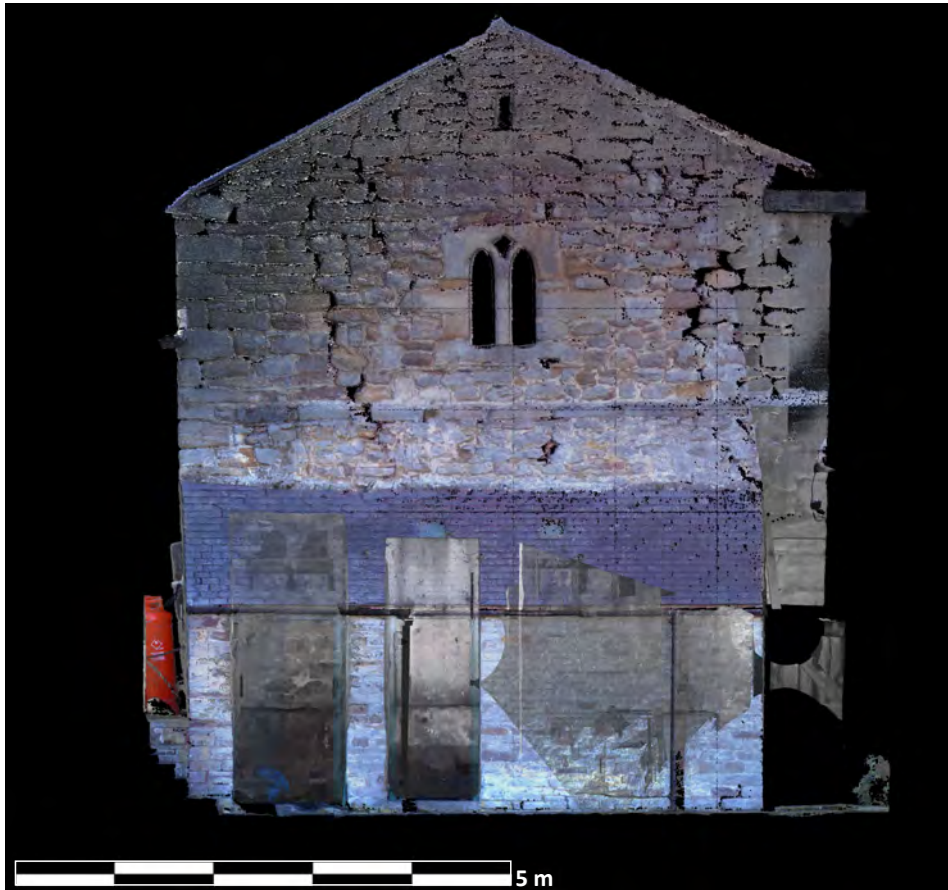
Illus. 20: Digital Scan of the north elevation of the Medieval north part of the West Range, Shield Hall, processed by Gianluca Foschi, April 2022.

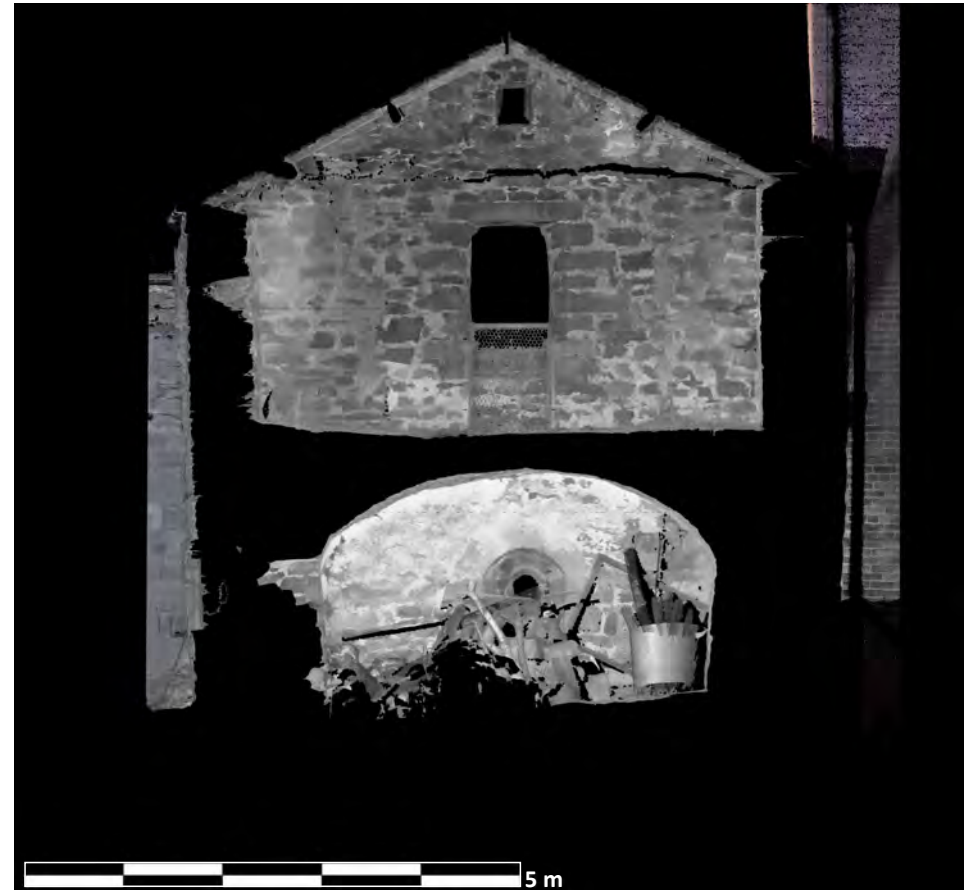
Illus. 21: Digital Scan of the south-facing internal face of the north wall of the West Range, Shield Hall, processed by Gianluca Foschi, April 2022.

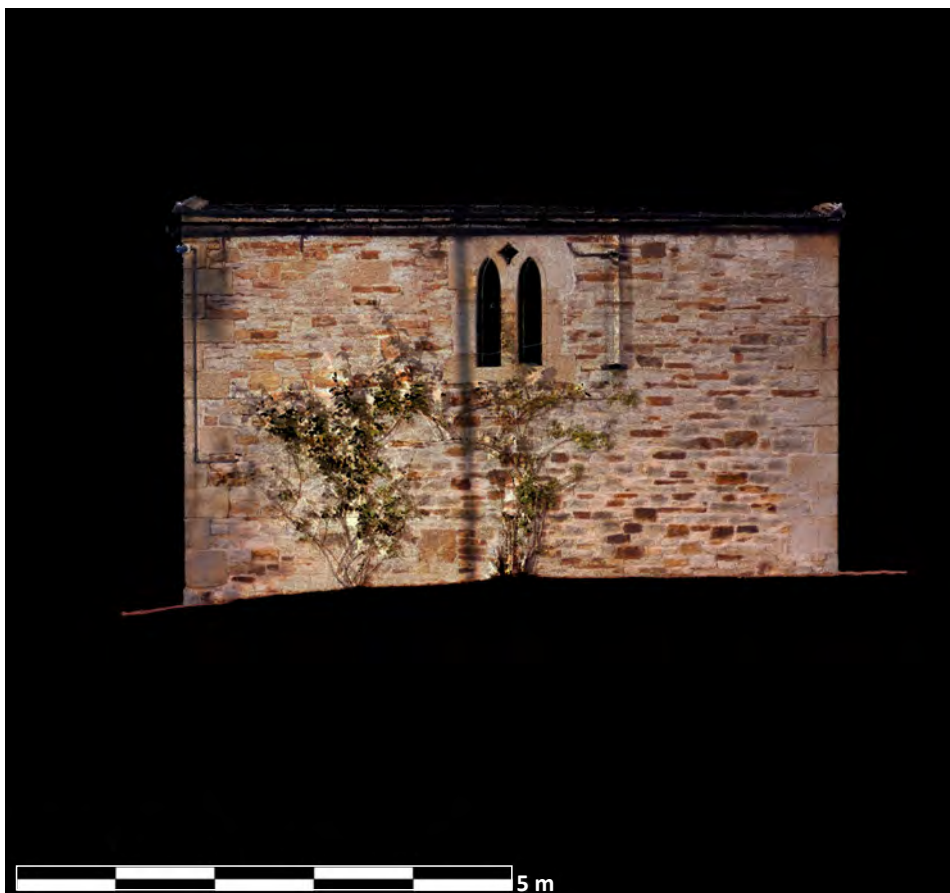
Illus. 22: Digital Scan of the south elevation of the West Range, Shield Hall, processed by Gianluca Foschi, April 2022.

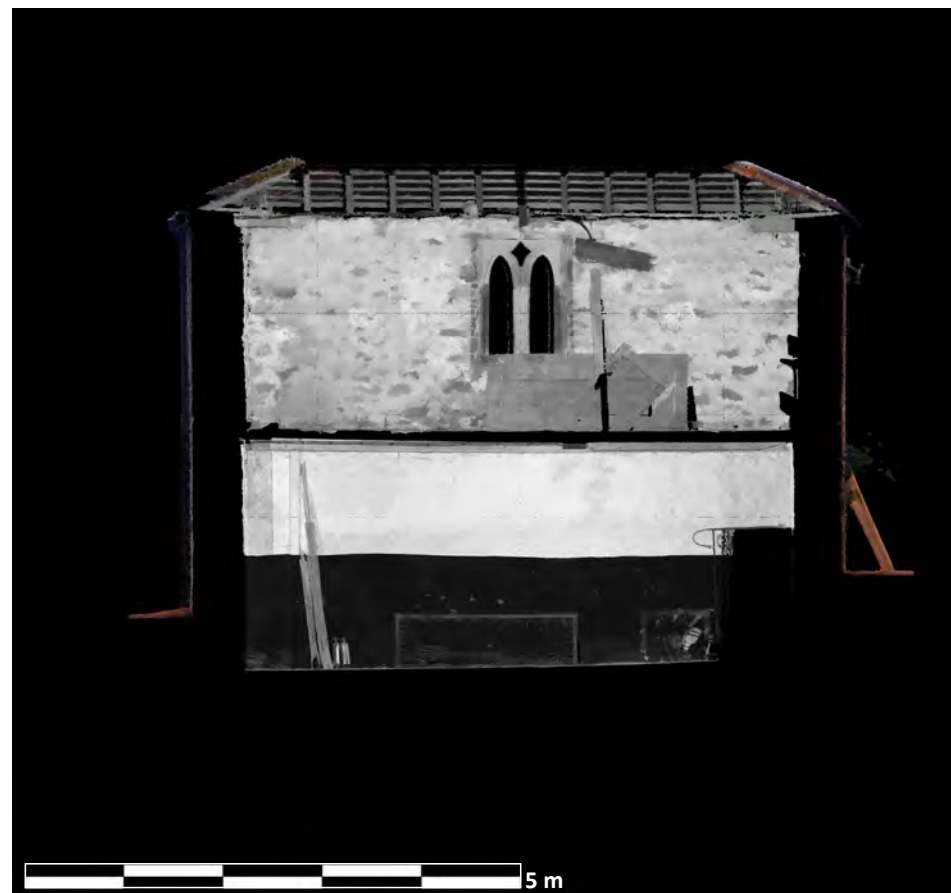
Illus. 23: Digital Scan of the north-facing internal face of the south end wall of the West Range, Shield Hall, processed by Gianluca Foschi, April 2022.

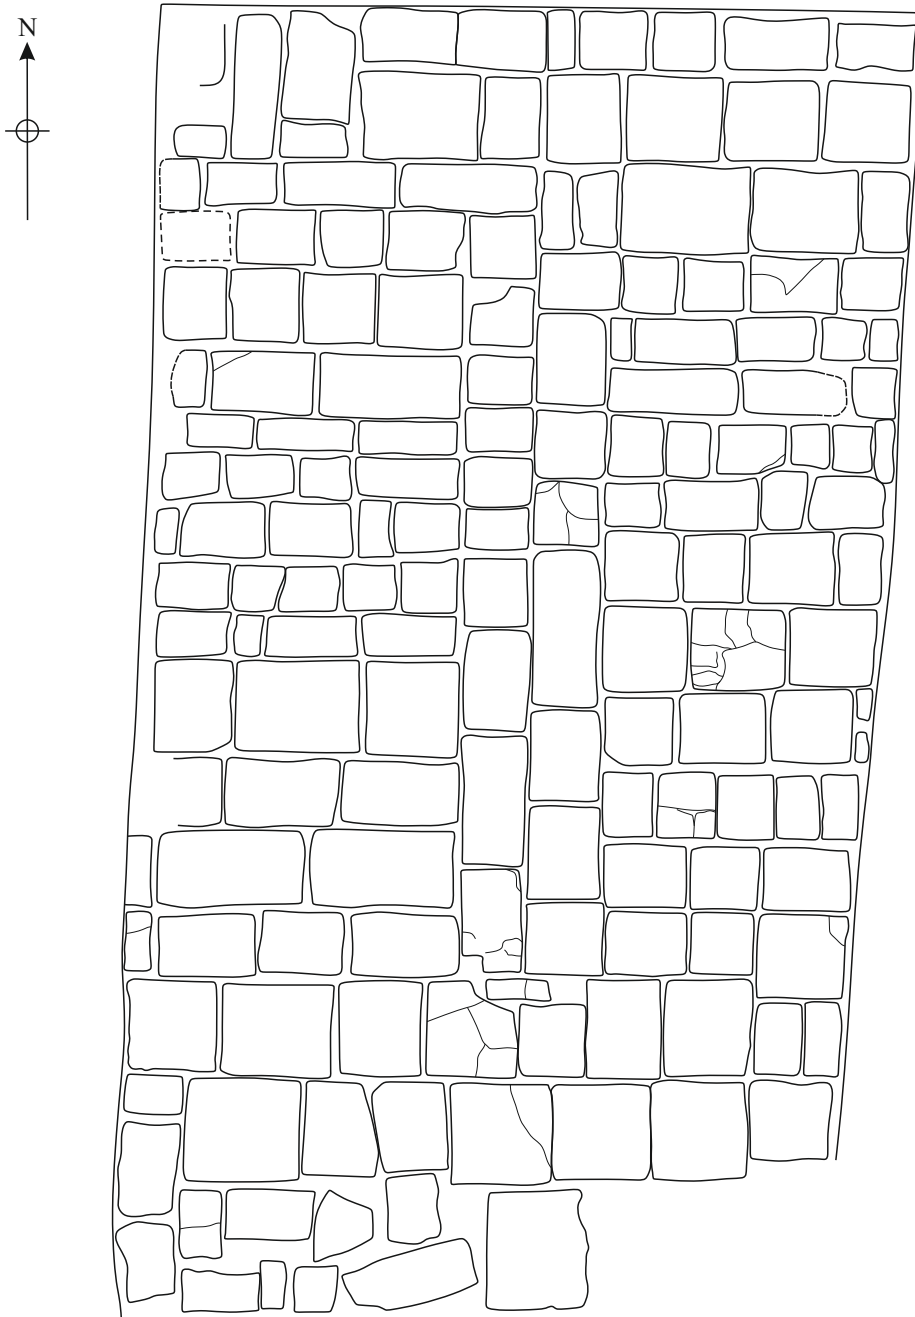
Illus. 27:
Plan of flagged floor, first floor of the medieval north end of the West Range.

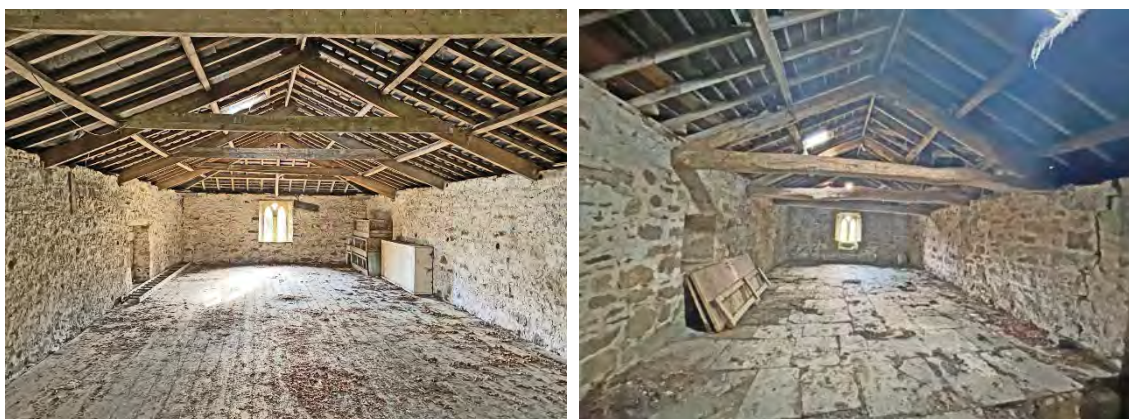
Illus. 06 (above left): Southward view of the southern, 19th century extension to the barn.

Illus. 07 (above right): The medieval part of the barn with older roof timbers.

Level 2 survey of the southern, 19th-century, part of the building (seen on *Illus. 06*, below) using existing drawings and additional photography by a suitably experienced professional archaeologist;

Recording and dating by dendrochronology of historic roof timbers (seen on *Illus. 07*, below), if they are to be removed, depending on specialist advice. Drawings will be produced from the existing digital survey data, with dating carried out by the Nottingham Tree-ring Dating Laboratory (NTRDL).
