## Part 2: Early coal mining to 1840

#### 4. TCR walkover survey: individual site details

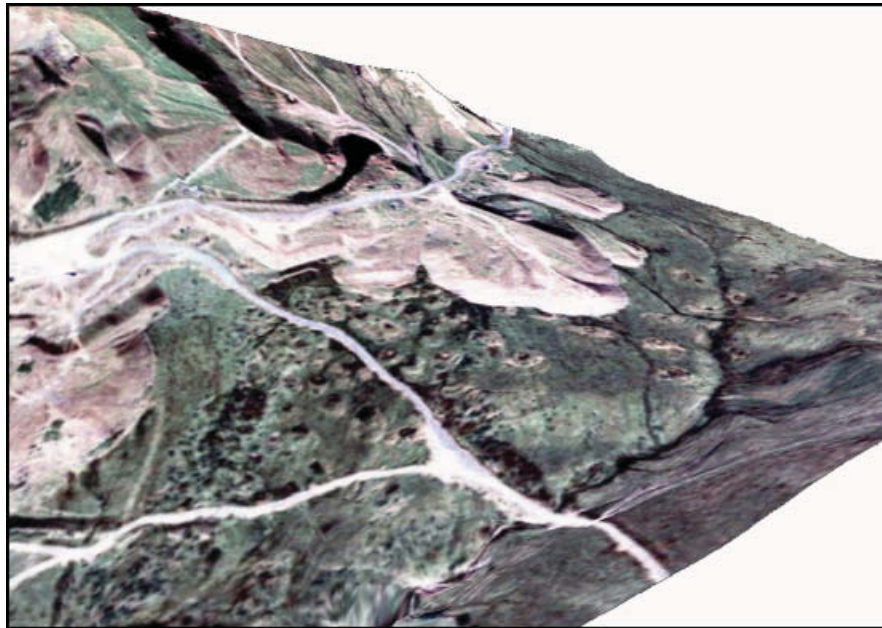
*Fig. 1: Opencast and bell pits at Benson's Brook*

- **Open-cast**, as described above, the simplest and earliest method of extraction is the open-cast trench mining of close to surface deposits, overburden being removed where the coal occurs close to the surface and the seams followed by open trenches. Few examples of this style of mining remain extant as they tend to be over-worked by later, deeper pits. However, it is possible to recognise some evidence of this type of working as at Horseditch in proximity to Benson's Brook and possibly on parts of Catherton Common.

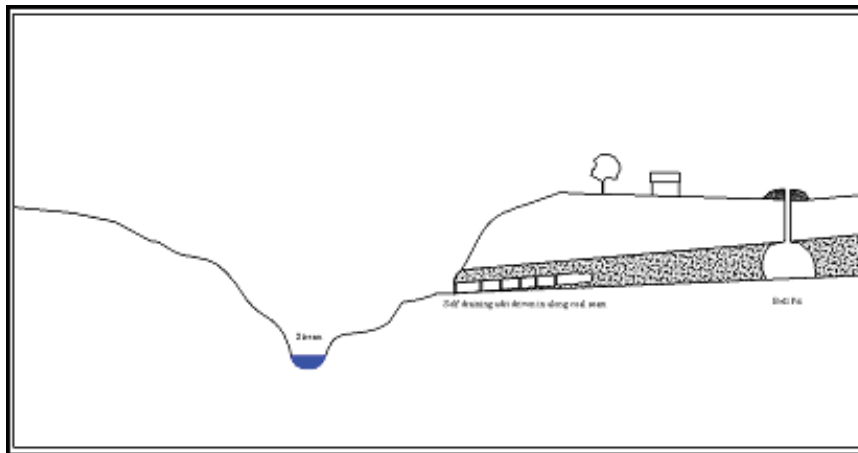
*Fig.2: Section through simple self-draining drift mine*

- **Drift mines** were a natural progression from trench working where roads were driven into the hillside following the coal or iron seams. This type of working is known by a variety of regional names throughout the country - in the Forest of Dean as 'gales', in the tin workings of Cornwall as 'wheals and in South Wales as 'futerrails'. A version of this latter form appears to have been adopted on Clee as 'footrail'. As noted above the Knights' Cornbrook drift mine was referred to as the 'Footrail Pit'. In the Cornbrook area, this pit was driven upwards at an angle of between 15 and 20 degrees following the dip of the Gutter Coal. This had the advantages of allowing drainage by channels cut into the sides of the drift floor. The angle of the drift at the Footrail Pit also allowed loaded tubs to be moved from the face by gravity. Characteristically, such drifts had a problem with both drainage and ventilation. On Clee Hill the high rainfall in winter months and the spring line made these simple drifts notoriously wet. As a result many were abandoned or later converted into drainage adits. A modification of the technique designed to alleviate the problem was the drainage sough. Here the drift itself is driven from the hillside sloping downwards. A smaller adit or sough is driven from a lower position on the hillside in a slightly rising plane to intersect with the drift itself as far into the seam as possible. Water would drain from the work area into the sough and flow out beneath the drift itself. On Titterstone Clee, the upward angle of the seams would have made this system impractical. Where drift mines were worked successfully over a length of time, ventilation also became a problem and it was necessary to drive a ventilation shaft vertically from the

surface to create a circulation of air within the mine. The remains of several such drifts can be identified around the hill. The Footrail Pit itself was still accessible up to comparatively recently but its entrance can no longer be located.

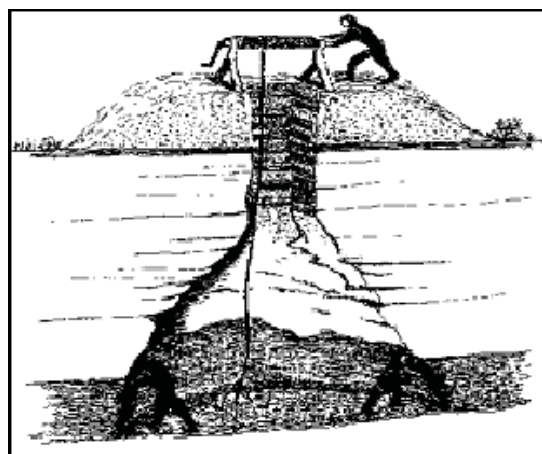
*Fig. 3: Section through bell pit*

- **Bell pits** were small pits where a shaft averaging 3-5ft in diameter was sunk vertically through the overburden into the coal seam. The coal was then worked out around the shaft creating a bell-shaped profile until the point that the roof of the pit became unsafe. Spoil and coal were raised from the pit by a simple bucket system. By this time, another shaft would have been cut adjacent to the first down to the coal, ready for opening. In this way it was a continuous process, the spoil from the excavation of the new shaft being used to fill up the adjacent exhausted pit. Characteristically, the coal extracted formed a shallow hollow of a rough circle in plan with an average diameter of 6m and a distance between pits of 5 to 10m usually with a crescent of circular spoil mound surrounding the central shaft. These were small gang work operations, not without some danger and considerable skill would have been required to know how far the bell could be extended before collapse occurred. It can be seen from the description of the process employed how rapidly this type of pit can proliferate over an extensive area.

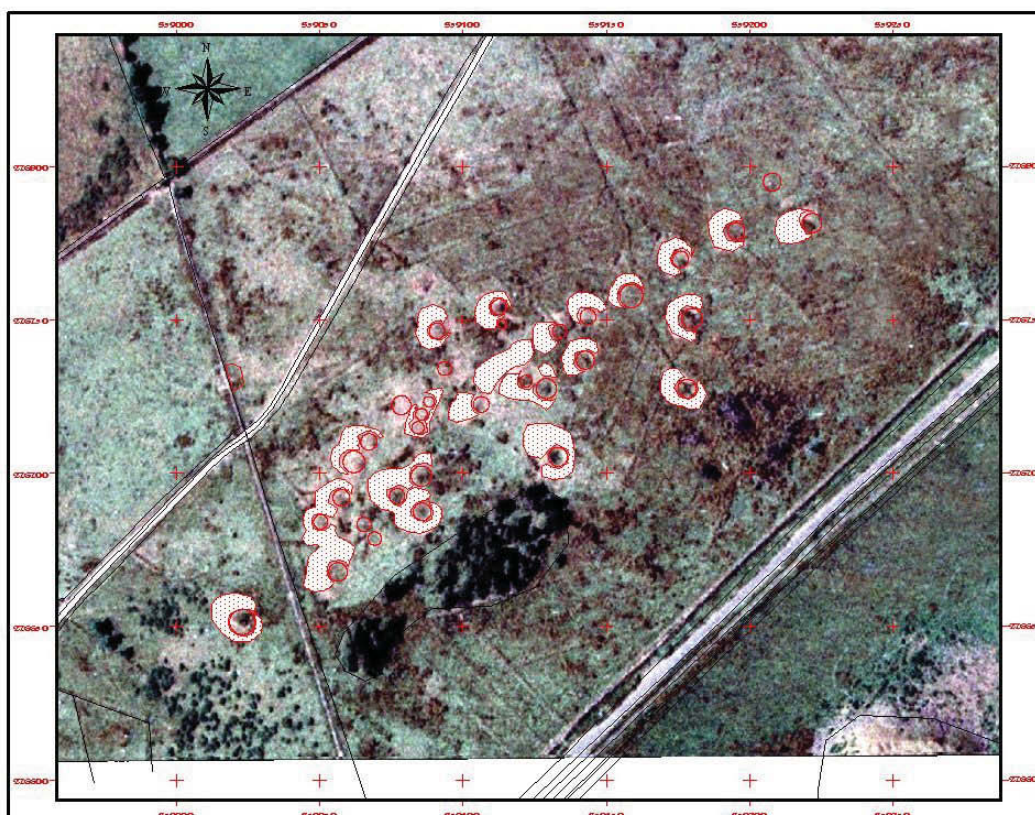
*Fig.5: Location and distribution of bell pits centred at SO 5911 7672*

A group of 32 bell pits lying along a west-facing slope to the west of Dhustone Lane below Hoare Edge, running from SO 59014 76643 in the south to SO 59221 76792 in the north on a SW-NE orientation (252m by 84m) to give an overall area of some 1.7ha. The pits lie across the slope at a height of 409m AOD in the south, 429m in the north. The shafts vary in diameter from the largest at 9.0m to the smallest at 3.5m with an overall average of 5.0m. The content of the waste mound indicates that they were coal workings. This complex appears to be working the same coal seam as the Horseditch pit complex which lies to the north-east and these pits may be an extension of this mining operation.

The pits lie in marginal but enclosed hill pasture which shows evidence of having been improved by herring bone drainage at some time in the past. Today the vegetation is a mixture of grass, sedge and some gorse.

This group of bell pits lies in enclosed hill pasture to the north-west of Dhustone Lane and is not visible from the Lane. There is a footpath from the lane to Nine Springs Farm which passes close by the SW corner of the group. However, these pits do not readily lend themselves to any enhanced presentation.

No further action required.

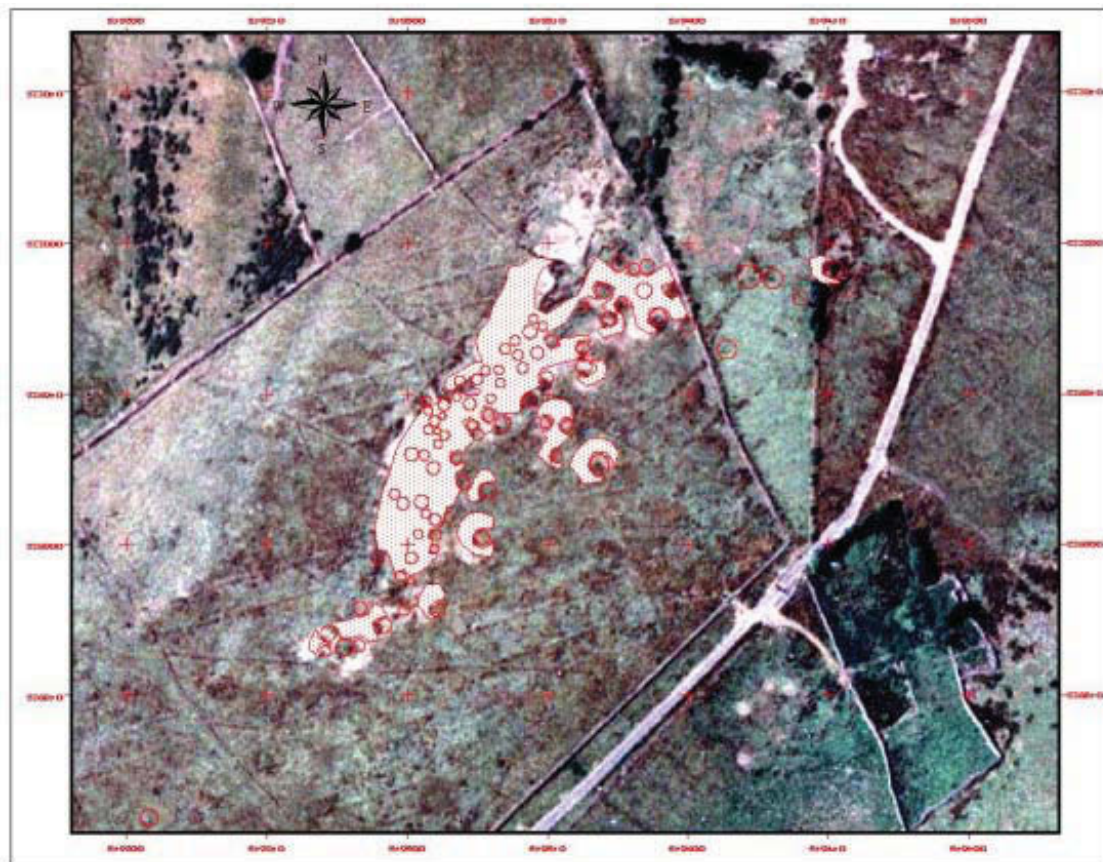
*Fig.6: Location and distribution of bell pits centred at SO 5933 7695*

A group of some 75 bell pits lying along a west facing slope to the west of Dhustone Lane below Hoare Edge, running from SO 59265 76857 in the south to SO 59453 77000 in the north on a SW-NE orientation (240m by 75m) to give an overall area of some 1.4ha. The pits lie across the slope at a height of 431m AOD in the south, 439m in the north. The shafts vary in diameter from the largest at 7.0m to the smallest at 3.5m with an overall average of 5.0m. The content of the waste mound indicates that they were coal workings. This complex appears to be working the same coal seam as the Horseditch pit complex which lies to the north-east and these pits may be an extension of this mining operation.

The pits lie in enclosed hill pasture which shows evidence of having been improved by herring bone drainage at some time in the past. Today the grass is a mixture of grass, sedge and some gorse.

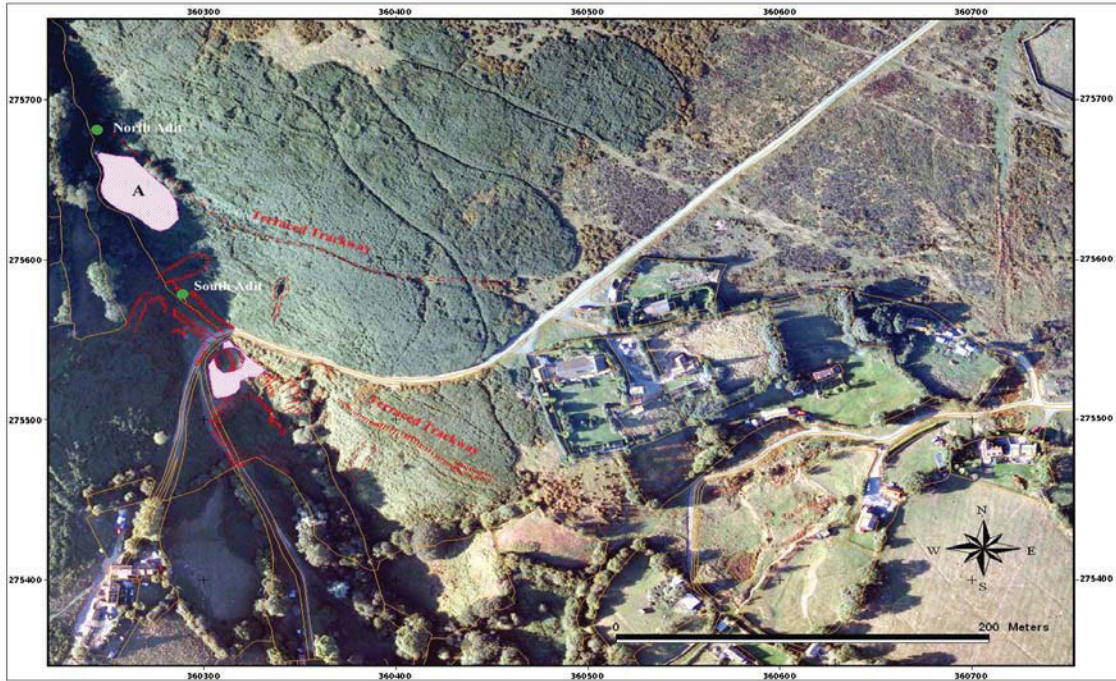
**Fig. 12: Area of Footrail Mine Complex**

This routeway can be followed from SO 60366 75514 where it ends abruptly on the east side of the rock fissures, described above (B Fig 12). From this point it runs as a well made and well preserved terrace with an average width of 2m, in a south east direction running between the 290m and 300m contour (Plate 18). Although now washed out in the area of SO 6052 7543, it continues beyond as a recognisable track-way which links with an existing track at SO 6055 7543, an area that is locally associated with a possible former brickworks (MSA 3719). From here the track complex links into the road network to the west. It seems probable that this terraced way is the original access road to the Footrail mine. Although now broken by collapse from the limestone exposures at SO 6035 7553 (area B on Fig. 12), a short length of terrace immediately north of the existing roadway, running between SO 6031 7555 and SO 6028 7558 lies on the same alignment as the terrace to the east and may be a continuation of this routeway. The north end of this feature ends at what is thought to be the position of the mouth of the adit, now infilled.

The exact position of the drift entrance is uncertain as it has been capped and covered over and today is heavily overgrown with bracken. However two positions at a height of 320m OD suggest themselves as possible locations (area C Fig. 12). The first at SO 60282 75580 is shallow stony cutting from which a steady stream of iron stained water issues (Plate 20). It is notable that even in the extreme dry conditions of the summer of 2006, water continued to flow from this position, suggesting that the adit was still functioning as a sough for the pits to the north. The second position lies 7.5m to the north-west; this position is a shallow bracken covered scoop in the hillside. Sounding and probing in this area revealed a hollow 'feel' to the ground with several bricks below the surface. Neither position is certain but it seems very probable that the adit entrance did lie in this vicinity and was served by the terraced way from the south-east.

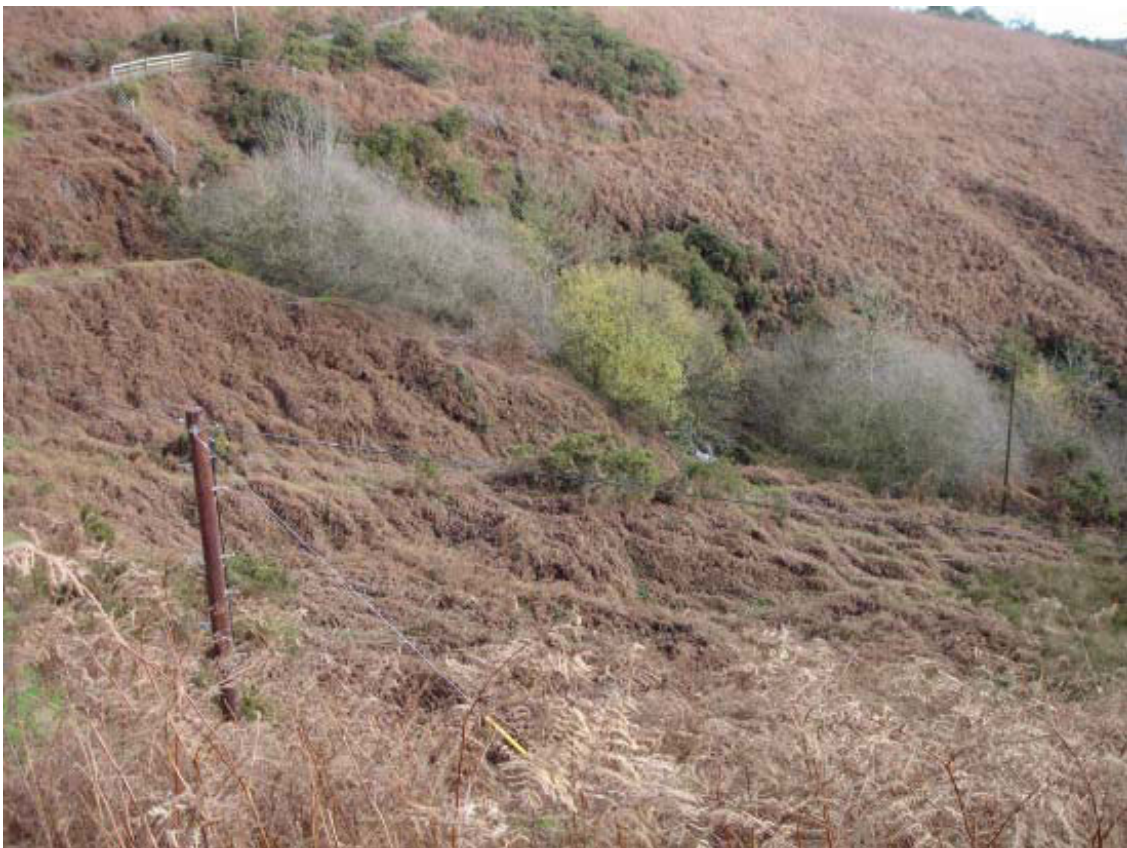
Two deep fissures centred at SO 6035 7553 immediately south of Furnace Lane itself may also be of a similar origin. These however have vertical stone faces, which fall from the roadside to the stream and present a considerable potential hazard. A wooden protection fence bounds their northern, uphill extent (Plate 19).

*Plate 16: Deep ravine with protection fence, upper left*

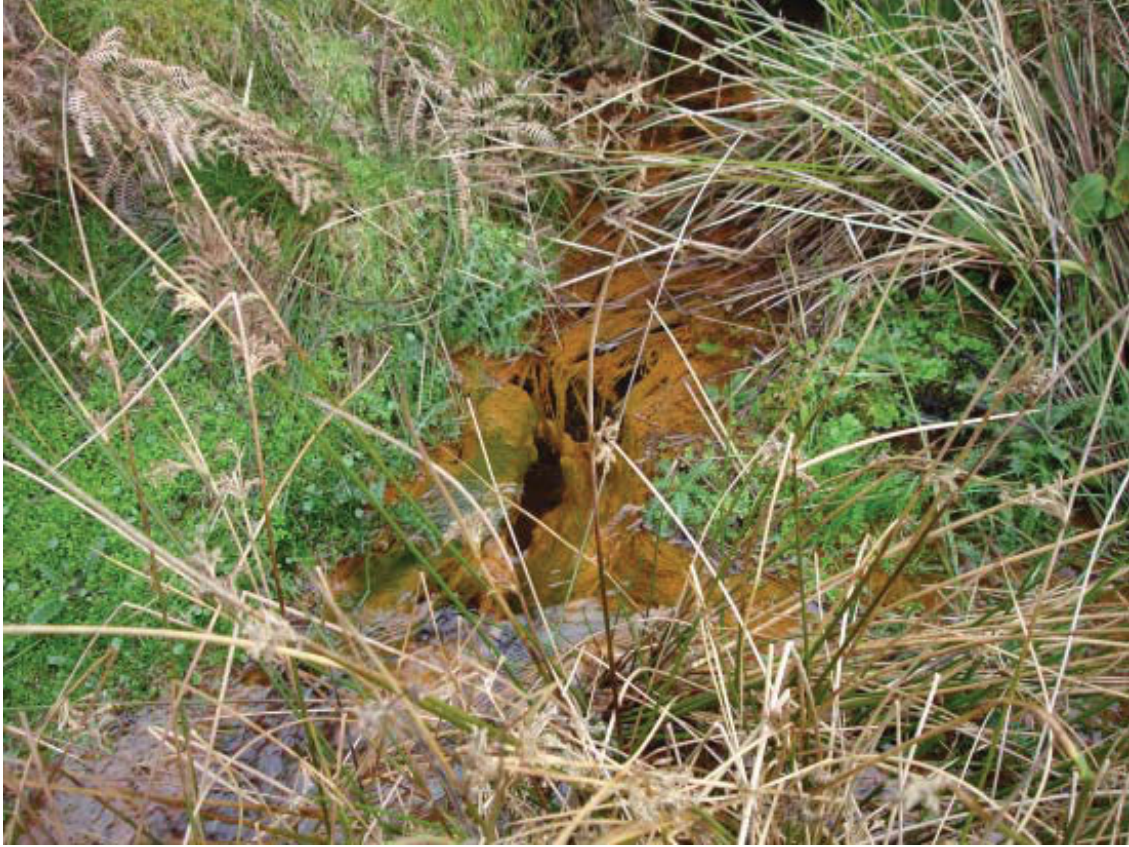
The second drift mine lies at SO 60236 75681, some 144m up-stream from the stream crossing and at a height of 328m OD. The adit itself is largely buried but can be recognised as a shallow fissure in the exposed limestone with iron stained water issuing from its base, similar to the lower mine site. This mine was quite clearly not served by the current line of Furnace Lane, as to access the site from the lane necessitates a scramble over a steep slope to climb the stream valley to a point above a small water-fall. The area of hillside above this mine is densely covered with bracken. However it is possible to identify a terraced trackway which climbs the valley side from the proximity of the adit to the valley lip at around SO 6026 7567. From this point, a well defined terraced track-way can be followed curving across the hillside in a south-easterly to easterly direction for some 250m to end at SO 6050 7558 on the current Furnace Lane. From this point it may have continued to the east skirting to the north of a group of squatters' settlements to link into the same track and road network as the previously described, more southern terraced way, at SO 6078 7551. It seems certain that this is the original access route-way to the mine. Although the dense bracken makes full interpretation difficult the first 40m of so of the track-way runs along a stone walled revetment. This lies immediately above an extensive flat area centred at SO 6026 7564 (A Fig. 11 ) with dimensions of 60m NW to SE by 25m transversely, and at least some of this platform appears to be made up of spoil. This is probably the work and storage area associated with the working of the mine.

*Plate 17: Iron-stained water issuing from adit site*

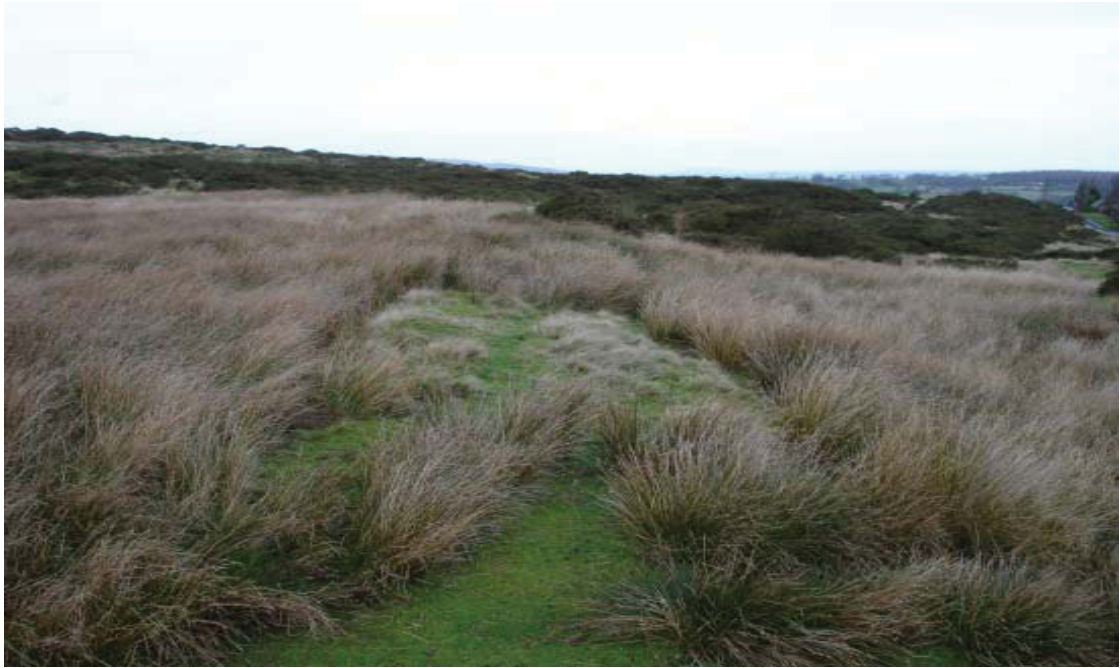
Situated within and towards the northern end of the main belt of bell-pits, described as TCR (C205) are the remains of an embankment (B on Figure 14), forming a D-shaped enclosure against the naturally rising ground to the west. The interior is flat with dimensions of 120m north to south by 60m east to west. It is comprised of a series of lengths of linear banks the most northerly commencing at SO 61868 77144 and running to the SE for 21m where it is broken before continuing on the same alignment for a further 8m to SO 61892 77124 where it is again broken. Some 4.5m to the south the embankment re-commences on a more southerly alignment running for 11m between SO 61894 77119 and SO 61895 77109 where it is again broken. From SO 61894 77105 it continues running north-south as a well-defined bank up to 1m high and 7.6m wide to SO 61896 77081 where it is overlain by the spoil and crater of a later bell-pit. South-west of the bell pit the embankment re-emerges at SO 6190 7706 to run on a north-east to south-west alignment as a slighter bank up to 6m wide and 0.4m high for a length of some 45m before fading out at around SO 61873 77037. The age and purpose of this enclosure are uncertain, but it seems likely that the embankment was originally designed to pond water against the hillside to the west. There are springs in the in flat interior, which is wet and vegetated predominantly by sedge. Water flows down to the east through the breaches in the embankment and if the bank were intact would be contained within it to form a substantial body of open water.

*Plate 21: Section of embankment with flat wet interior to the left and hillslope to east*

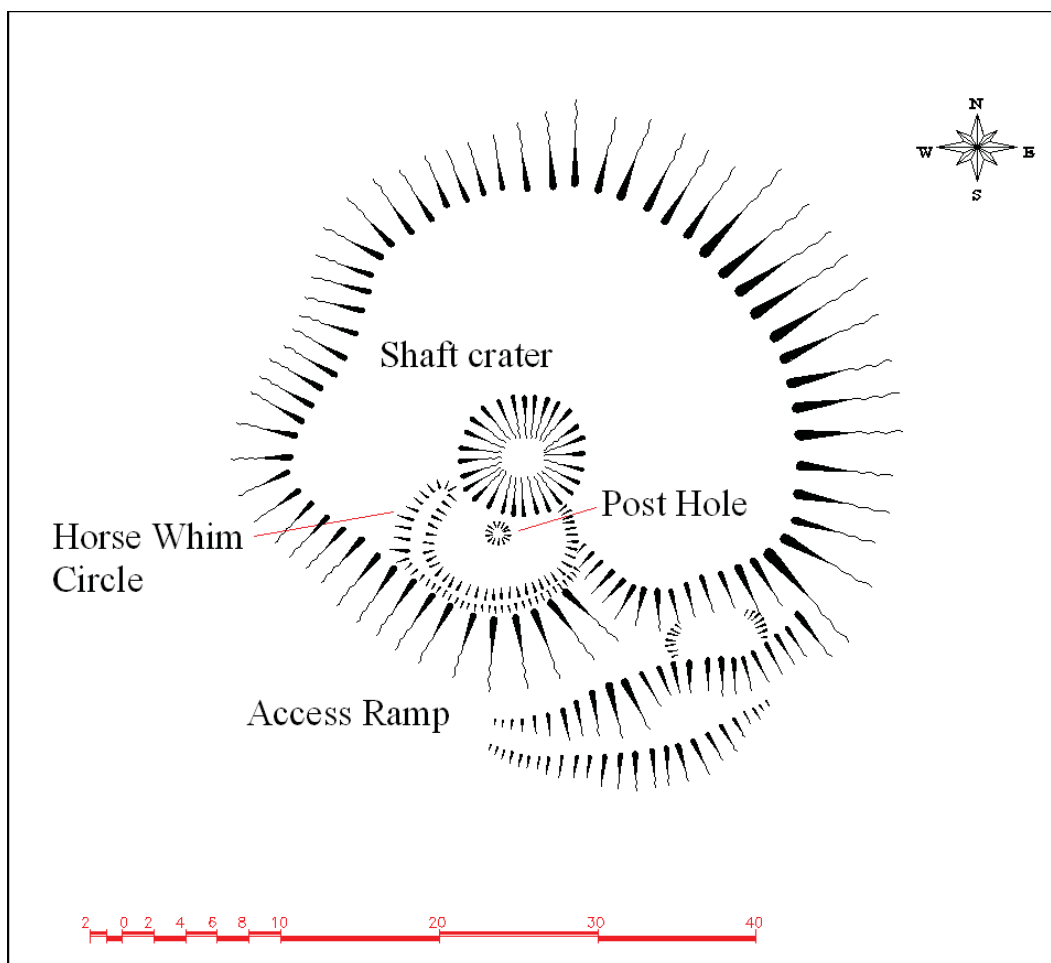
The surface remains of the pits on this eastern slope are also unusual compared to the pits in the main belt of bell-pits described further to the west as (TCR C207). Several exhibit secondary features such as attached enclosures and coal screening areas suggesting a more sophisticated method of mining and management. One such unusual survival is the pit centred at SO 62360 77938 (Fig.16). The shaft crater lies roughly central to a substantial mound of spoil and is 7.6m in diameter at its top and 2.6m, squared at its base and up to 2.4m deep. The spoil is a flat-topped, roughly circular, mound 42m east to west by 43m north to south standing to a height of 2.8m. The top of the mound is approached by a made ramp-way which climbs the mound at its south-west quarter. On the top of the spoil mound, adjacent to the south western quarter of the shaft crater, is a very unusual survival, possibly unique upon the hill. A shallow circle 8.5m in diameter has been eroded into the top of the spoil to create a shallow bank no more than 10cm high and up to 2m wide. The northern quarter of the circle has been lost in the collapse of the shaft crater. However at its centre is a shallow circular hollow 1.5m in diameter and up to 10cm deep. These features are almost certainly the remains of a horse whim, the central hollow being the site of the winding post and the outer circle created by the tread of the horse walking constantly around the post.

**Fig. 17: Horse Whim Pit centred at SO 62360 77938 (A)**

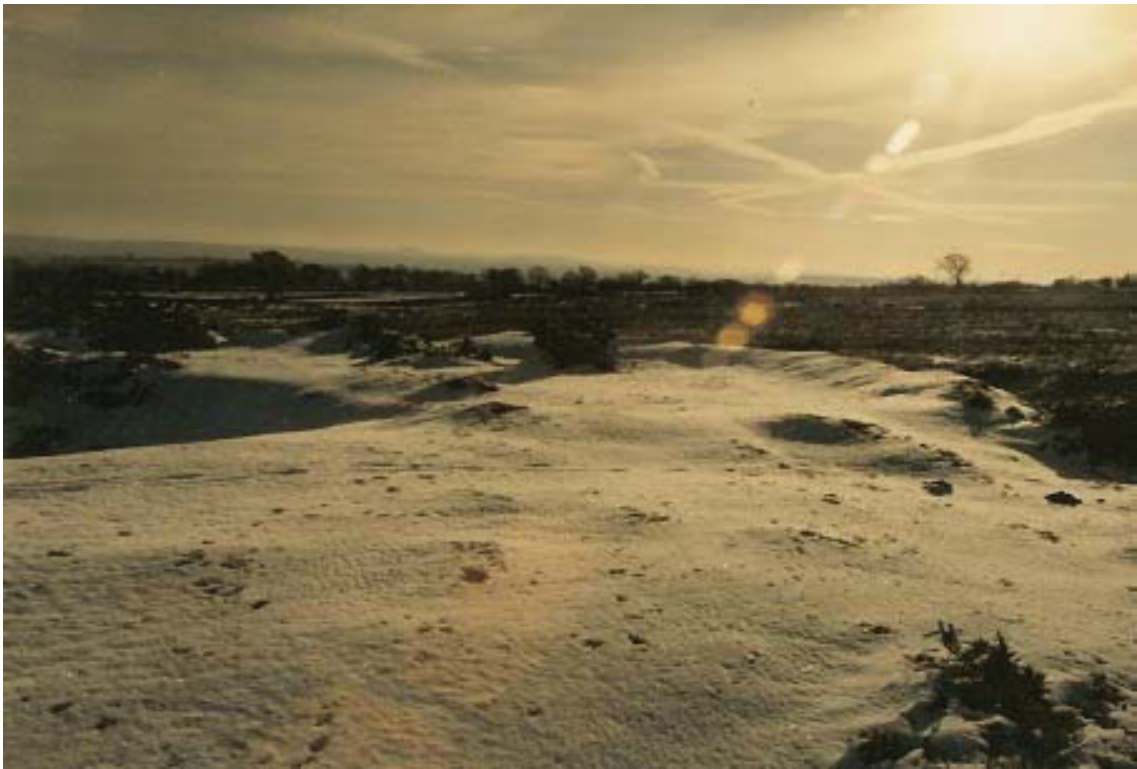
*Plate 29: Horse Whim SO 6236 7794 ( Pit A) under light snow, 1989*

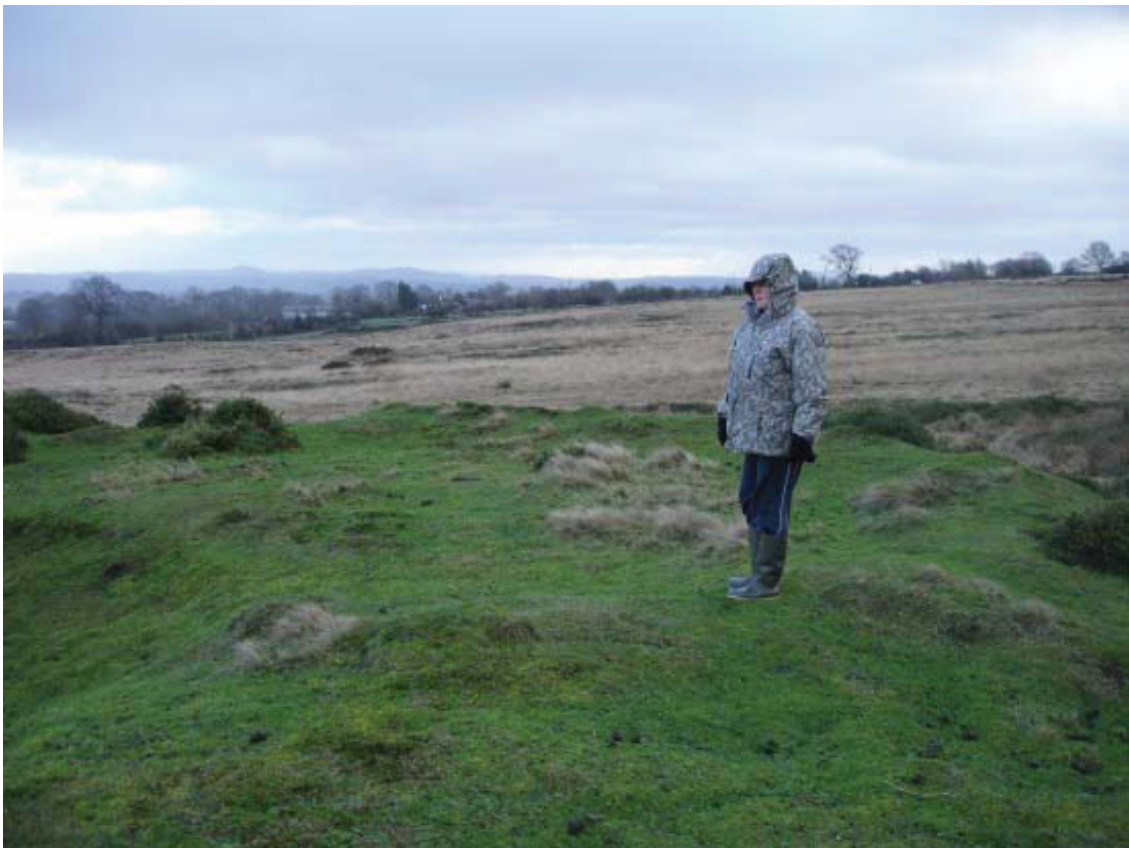
*Plate 30: Horse Whim 2006; figure is standing on bank of whim*
