DELPH HILL CHURCH, CHORLEY OLD ROAD, BOLTON, GREATER MANCHESTER: AN ARCHAEOLOGICAL BUILDING RECORD

CS Archaeology
March 2013

Project Number: 113

Planning Ref: 86666/11

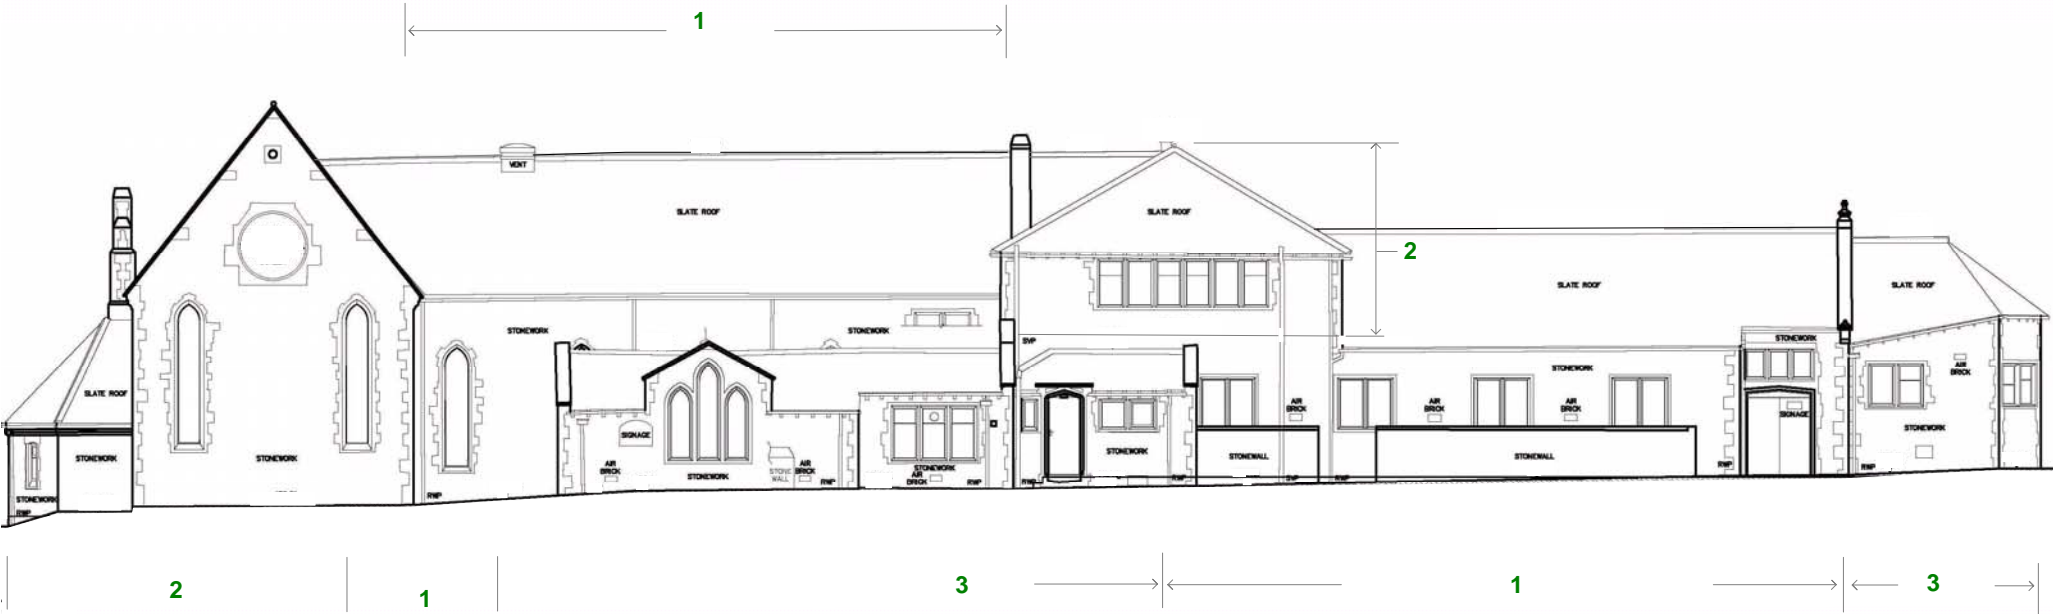
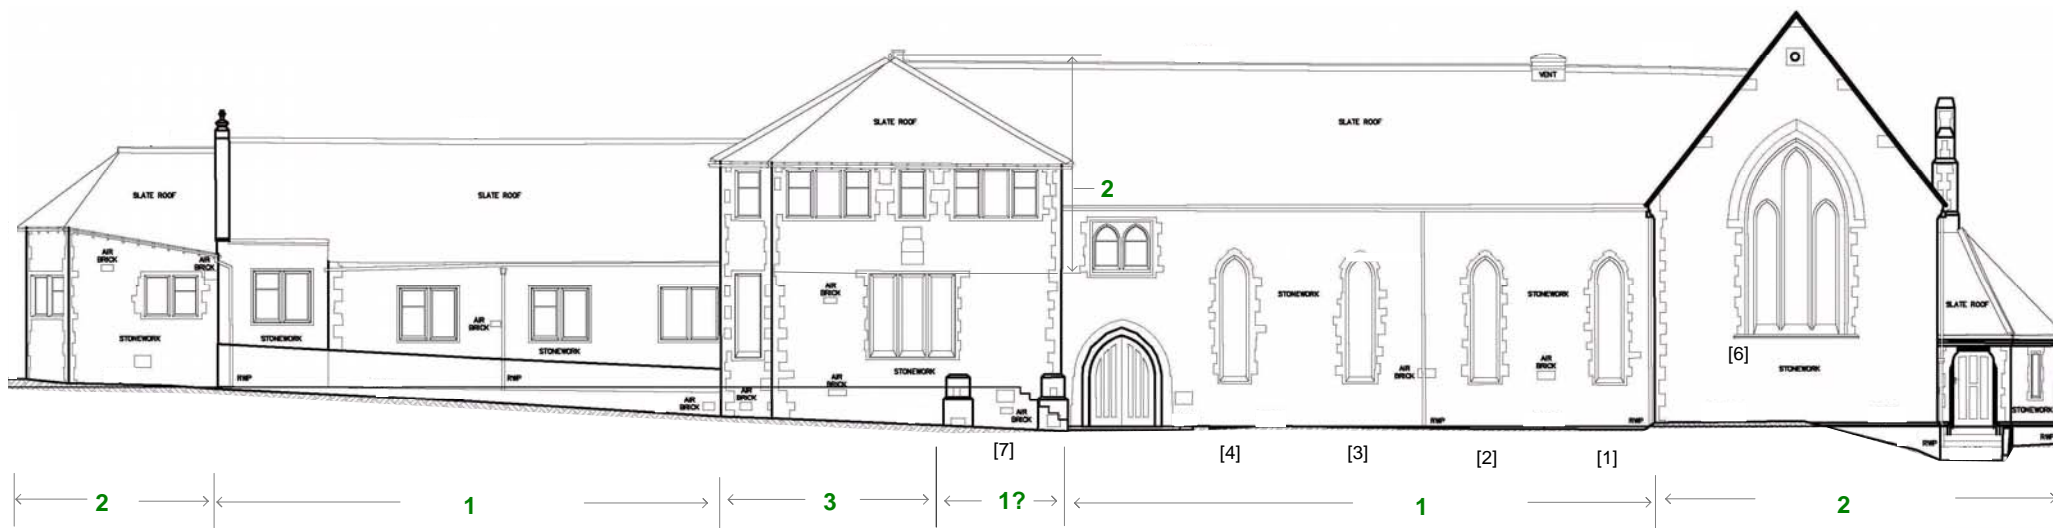
North Elevation

Building phases 1-3

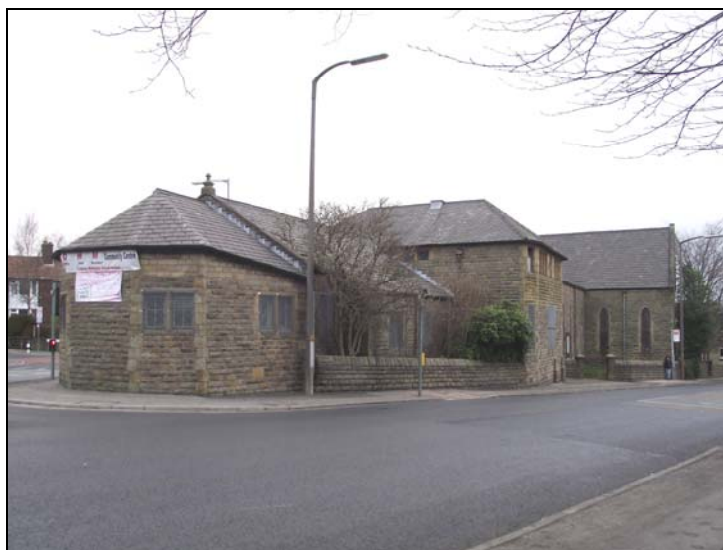
Plate 1, 15: general view of the church's west elevation, from the west southwest

- 7.1.1 Delph Hill Church and Sunday School is a substantial building, nearly 54m in length, situated in a prominent position, to the north of Chorley Old Road (**Plate 1**, 157). The building features variable roof and wall lines. The walls are of coursed stone (course grained sandstone/millstone) with a rusticated relief finish. The wall's coursing varies between 0.15 and 0.19m deep to the lower walls and diminishes with height. Windows and doorways, form a common style, and feature smooth ashlar stonework with splayed mullions and chamfered surrounds. The roofs are all in Welsh trimmed slate and are finished with scrolled dark clay ridge tiles, broken only by the remains of a capped louver to the church nave. Arranged around the building are a number of ashlar memorial stones built into the building's walls. Gables are marked by stone copings. The grounds are limited to an apron of land around the east elevation of the church. The church does not contain a burial ground.

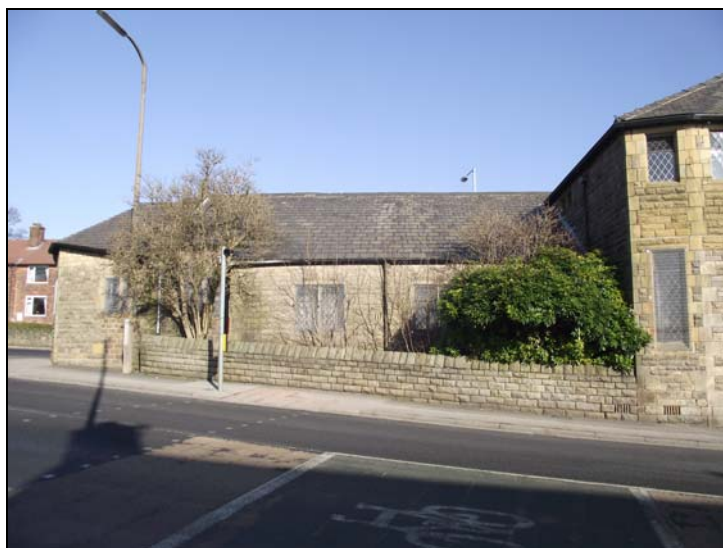
Plate 2, 16: view of the Sunday School's south elevation, from the south

- 7.1.2 The front, *South Elevation*, is nearly 54m in length and 11m high. The building is built on an eastern slope but deceptively increases in height the further east the building goes. There is architectural division in the fenestration between the Sunday School and the Church. The Sunday School is situated at the western end of the building and features square headed ashlar windows with splayed mullions and chamfered jambs and sills. The associated keystones contrast with the coursed rustic walls (**Plate 2**, 16). To the lower wall of the extension is an ashlar memorial stone¹,

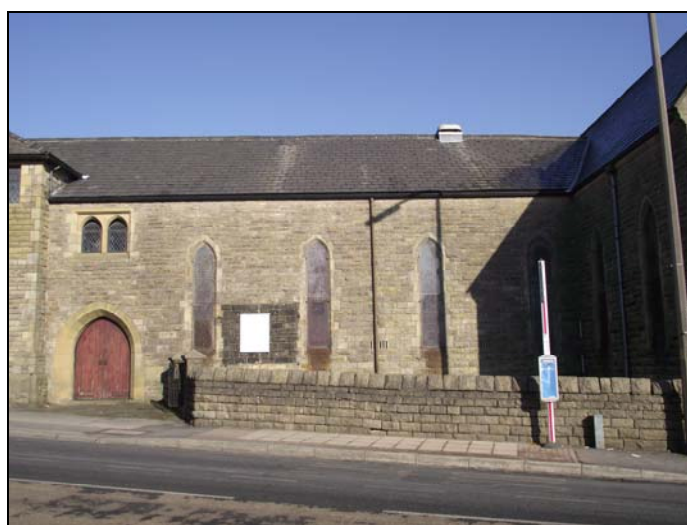
Plate 3, 22: view of the Nave's south elevation, from the south

one of a series to the south elevation. The church, in contrast with the square headed windows, is represented by tall lancet ones (**Plate 3, 22**), culminating in the eastern transept with its triple lancet window to the gable.

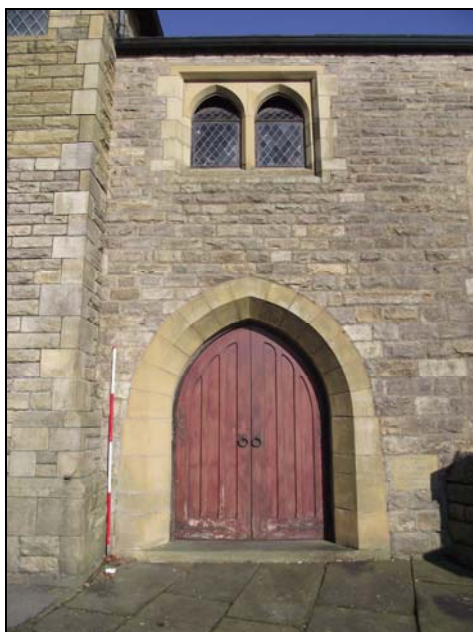
Plate 6, 19: the church's front entrance doorway, from the south

- 7.1.4 The church doorway is situated immediately east of the Sunday School, next to the south wall of the Nave (**Plate 6, 19**). It is a wide arched doorway with an ashlar surround that features a plain deep continuous chamfer. The doorway is fitted with double oak doors with vertically set boards. Close examination of the doorway suggests it was inserted into its present position. This is based on the truncated adjacent walling and the weathering/stone source of the chamfered surround which is consistent with the phase 3 stone work to the Sunday School. Above the front door set in chamfered ashlar surround is a 4-light, twin arched window, and may have been inserted when the 'new' classrooms were adapted and subdivided the original *Gallery c. 1881* (Rms. 24-26) of the Sunday School in the 1930s. Next to the front door there is an ashlar memorial stone³. The south elevation of the Nave features 4 lancet windows with chamfered ashlar surrounds. The wall features rusticated stone work with 0.19m joints, graduating to shallower courses with height. To the lower wall is a chamfered plinth which extends 0.15m from the wall. This plinth was adopted in the Transept and Vestry. The gable southern elevation of the transept features a single triple lancet window with splayed mullions, with chamfered mouldings to the jamb and arch, and a scrolled protecting sill (**Plate 7, 25**). Above this window is a small circular ashlar opening, probably served as a ventilator. To the gabled roof are a series of interlocked (rebated) coping stones, with a carved scroll to the apex. At the eastern end of the south elevation is the five externally sided *Vestry*. This elevation features the *Vestry* door with its stop chamfered jambs, carved lintel, and oak paneled door (**Plate 8, 2**). The Vestry windows feature chamfered ashlar jambs with a false arch to the square headed lintels. To the roof there is a stepped tower, its purpose is unknown but may have originally been designed as a bell tower.

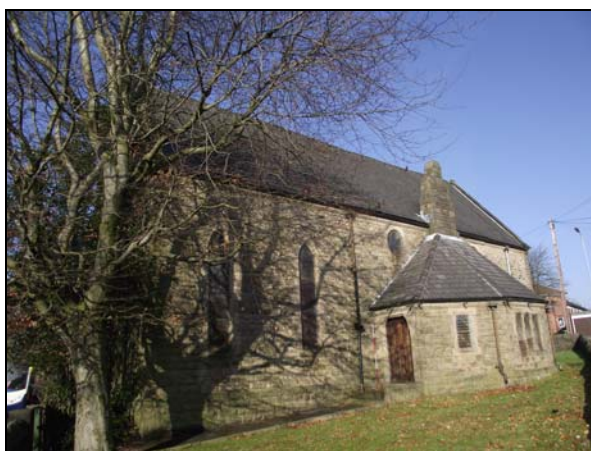
Plate 9, 7: view of the east elevation with Vestry, from the southeast

- 7.1.5 The *East Elevation* consists of the transept and vestry (**Plate 9, 1**). The transept dominates the elevation with its gabled roof and coping stones. The transept wall features two lancet windows and either side of the vestry roof are two multi-foil circular windows. Three walls of the Vestry are visible and feature arrised (corner ashlar tooling) edges to each wall. The lower vestry walls feature a chamfered plinth, and the upper walls a ashlar chamfered cornice. The Vestry windows feature splayed mullions, with chamfered sills, stop chamfered jambs and false

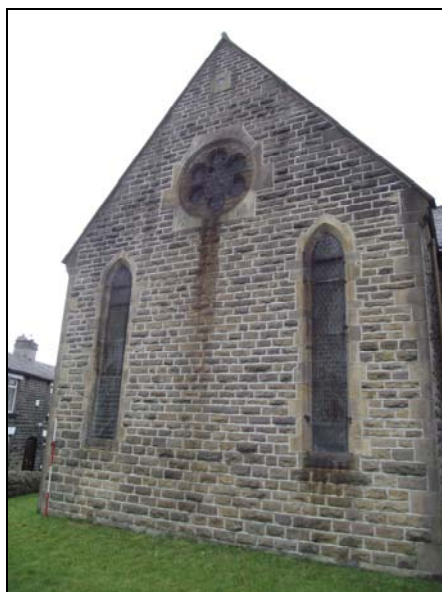
Plate 10, 3: view of the transept's gabled north elevation with multi-foil circular window, from the north northwest

7.1.6 The *North Elevation* is apart from, a reflection of the southern elevation with the pitched roof of the Vestry, transept gable with its twin lancet windows and a further multi-foil circular stain glass window (**Plate 10, 3**). Towards the roof apex is a further small circular opening which may be a ventilator facilitating a cross flow of air with a corresponding ventilator to the southern gable. The 1930s extension obscures the lancet windows to the Nave (**Plate 11, 10**), but features the tall triple lancet window contrasting with the remaining square headed (splayed mullion) windows to the Sunday School. The central 2 storey Sunday School section features a chimney stack to the east of its hipped roof. There is a multi-light first floor window which also reflects the window to the south elevation. There is a horizontal building line marking the 1930s vertical extension to the Sunday School and the original splayed mullion to the ground floor remains in situ as a series of three similar windows to the school. Towards the west of the elevation is the main Sunday School door (**Plate 12, 14**). This is stepped back from the main façade and features a wide chamfered doorway with a splayed mullion and chamfered jambs and sill above.

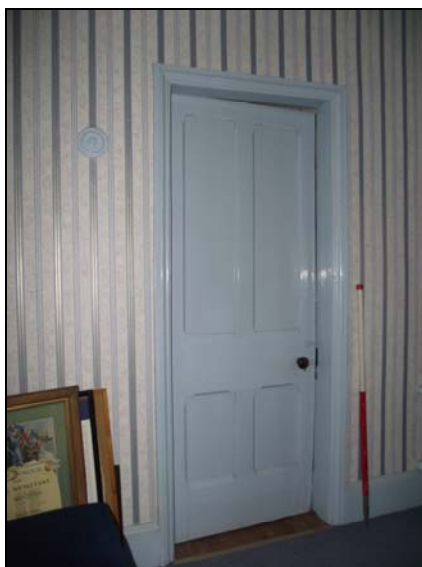
Plate 14, 155: room 2, detail of the 4 panelled doorway with stop chamfered decoration (c. 1870), from the south southwest

- type 1 – four paneled with recessed panels and stop chamfer, c.1870 (Vestry doors, **Plate 14, 155**);
- type 2 - two recessed panels, c. 1930 (**Plate 15, 113**).

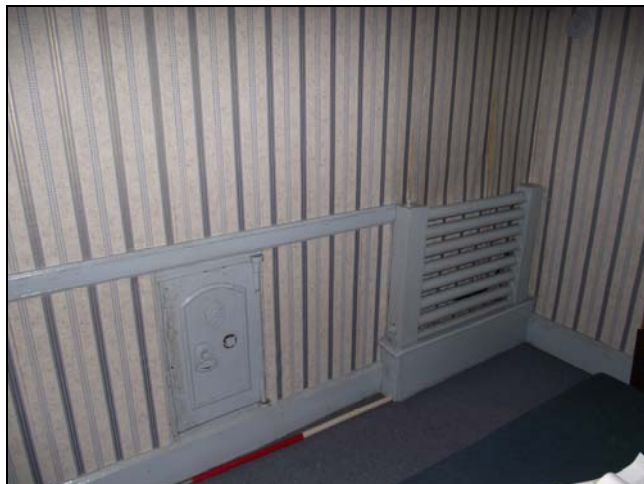
Plate 18, 153: Room 2, view of the safe and radiator to the west wall

floor is probably boarded throughout and is presently carpeted. The walls are plastered and there is a deep chamfered skirting board to the Lobby (Rm. 1). Fitted to the west wall is a cast iron 'tubular' radiator and a wall safe (**Plate 18**, 153), which was found to be a later insertion (see Rm. 4b) into the west wall. Also to the west wall is a deep moulded dado rail. The door to the toilet is also a 4 panelled door with stop chamfers but has an internal rim lock with turned handles and its surround features ogee moulded architrave.

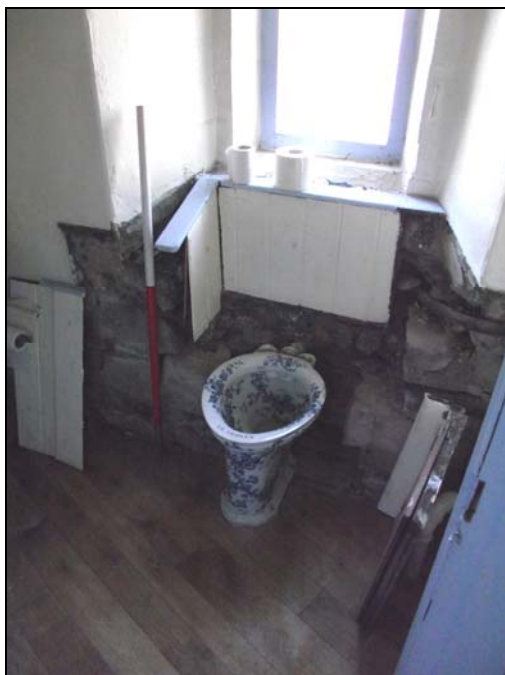
Plate 19, 90: room 3, view of the decorative *Vestry* toilet, from the southwest

- 7.2.4 **Room 3** (l. 1.83m x w. 2.32m x ht. 2.8 m) at the northern end of the *Vestry* features a decorative blue and white "LE TRIPLEX" toilet (**Plate 19**, 90) which was set against timber to the northeast wall and large "Masius Rd No 614017" wash hand basin set against the north wall. The walls are fully plastered throughout and the floor is carpeted, obscuring the timber boards beneath. Natural light is provided by a 2-light chamfered mullion with splayed reveals to the northeast wall.

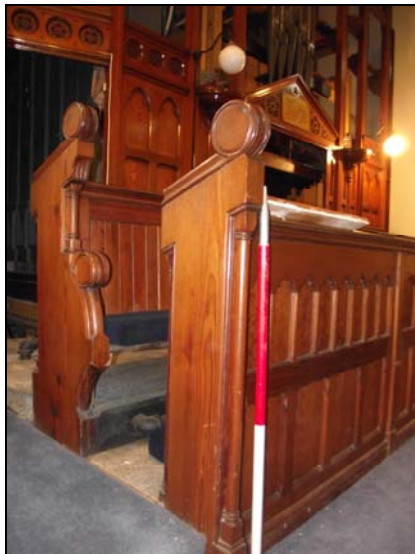
Plate 30, 177: view of the pews south of the organ, from the southwest

- 7.2.8 The choir stalls (**Plate 30, 177**) represent the earliest seated fixtures of the church and they are made out of pitch pine. The front panels feature lancet arched panels with cusped headed insets, turned columns and round decorated finials. In contrast the majority of the pews to the Nave and the Transept are later in date and are much lower in height (**Plate 31, 178**), and feature paneled dividers and have a 'scumbled' oak varnished.
