BARKER'S YARD, BOROGATE, HELMSLEY, NORTH YORKSHIRE: AN ARCHAEOLOGICAL WATCHING BRIEF

On behalf of
The Duncombe Park Estate

CS Archaeology
May 2011

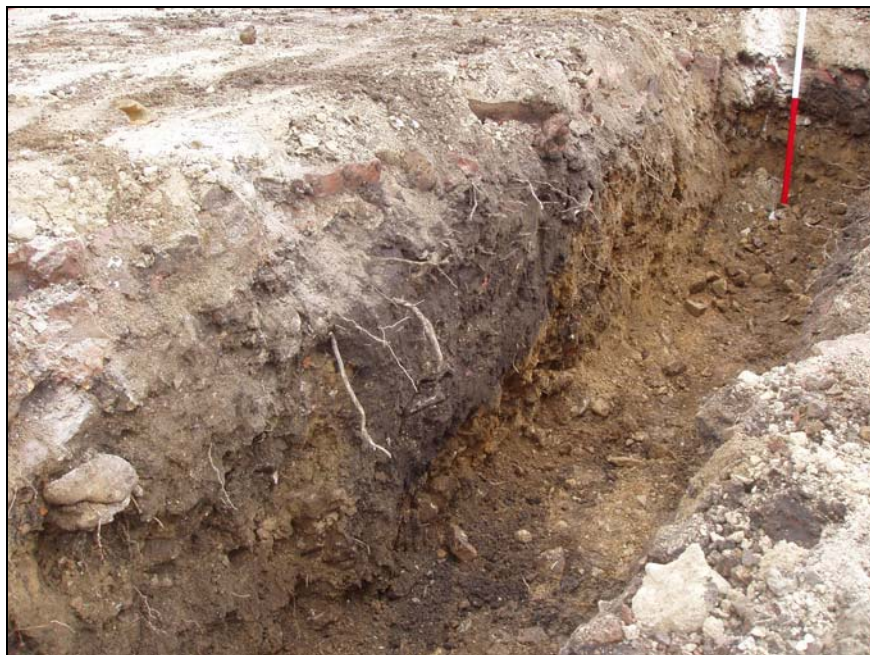
Plate 4: view of the edge of the hollow in the southwest section (Unit 6, trench D), from the northwest

- 5.3 As noted in the evaluation trenches the pronounced undulations in the underlying topography were able to be noted during the watching brief. Apart from the general southwest slope of the underlying sands and gravels the edge of a hollow was revealed at the north corner of the unit 6 foundation trench, which corresponds to the marked scope at the southeast end of evaluation trench 2 (*CS Archaeology 2010: Figure 11*). An apparent sand bank was noted in the southwest unit 5 trench (Plate 5) and a possible continuation of the channel was also noted in the southeast trench of unit 6, trench A. This consisted of at least two courses of rounded limestone boulders which were marked by a void in the section (Plate 6).

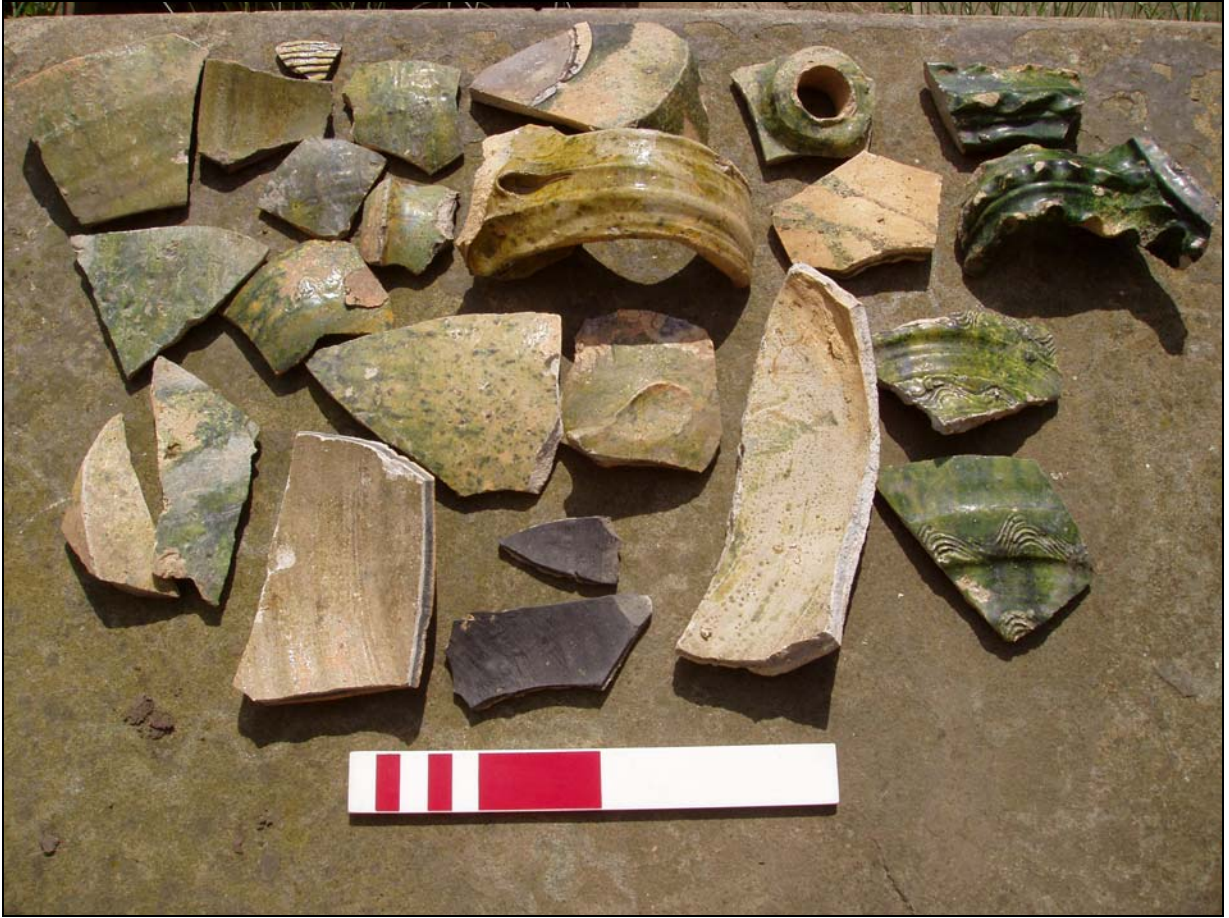
Plate 7: view of the unstratified medieval pottery recovered during the watching brief characterised by large un-abraded sherds

- 5.4 Through the course of the watching brief pottery was recovered and was notable both in its medieval date and in the large un-abraded sherds (Plate 7). A number of sherds were decorated and one appeared to feature a bug hole from a medieval pitcher.
